**HILLYBARN FARM, HILLYBARN ROAD, THE MOUNT,
IFIELD, CRAWLEY, WEST SUSSEX, RH11 0LH**

Preliminary Contamination Risk Assessment

January 2023

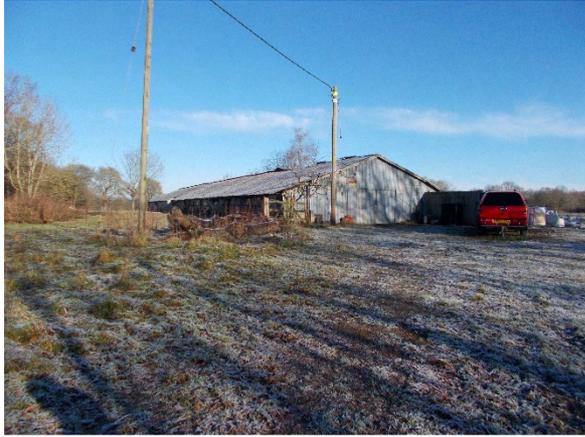
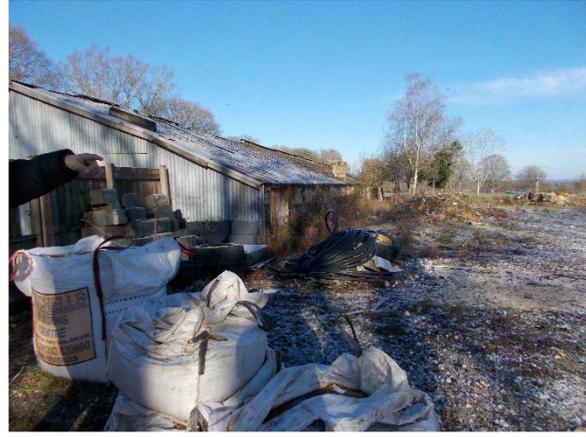
Photographs 1 and 2: Access up to the southern façade of the shed and building materials stored adjacent to the southeast corner of the shed.

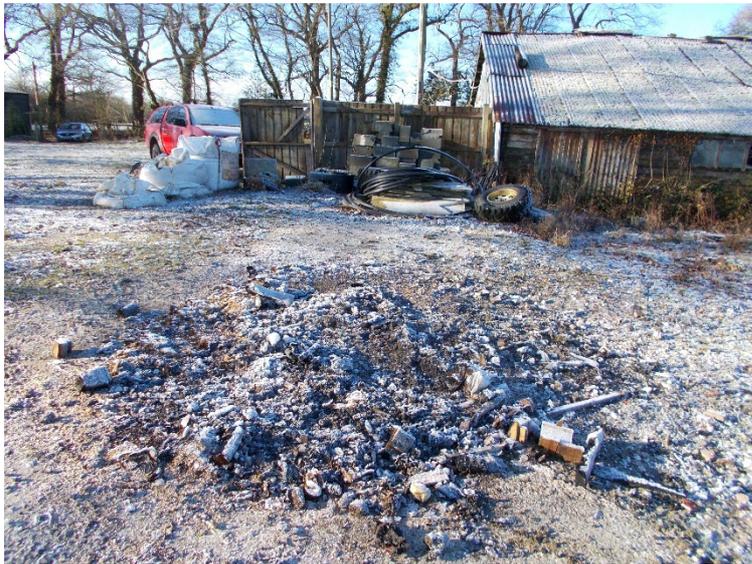
Photograph 3:

Bonfire residue adjacent to the southeast corner of the shed.

- 10.2 All waste and bonfire residue should be removed as part of the site’s pre-development clearance, together with any affected underlying soil. The waste removal documents should be retained as evidence of this work.

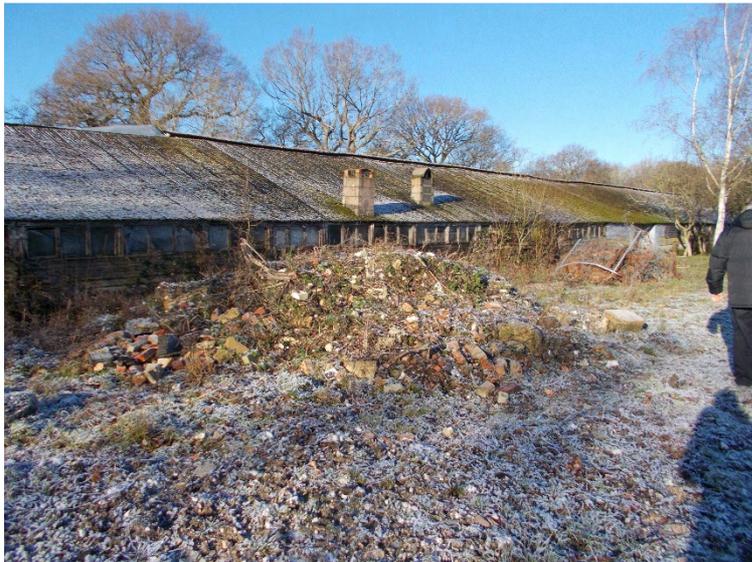
Photograph 4:

Mixed building rubble with some surface vegetation located adjacent to the southern end of the western façade of the shed.

Two chimneys located towards the centre of the shed on the eastern side of the building.

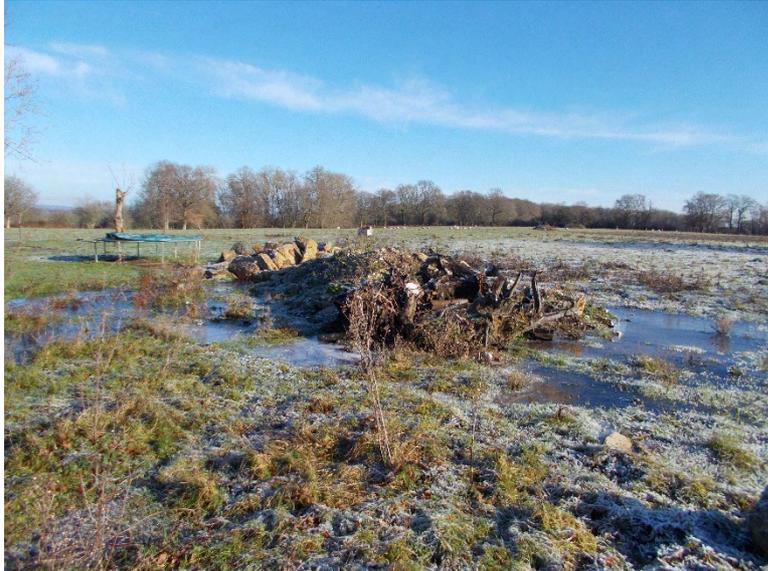
Photograph 5: Pile of brash (cut / felled wood), mixed soil and building rubble, large section of concrete slab / rubble.

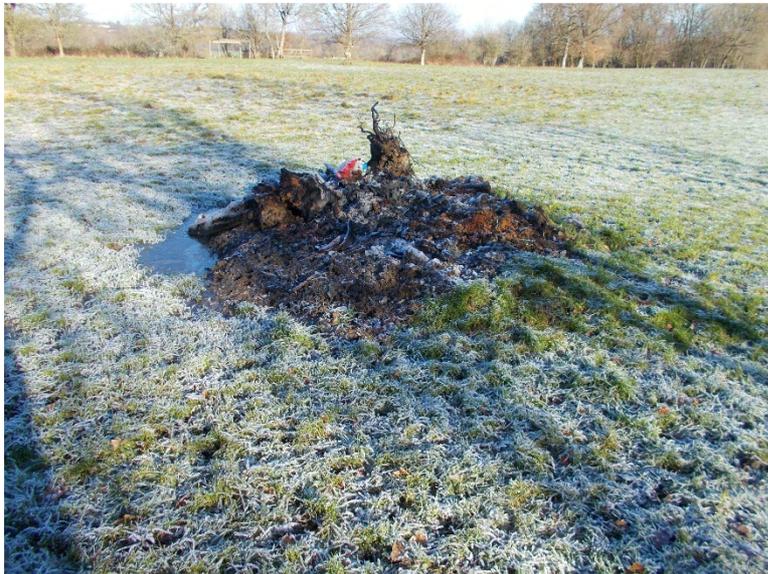
Photograph 6:

Bonfire residue with remaining wood waste located adjacent to the northeast corner of the shed.

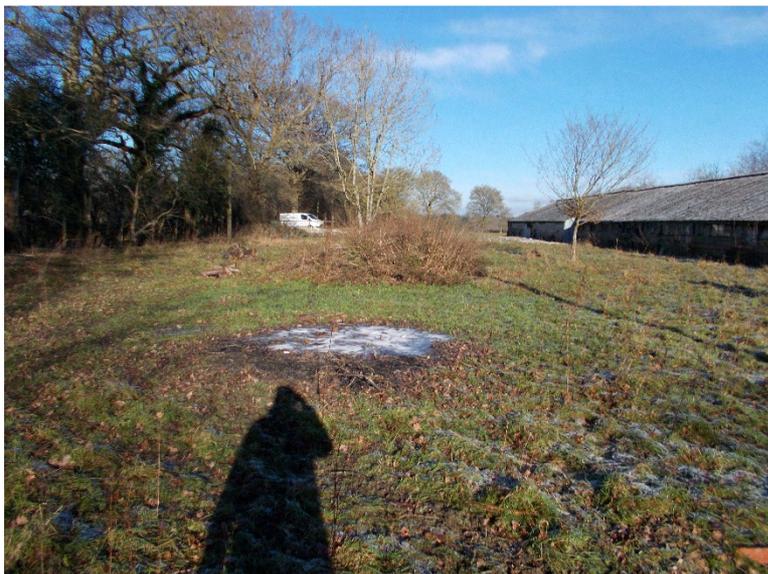
Photograph 7:

Bonfire residue and brash pile located to the west of the shed.

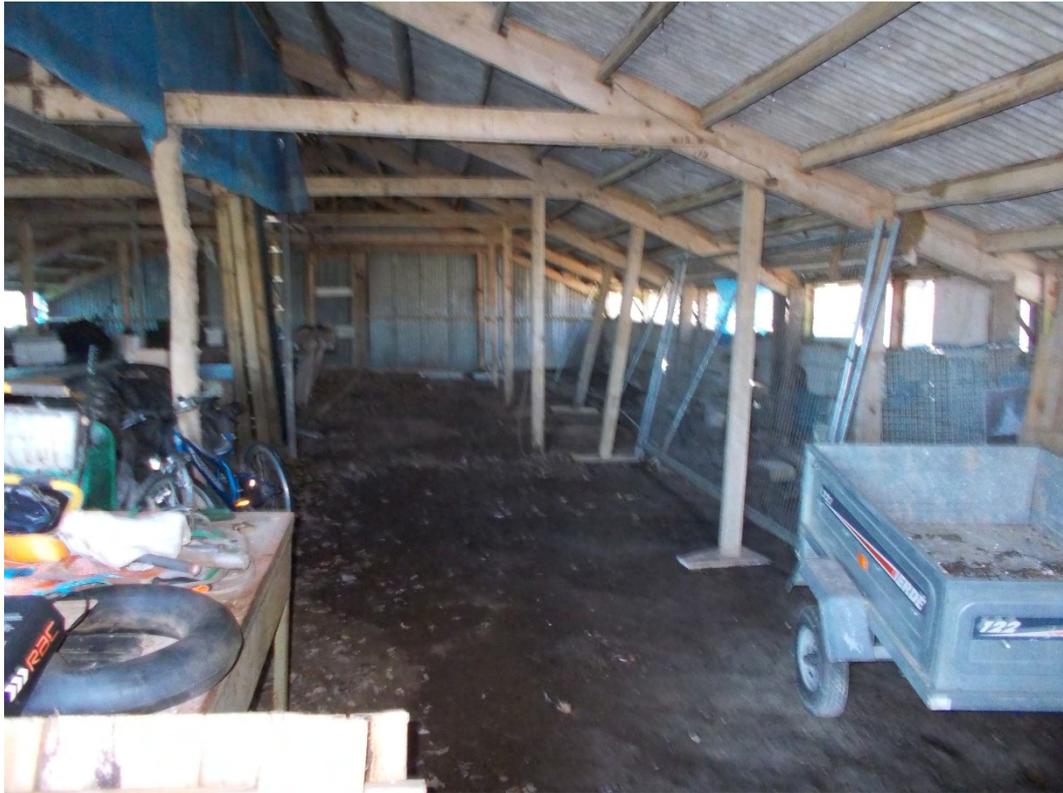
Photograph 8: Northern section of the shed with compressed dirt floor.

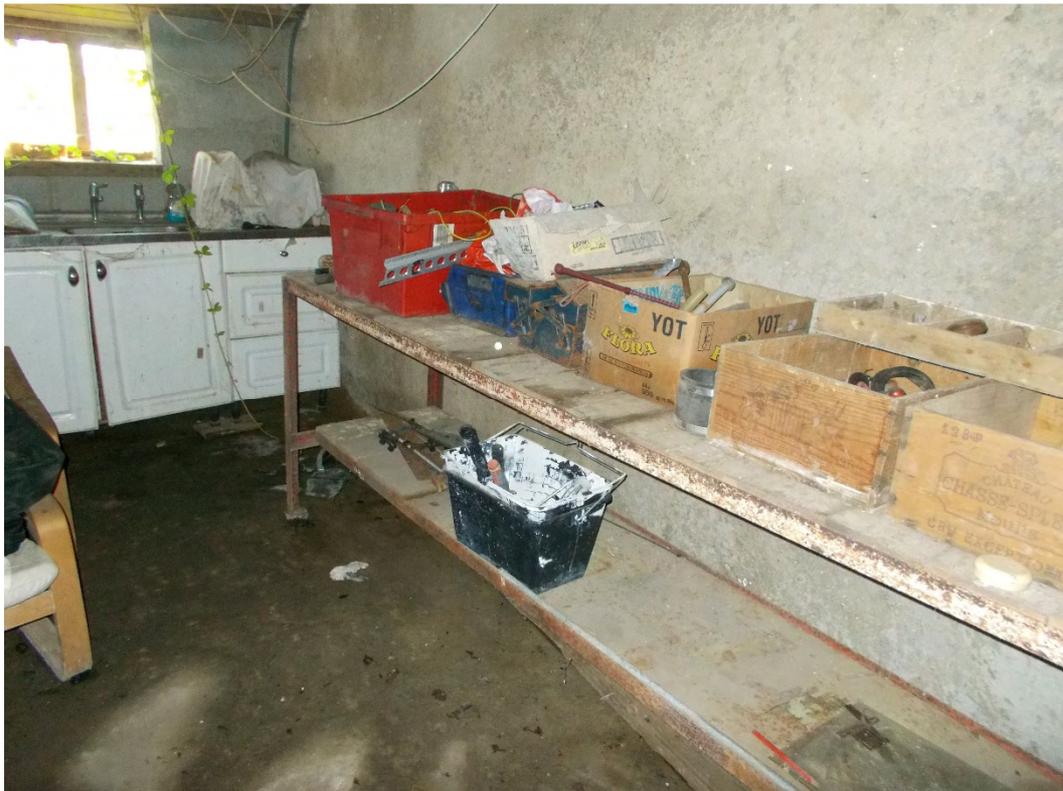
- 7.7 There may be some fill beneath the concrete flooring within the southern section of the building. Fill can be a potential source of contamination depending on the origin of the material used.

Photograph 9: Southern section of the shed with concrete flooring.
