**Project Name:** Menzies Wood Farm  
**Project Description:** CCTV Survey, trace & plot  
**Project Status:** Complete  
**Project Date:** 08/07/2024  
**Inspection Standard:** MSCC5 Sewers & Drainage GB (SRM5 Scoring)

# **EYES ON DRAINAGE**

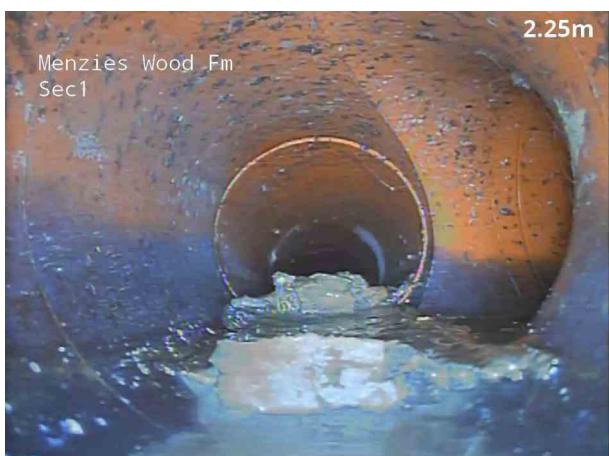
5, 00:00:48, 2.40 m  
Settled deposits, hard or compacted, 15% cross-sectional area loss

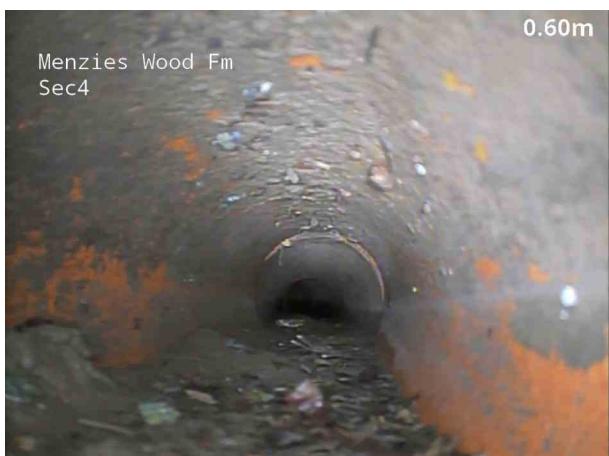
3, 00:00:31, 0.60 m  
Settled deposits, hard or compacted, 15% cross-sectional area loss, start

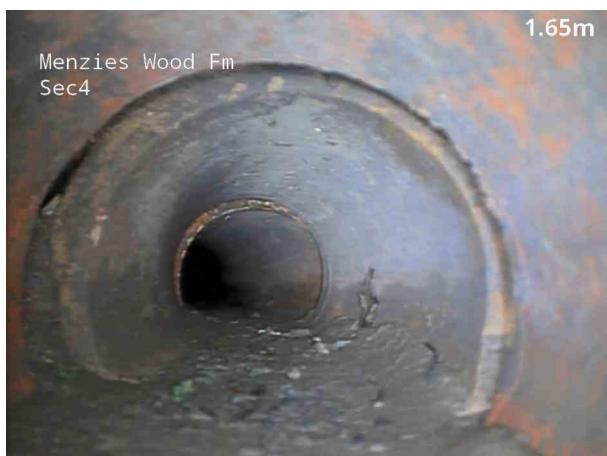
4, 00:00:39, 1.65 m  
Open joint, medium, open

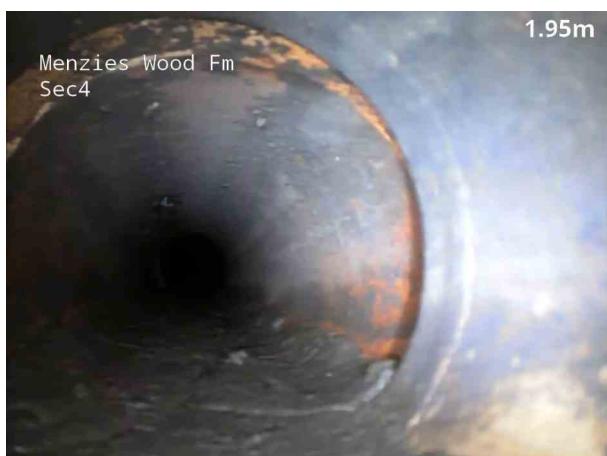
6, 00:00:46, 1.95 m  
Joint displaced, medium

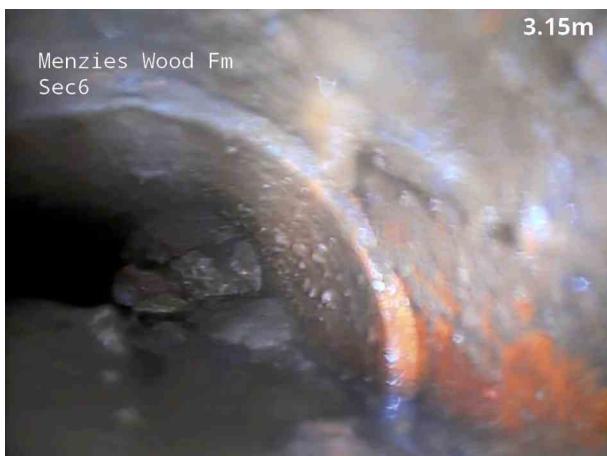
5, 00:00:51, 3.60 m  
Settled deposits, coarse, 100% cross-sectional area loss

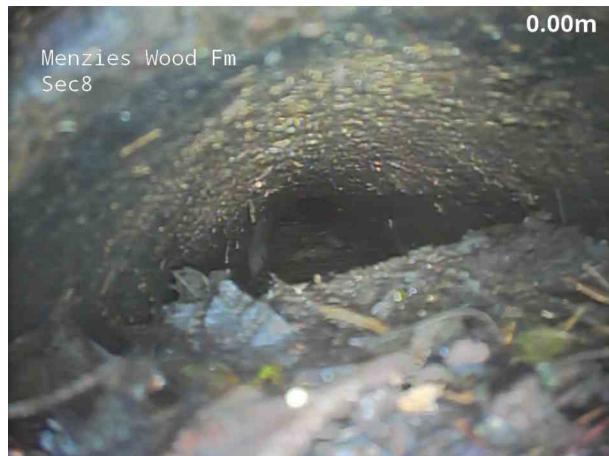
2, 00:00:04, 0.00 m  
Settled deposits, coarse, 85% cross-sectional area loss, start

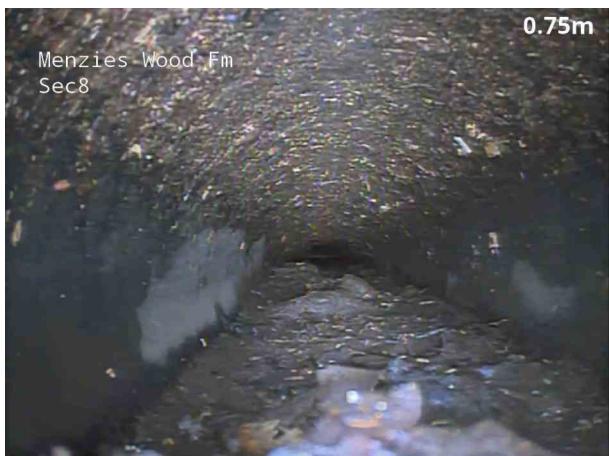
3, 00:00:23, 0.70 m  
Settled deposits, coarse, 45% cross-sectional area loss, change

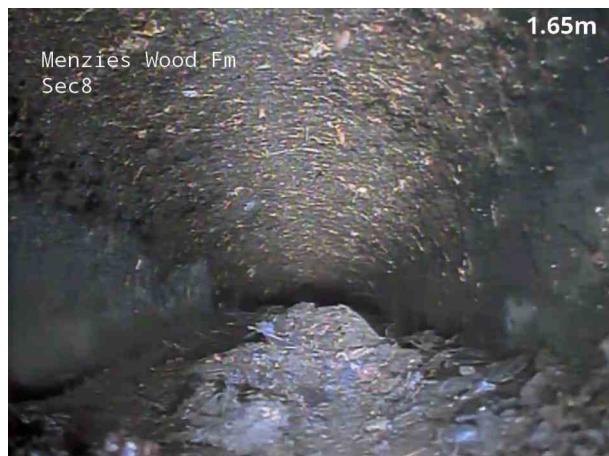
4, 00:00:33, 1.70 m  
Settled deposits, coarse, 55% cross-sectional area loss, change

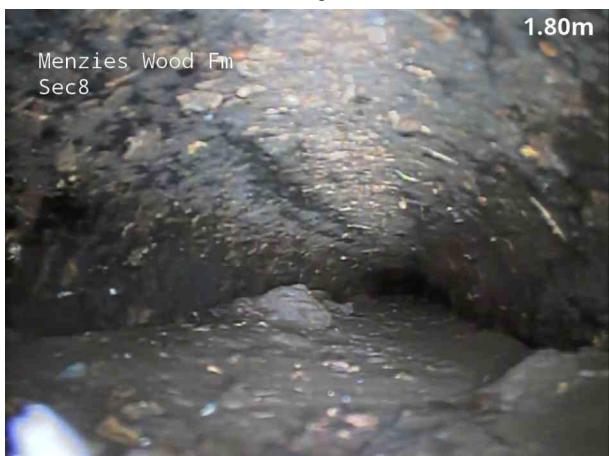
5, 00:00:44, 2.00 m  
Settled deposits, coarse, 70% cross-sectional area loss, change

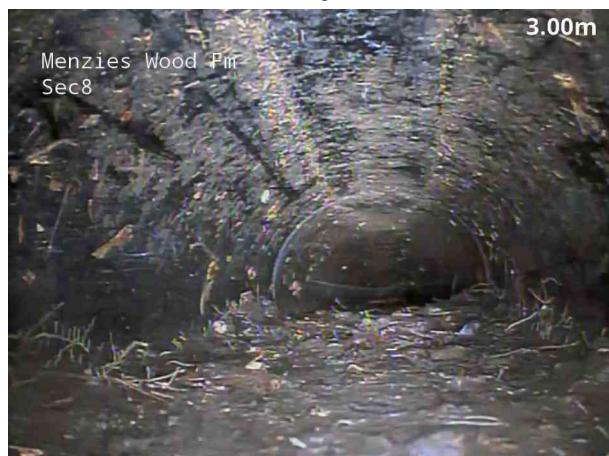
6, 00:01:10, 3.00 m  
Settled deposits, coarse, 60% cross-sectional area loss, change

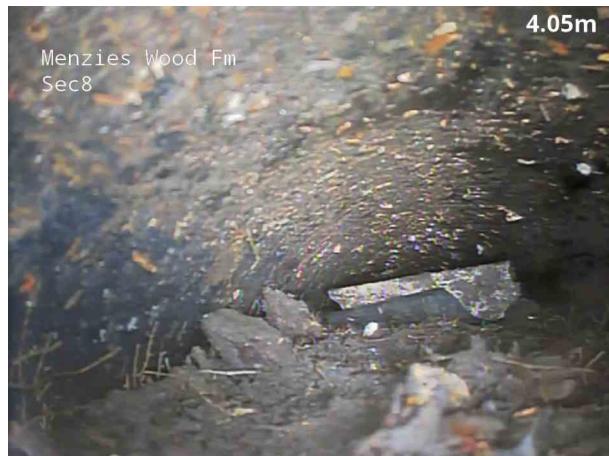
8, 00:01:29, 4.30 m  
Settled deposits, coarse, 90% cross-sectional area loss

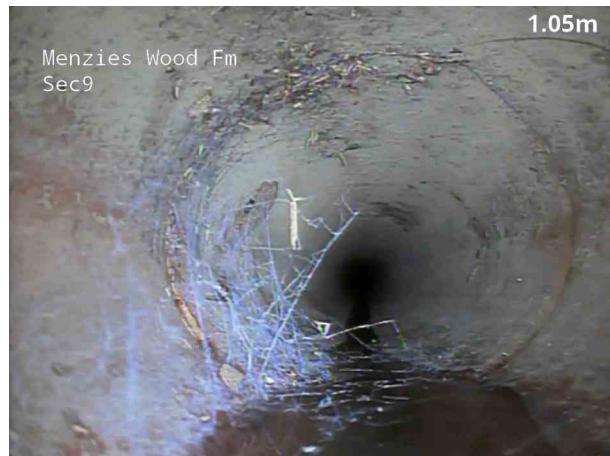
2, 00:00:14, 1.20 m  
Fracture, circumferential from 12 o'clock to 12 o'clock

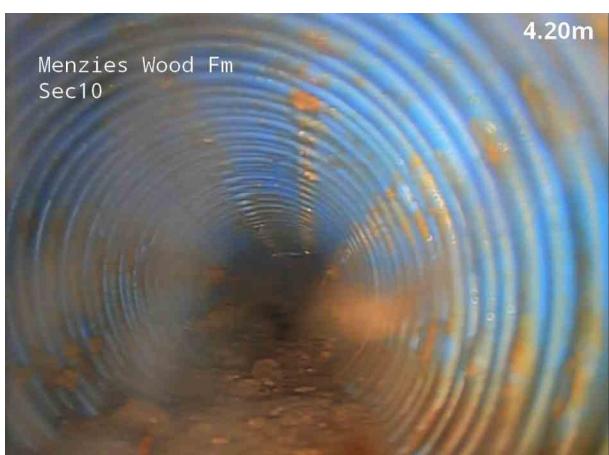
5, 00:00:52, 4.30 m  
Settled deposits, fine, 10% cross-sectional area loss, start

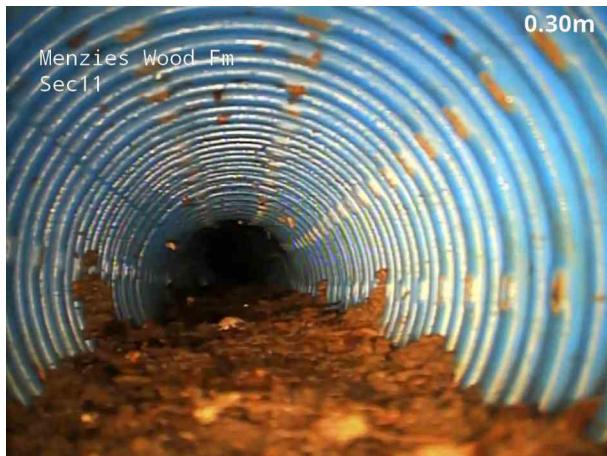
2, 00:00:09, 0.30 m  
Settled deposits, fine, 25% cross-sectional area loss

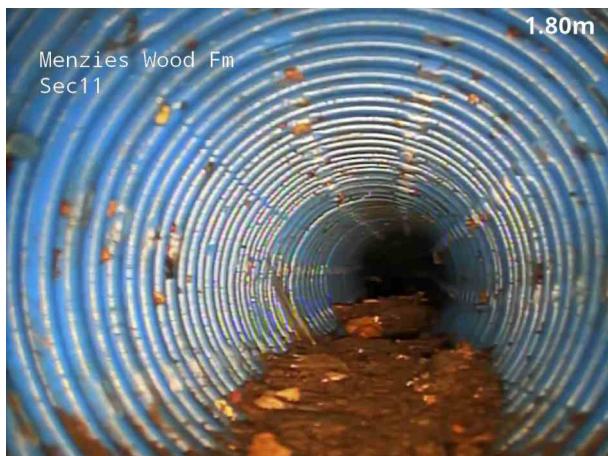
3, 00:00:28, 2.00 m  
Settled deposits, fine, 15% cross-sectional area loss, start

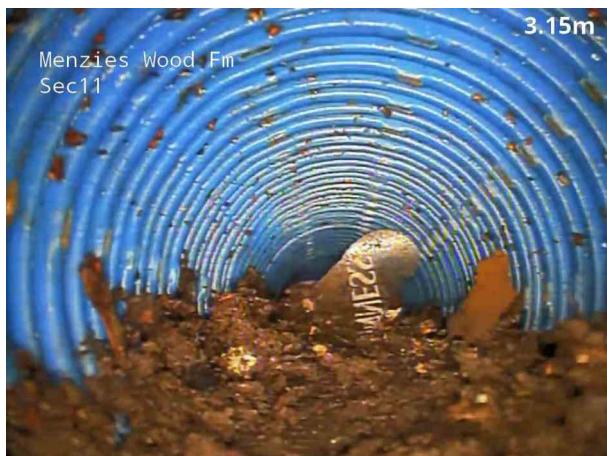
4, 00:00:50, 3.20 m  
Settled deposits, fine, 50% cross-sectional area loss, change

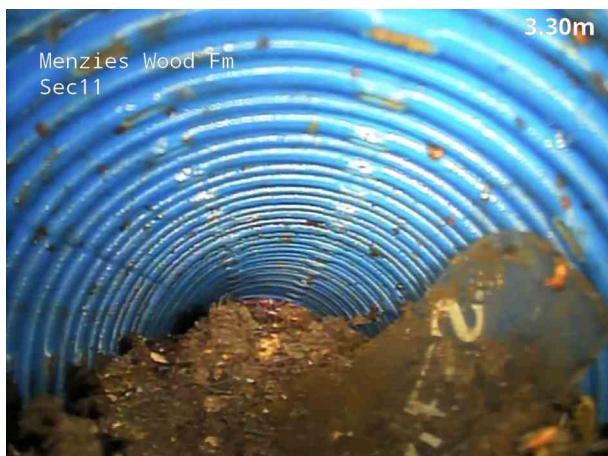
5, 00:01:24, 3.50 m  
Settled deposits, coarse, 90% cross-sectional area loss

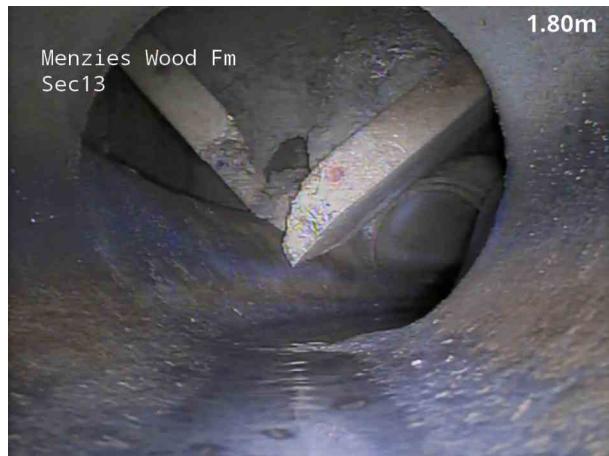
2, 00:00:21, 2.10 m  
Finish node, manhole, reference: SW7, Buried. Cover collapsed

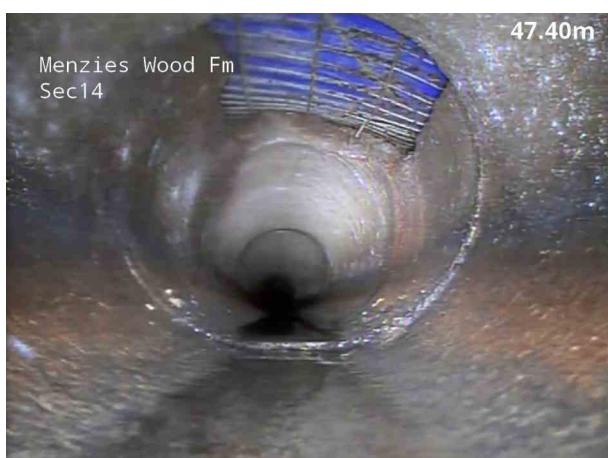
5, 00:02:53, 47.70 m  
Point repair, hole repaired from 11 o'clock to 2 o'clock

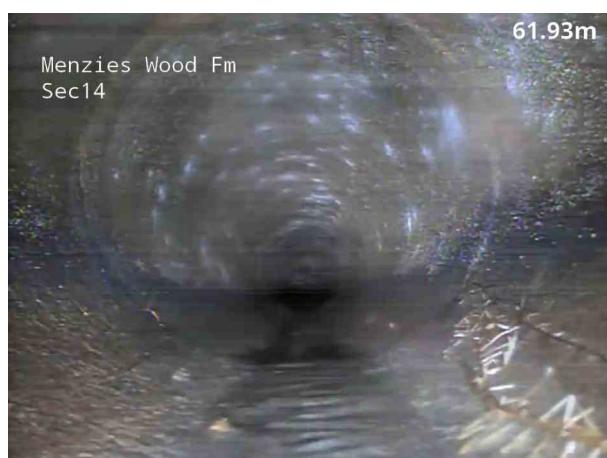
6, 00:03:23, 62.20 m  
Roots, fine at joint

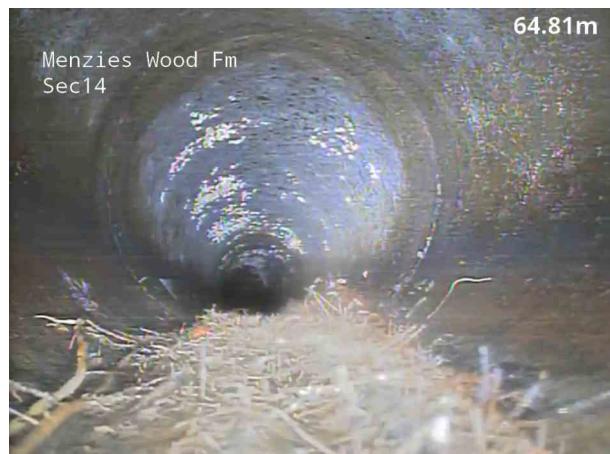
10, 00:03:59, 65.20 m  
Survey abandoned, Unable to continue. Acoustic tested to prove connectivity

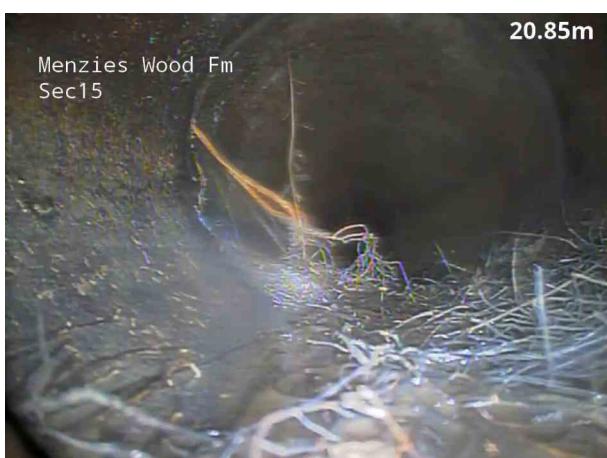
5, 00:03:03, 21.00 m  
Roots, tap at joint

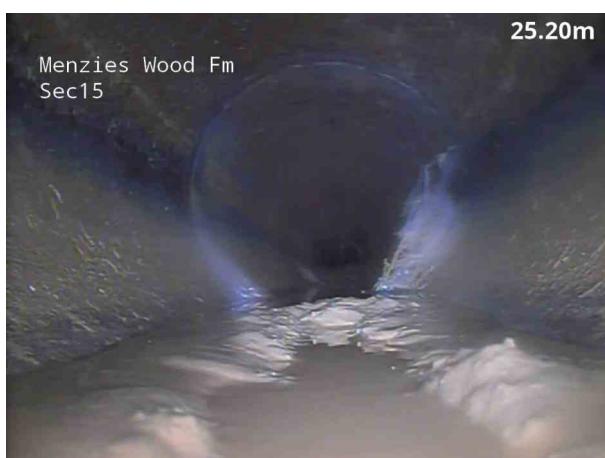
6, 00:03:31, 25.40 m  
Settled deposits, fine, 10% cross-sectional area loss

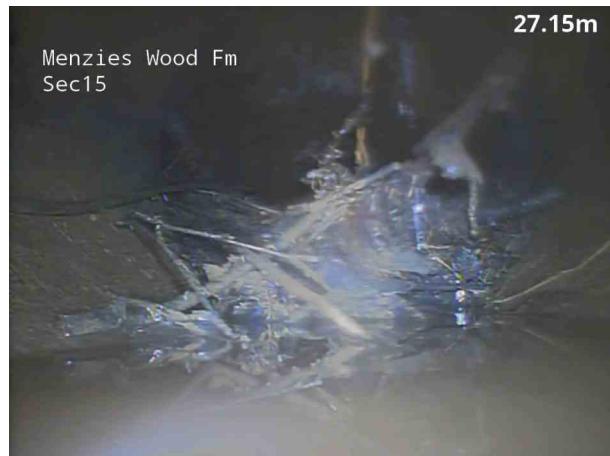
8, 00:03:55, 27.40 m  
Roots, mass at joint, 40% cross-sectional area loss

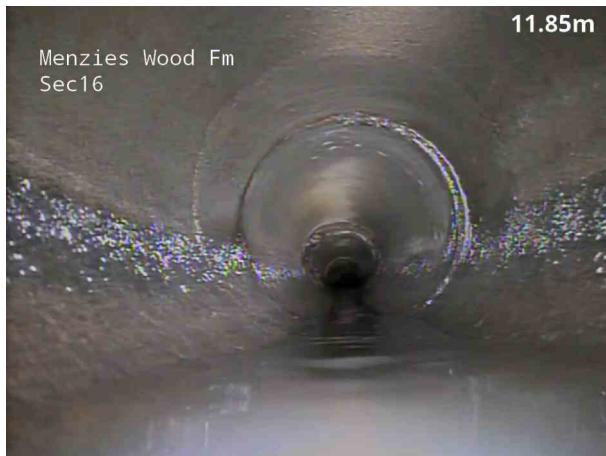
7, 00:01:19, 12.10 m  
Fracture, circumferential from 12 o'clock to 12 o'clock

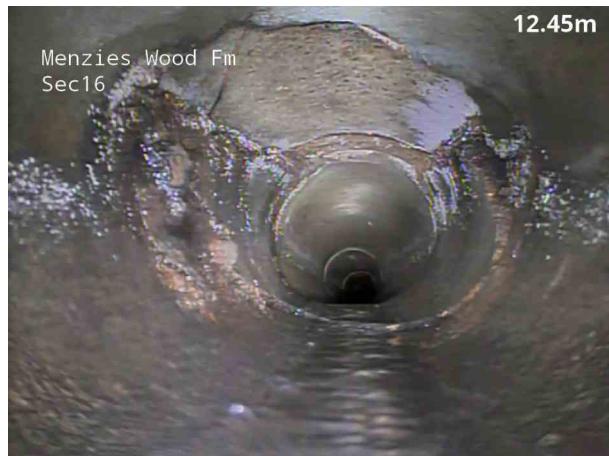
8, 00:01:26, 12.70 m  
Point repair, hole repaired from 10 o'clock to 2 o'clock

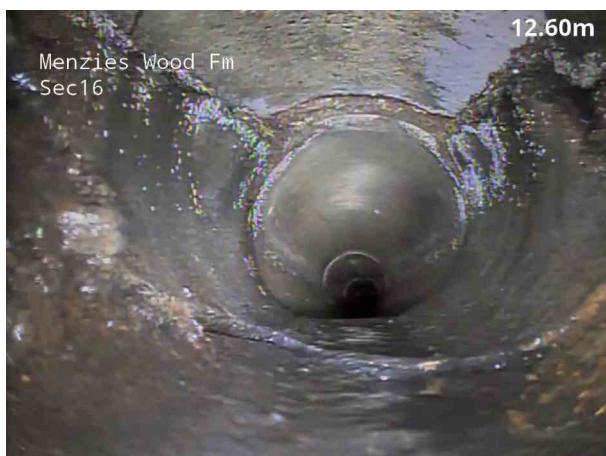
9, 00:01:26, 12.70 m  
Point repair, hole repaired from 10 o'clock to 2 o'clock

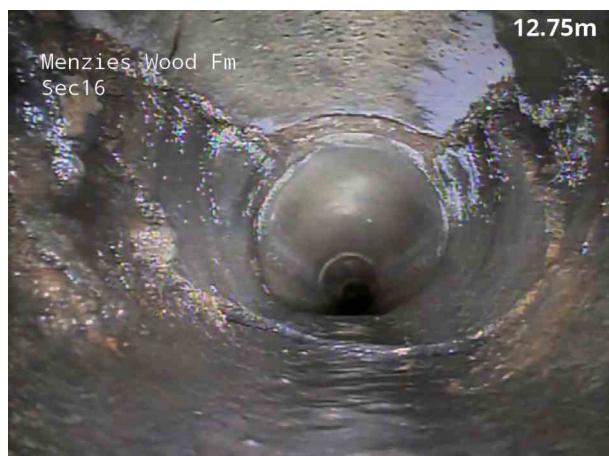
10, 00:01:33, 12.80 m  
Fracture, circumferential from 3 o'clock to 9 o'clock

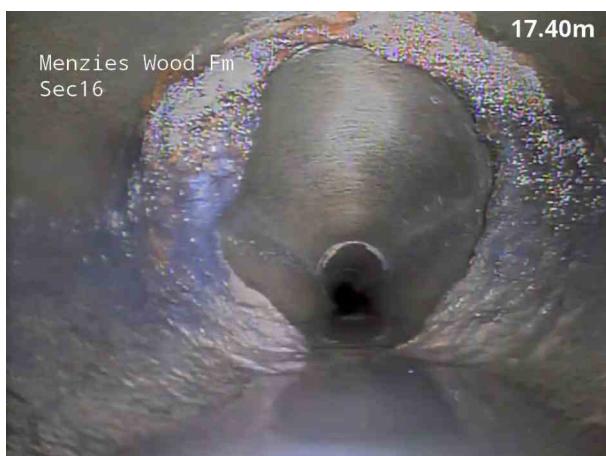
11, 00:01:55, 17.60 m  
Attached deposits, encrustation at joint from 12 o'clock to 12 o'clock, 40% cross-sectional area loss

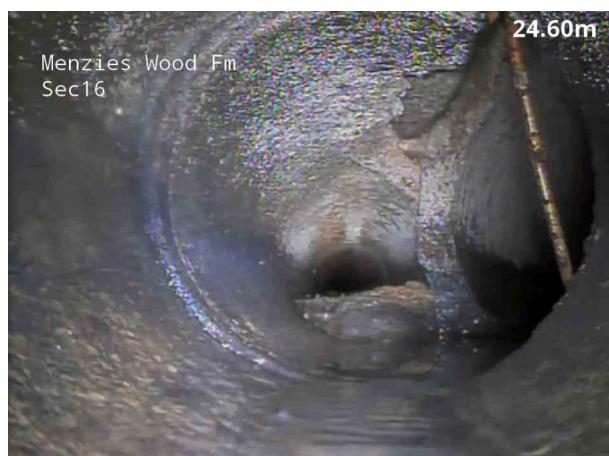
12, 00:02:23, 24.80 m  
Connection defective at 3 o'clock, 150mm dia, Assumed to serve neighbouring FW treatment plant

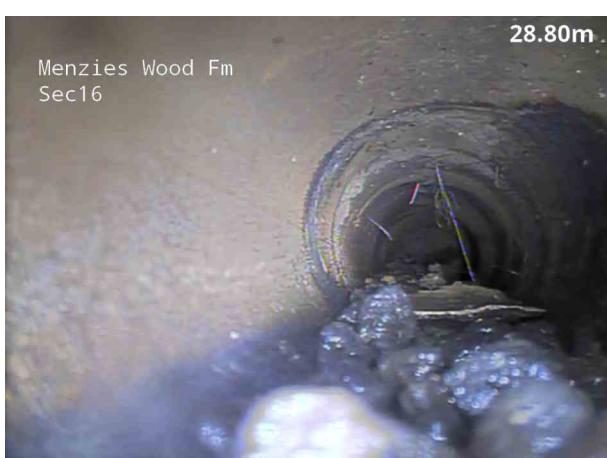
17, 00:03:04, 29.00 m  
Settled deposits, coarse, 25% cross-sectional area loss, change

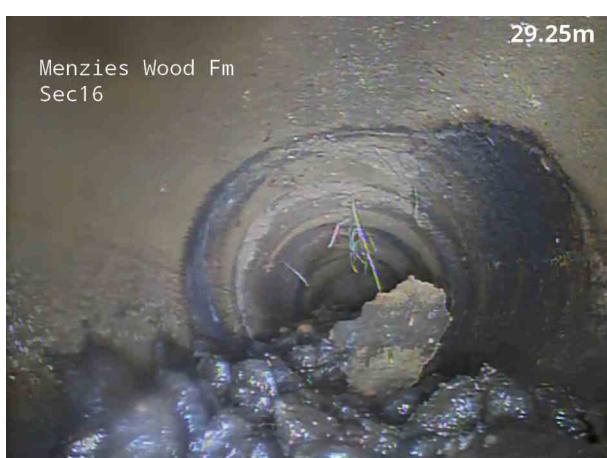
18, 00:03:08, 29.40 m  
Fracture, circumferential from 8 o'clock to 4 o'clock

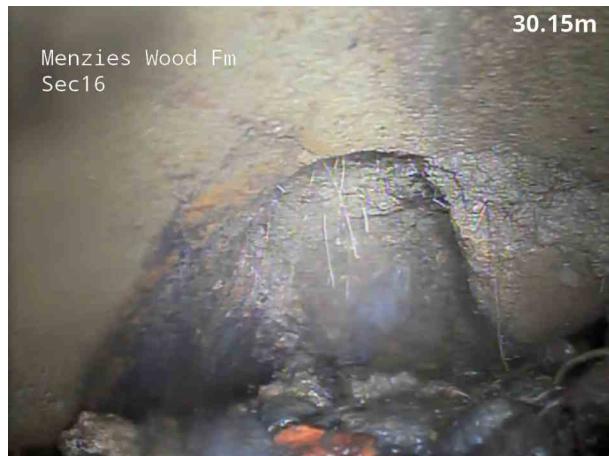
Section	PLR	Grade	Description
9	TPX	3	Fracture, circumferential from 12 o'clock to 12 o'clock
14	SW8X	4	Hole in drain or sewer at 12 o'clock
16	AX	5	Collapsed drain or sewer, 100% cross-sectional area loss
17	AX	5	Hole in drain or sewer from 7 o'clock to 11 o'clock

20, 00:03:26, 30.30 m  
Collapsed drain or sewer, 100% cross-sectional area loss

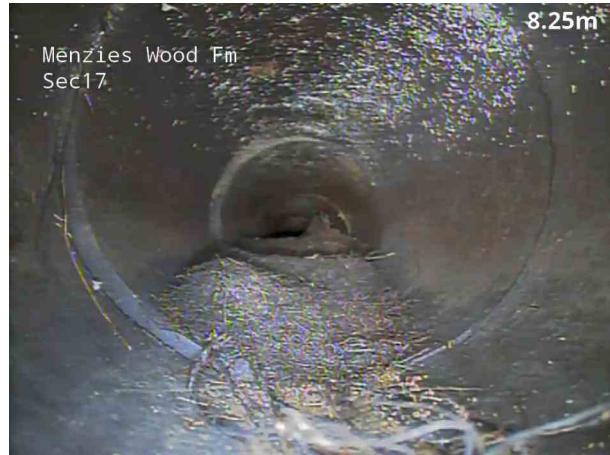
8, 00:01:05, 8.40 m  
Roots, mass, 20% cross-sectional area loss

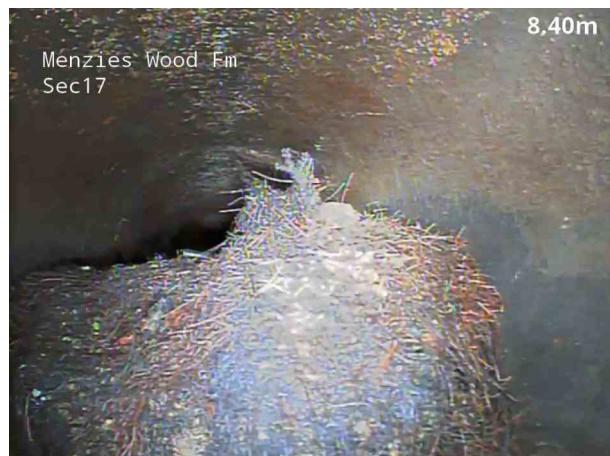
10, 00:01:25, 8.60 m  
Survey abandoned, Unable to pass, serving unknown
