## Phase I Desk Study

**Lower Perryland Farm, Basing Hill,  
Dial Post, West Sussex  
RH13 3NT**

Document Reference: ON251025-XX-XX-RP-X-701-C02

Prepared for:  
**Lower Perrylands Limited**

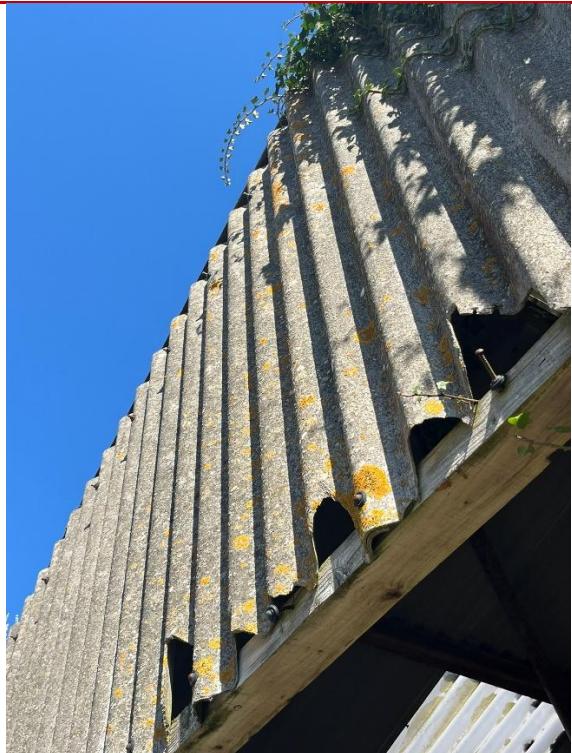
**Photo 2 – Suspected corrugated asbestos cement sheeting with fragments missing.**

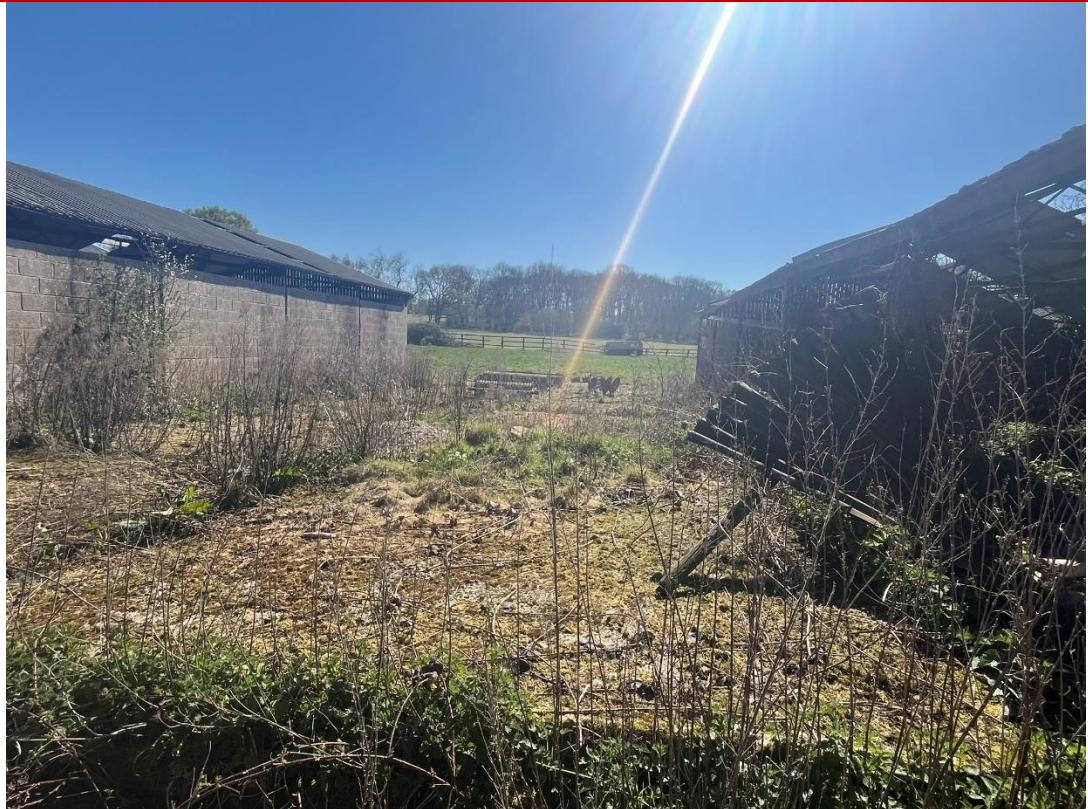
**Photo 3 – View south between the barns with agricultural machinery visible.**

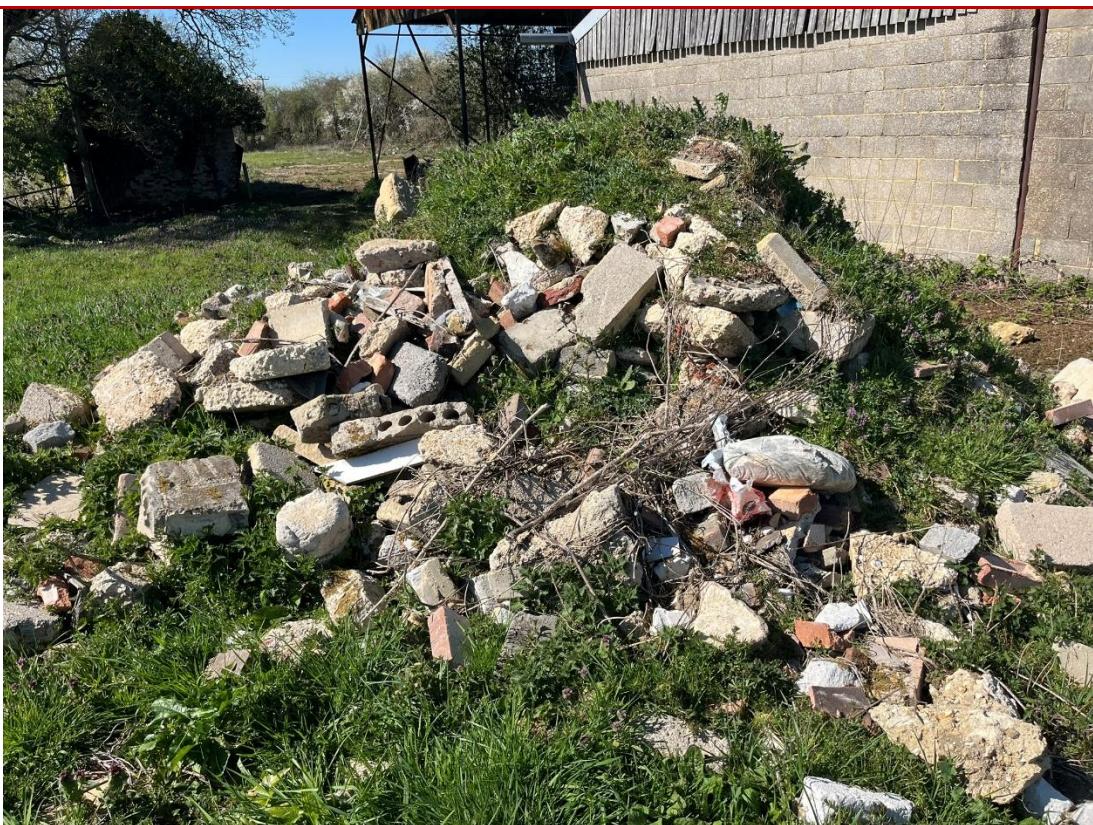
**Photo 6 – Stockpile of building rubble to the south of the western barns.**

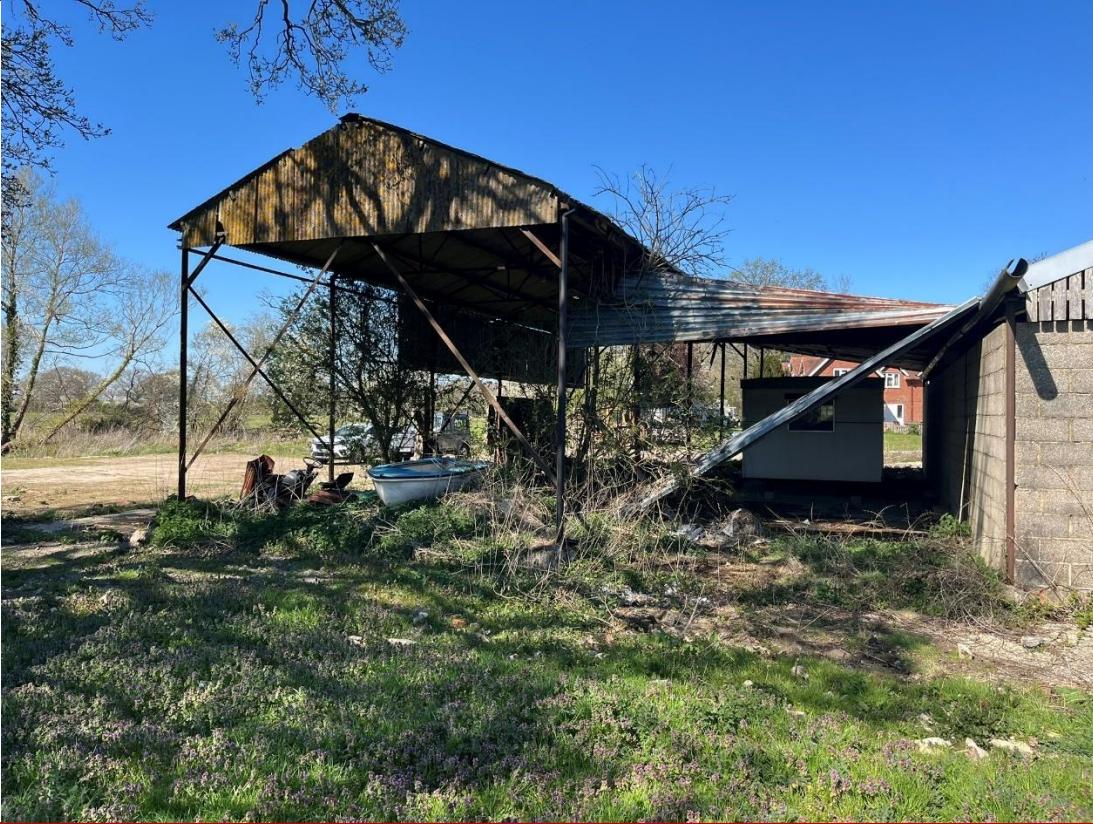
**Photo 7 – Southern side of the western barn with a caravan inside.**

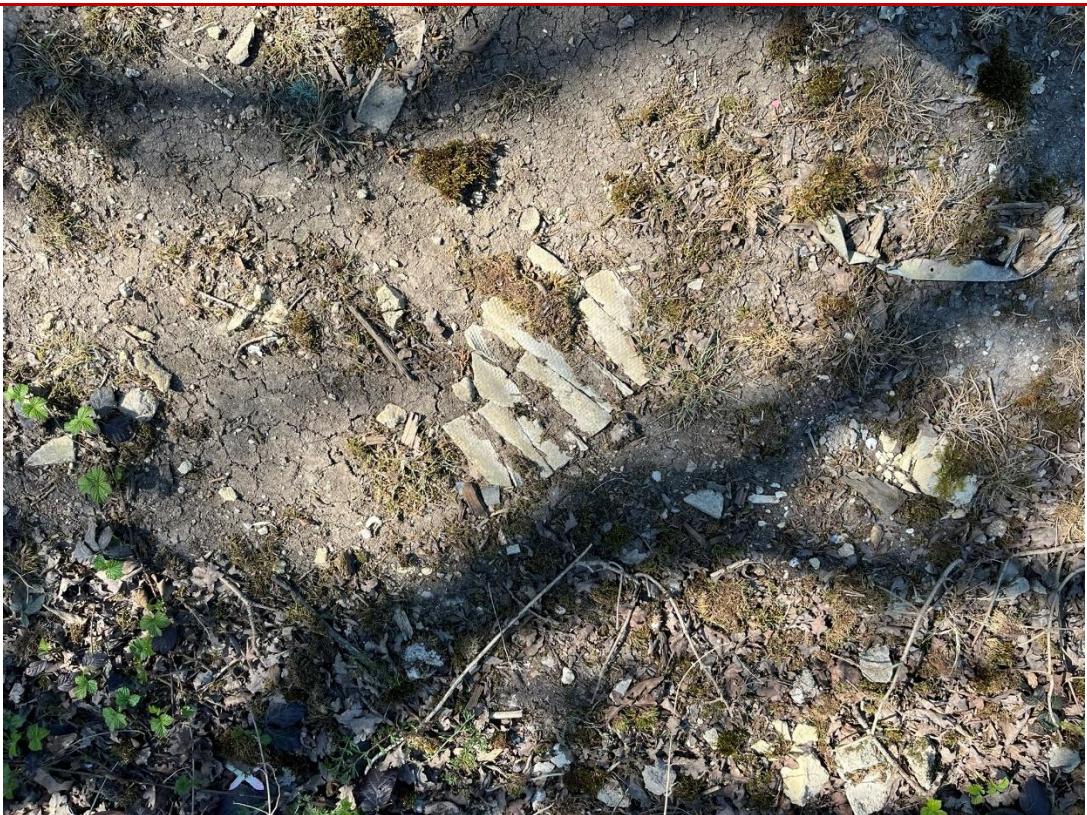
Suspected asbestos cement sheeting was observed within the structure of several of the buildings on site, with further fragments of these materials observed on the ground surface. There is the potential for the soils on site to be impacted with asbestos containing materials, which would pose an unacceptable (high) risk to future site users and construction workers.

**Photo 13 – Fragments of suspected asbestos cement on the ground.**

This desk study has identified several potential sources of contamination on site, most notably the presence of asbestos within the structures and on the ground surface. Therefore, it is recommended that shallow site investigation is undertaken to enable chemical testing of the soils and an assessment of the risk to future site users. It is recommended that following the demolition of the existing barns a visual inspection, sampling and laboratory testing of the exposed soils is undertaken to assess whether any contamination is present beneath the current building footprints.

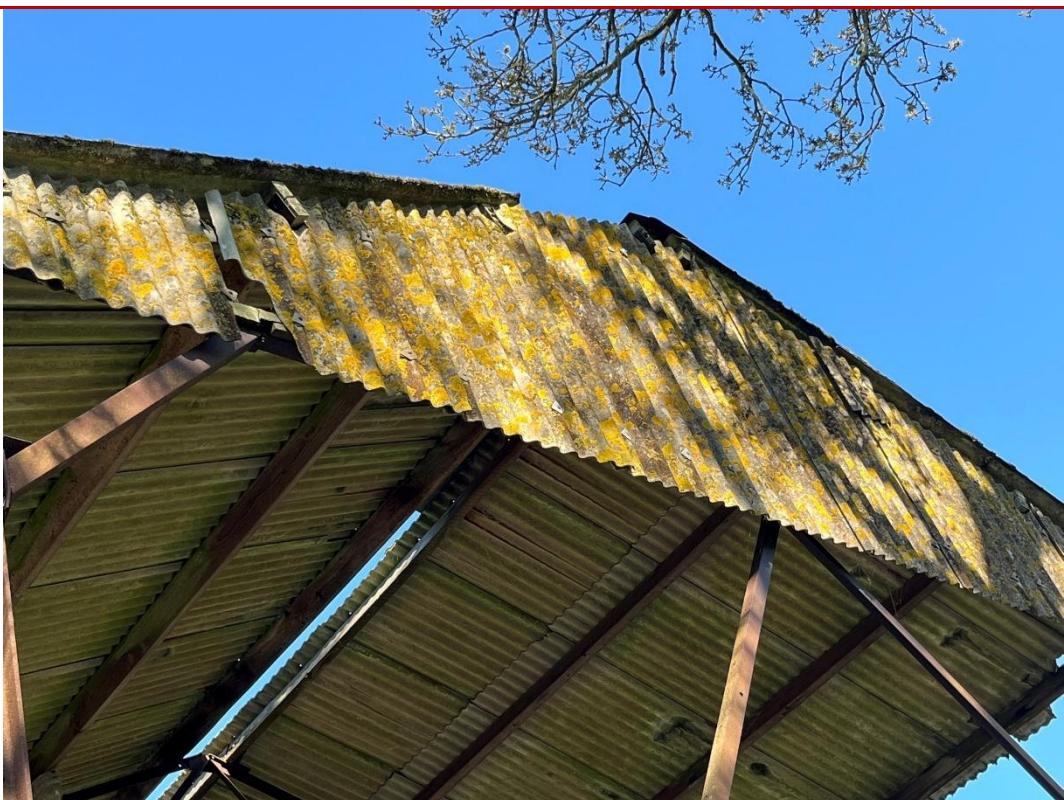
**Photo 11 – Suspected asbestos cement on the western barn with fragments missing.**

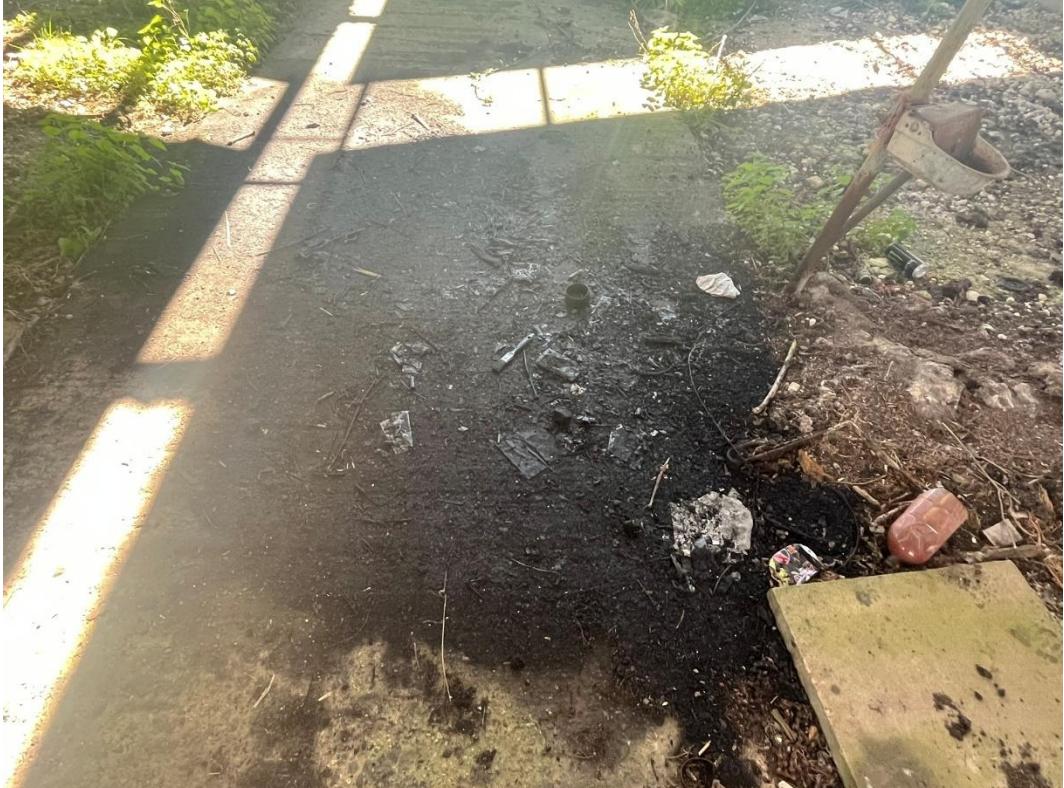
Aerial imagery indicates that several vehicles were previously stored on site, therefore there is the potential that fuel leakage / spillage has occurred on site. However, no odours, significant ground staining or other evidence was observed on site. Furthermore, any such contamination if present would likely be minor and highly localised given the low permeability strata. Therefore, the risk is considered negligible.

**Photo 12 – Darkly stained area of concrete.**
