WEST OF IFIELD PHASE 1 INFRASTRUCTURE

Stage 1 Road Safety Audit

Designers Responses Report

Document Ref: 10053900-ARC-HRR-ZZZ-TS-HE-00011

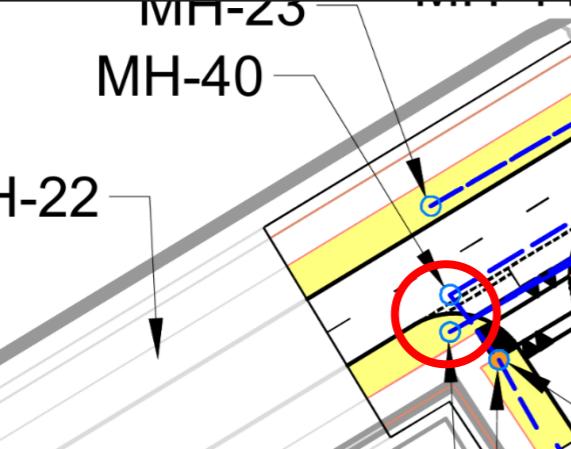
<p>Summary: Risk of slip hazards for exiting motorists. There is a risk that cyclists and powered-two-wheelers exiting the RD_1A_S02 side road may ride across the path of manhole cover MH-40 whilst turning and become unseated (see insert). This may lead to leading to secondary collisions (see insert). A similar situation occurs at the following locations (ref. Drg. 10051123_ARC-070-1A-DR-CE-00004 Rev P06):</p> <ul style="list-style-type: none"> • MH-10 near the foul pumping station • MH-4 (opposite above pumping station) 	<p>Ensure the manhole cover does not pose a slip / skid risk to riders.</p>	<p>RSA problem and recommendation accepted. Suitable skid resistance for the manhole cover will be proposed at detailed design. Or alternatively the manhole could be relocated.</p>

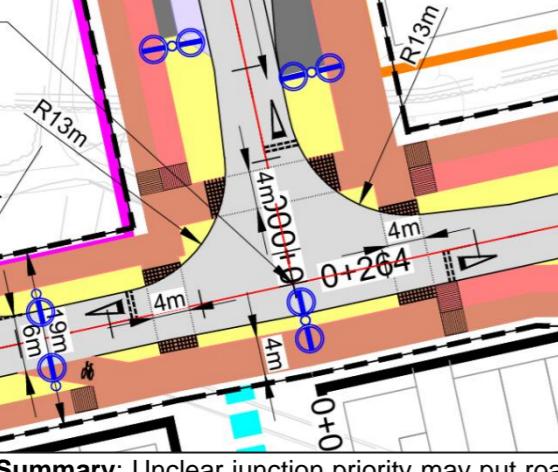
1A 3.2.1	<p>Location: C – JC_1A_P01, West of Ifield Phase 1A (Drg. 10051123_ARC-070-1A-DR-CE-00007 Rev P06).</p>	<p>Establish clear and suitable junction priority.</p>	<p>RSA problem and recommendation accepted. This is now a signalised controlled junction.</p>

<p>Summary: Unclear junction priority may put road users at risk. There is a risk that unclear junction priority may lead to confusion, indecision and conflicts leading to collisions between road users at the junction. For example, motorists approaching the junction are presented with give way carriageway markings and as such are required to give way to walkers crossing at the junction. However, beyond the give way markings motorists exiting the junction are permitted to travel through the crossing facility headless of crossing walkers. This may lead to injuries to those attempting to cross at the junction. In addition, in the absence of walkers present at the junction, all motorised traffic streams are required to give way on all approaches to the junction. This may also lead to confusion, indecision or motorists taking risks when travelling through the junction. There may also be a risk of collisions if the give way markings at the junction are not visible or conspicuous. This may be due to traffic volumes affecting headways or wet weather conditions making the markings less conspicuous.</p>

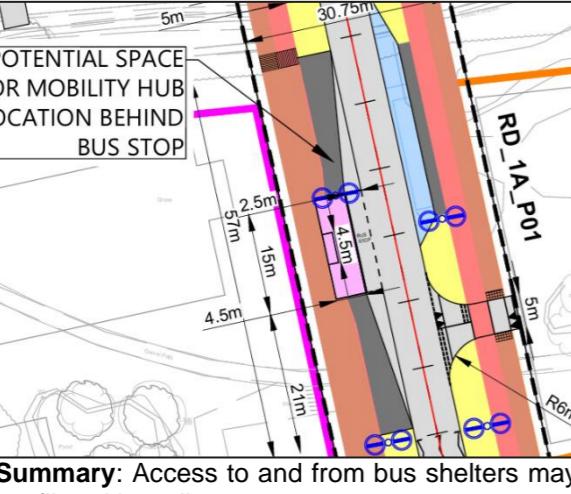
1A 3.3.3	<p>Location: General – Rear of bus stops along RD_1A_P01 & RD_1A_P02 West of Ifield Phase 1A (Drg. 10051123_ARC-050-1A-DR-CE-00004 Rev P06 & 10051123_ARC-050-1A-DR-CE-00007 Rev P06).</p>

<p>Summary: Access to and from bus shelters may conflict with cyclists. There does not appear to be any designated or prioritised route generally for users walking to or from the proposed bus shelters (see insert). Given that passenger numbers alighting can notably be high, with some users distracted, looking the wrong way, impaired, or unaware of approaching cyclists, there is a risk that pedestrians may proceed towards the footpath heedless of approaching cyclists.</p>	<p>Establish a safe route to the bus stop shelters and encourage courtesy from approaching cyclists. This may consist of additional formal or informal measures to calm approach speeds and manage the shared space more effectively.</p>	<p>RSA problem and recommendation accepted.</p> <p>Measures will be assessed at detailed design to reduce cyclist approach speeds at these locations. This is a common issue with combined cycle/pedestrian schemes when interacting with bus stops.</p>

Reference	RSA1 Problem	RSA1 Recommendation	RSA1 Design Organisation Response	Overseeing Organisation Response	Agreed RSA Action
	In addition, the space behind some bus shelters becomes narrow and creates a potential pinch point for pedestrians and cyclists alike, and this is likely to exacerbate conflicts further.				
1A 3.3.4	Location: D –Bus stop along south side of RD_1A_P02, West of Ifield Phase 1A (Drg. 10051123_ARC-050-1A-DR-CE-00004 Rev P06). Summary: Position of bus stop may hinder northbound walkers crossing RD_1A_P02. The in-carriageway bus stop is proposed just east of and close to the uncontrolled crossing facility. The presence of a stationary westbound bus may restrict sight lines for those attempting to cross RD_1A_P02 northbound. This may lead to collisions between walkers and motorists.	Ensure those crossing have suitable sightlines of approaching traffic. This may be achieved by instead providing an inset bus layby.	RSA problem and recommendation accepted. An inset layby cannot be implemented due to restrictions imposed by the urban design code; however, adequate sight lines have been ensured. Additionally, it is important to note that buses will stop at this location only infrequently.

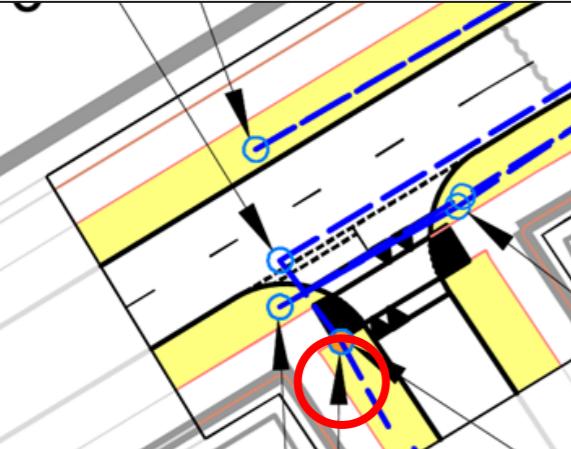
Summary: Risk of slip / trip hazards associated with manhole cover.	Ensure manhole covers does not pose a risk to walkers or cyclists.	RSA problem and recommendation accepted. Suitable skid resistance for the manhole cover will be proposed at detailed design or manhole relocated.

Reference	RSA1 Problem	RSA1 Recommendation	RSA1 Design Organisation Response	Overseeing Organisation Response	Agreed RSA Action
	<p>The position of manhole cover MH-39 appears to be located at or near the southern side road uncontrolled crossing RD_1A_S02 tactile paving (see insert). This may present a slip / trip hazard to those using the uncontrolled crossing facility particularly if the manhole cover is uneven, incorporates an upstand or is slippery underfoot. A similar situation occurs at the following locations:</p> <ul style="list-style-type: none"> • MH-73 RD_1A_P01 • MH-30 RD_1A_P01 • MH-53 RD_1A_P02 • MH-87 RD_1A_P02 • MH-143 RD_1A_P02 				
1A 3.3.7	<p>Location: E – RD_1A_P02 / Rusper Road crossing facility, West of Ifield Phase 1A (Drg. 10051123_ARC-050-1A-DR-CE-00009 Rev P06).</p> <p>Summary: Risk of crossing collisions. Walkers crossing at the junction are expected to cross the carriageway in one go or risk being stranded in the middle of the road where they may be struck by turning traffic. This may be a particular problem for those frail, mobility / sensory impaired crossing the wide carriageway, looking in multiple directions and avoiding large turning vehicles such as buses.</p>

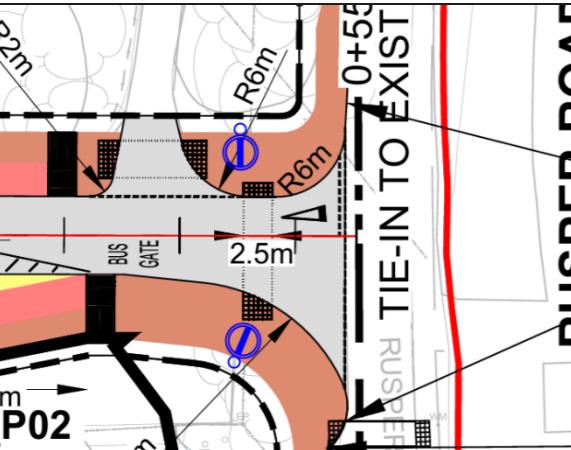
<p>The use of a refuge island at the junction bellmouth may allow crossing walkers to cross safely in two halves, whilst providing a safe space to wait and observe oncoming traffic.</p>	<p>Disagree with the RSA problem and recommendation.</p> <p>This junction is intended solely for infrequent bus use and private access, with no through route. As a result, incorporating a refuge island would be excessive given the limited vehicle activity at the junction. Additionally, the area is constrained by the available land, and the crossing length is less than 10 meters.</p>

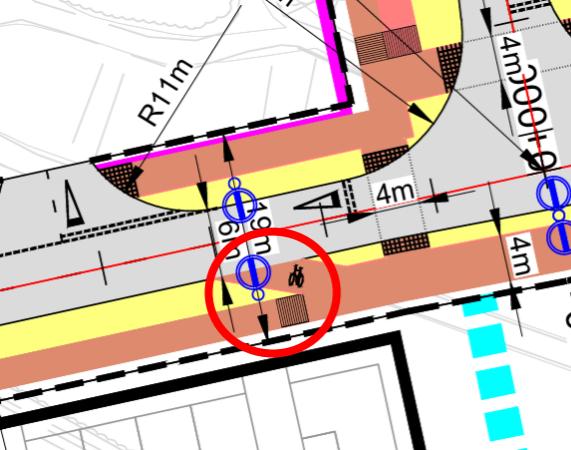
1A 3.3.9	<p>Location: F – RD_1A_S01 opposite RD_1A_P01 Southern shared use facility, West of Ifield Phase 1A (Drg. 10051123_ARC-050-1A-DR-CE-00007 Rev P06).</p>

<p>Summary: Risk of cycle collisions. Cyclists are required to exit the share use facility and rejoin the carriageway with their backs to oncoming westbound traffic (see insert). If cyclists continue to enter the road heedless of oncoming traffic, this may lead to side-swipe collisions.</p>	<p>Ensure cyclists entering the carriageway to join traffic have a clear sight of oncoming traffic, or be expected to yield accordingly.</p>	<p>RSA problem and recommendation accepted. This junction is now signalised and therefore the cyclists will be able to join the carriageway accordingly. In addition the entry to the highway could be widened so cyclists could join and stop at 90 degrees to the road.</p>

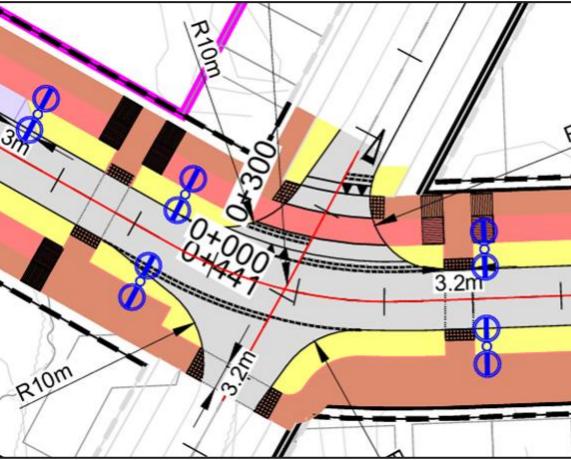
Reference	RSA1 Problem	RSA1 Recommendation	RSA1 Design Organisation Response	Overseeing Organisation Response	Agreed RSA Action
1A 3.3.10	<p>Location: G – JC_1A_S06 Junction crossing facilities, West of Ifield Phase 1A (Drg. 10051123_ARC-070-1A-DR-CE-00007 Rev P06).</p>

<p>Summary: Risk of walker collisions. Poorly located crossing facilities either side of the junction may lead to collisions with walkers (see insert). There is a risk that motorists approaching the junction may be preoccupied by turning manoeuvres or focus on emerging traffic, rather than concentrating on crossing activities.</p>	<p>Provide suitable refuge islands at the junction to enable walkers to cross one stream of traffic at a time.</p>	<p>Disagree with the RSA problem and recommendation.</p> <p>Crossing facilities have been positioned further back at the junctions to minimise crossing width, allowing pedestrians to cross in a single movement without difficulty. These are minor junctions anticipated to experience low traffic volumes, thereby reducing the likelihood of potential conflicts.</p>

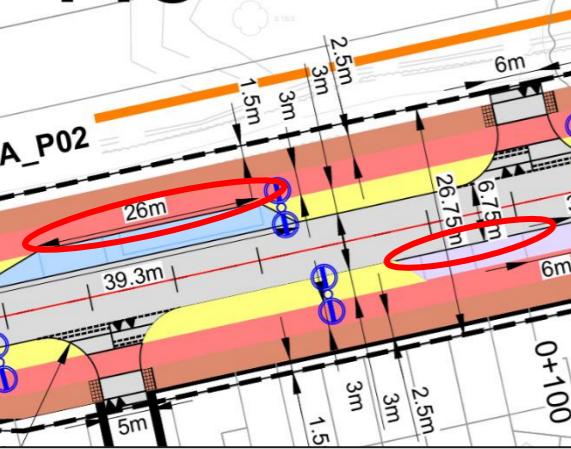
1A 3.3.11	<p>Location: H & I – RD_1A_P02, West of Ifield Phase 1A (Drg. 10051123_ARC-070-1A-DR-CE-00007 Rev P06).</p>

<p>Summary: Risk of cyclists being struck by car doors. Parking and loading bays positioned immediately adjacent to cycleways may put cyclists at risk of collisions when vehicle doors are opened directly into the path of approaching cyclists.</p>	<p>Provide a suitable 'buffer zone' between cyclists and parked vehicles to mitigate the risk of vehicle doors opening onto oncoming cyclists.</p>	<p>RSA problem and recommendation accepted.</p> <p>A buffer zone will be included.</p>

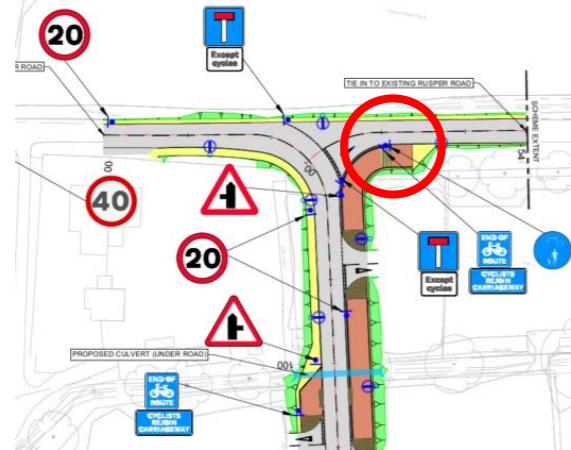
Reference	RSA1 Problem	RSA1 Recommendation	RSA1 Design Organisation Response	Overseeing Organisation Response	Agreed RSA Action
	where wet weather conditions could compromise the skidding resistance of the surfacing.				
1B 3.2.1	<p>Location: C – Phase 1B alignment, northern and southern section of scheme (Drg. 10051123_ARC-010-1B-DR-HE-00001 Rev P04 and Drg. 10051123_ARC-010-1B-DR-HE-00007 Rev P04)</p> <p>Summary: Risk of head-on collisions between cyclists and motorists.</p> <p>Whilst shared use facilities are provided generally along the scheme, there is a risk that some shared use terminal points may force walkers and cyclists to exit the facilities onto the verge, into opposing traffic lanes unaided or onto a narrower section of footpath (see insert showing southern section of scheme), putting themselves at risk of head-on collisions, being struck when crossing or continuing along unsuitably narrow sections of footpath.</p> <p>A similar situation occurs at the northern tie-in of the scheme.</p> <p>The Audit Team notes that design measures particularly at the tie-in points, may take account of adjacent developments that fall outside the scope of this audit.</p>

<p>It is recommended that shared use provision at terminal points is safe, clear, appropriately signed and supplemented with tactile paving. Furthermore, ensure that if permitted, cyclists are able to safely access / leave the shared use facilities at all access and terminal points.</p>	<p>RSA problem and recommendation accepted.</p> <p>Signage has been provided to clarify the end of cycle / shared routes where cyclists would be required to dismount. Tactiles and corduroys will be provided in the specific location highlighted as defined in DfT guidance on the use of tactile paving surfaces.</p>

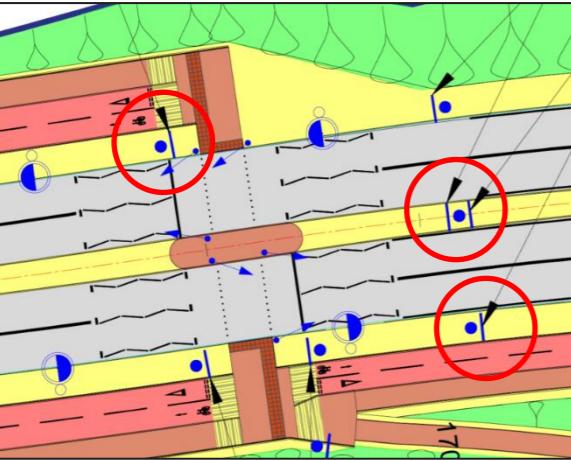
<p>CH1+690 (Drg. 10051123_ARC-XXX-1B-DR-HE-00001 Rev P04).</p>	<p>Ensure speed limit signs do not obscure the operation of the crossing traffic signals.</p>	<p>Disagree with the RSA problem and recommendation.</p> <p>The speed limit signs are positioned sufficient distance away from the signals to not interfere with visibility. Visibility will be confirmed at detailed design, any clashes and signs will be relocated.</p>

Reference	RSA1 Problem	RSA1 Recommendation	RSA1 Design Organisation Response	Overseeing Organisation Response	Agreed RSA Action
	<p>Summary: Risk of overshooting / late braking / crossing collisions.</p> <p>There is a risk that the speed limit and shared use signs located in advance of the controlled pedestrian crossing facility may obscure the traffic signal operation (see insert). This may lead to overshooting / late braking / crossing collisions.</p>				
1B 3.5.1	<p>Location: I – Charlwood Road / Ifield Avenue, West of Ifield Phase 1B (Drg. 10051123_ARC-010-1B-DR-HE-00007 Rev P04)</p>

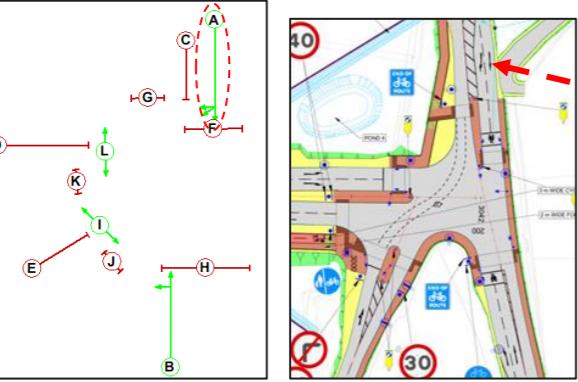
<p>Summary: Risk of turning traffic collisions.</p> <p>Southbound 'nearsid' traffic from Charlwood Road (Phase A - all movements) appears permitted to run 'opposed' with northbound nearside and offside traffic from Ifield Avenue (Phase B - all movements), whilst Phase C (Charlwood Road southbound left turn) is 'held' for traffic.</p> <p>This arrangement may result in confusion and may lead to late braking or lane changing collisions, as northbound motorists travelling from Ifield Avenue are presented with right turning motorists not emerging from the opposing 'offside' lane of Charlwood Road (as this is phase currently held in Stage 1) but the 'nearsid' lane.</p> <p>The Audit Team notes that the 'nearsid' lane of Charlwood Road is proposed as ahead-only, and very little has been provided to manage or guide opposing traffic through the junction (see image 2).</p> <p>This issue was raised in the previous Stage 1 Road Safety Audit report (Problem 1).</p>	<p>Ensure that the operation of the junction promotes safe turning traffic manoeuvres with good vehicle positioning, and that carriageway markings are not confusing.</p>	<p>Disagree with RSA problem and recommendation.</p> <p>This is a common occurrence at many junctions across the UK, with no conflicting movements present. The road markings clearly show that vehicles travelling from Charlwood Road in the nearside lane are designated ahead movements only, while the offside lane is restricted to right turns only. The alignment from Ifield Avenue has been realigned following the previous RSA problem 1, ensuring that the straight ahead movement no longer conflicts with any of the opposing traffic.</p>

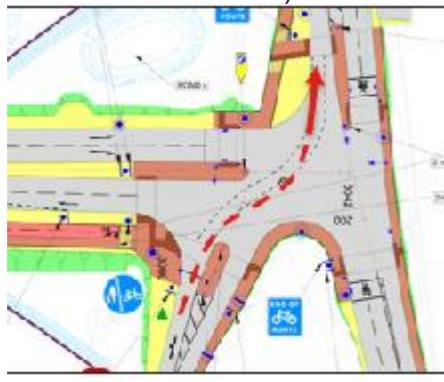
Reference	RSA1 Problem	RSA1 Recommendation	RSA1 Design Organisation Response	Overseeing Organisation Response	Agreed RSA Action
1B 3.5.2	<p>Location: I – Ifield Green / Ifield Avenue / Charlwood Road (Drg. 10051123_ARC-010-1B-DR-HE-00007 Rev P04)</p>

<p>Summary: Risk of loss of control collisions. northbound motorists approaching the Ifield Green / Ifield Avenue / Charlwood Road junction will emerge from Ifield Green and immediately be presented with an offset junction alignment (see insert). This alignment, which may or may not be clear to approaching motorists travelling along the 40mph road, may result in loss of control collisions. This situation could be worse particularly during the hours of darkness, poor weather conditions or because of excessive speed. Although guidance markings appear to be provided to highlight the alignment, they are likely to be ineffective during wet weather periods, or quickly eroded through junction turning traffic manoeuvres.</p>	<p>Provide advance warning of the traffic signal junction ahead. In addition, there may also be benefit in providing a map-type sign on the approach to the junction, similar to those provided on all other approaches. The use of speed management measures may also benefit safety.</p>	<p>RSA problem and recommendation accepted.</p> <p>Advance warning signage and map style sign will be developed at detailed design stage.</p>
