1.0 Introduction

- 1.1 This technical note has been prepared in response to West Sussex County Council's (WSCC's) comments on DC/25/0403 as the Lead Local Flood Authority (LLFA). Following WSCC's review of Motion's Flood Risk Assessment (FRA) and Drainage Strategy, WSCC have provided a holding objection until further information is provided.

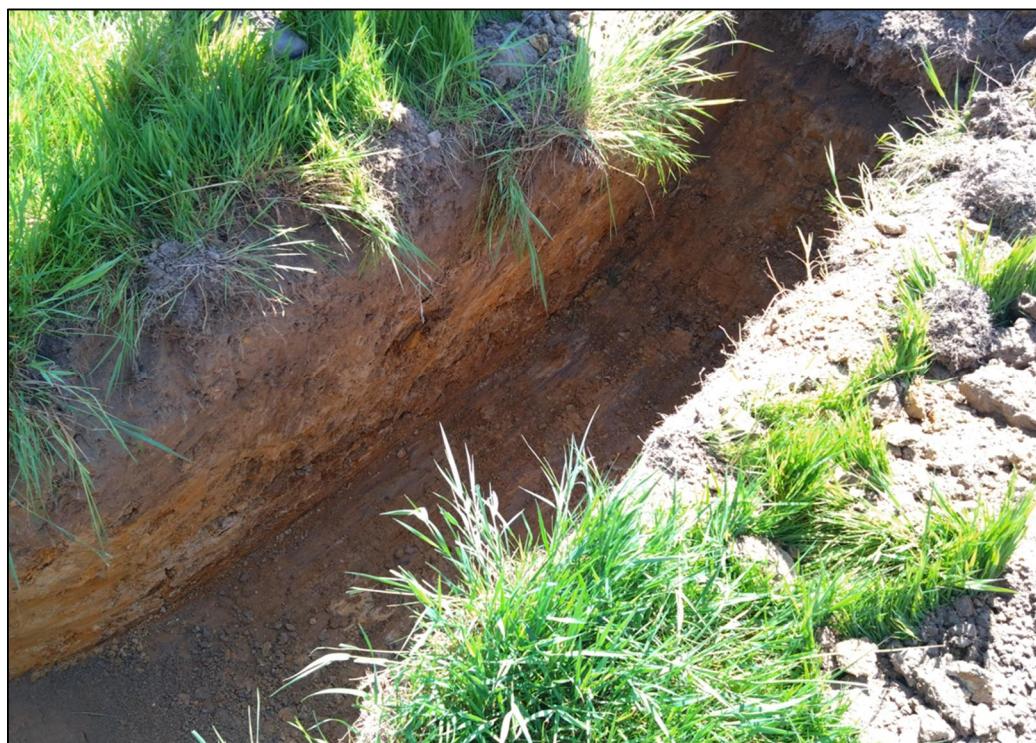
Figure 2.1 - Stonehouse Business Park Trial Pit (Note Orange Clay Particles)

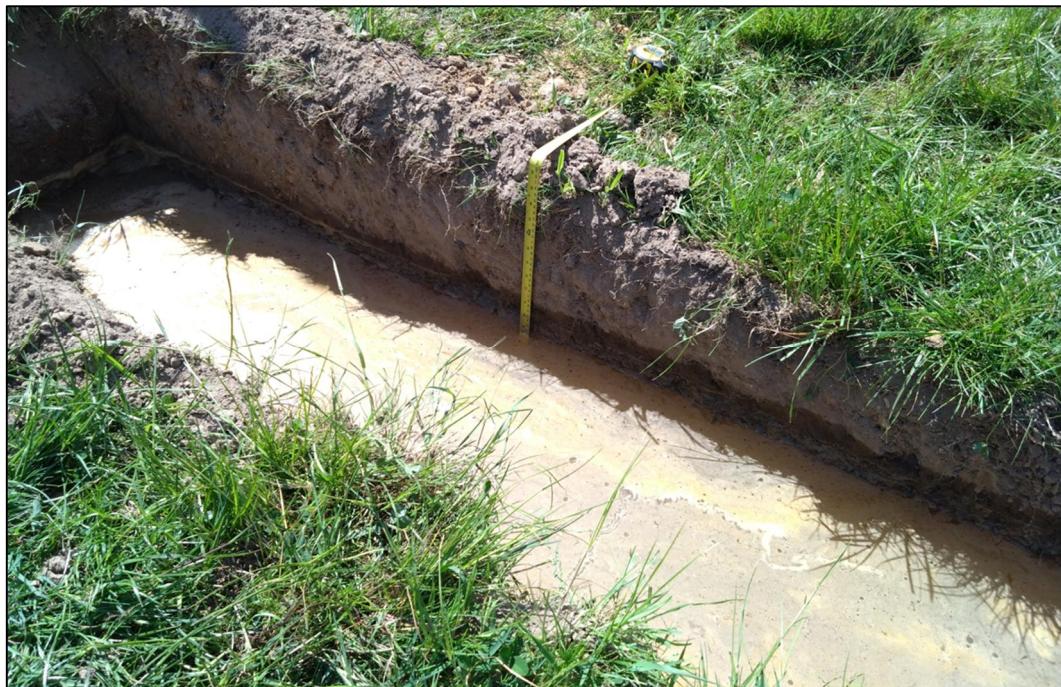
Figure 2.2 – Full Trial Pit on Lot 8

2.10 The trial pits showed an initial fall in water levels, but as can be seen in Figure 2.2, above, and Figure 2.3, below, this was predominantly due to water being absorbed sideways and upwards by capillary action into the dry topsoils, plus it was expected that evaporation rates would be above-average on due to the hot and breezy conditions.

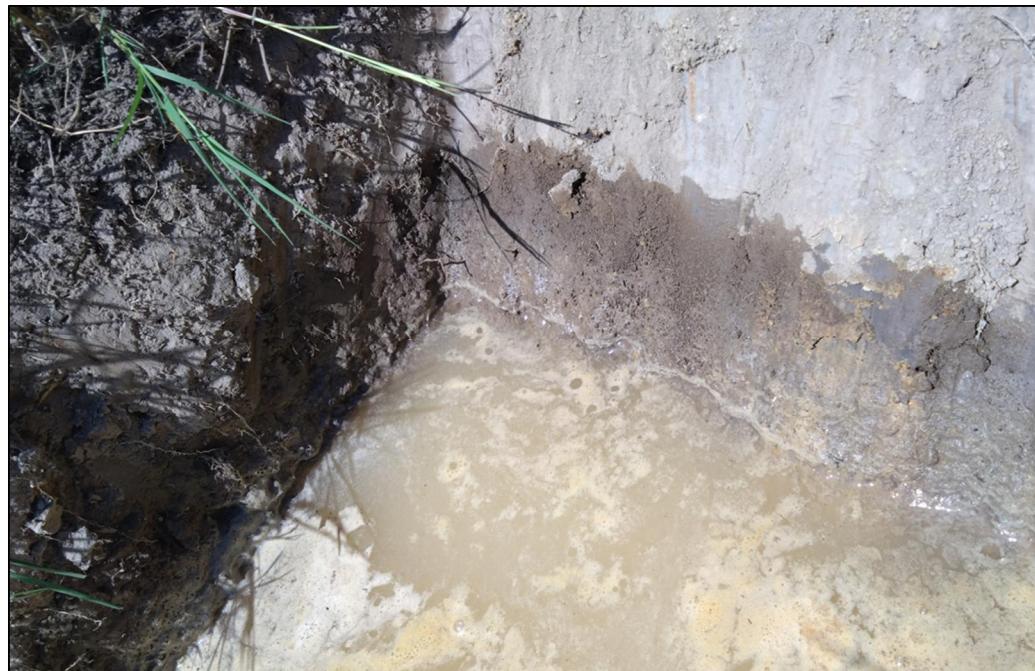
Figure 2.3 – Upward Capillary Absorption of Water Into Dry Topsoil

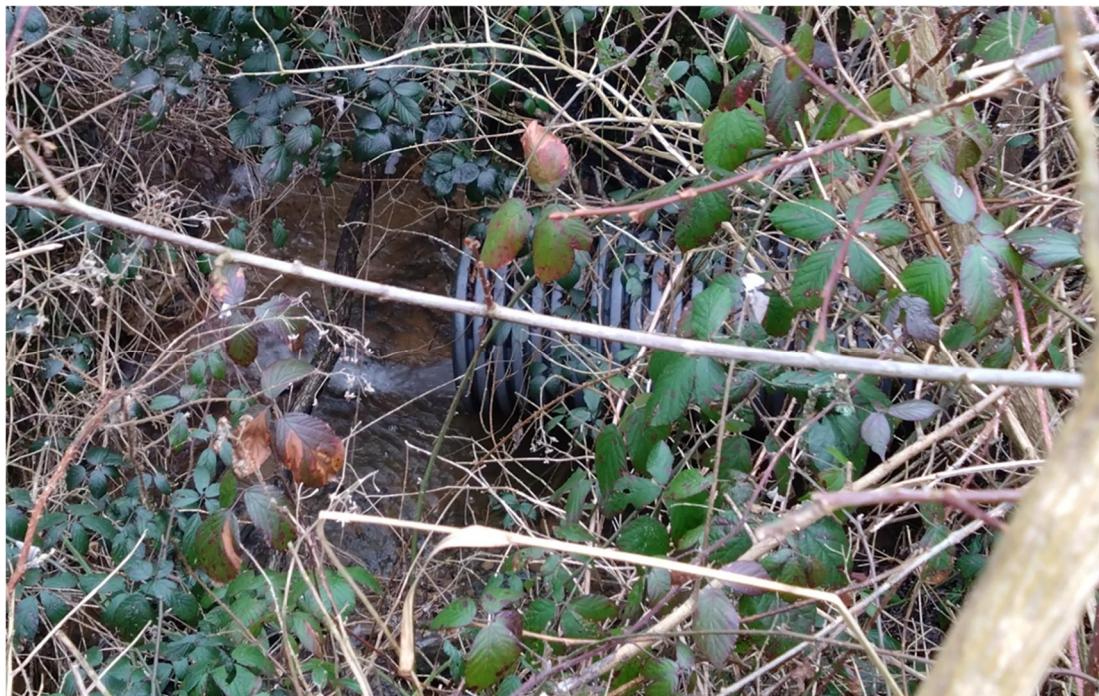
- 2.26 Full details of the pipe are in Page 67 of the CCTV survey. It is a 450mm diameter polyvinyl chloride (PVC) pipe. It is listed as having some minor defects and was traced for the full length of the CCTV camera and flexible hose (beyond which the survey was abandoned). Due to the diameter of the pipe (450mm) we understand that a crawler would be more suitable for inspection.

Figure 2.4 – Outfall of 450mm Pipe to Watercourse.

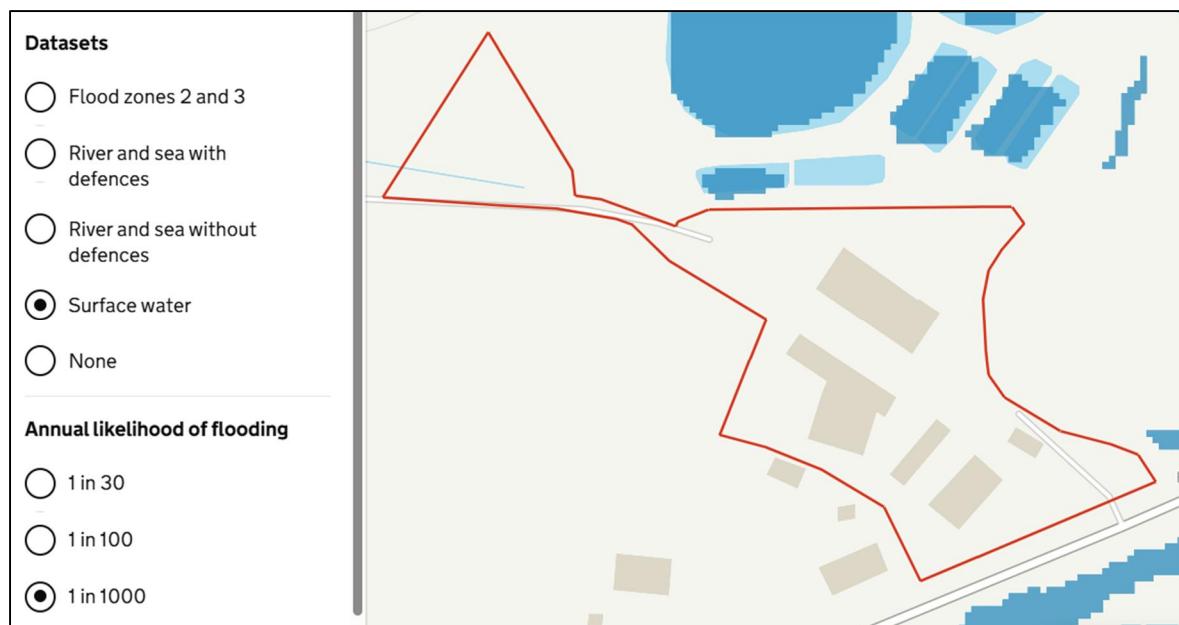
Figure 2.5 – 1 in 1,000-year RoFSW Outline at Stonehouse Business Park

2.40 Consequently, flood risk is not a concern on any of the three sites and does not need to be considered further or addressed over what has already been provided in the FRA and Drainage Strategy.

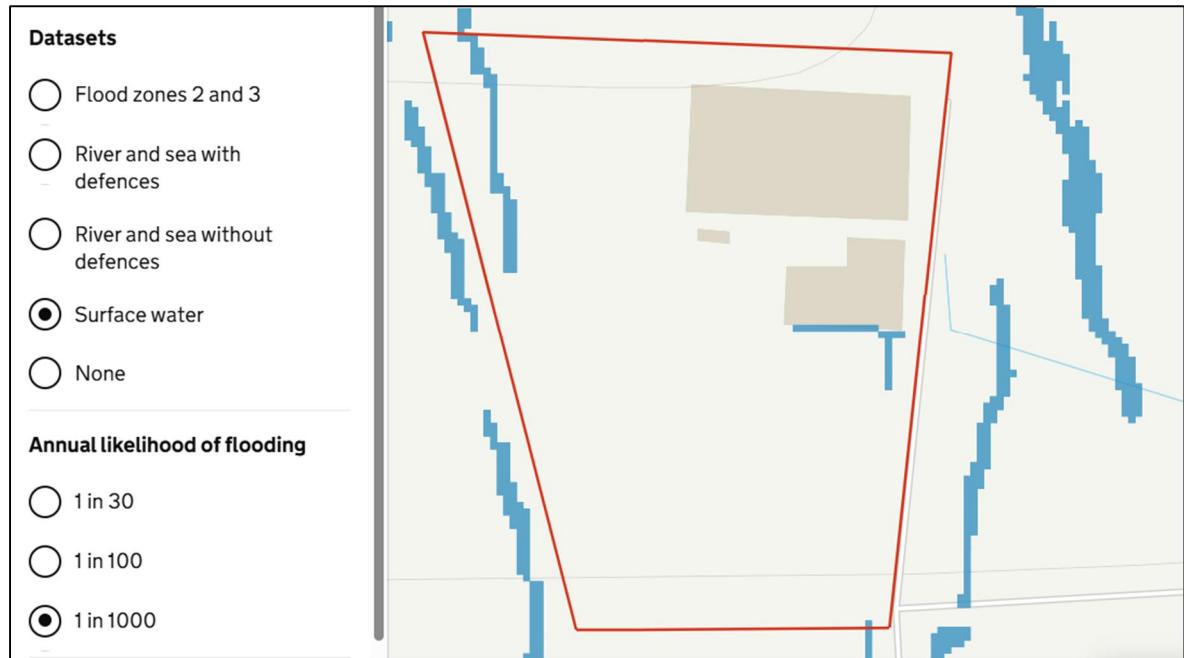
Figure 2.6 – 1 in 1,000-year RoFSW Outline at Lot 8

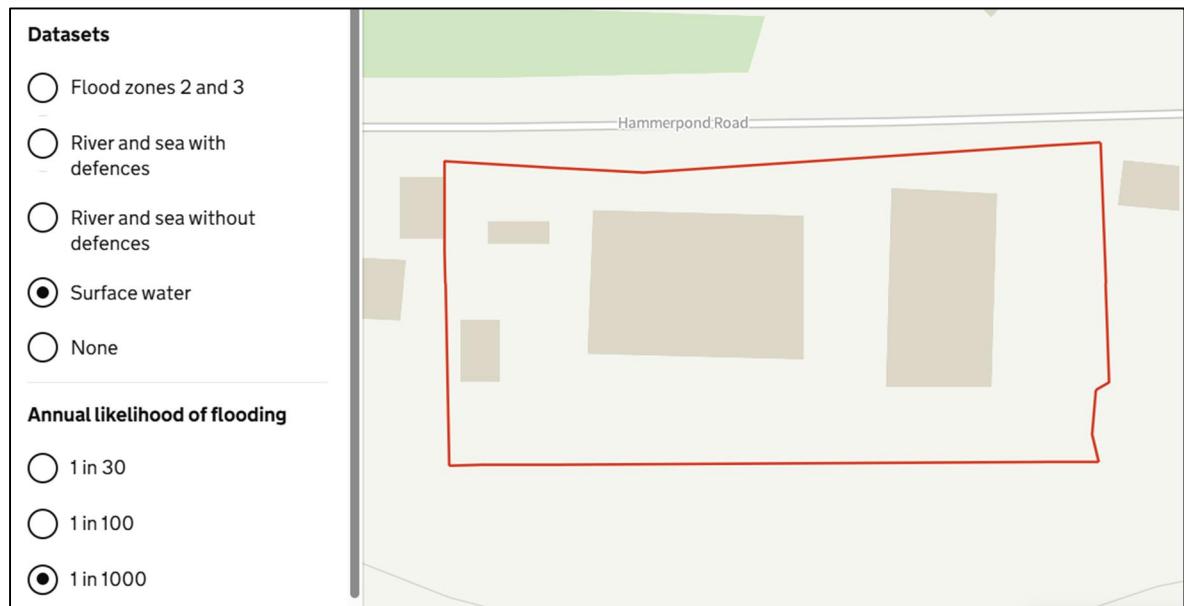
Figure 2.7 – 1 in 1,000-year RoFSW Outline at Jacksons Ridge

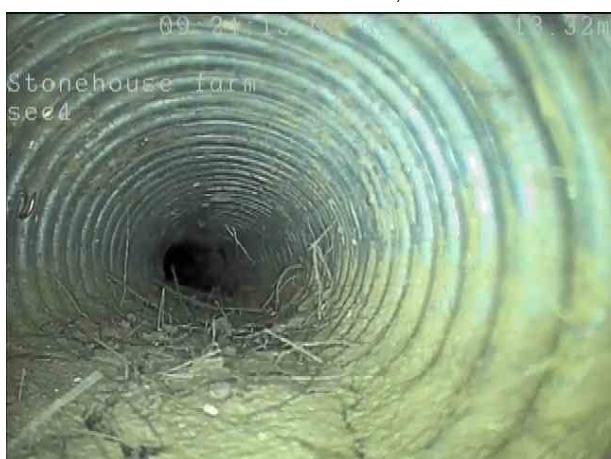
Settled deposits, fine, 35% cross-sectional area loss

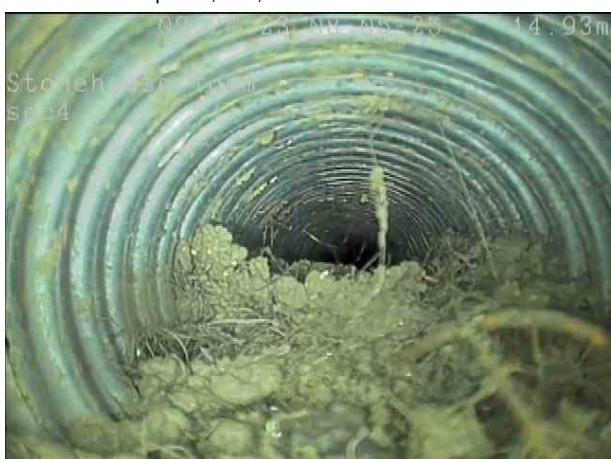
Settled deposits, fine, 25% cross-sectional area loss

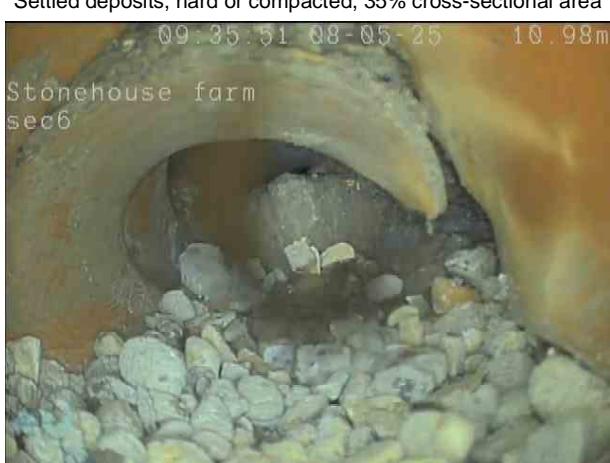
Collapsed drain or sewer, 60% cross-sectional area loss

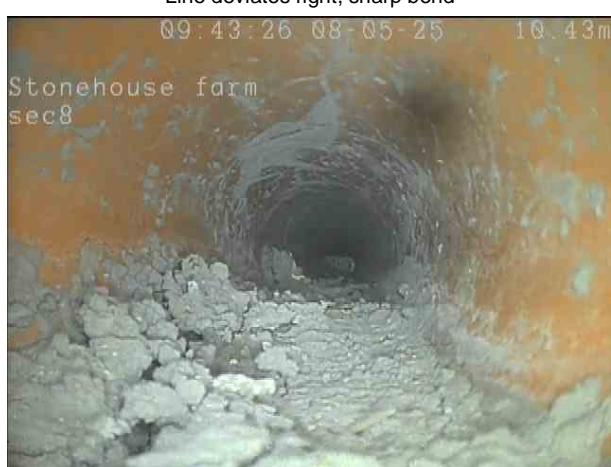
Settled deposits, fine, 15% cross-sectional area loss

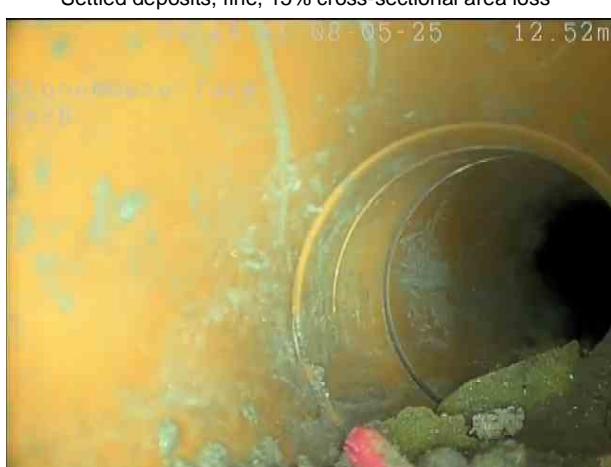
Settled deposits, fine, 35% cross-sectional area loss

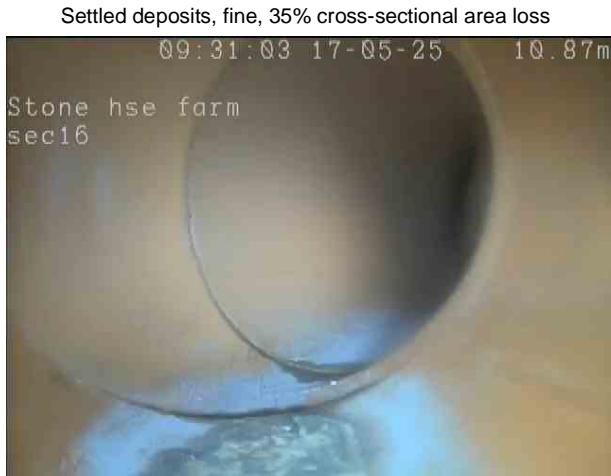
Settled deposits, fine, 25% cross-sectional area loss

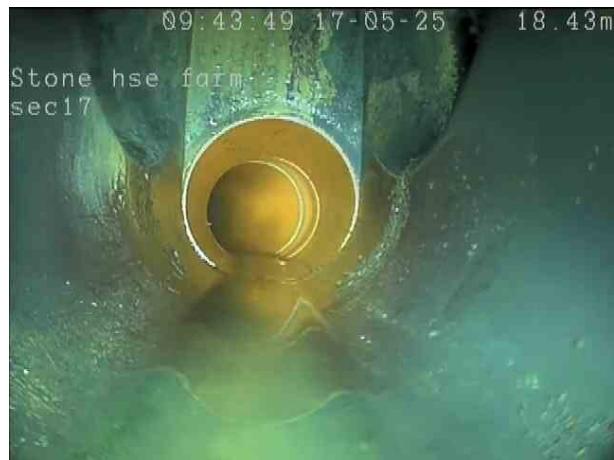
Loss of vision, camera under water, dropped section

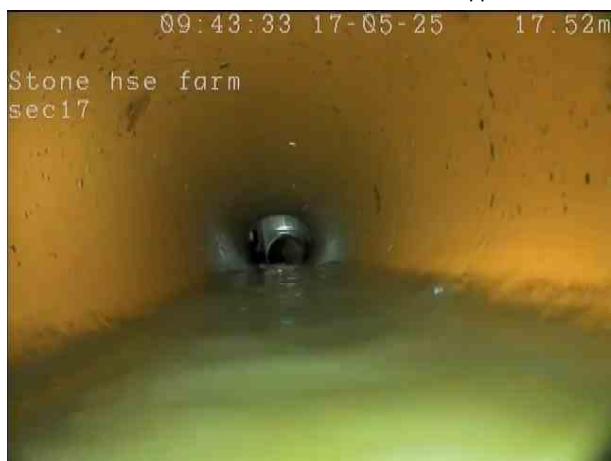
Water level, 85% of the vertical dimension, dropped section

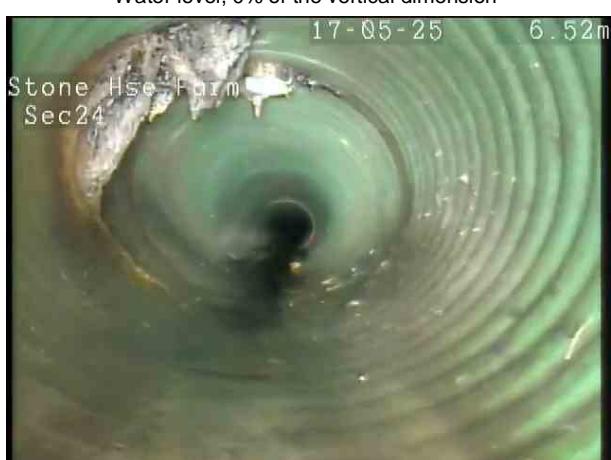
b11ae014-a296-4f4f-9917-cff9ea64299f.png, 00:00:40, 4.80 m
Deformed sewer or drain, 10%

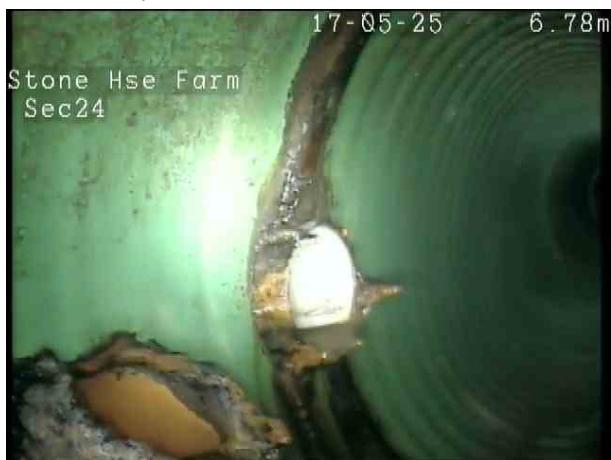
4b4f561f-f90c-4427-90e9-f38d68e4a95f.png, 00:01:16, 6.80 m
Connection other than junction at 11 o'clock, 100mm dia,
intruding

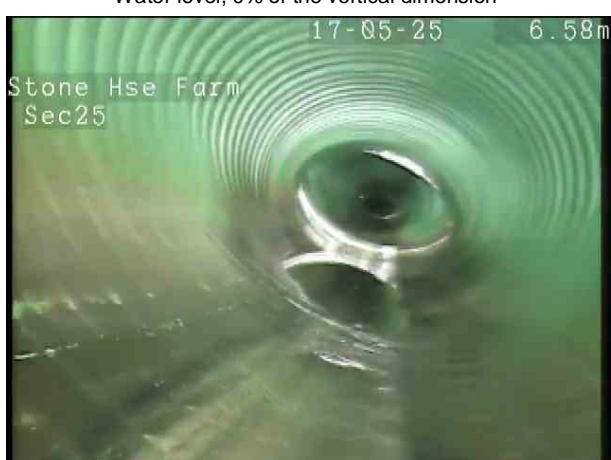
Other obstacles, brick or masonry in invert from 5 o'clock to 7

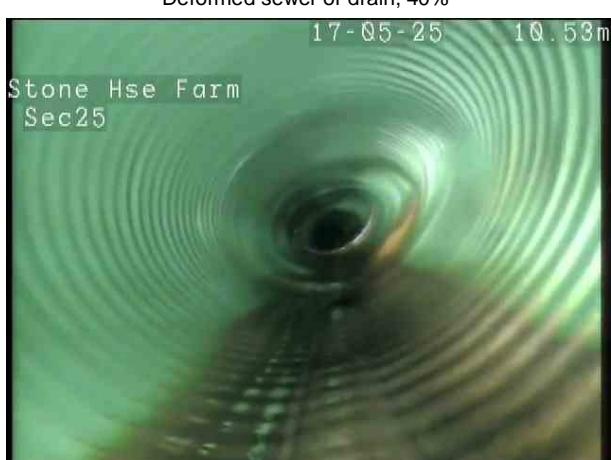
Deformed sewer or drain, 45%

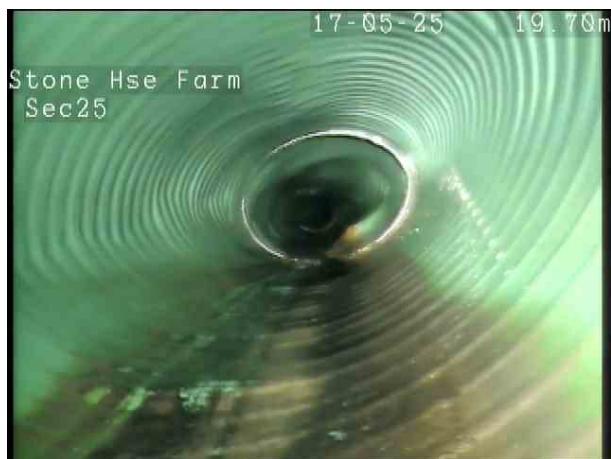
Deformed sewer or drain, 40%

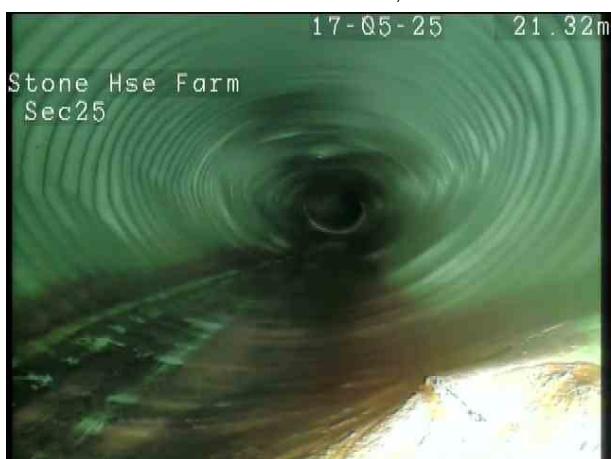
Hole in drain or sewer from 4 o'clock to 6 o'clock
