## Asbestos Demolition Report

High Barn  
Crays Lane  
Goose Green  
Pulborough  
RH20 2LR

Reference: C-10078

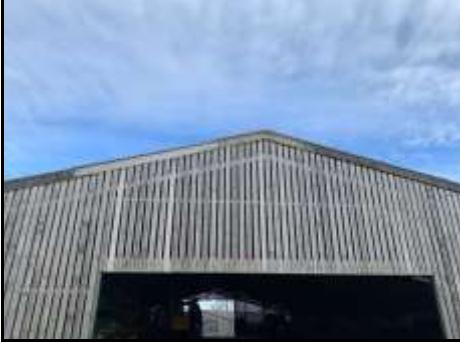
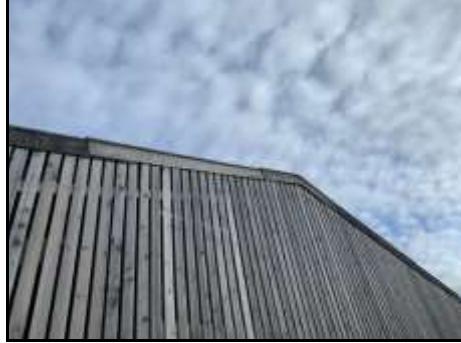
Building:	High Barn	Floor	Ground Floor		
Location ID	001	Location	Barn		
Sample Number	S001	Extent	10 lin m		
Item / Position	Capping	Material	Cement Product		
Product Type		Scores	-		
Condition			-		
Surface Treatment			-		
Asbestos Type	<b>No asbestos detected</b>		-		
Material Assessment	N/A				
Substrate	Different in appearance from the other end capping (Light grey)	Accessibility	-		
<b>Main Photo</b>		<b>Close Up Photo</b>

Recommendation	<b>No action required</b>				
Comments	<p>Corrugated cement roof sheeting including ridge vents. Cement end capping. Timber cladding onto block walls. Timber and metal beams within. Timber and steel constructed doors. Plastic and metal rainwater goods. Small amount of cement debris and old slate roofing tiles found within the barn.</p> <p>Visually different in appearance from the other end capping (Light grey to the front entrance elevation only), other end capping cement products are a darker grey in appearance.</p>

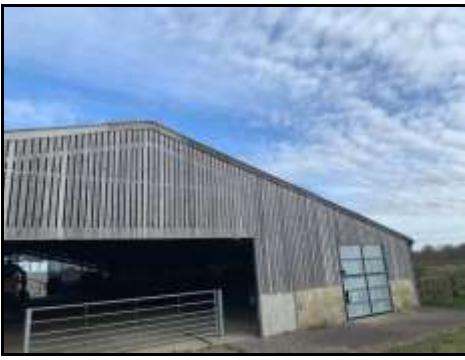
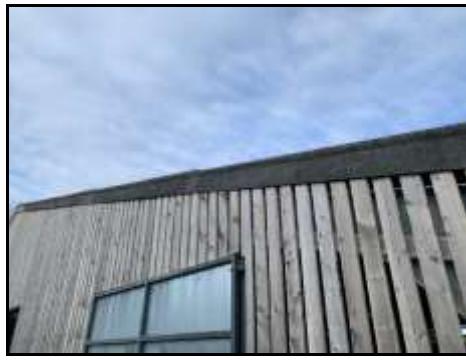
Building:	High Barn	Floor	Ground Floor		
Location ID	001	Location	Barn		
Sample Number	S002	Extent	50 lin m		
Item / Position	Capping	Material	Cement Product		
Product Type	Asbestos reinforced composites etc.	Scores	1		
Condition	Good Condition		0		
Surface Treatment	Sealed		1		
Asbestos Type	Chrysotile		1		
Material Assessment	Very Low		3		
Substrate	Bolted (Dark Grey)	Accessibility	High		
<b>Main Photo</b>		<b>Close Up Photo</b>

Recommendation	<b>Remove - NON-Licensed Material Removal by an asbestos contractor. This material is not licensed however may still be notifiable to the HSE prior to removal works taking place. All works must conform to the Control of Asbestos Regulations 2012.</b>				
Comments	Corrugated cement roof sheeting including ridge vents. Cement end capping. Timber cladding onto block walls. Timber and metal beams within. Timber and steel constructed doors. Plastic and metal rainwater goods. Small amount of cement debris and old slate roofing tiles found within the barn.

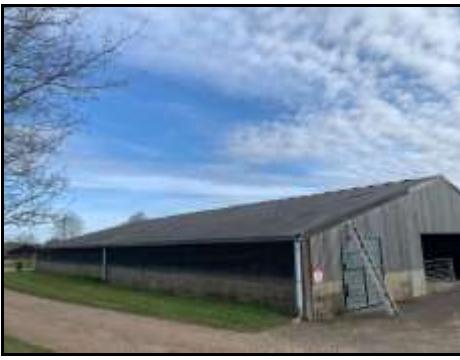
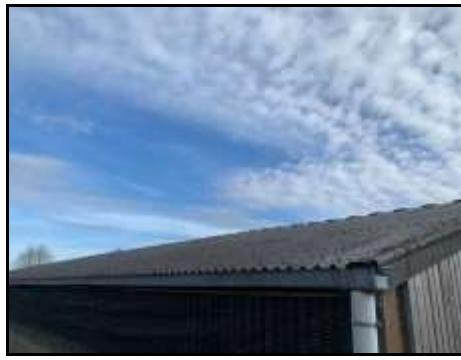
Building:	High Barn	Floor	Ground Floor		
Location ID	001	Location	Barn		
Sample Number	S003	Extent	300 m <sup>2</sup>		
Item / Position	Roof	Material	Cement Product		
Product Type	Asbestos reinforced composites etc.	Scores	1		
Condition	Low Damage		1		
Surface Treatment	Sealed		1		
Asbestos Type	Chrysotile		1		
Material Assessment	Very Low		4		
Substrate	Including ridge vents	Accessibility	High		
<b>Main Photo</b>		<b>Close Up Photo</b>

Recommendation	<b>Remove - NON-Licensed Material Removal by an asbestos contractor. This material is not licensed however may still be notifiable to the HSE prior to removal works taking place. All works must conform to the Control of Asbestos Regulations 2012.</b>				
Comments	Corrugated cement roof sheeting including ridge vents. Cement end capping. Timber cladding onto block walls. Timber and metal beams within. Timber and steel constructed doors. Plastic and metal rainwater goods. Small amount of cement debris and old slate roofing tiles found within the barn.  Including ridge vents

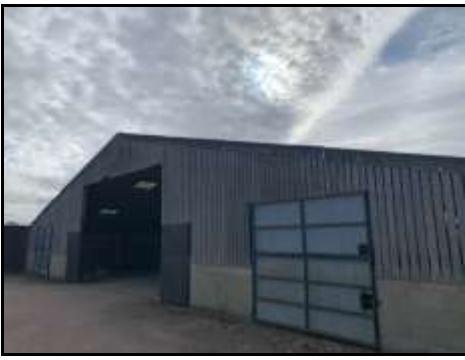
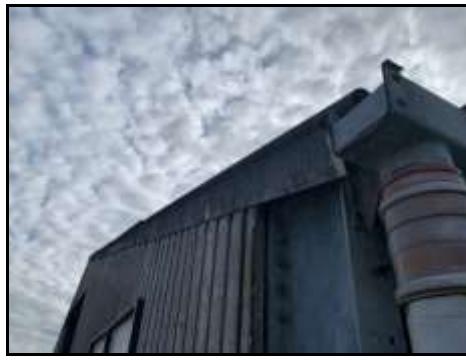
Building:	High Barn	Floor	Ground Floor		
Location ID	001	Location	Barn		
Sample Number	S004	Extent	50 lin m		
Item / Position	Capping	Material	Cement Product		
Product Type	Asbestos reinforced composites etc.	Scores	1		
Condition	Low Damage		1		
Surface Treatment	Sealed		1		
Asbestos Type	Chrysotile		1		
Material Assessment	Very Low		4		
Substrate		Accessibility	High		
<b>Main Photo</b>		<b>Close Up Photo</b>

Recommendation	<b>Remove - NON-Licensed Material Removal by an asbestos contractor. This material is not licensed however may still be notifiable to the HSE prior to removal works taking place. All works must conform to the Control of Asbestos Regulations 2012.</b>				
Comments	Corrugated cement roof sheeting including ridge vents. Cement end capping. Timber cladding onto block walls. Timber and metal beams within. Timber and steel constructed doors. Plastic and metal rainwater goods. Small amount of cement debris and old slate roofing tiles found within the barn.

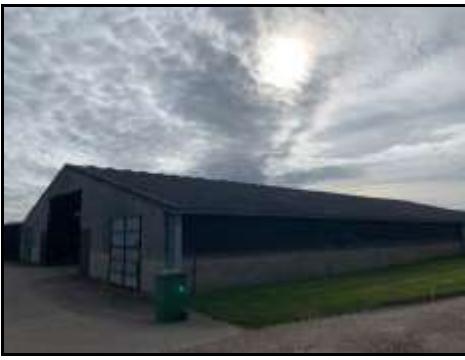
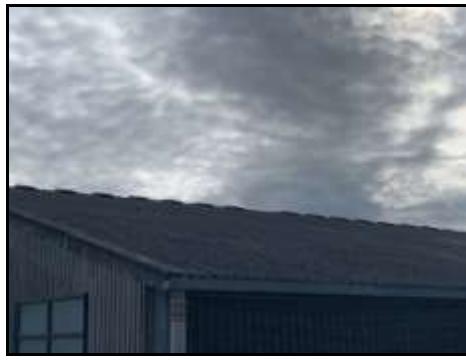
Building:	High Barn	Floor	Ground Floor		
Location ID	001	Location	Barn		
Sample Number	S006	Extent	300 m <sup>2</sup>		
Item / Position	Roof	Material	Cement Product		
Product Type	Asbestos reinforced composites etc.	Scores	1		
Condition	Low Damage		1		
Surface Treatment	Sealed		1		
Asbestos Type	Chrysotile		1		
Material Assessment	Very Low		4		
Substrate		Accessibility	High		
<b>Main Photo</b>		<b>Close Up Photo</b>

Recommendation	<b>Remove - NON-Licensed Material Removal by an asbestos contractor. This material is not licensed however may still be notifiable to the HSE prior to removal works taking place. All works must conform to the Control of Asbestos Regulations 2012.</b>				
Comments	Corrugated cement roof sheeting including ridge vents. Cement end capping. Timber cladding onto block walls. Timber and metal beams within. Timber and steel constructed doors. Plastic and metal rainwater goods. Small amount of cement debris and old slate roofing tiles found within the barn.

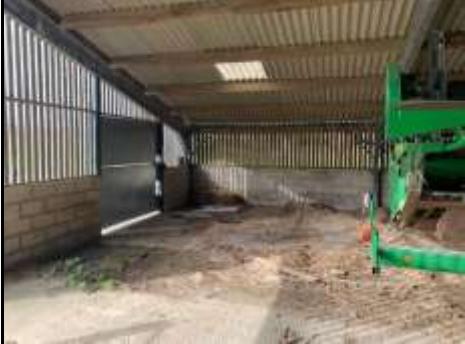
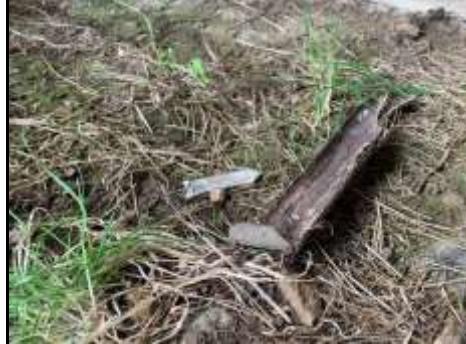
Building:	High Barn	Floor	Ground Floor		
Location ID	001	Location	Barn		
Sample Number	S007	Extent	Small amounts		
Item / Position	Roof	Material	Cement Product		
Product Type		Scores	-		
Condition			-		
Surface Treatment			-		
Asbestos Type	<b>No asbestos detected</b>		-		
Material Assessment	N/A				
Substrate	Small amounts of cement debris found within barn.	Accessibility	-		
<b>Main Photo</b>		<b>Close Up Photo</b>

Recommendation	<b>No action required</b>				
Comments	Corrugated cement roof sheeting including ridge vents. Cement end capping. Timber cladding onto block walls. Timber and metal beams within. Timber and steel constructed doors. Plastic and metal rainwater goods. Small amount of cement debris and old slate roofing tiles found within the barn. Small amounts of cement debris found within barn.

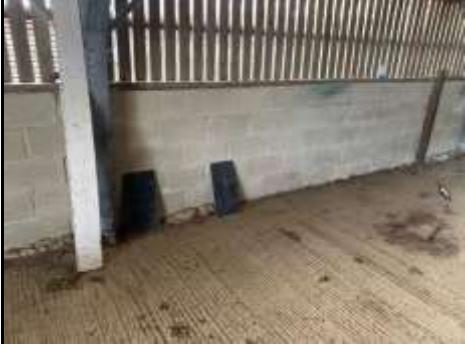
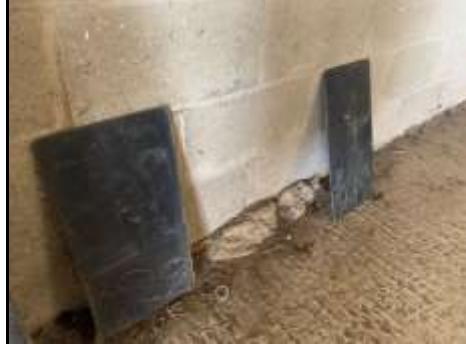
Building:	High Barn	Floor	Ground Floor		
Location ID	001	Location	Barn		
Sample Number	S008	Extent	2 no		
Item / Position	Redundant Roofing Slates	Material	Cement Product		
Product Type	Asbestos reinforced composites etc.	Scores	1		
Condition	Low Damage		1		
Surface Treatment	Sealed		1		
Asbestos Type	<b>Chrysotile</b>		1		
Material Assessment	Very Low		4		
Substrate	X2 redundant cement roofing slates found within the barn.	Accessibility	Low		
<b>Main Photo</b>		<b>Close Up Photo</b>

Recommendation	<b>Remove - NON-Licensed Material Removal by an asbestos contractor. This material is not licensed however may still be notifiable to the HSE prior to removal works taking place. All works must conform to the Control of Asbestos Regulations 2012.</b>				
Comments	Corrugated cement roof sheeting including ridge vents. Cement end capping. Timber cladding onto block walls. Timber and metal beams within. Timber and steel constructed doors. Plastic and metal rainwater goods. Small amount of cement debris and old slate roofing tiles found within the barn. X2 redundant cement roofing slates found within the barn.

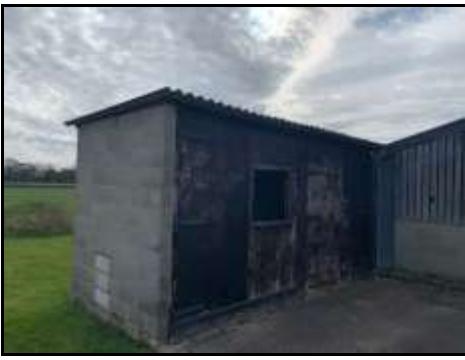
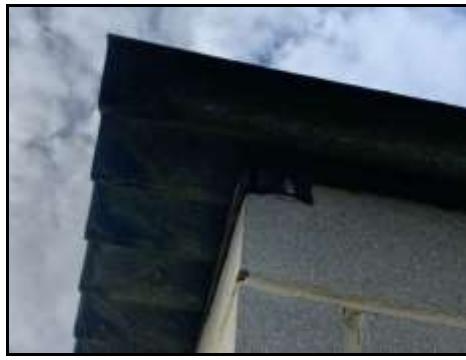
Building:	High Barn	Floor	Ground Floor		
Location ID	002	Location	Store		
Sample Number	S005	Extent	20 m <sup>2</sup>		
Item / Position	Roof	Material	Cement Product		
Product Type	Asbestos reinforced composites etc.	Scores	1		
Condition	Low Damage		1		
Surface Treatment	Sealed		1		
Asbestos Type	Chrysotile		1		
Material Assessment	Very Low		4		
Substrate	Bolted	Accessibility	High		
<b>Main Photo</b>		<b>Close Up Photo</b>

Recommendation	<b>Remove - NON-Licensed Material Removal by an asbestos contractor. This material is not licensed however may still be notifiable to the HSE prior to removal works taking place. All works must conform to the Control of Asbestos Regulations 2012.</b>				
Comments	Corrugated cement roof sheeting. Block and timber walls. Concrete floor.
