Phase I Desk Study

**Lower Perryland Farm, Basing Hill,
Dial Post, West Sussex
RH13 3NT**

Document Reference: ON251025-XX-XX-RP-X-701-C01

Date: 14 April 2025

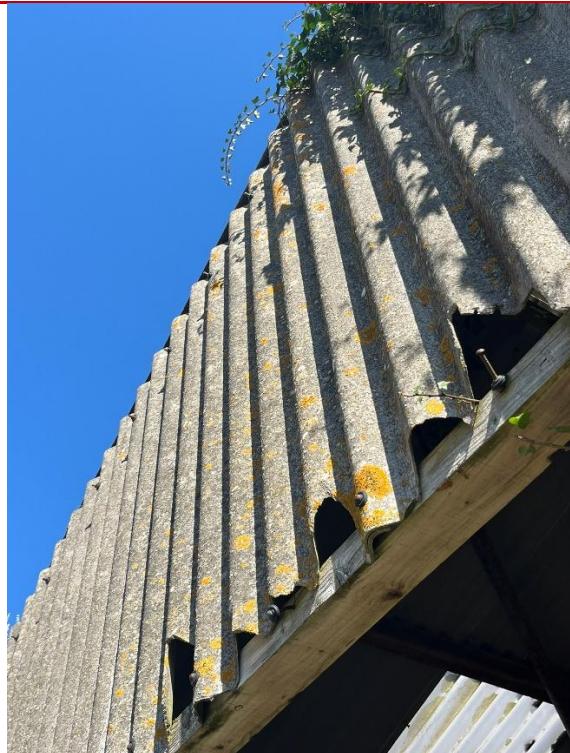
Suspected asbestos cement sheeting was observed within the structure of several of the buildings on site, with further fragments of this materials observed on the ground surface. As such there is the potential for the soils on site to be impacted with asbestos containing materials which would pose an unacceptable (high) risk to future site users and construction workers.

Photo 2 – Suspected corrugated asbestos cement sheeting with fragments missing.

This desk study has identified several potential sources of contamination on site, most notably the presence of asbestos within the structures and on the ground surface. Therefore, it is recommended that shallow site investigation is undertaken to enable chemical testing of the soils and an assessment of the risk to future site users. It should also be noted that if any of the barns

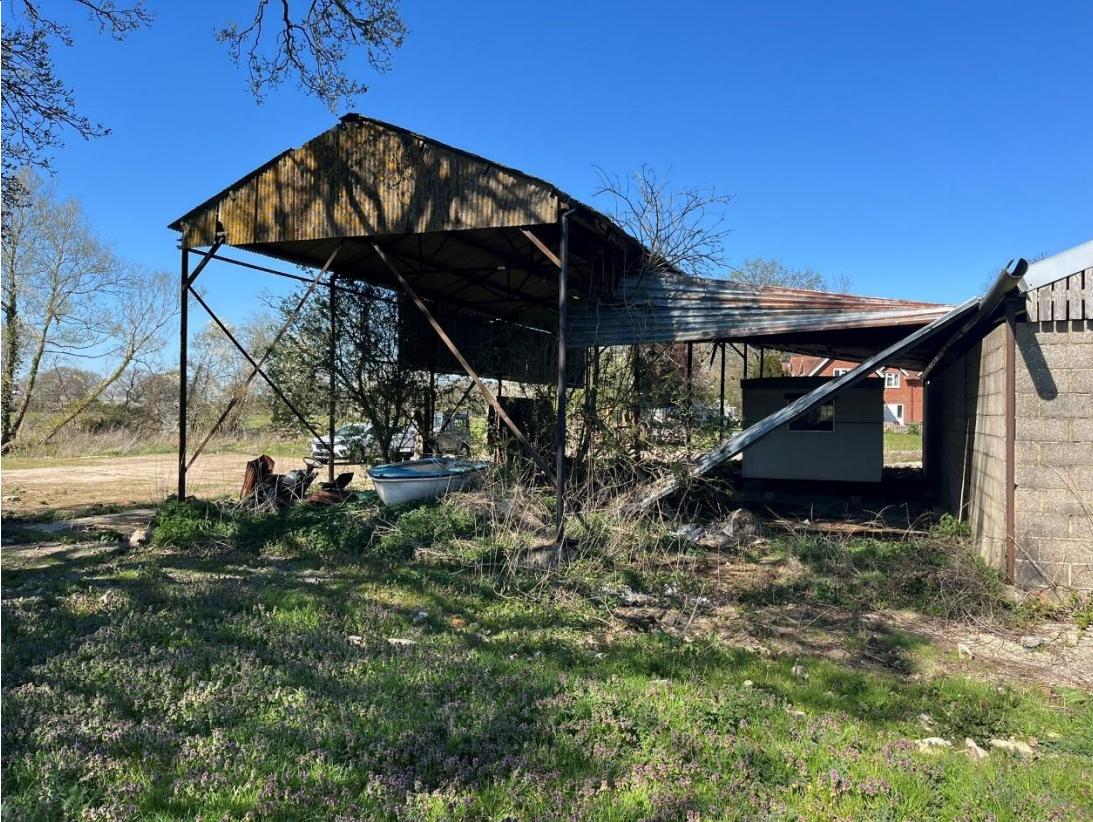
Photo 7 – Southern side of the western barn with a caravan inside.

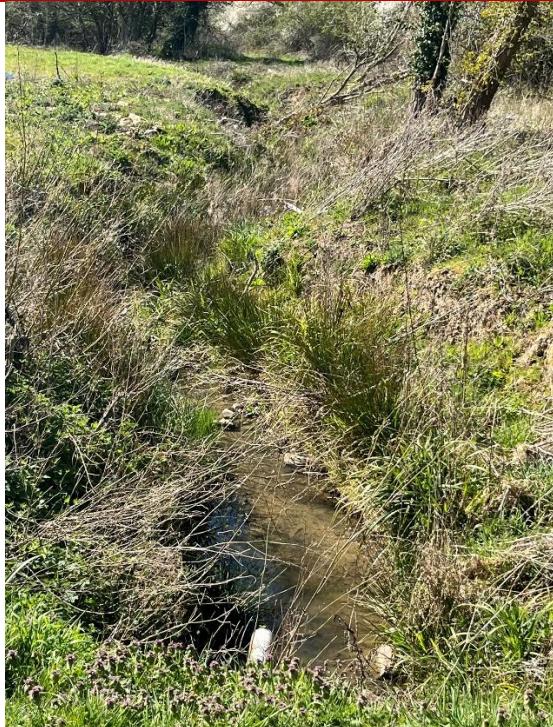
Other than asbestos cement fragments, no significant evidence for contamination, particularly liquid contaminants, was observed on site. As such the risk of contaminants impacting the onsite stream are generally considered low. However, care should be taken during construction to ensure that significant surface water runoff from the site does not impact the stream. Consideration should also be made to ensure that run off does not result in excessive silting up of the watercourse.

Photo 9 – View of the onsite stream looking west.

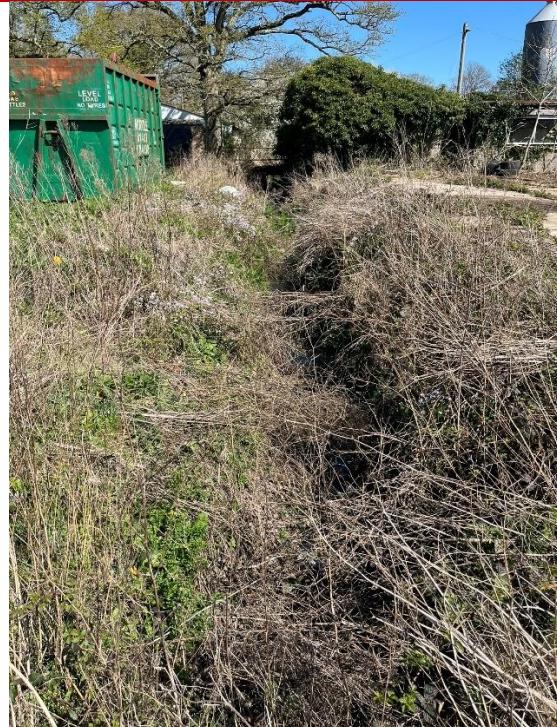
Photo 10 - View of the onsite stream looking east.
