**BS5837: 2012 Tree Survey,
Arboricultural Impact Assessment
and preliminary Tree Protection Plan**

**Site: The Lodge at Wineham Place, Wineham Lane, Henfield,
BN5 9AZ**

Report Date: 03/11/25

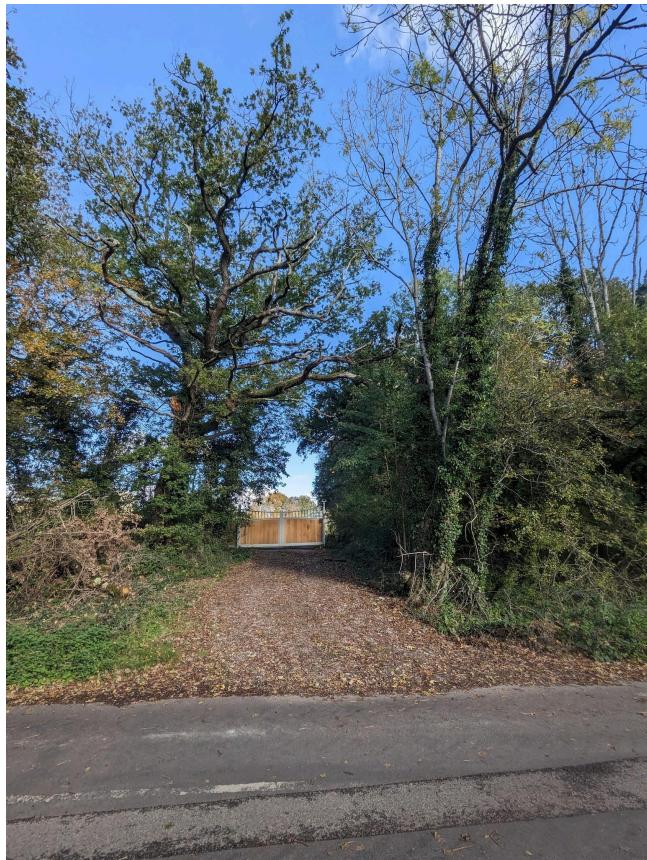
South Entrance from Kent St

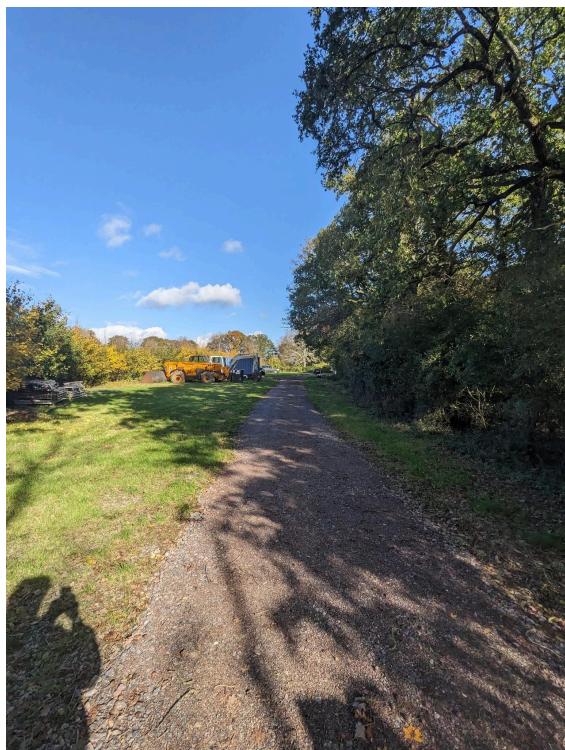
Interior of site from south entrance

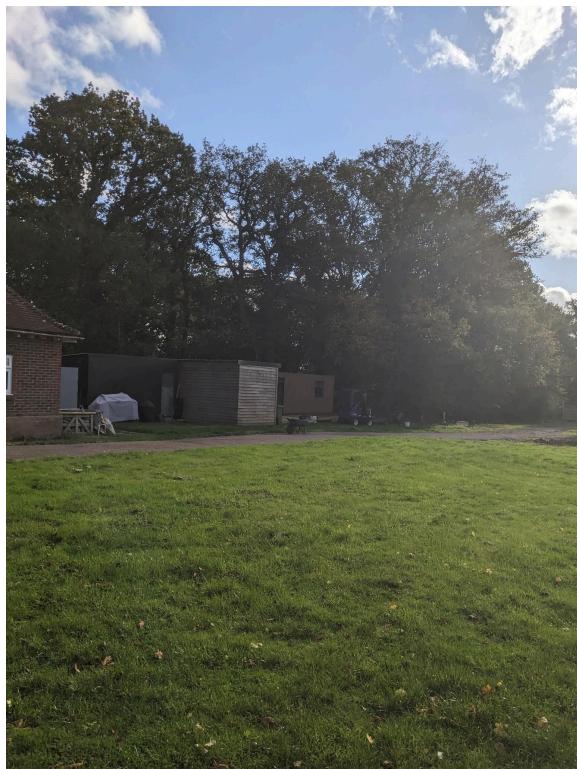
The Lodge (Left) and temporary living units (Right) viewed from the northwest corner of the site

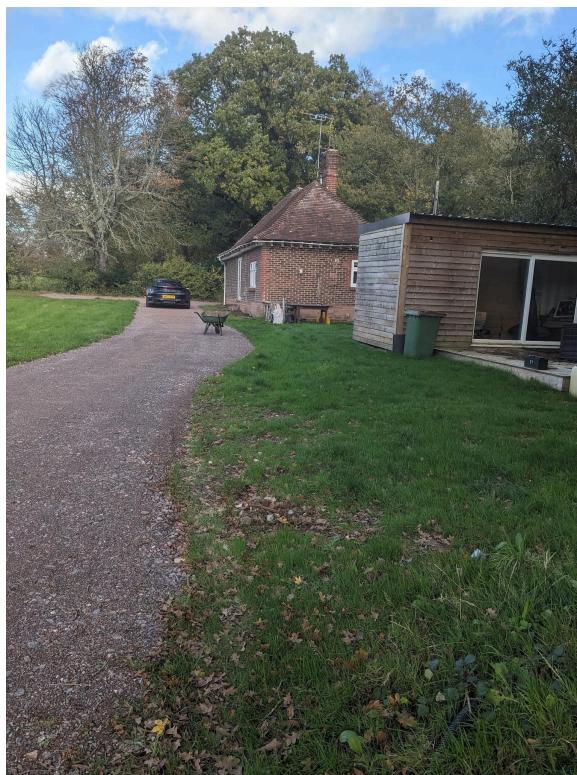
The Lodge viewed from the south

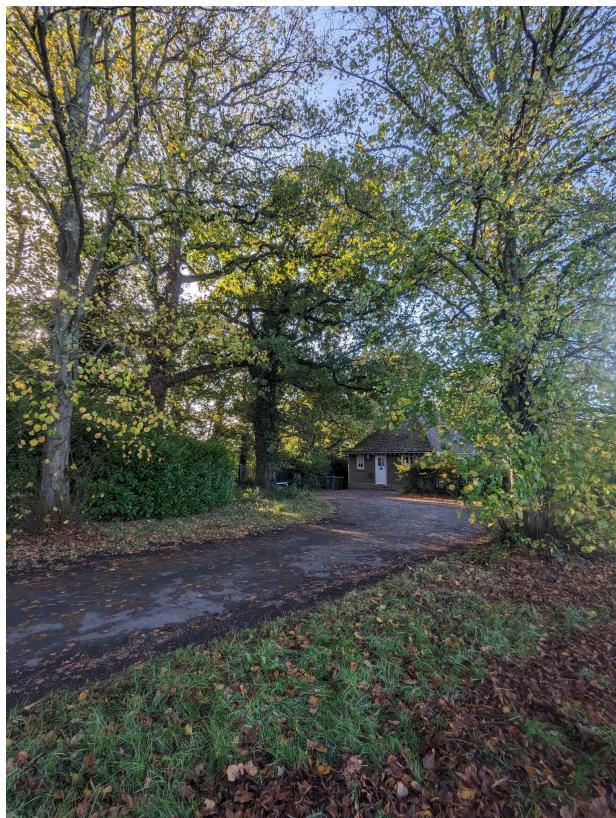
View of the lodge between T005 (left) and T004 (right)

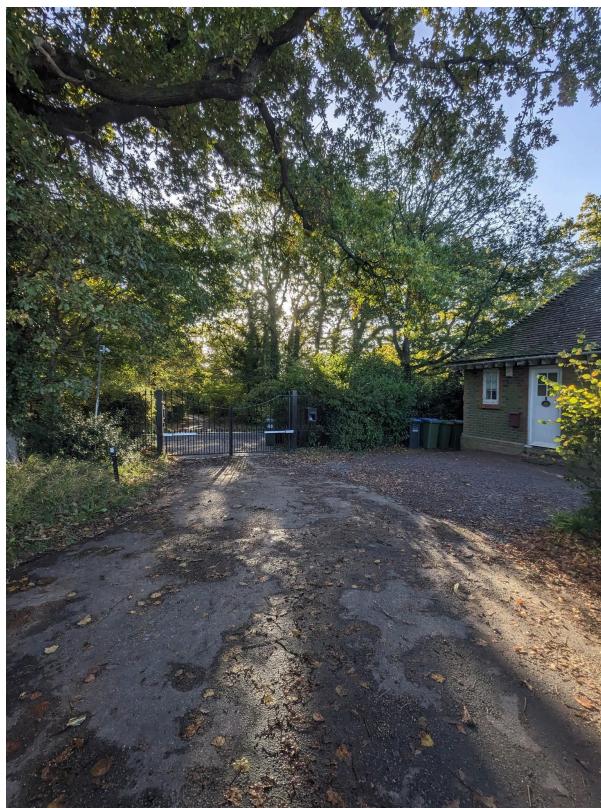
Northern site entrance to Wineham Ln

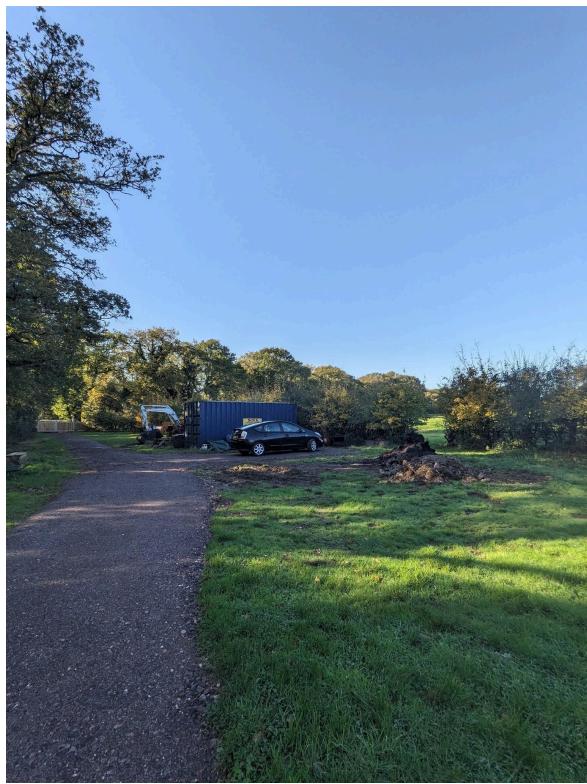
The site for the new dwelling looking south from the lodge
