**CHIDHURST LTD**

GREENACRES, SAUCELANDS LANE, SHIPLEY,  
HORSHAM, WEST SUSSEX RH13 8PU

**Preliminary Contamination Risk Assessment**

July 2025

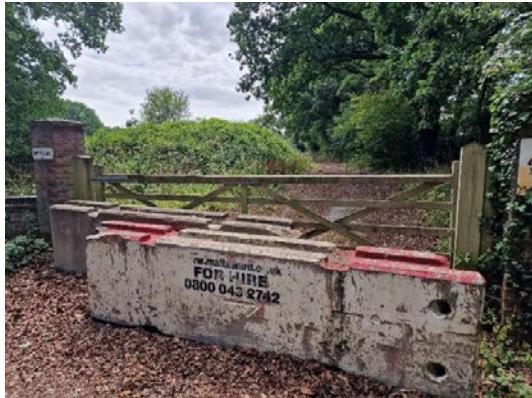
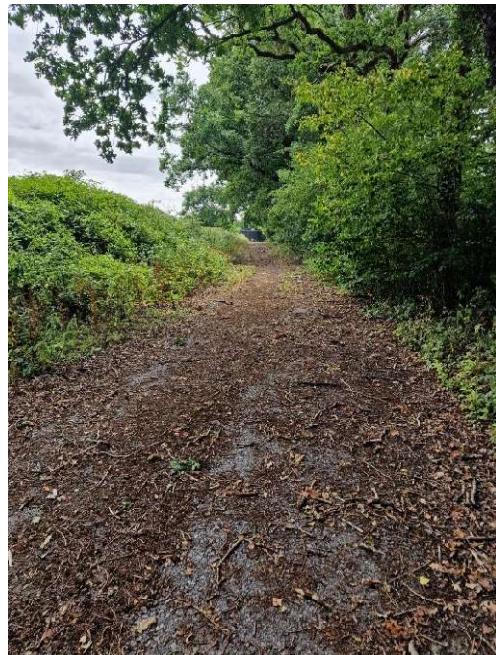
### Photographs 1 and 2: Site Access

The site access has been secured and there are no signs of misuse or fly tipping. A bund lies along the eastern boundary of the access road and a tree lined ditch lies along the western side.

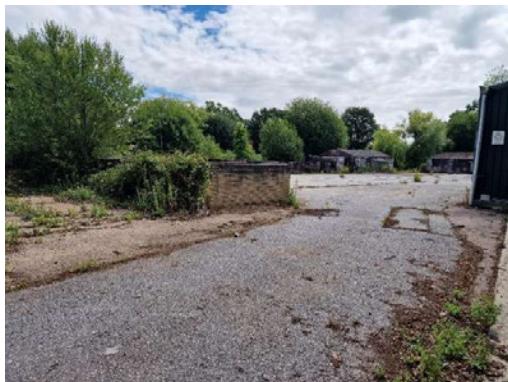
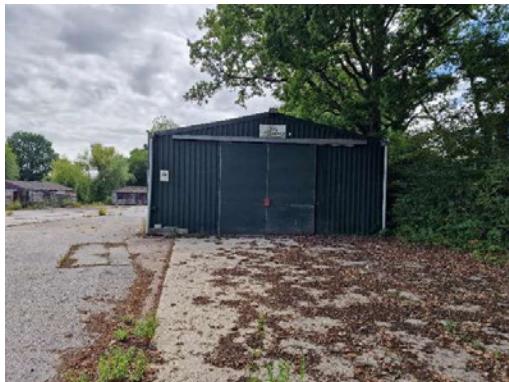
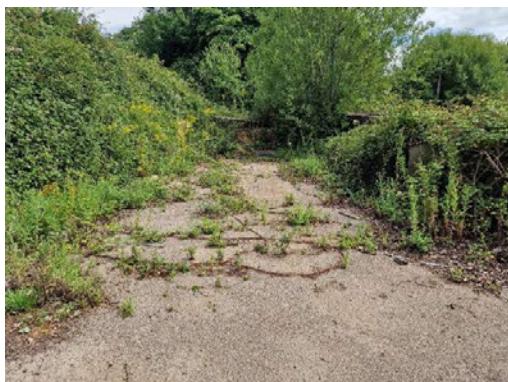
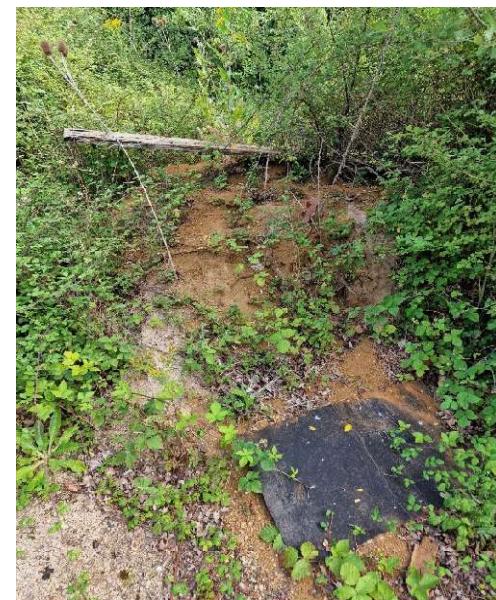
**Photographs 3 - 6:** Southern end of the access road into Yard 1 and Building 1, with concrete surfaced areas to the east and west. Aggregate (sand) lies at the eastern end of the concrete surfacing to the east.

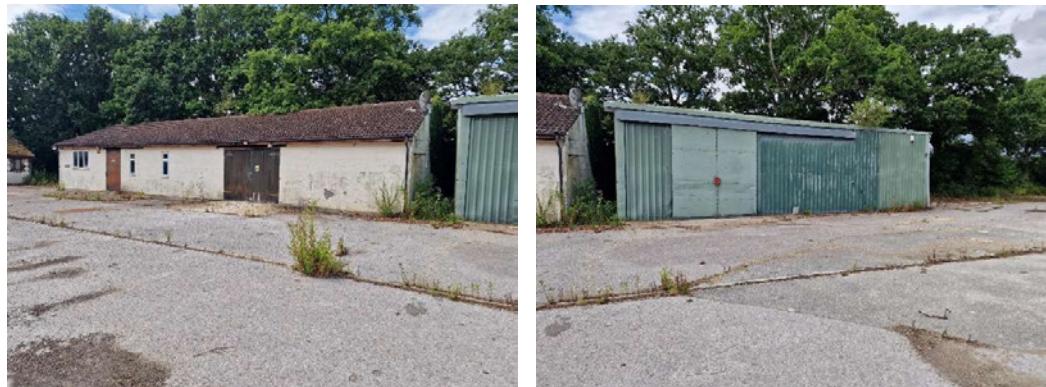
**Photographs 7 and 8:** Buildings 1 (pictured right) and 2 (pictured left), as they stand adjacent to one another along the western boundary of Yard 1.

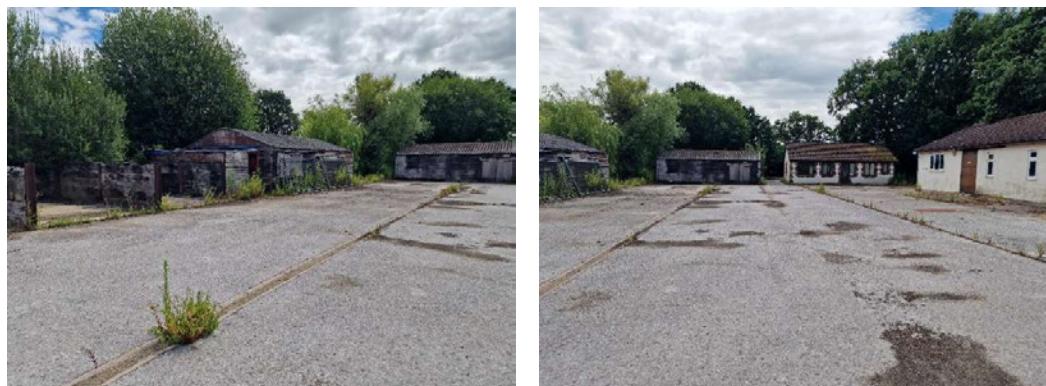
- 5.5 It appears that the first yard area has been used to store aggregate in bays. The surfacing is tarmac and appears to be in generally good condition with no significant signs of staining, damage or slumping.
- 5.6 To the north of the northern line of aggregate bays is a concrete surfaced area which lies outside of the redline boundary of the site and outside the earth bund line which divides the site from the adjacent scrubland. This area clearly formed part of the previous site use, and includes a pile of aggregate (sand) at the eastern end. (Felt for reptile surveying has been placed on the sand).

**Photographs 9 and 10:** View looking southeast (towards Building 5) and south (towards Buildings 3 and 4) across Yard 1. The darker patches on the concrete surfacing are accumulations of soil and leaf litter, not staining.

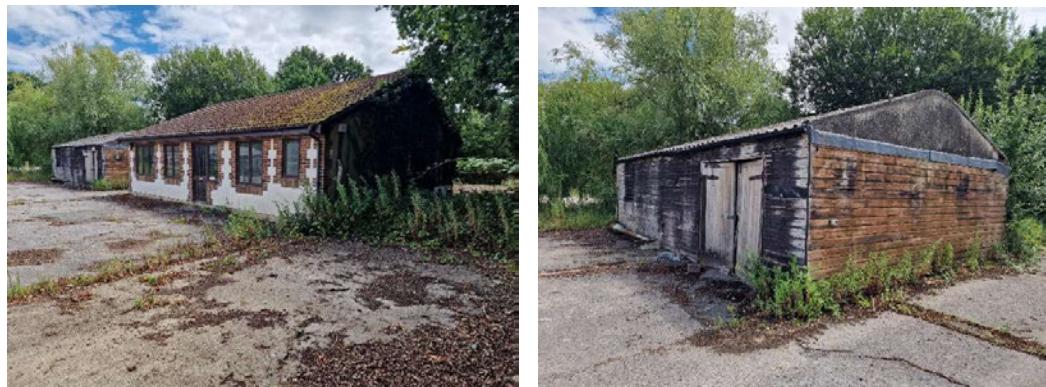
- 5.13 Building 3, located within the southwest corner of the first yard area, is a single storey building of brick construction with a pitched roof clad in cement tiles. This building has windows and a personnel door only, likely to be used as an office and staff facilities.
- 5.14 Building 4, located to the east of building 3, is a single storey barn comprising wooden outer cladding, with corrugated cement roofing sheets (likely to contain asbestos), plastic gutters and a concrete floor.
- 5.15 Building 5, located at the southern end of the eastern boundary of the first yard, is of similar construction to building 4, with corrugated cement roofing sheets likely to contain asbestos.
- 5.16 Building 6 is located along the western boundary of the second yard (adjacent to a pond). This is an open sided barn comprising corrugated cladding (likely to contain asbestos) over a concrete frame.

**Photographs 11 and 12:** Buildings 3 (pictured left) and Building 4 (pictured right).

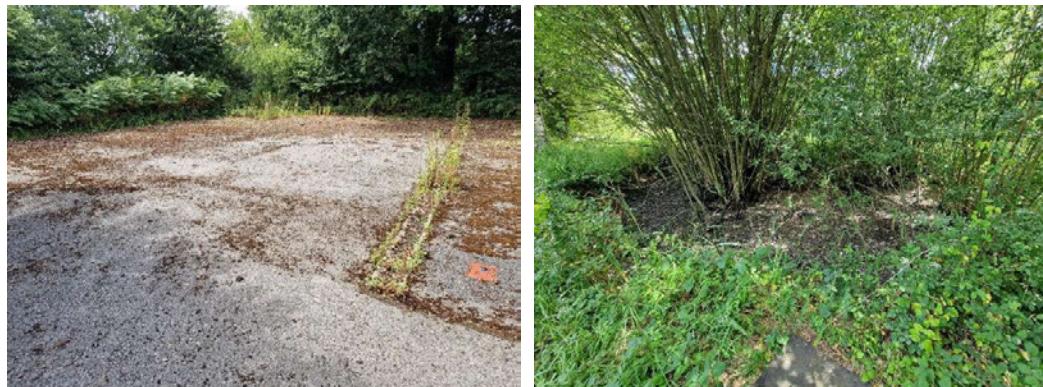
- 5.9 The third yard area, located to the rear of Building 3, has tarmac surfacing in good condition with no signs of staining. The structure, possibly an above ground diesel fuel tank, shown on site mapping has been removed.
- 5.10 To the east of the yard, to the rear of the open-sided barn in Yard 2, is a pond (dry at the time of our visit). This is a shallow pool, overshadowed by vegetation, likely to be fed from surface water runoff from the adjacent yard areas.

7.7 The shallow pool, located to the rear of Buildings 4 and 6, is likely to be fed from surface water runoff from the adjacent yard areas. This pool lies close to the wash bay and drum located to the north of Building 6. It is not known if the wash bay is a contained unit, or if it discharges into the pool. Water and soil within the pool may be contaminated by wash water and surface water runoff which could contain oils / fuels in this case.

**Photographs 13 and 14:** Small yard area (Yard 3) located to the rear of building 3, and a pond to the rear of buildings 4 and 6.

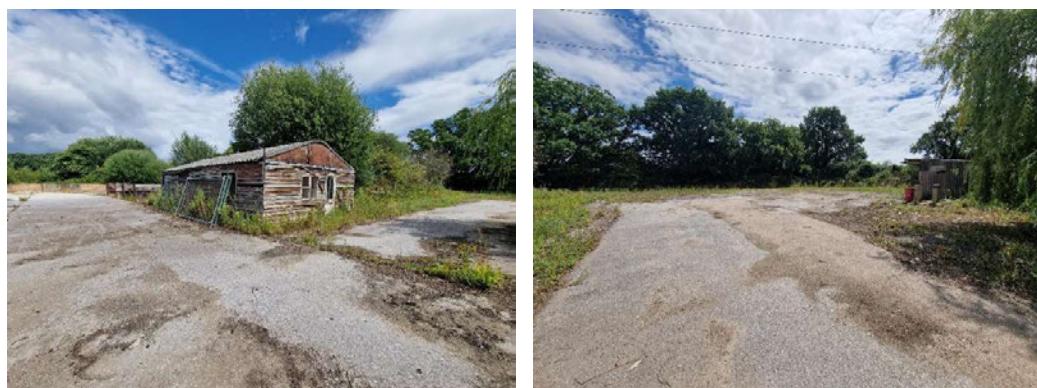
**Photographs 15 and 16:** Building 5 and the tarmac access between Yards 1 and 2.

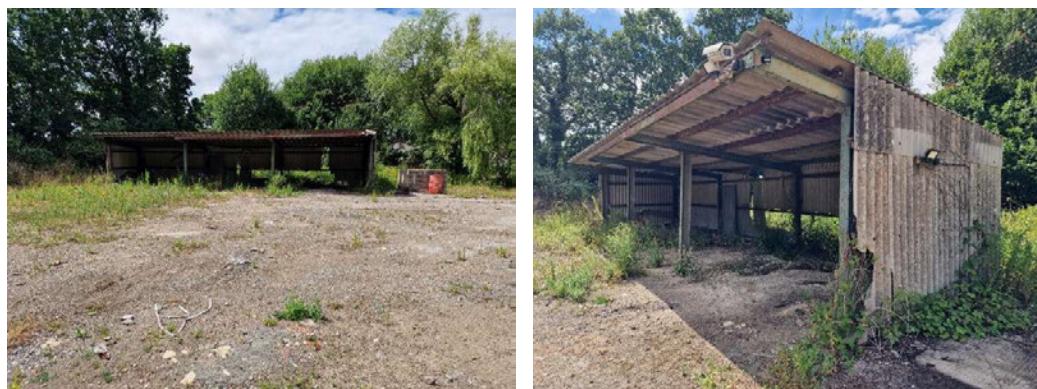
- 5.7 The second yard area, to the east, is covered with compressed road planings which fade out to earth towards the southern and eastern boundary of the site. There are earth bund (which may also include other materials) along the south, east and part of the northern boundary of the yard, which lie within the redline boundary of the site. An informal storage / waste area is present within the northeast corner. Items include corrugated roofing sheets (likely to contain asbestos), large vehicle tyres, tarmac planings for resurfacing, concrete, wooden sleepers and a single (empty) metal 200 litre drum.
- 5.8 To the northwest of Yard 2, east of building 6, is a portacabin. This lies outside the redline boundary of the site, but clearly formed part of the previous site use.

**Photographs 17 and 18:** Yard 2 and Building 6, an open sided barn.

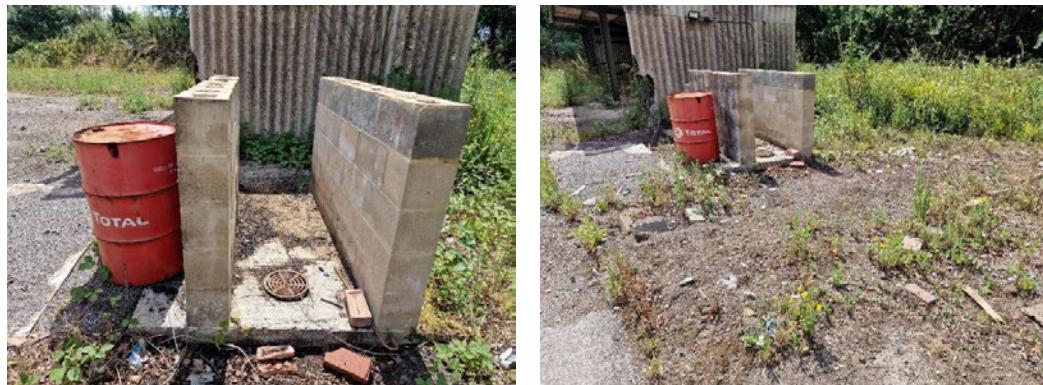
7.6 There is wash bay and oil drum located to the north of the open sided barn within the second yard. A hydrocarbon odour was noted within this area, together with staining of the ground. It is considered likely that there may be some significant hydrocarbon contamination of the ground within this area, a localised hotspot which could impact the adjacent pond to the rear of Buildings 4 and 6.

**Photographs 19 and 20:** Wash bay and drum located to the north of Building 6.

- The maintenance area to the north of Building 6 (including wash bay and drum).
- The pond to the rear of Buildings 4 and 6.
- The waste storage area within the northeast corner of Yard 2.
- The (potential but unconfirmed) former tank location within the southwest corner of the site (southwest corner of Yard 3).

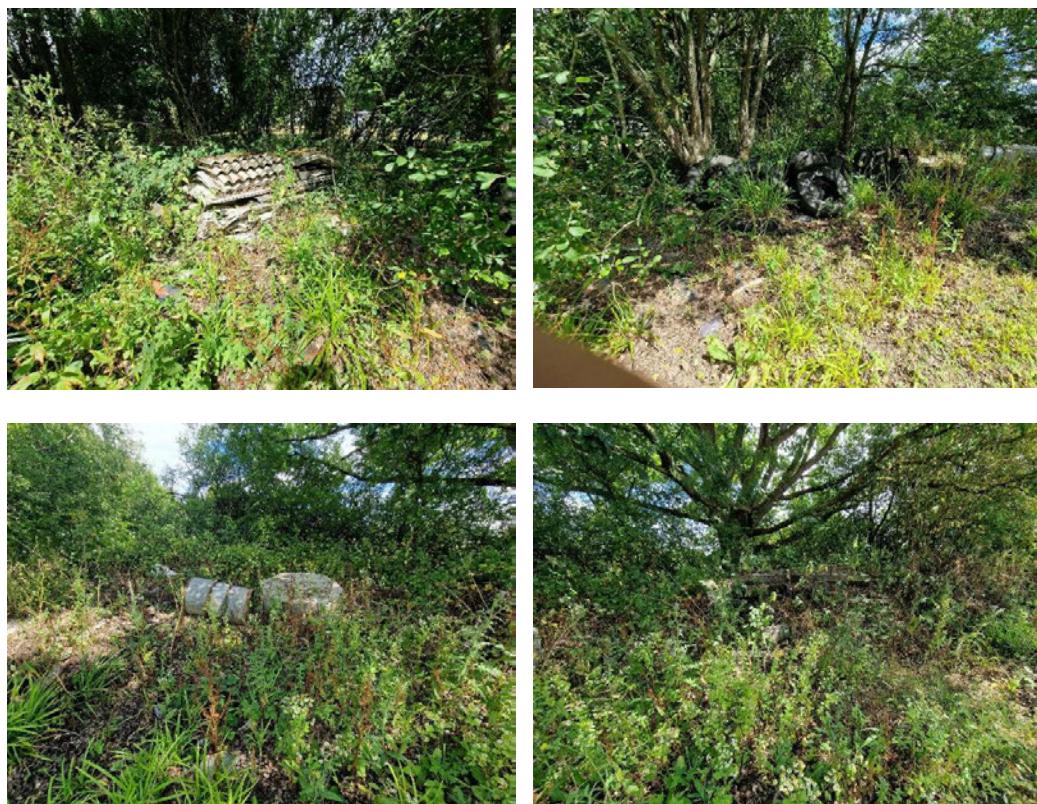
7.4 Buildings 4, 5 and 6 include building materials considered likely to contain asbestos. Further corrugated sheets were also identified in a stack within the northeast corner of the second yard.

7.5 There are waste items including corrugated roofing sheets (likely to contain asbestos), large vehicle tyres, tarmac planings for resurfacing, concrete, wooden sleepers and a single (empty) metal 200 litre drum within the northeast corner of the second yard area to the east of the site. Such waste items on bare ground have the potential to cause contamination of the upper soil layers.

**Photographs 21 – 24:** Waste located within the northeast corner of Yard 2 including corrugated cement sheets (possible asbestos), large vehicle tyres, concrete and a metal 200 litre drum (empty) and wooden sleepers.

10.1 It is recommended that a pre-demolition asbestos survey is completed in accordance with HSG264 prior to the commencement of works and, where asbestos containing materials are confirmed to be present, a remedial mitigation scheme is prepared and implemented to control risk to site workers and future site users. No asbestos containing materials, including the loose stack of corrugated cement sheets within the northeast corner of Yard 2, should be retained on site.
