Arboricultural Report
composed of
Arboricultural Impact Assessment
Arboricultural Method Statement
& Tree Protection Plan

3 Station Road, Billingshurst,
West Sussex, RH14 9RF

Written by
Barry Holdsworth MBA, RHS. Dip, MCI Hort, M.Arbor.A, MCMI
Horticultural Consultant

UPDATED 10th February 2026

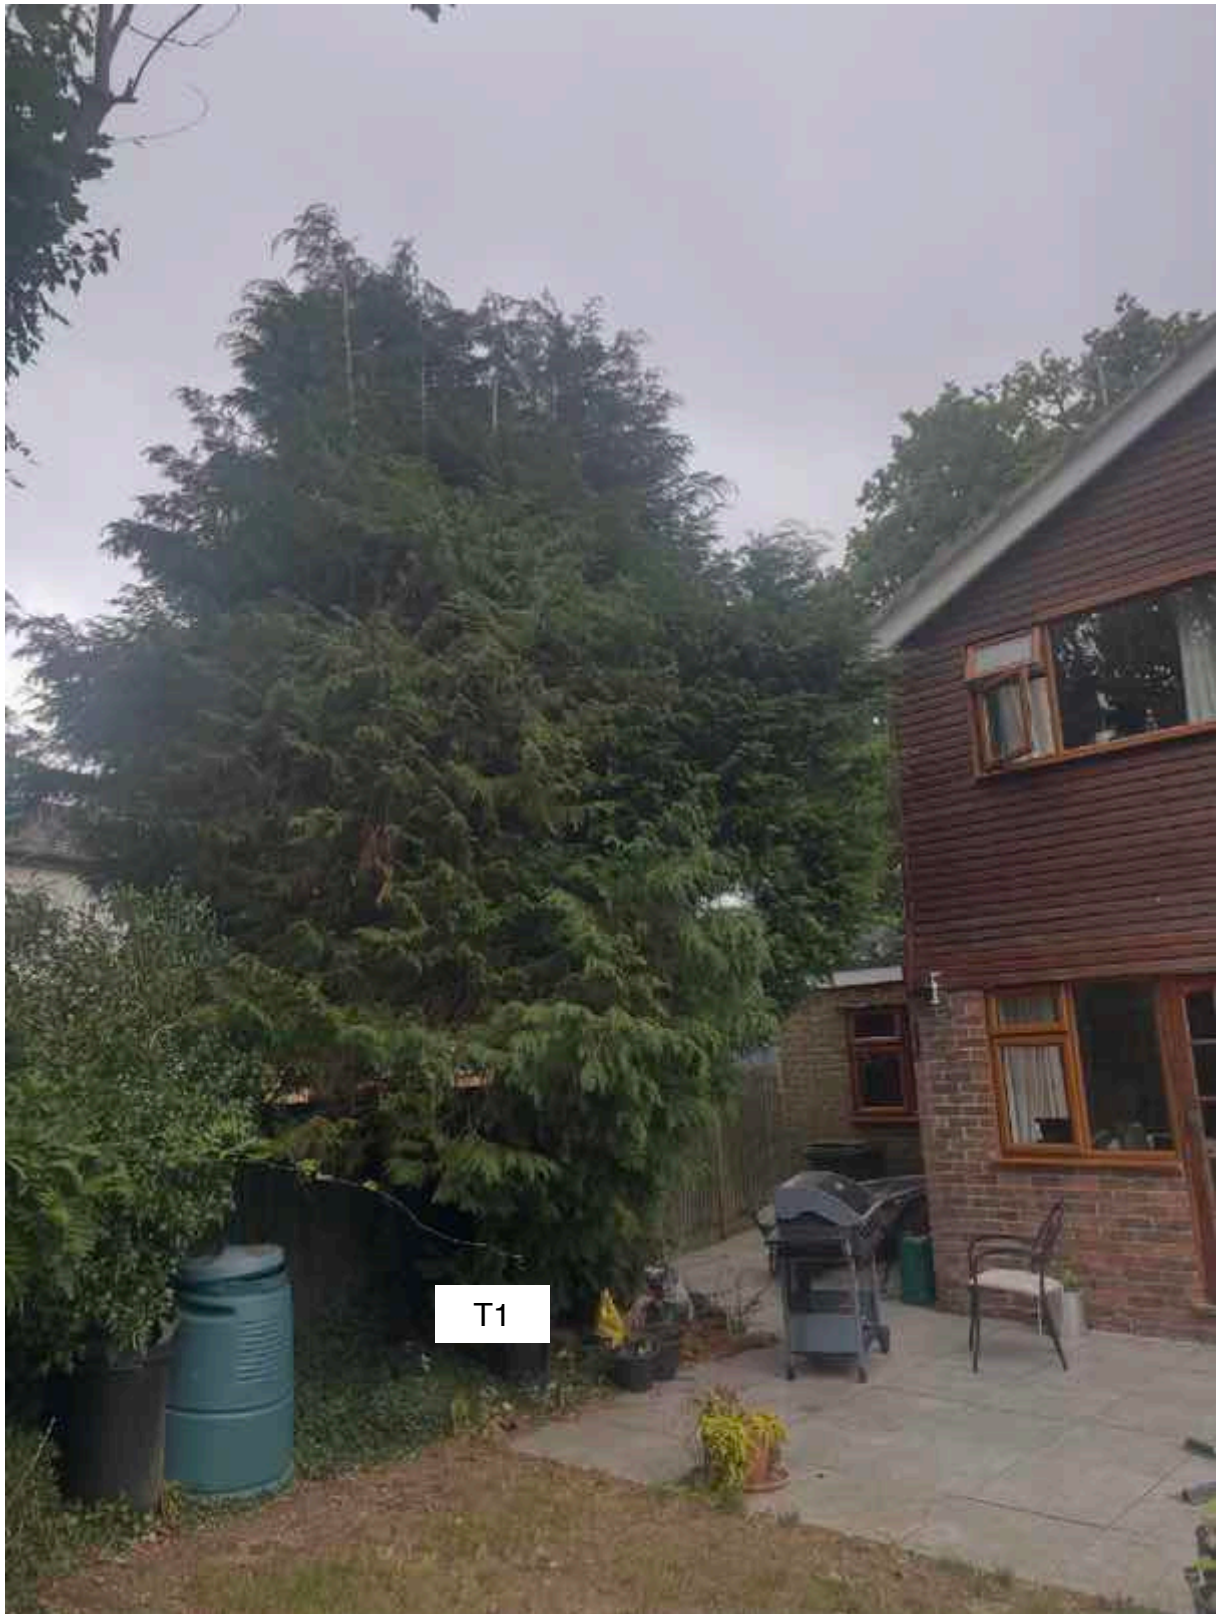
T1 Conifer to be removed

3.5.2. The trees that have been selected for removal are T1 Conifer tree (Class C - tree of low quality) and T2 Tulip Tree (U Class - trees unsuitable for retention).

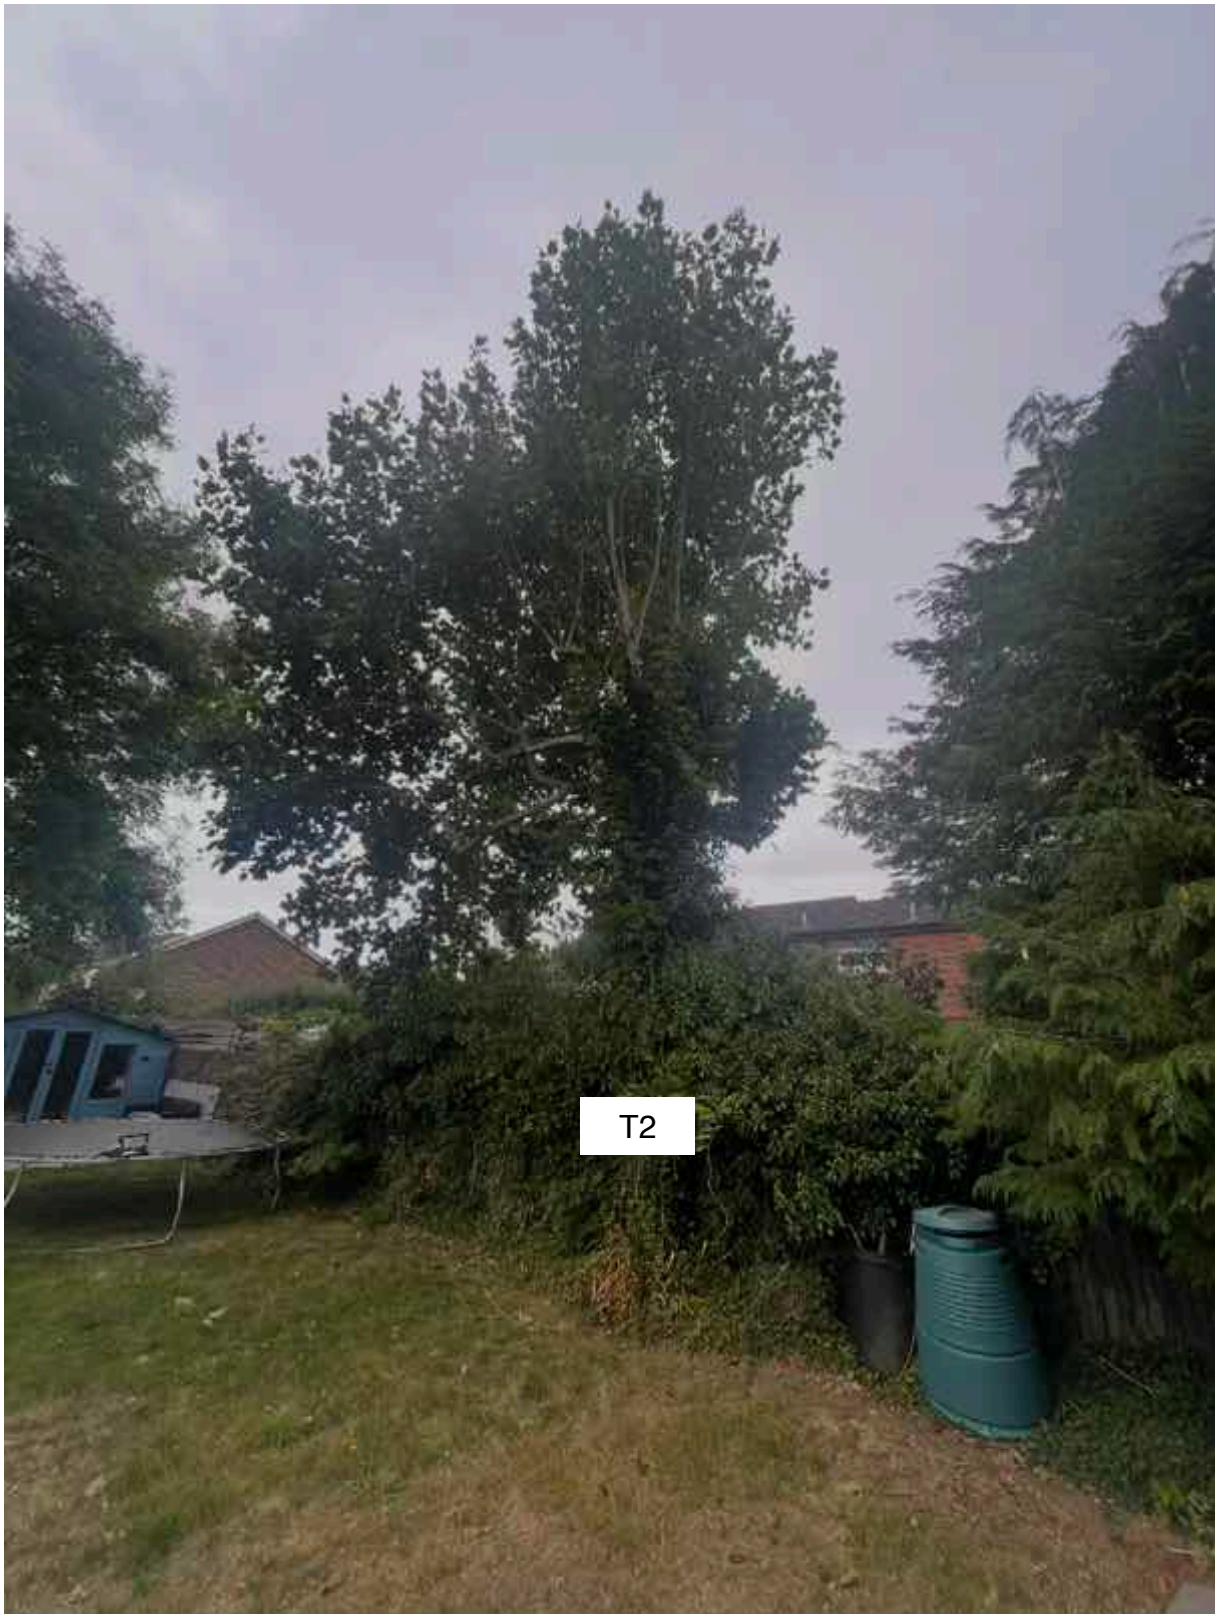
T2 Tulip tree to be removed

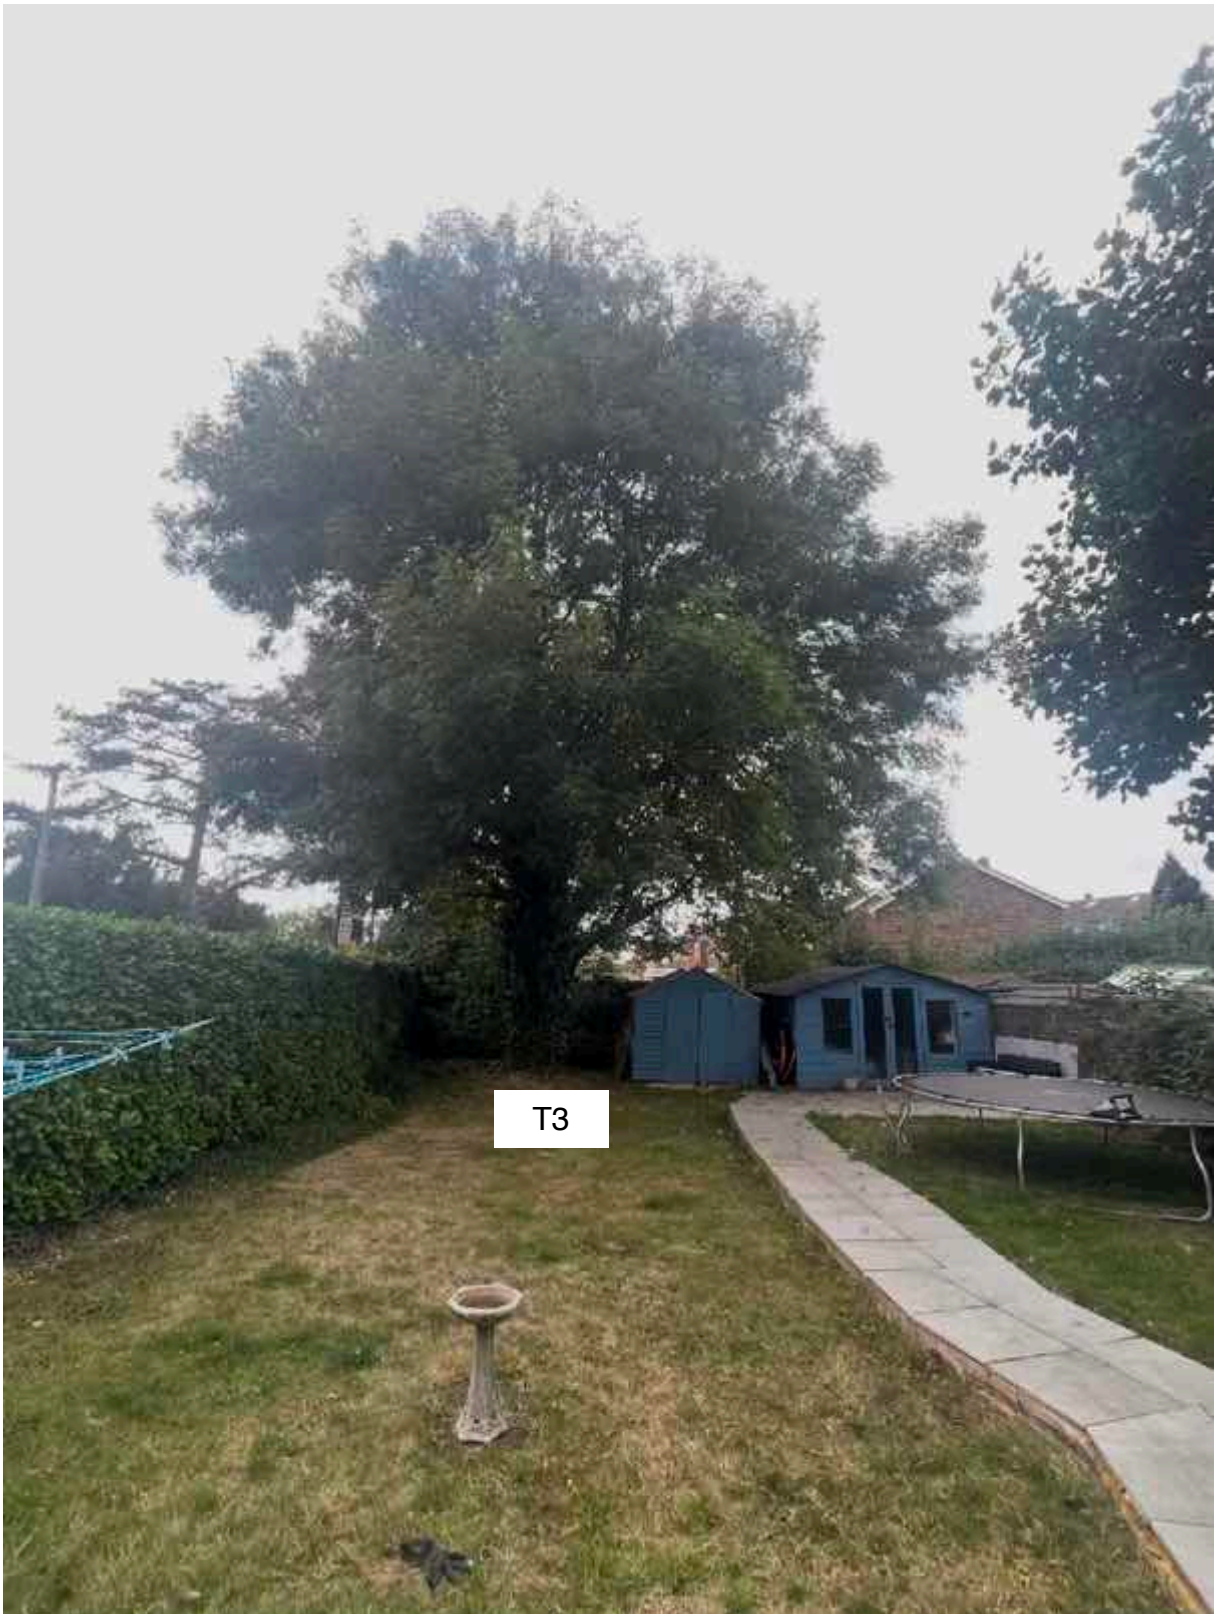
The Ash tree T3 has a total RPA of 248m² and the footprint of the new detached house has an incursion of 15m², allowing for foundation works to slightly increase this figure it is still within acceptable limits of under 10% of the total RPA. The roof of the detached house may interfere with the outer reaches of the canopy of the Ash tree and it is therefore noted that some lifting, or canopy reduction of the tree in that area maybe required. Whilst this is undertaken inspection of the black fungal growth located at 8m high on the end of a main branch to the south can be carried out. If this is *Inonotus hispidus* which causes a white rot in the trunk, then it is recommended that the local Tree Officer be informed and appropriate action be taken for the health of the tree.

T3 Ash tree - TPO tree

To directly address "root damage" risk of T3, the following commitments are to be adhered to:

Foundation type (tree-side interface): mini-piles / screw piles + ground beams + suspended slab/floor. to avoid continuous trenches and minimise excavation within sensitive rooting zones.

Trial pits / root checks: pile/cap positions confirmed by **hand-dig and/or air-spade** under arboricultural supervision prior to finalising near-tree details.

Root encounter protocol: if roots are encountered, **stop**, expose carefully, and **relocate** design elements; no cutting of significant roots without agreement/consent where applicable.

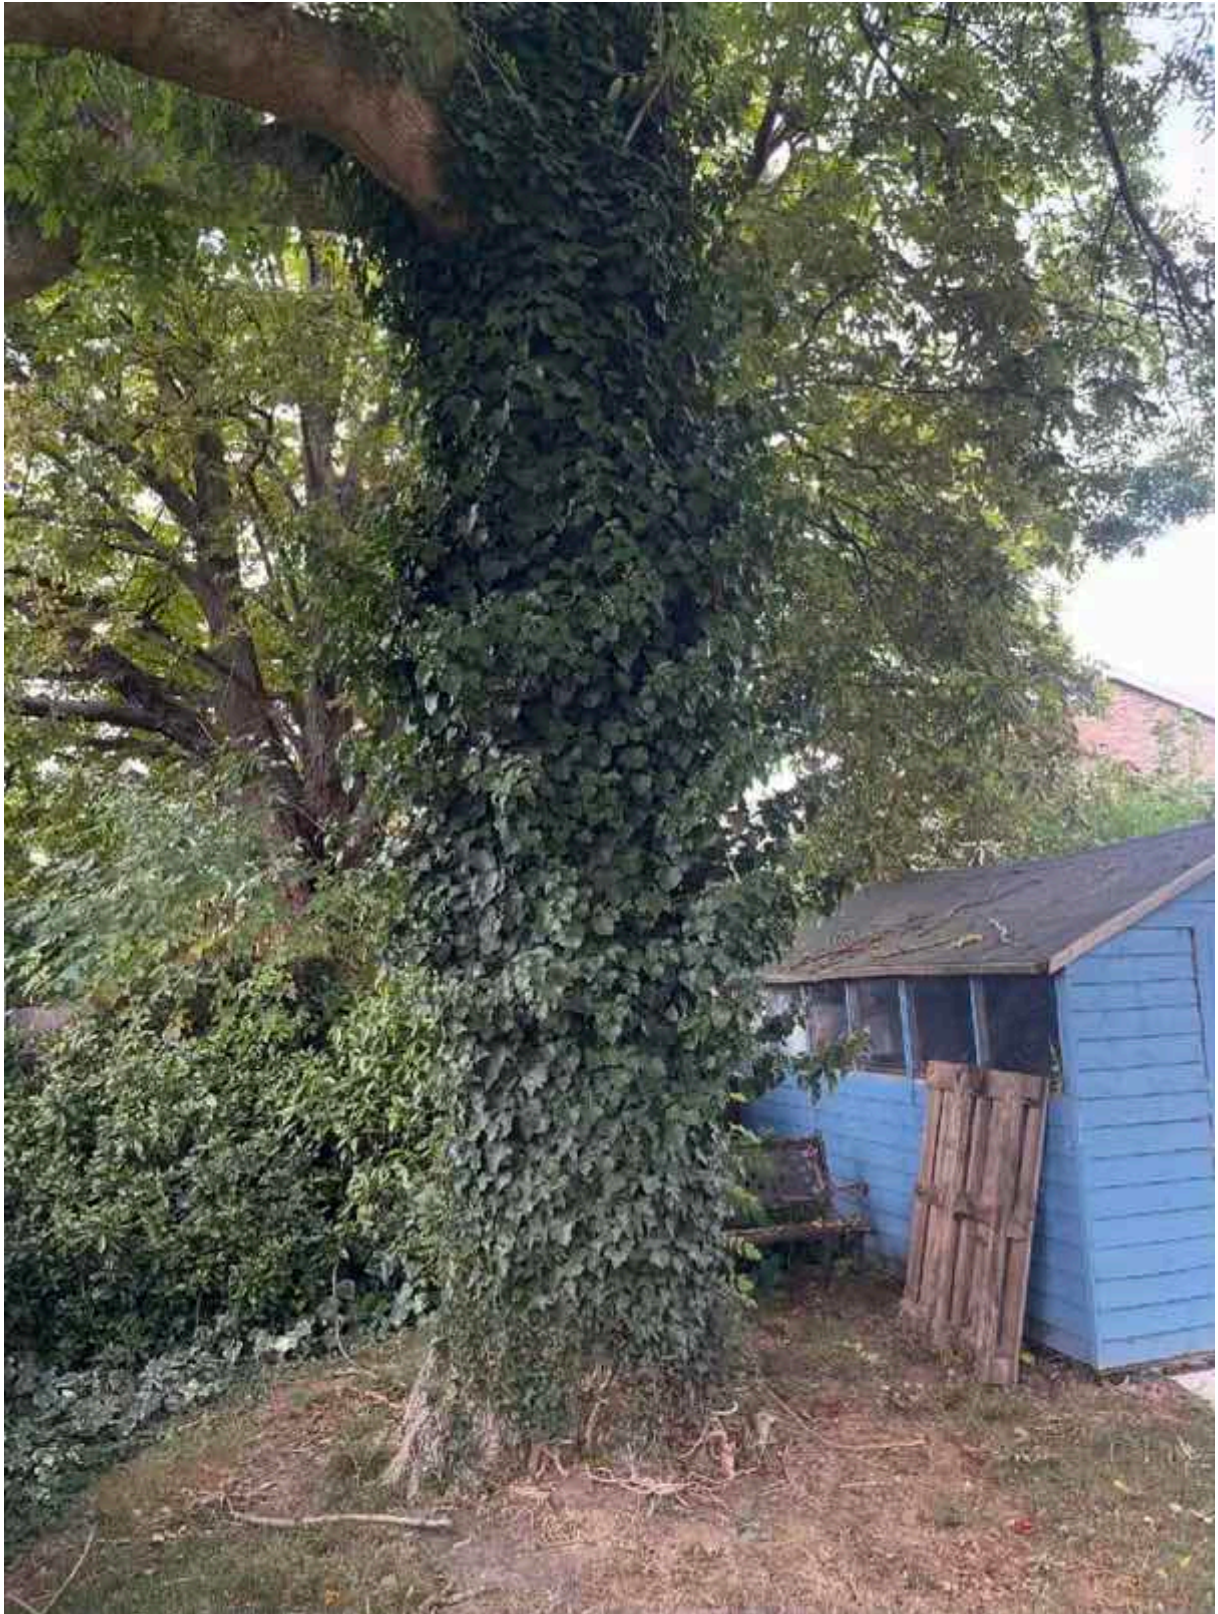
T3 Ash tree - remove ivy and wooden sheds around baser of tree

An improvement to be gained with this scheme is the removal of the sheds and pathway found within the rear garden at present. The removal of these items will allow the Ash tree T5 improved ground conditions for the roots of the tree. It is recommend that no sheds or paths are re-instated after the works have concluded to provide a permanent improvement in this regard.

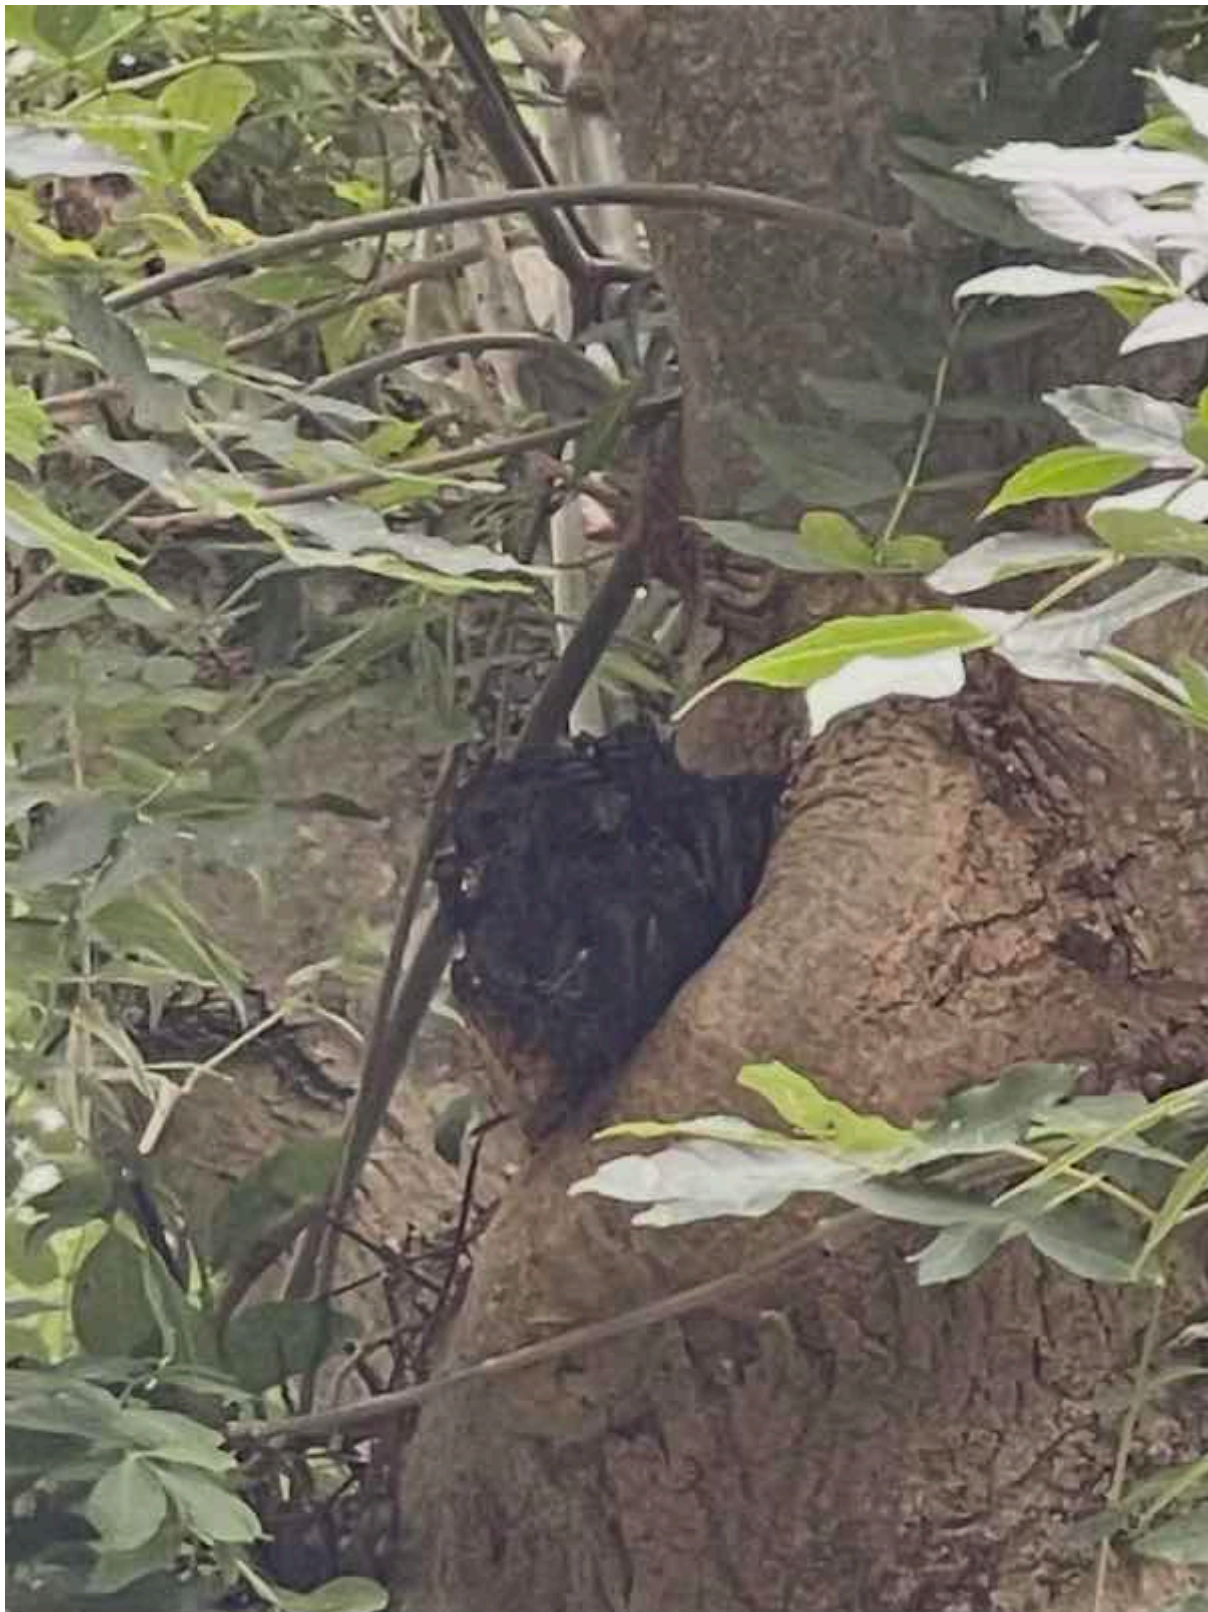
T3 Ash tree - possible fruiting body of *Inonotus hispidus* to be inspected

Inspection of the trees T3 and T5 by the Tree Officer is recommended with regard to the fruiting fungal bodies found on the trees as indicated within this report.

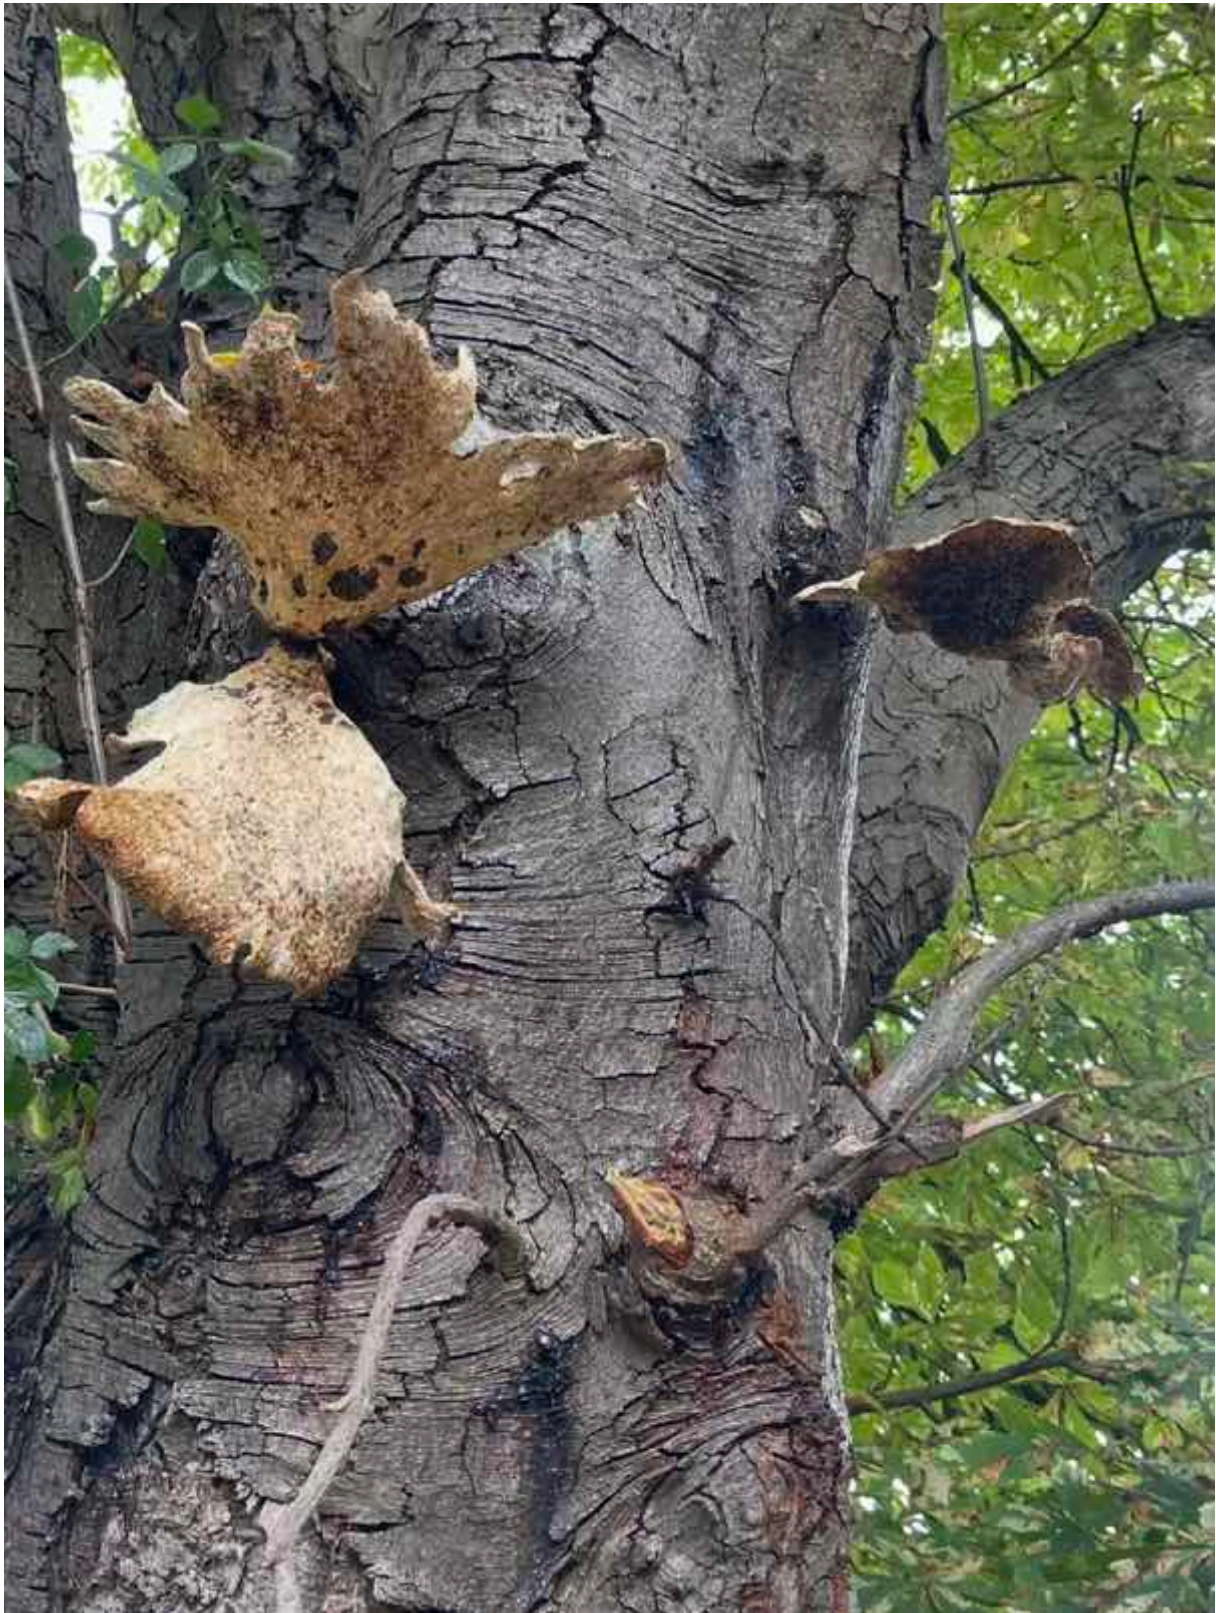
Outside the site is the Horse Chestnut tree T5, which has Oyster Mushroom fungal growth. The presence of Oyster Mushroom (*Pleurotus ostreatus*) on a Horse chestnut tree indicates the tree is in a state of decay as this is a saprobic fungus that causes white rot, decomposing the wood of the host tree. The tree also has a number of areas of canker staining. It is recommended that the local Tree Officer be informed and appropriate action be taken for the health of the tree.

Horse Chestnut T5 with fruiting bodies of Oyster Mushroom (*Pleurotus ostreatus*)

0.5-2m on northeast and south sides of main trunk Oyster mushrooms (<i>Pleurotus ostreatus</i>) found on dead limb sited on south side of tree @4m Recommend: Remove limb with <i>Pleurotus ostreatus</i> present and internal inspection be carried out				
T6	Oak <i>Quercus robur</i> T4 - TPO 1979	24	935	20.00	6mN	M	Physiological Condition: Fair	N	>40	B2	11.22
							Structural Condition: Good	Monitor	<24		
							Public Amenity Value: High				
							Inspection Limitations: None Lost limb at g/l, wind healed well - heartwood revealed Bleeding canker (<i>Phytophthora</i>) @0.5 and 1.5m W side Recommend: Biannual inspection regarding canker infection

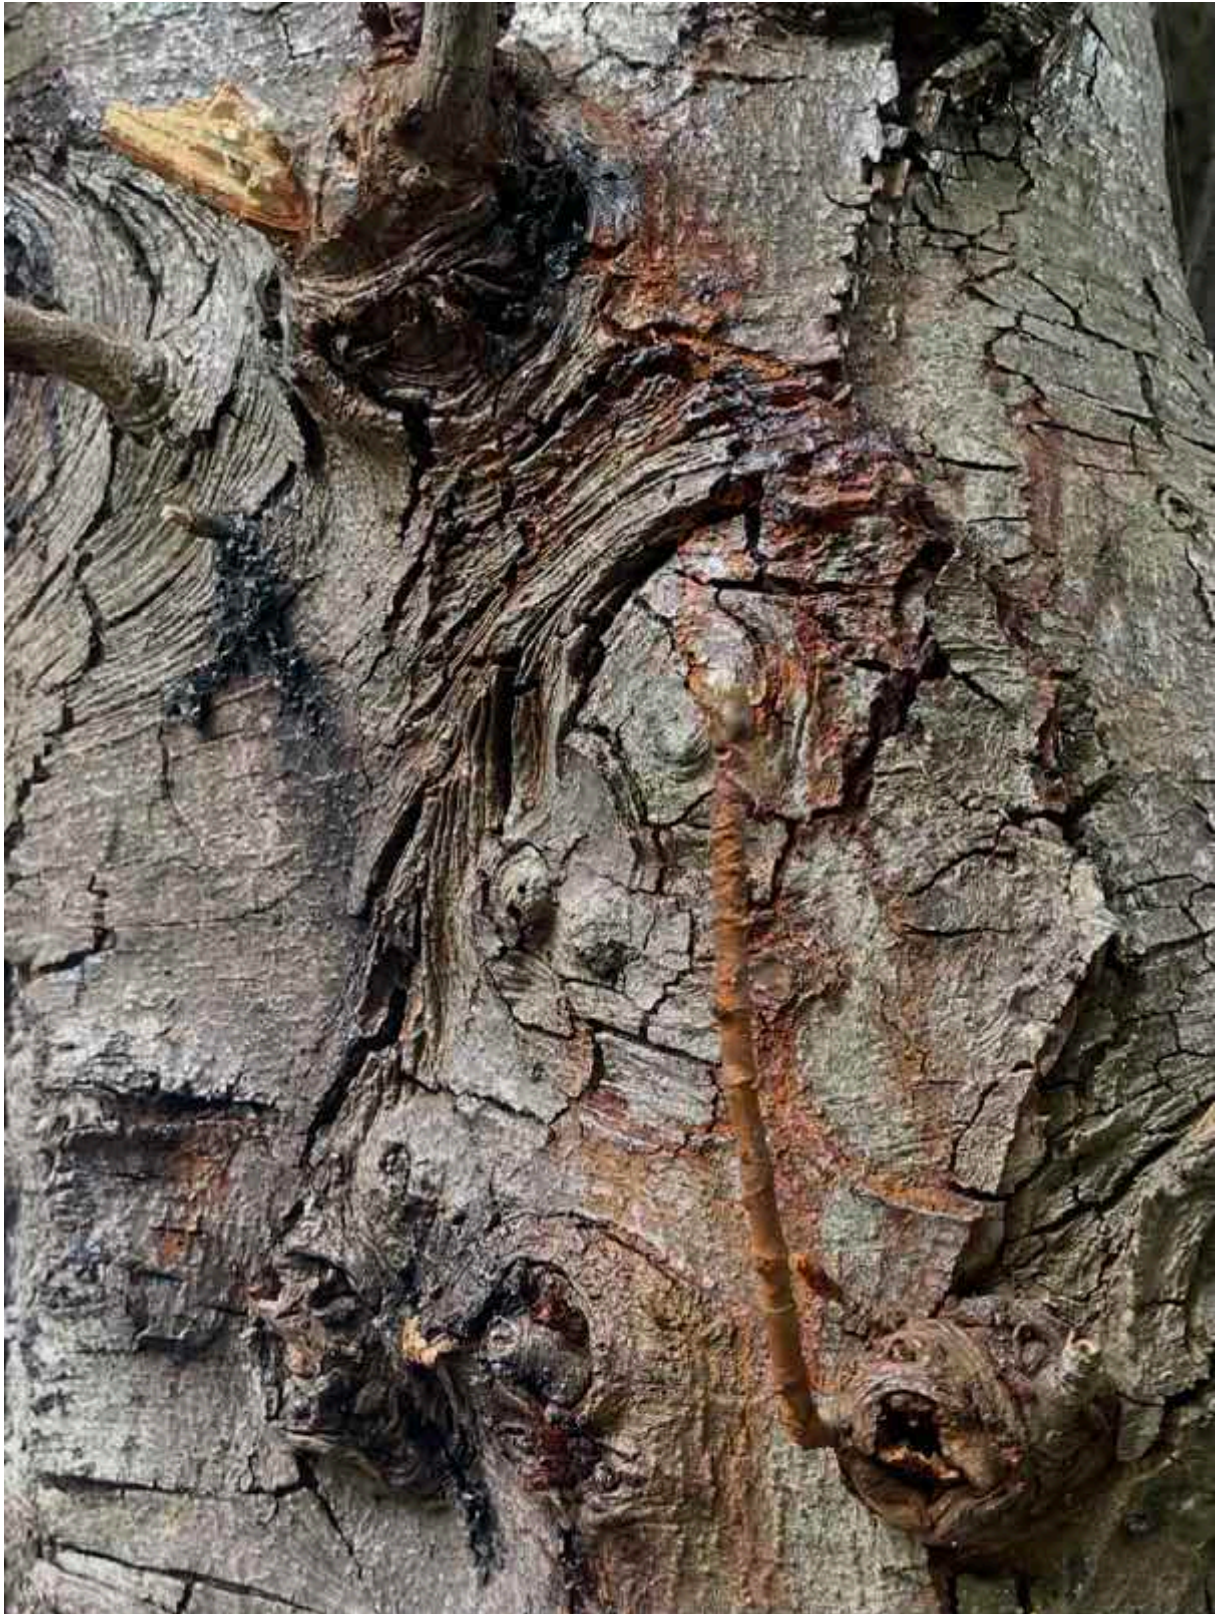
Horse Chestnut T5 with canker

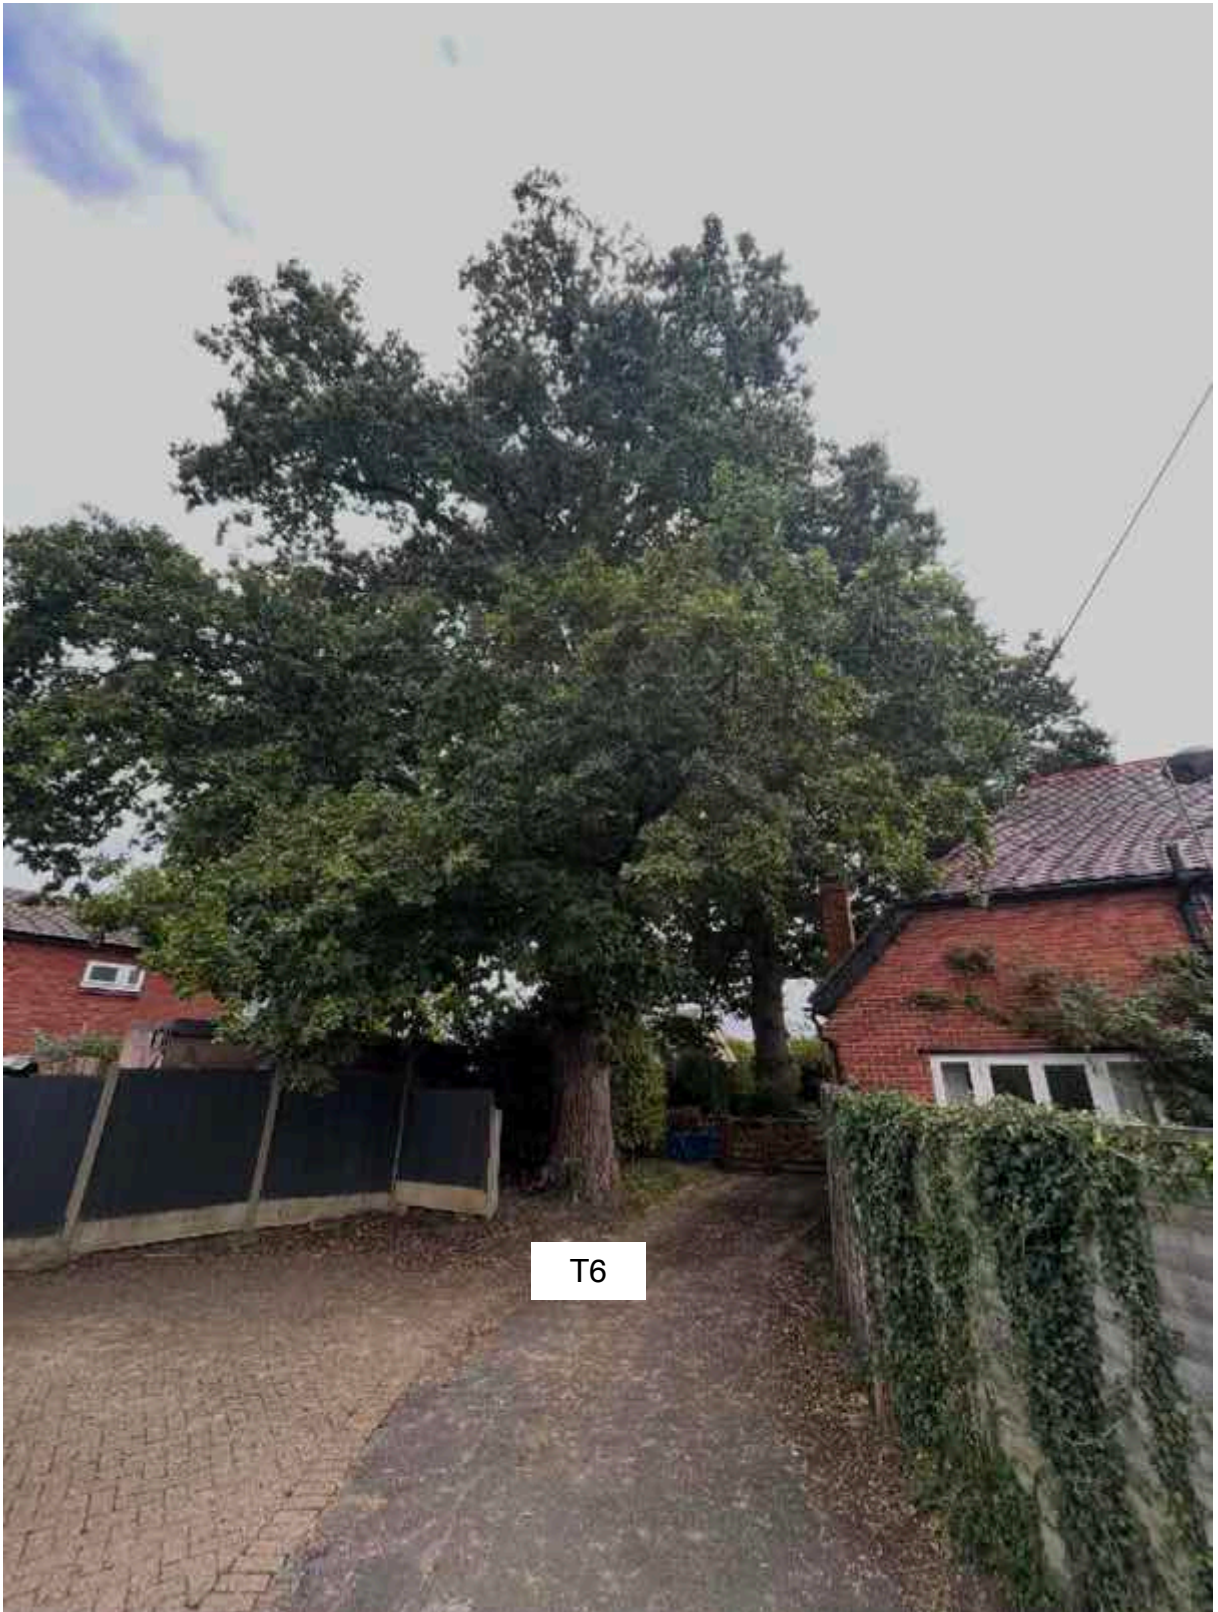
The Oak tree T6 sits outside the site boundary, however, the roots and canopy oversail the car parking area. This area is block paved and is already used for parking, but provision for a more permeable surface for the new parking area will be required. The removal of the existing surface and installation of the new materials will require monitoring to ensure that the root system of T6 is maintained in good condition and not damaged during this operation. Ground protection will be required for the duration of the build to ensure compaction of the ground this area is not compromised.

Oak tree T6 and existing parking area

3.7.3. For the ground protection of the Ash tree T3 and the Oak tree T6 it is advocated that heavy duty mats such as Hermes **Medium Duty Mats** are used that can take weights up to 20 tonnes on medium to soft ground. *These mats have a unique surface with one side being non-slip for pedestrians and the other side being a non-skid deep traction surface for vehicles. They are widely used on construction sites and outdoor events.*

3.10.1. The houses and their associated parking (which will be required to be permeable) will not interfere with the remaining trees, so there are no negative implications as regards landscaping. It is recommended that a permeable surface such as Ecogrid 40 be used and filled with crushed 14-20mm stone to both improve and maintain a surface suitable for parking and the roots of the Oak tree T6.
