RE: Fd6111. Duckmoor Barn, Wooddale Lane, Billingshurst, RH14 9DZ

Further to our first visit to the above property on the 8th May 2025 to inspect the existing barn with a view to preparing a structural Report in support of a planning application for conversion to a single residential dwelling. We now report as follows.

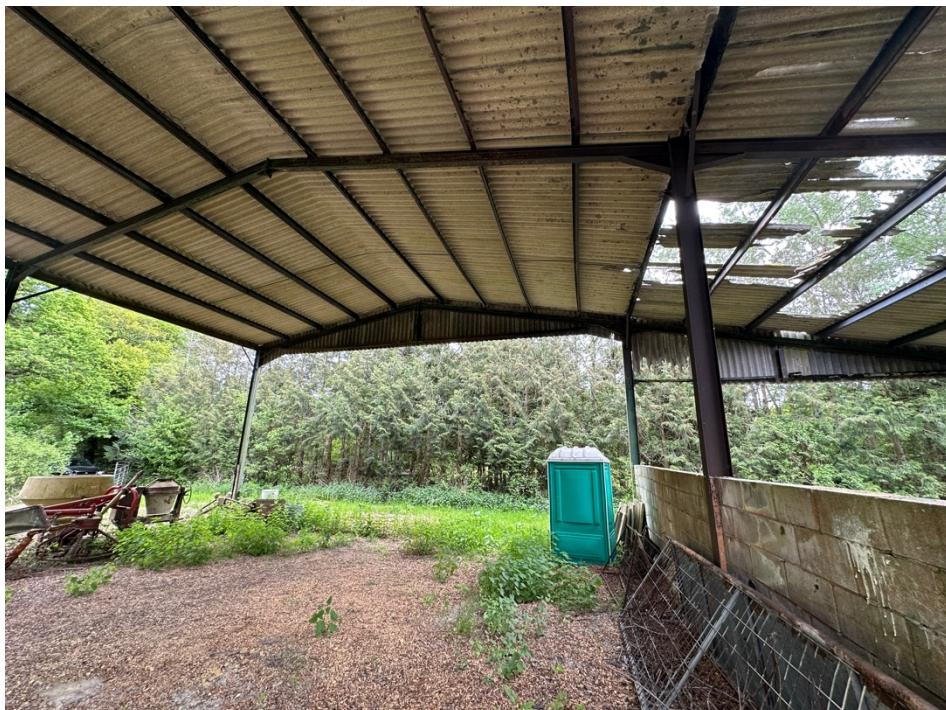
Aside from the fire damage to the steel frame and walls in the south west corner, the remaining steel frame appears to be in reasonable condition. With only light surface rusting that requires only cleaning and painting. The primary structure appears to be square and sound with all the principal members in place.

Internal View of existing barn looking from point A/2towards the eastern gable end.

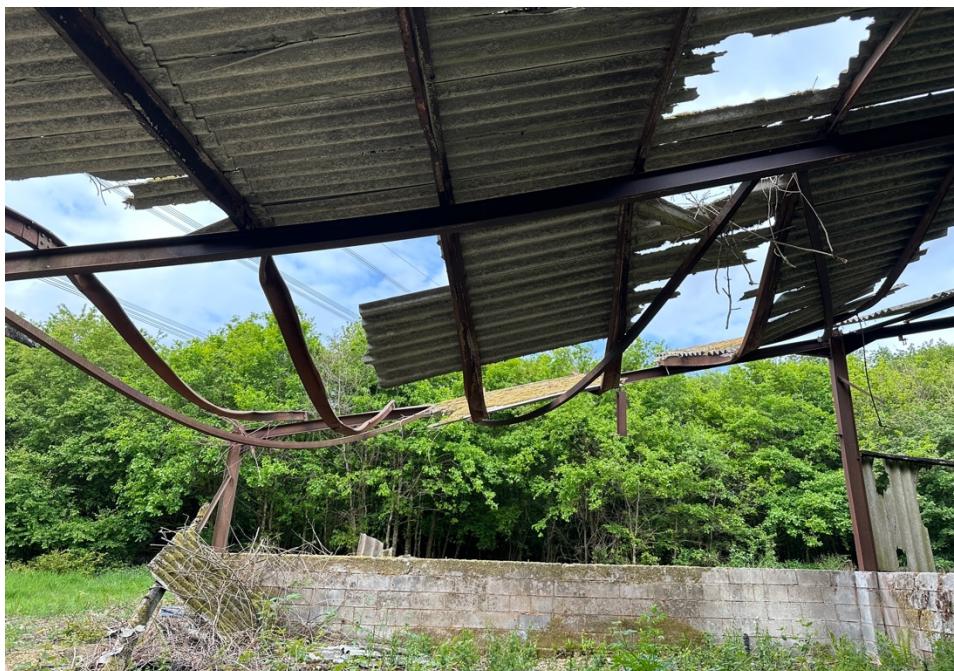
From our inspection it would appear that stored hay or similar has caught fire in the south west corner of the lean-to. The heat from the fire was sufficient to cause the steel frame to distort and buckle out of shape on grid line A 3-2. This includes the column and portal rafter at 2A. The heat damage in this area is extensive and has also caused the block wall locally to be badly cracked and unstable, with local areas having collapsed.

The roof and wall sheeting is a cement fire corrugated system that likely contains some asbestos. The sheeting is in poor condition with several large holes mainly caused by the fire.

Internal view of the fire damaged south west corner of the lean-too

The fire damaged section of the existing frame should be taken down and removed from site as part of any future works.
