East Street, Rusper

**Client Ref:** GE22977 / PO-8160  
**Report Ref:** GS-QDH-REA-PUI-2QX  
**Grid Ref:** 520779, 137272

## **APPENDIX B**

### **Photographic Record**

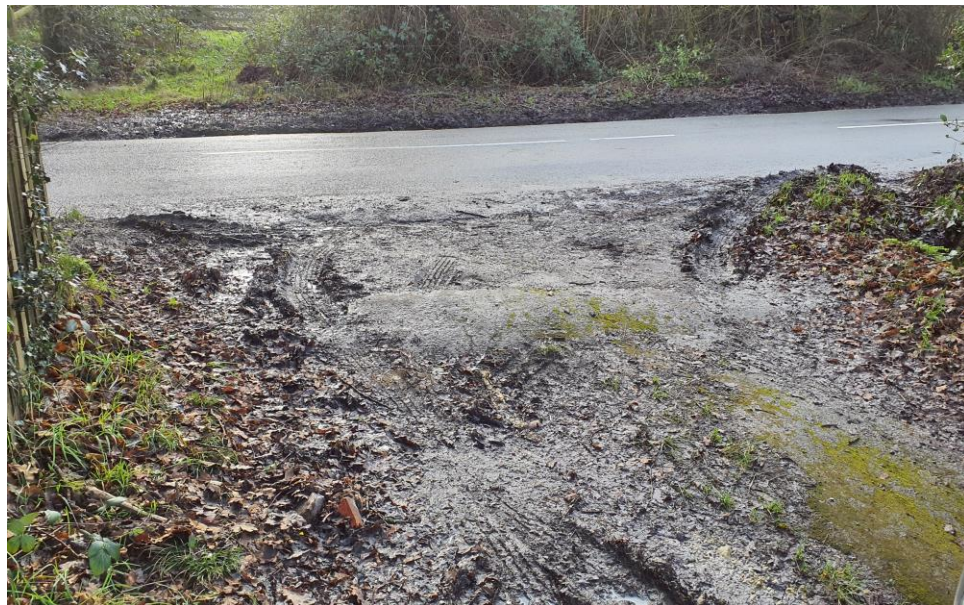
Plate 1: Access Path from East Street, Rusper

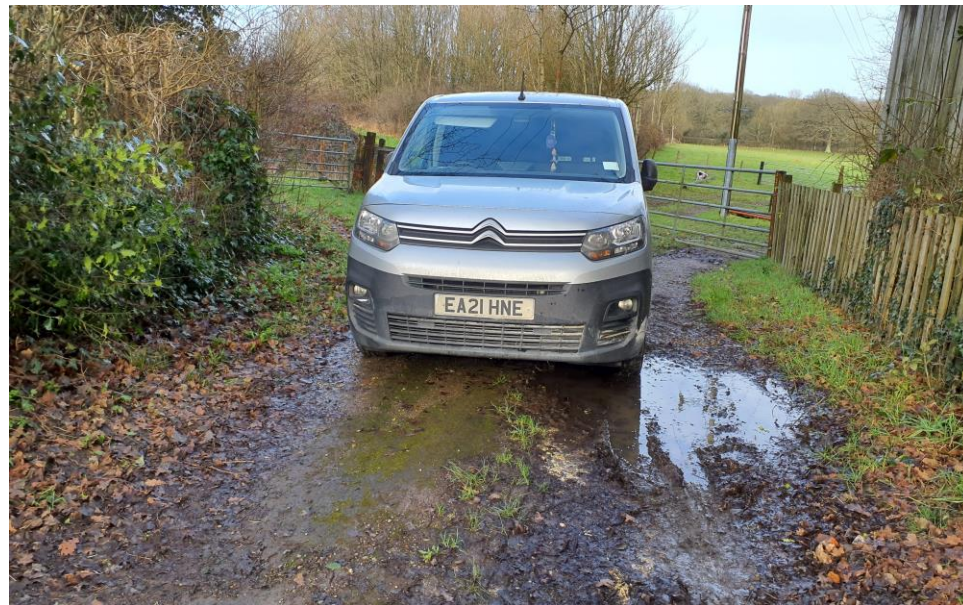
Plate 2: Access path showing shared access onto site and into adjacent field

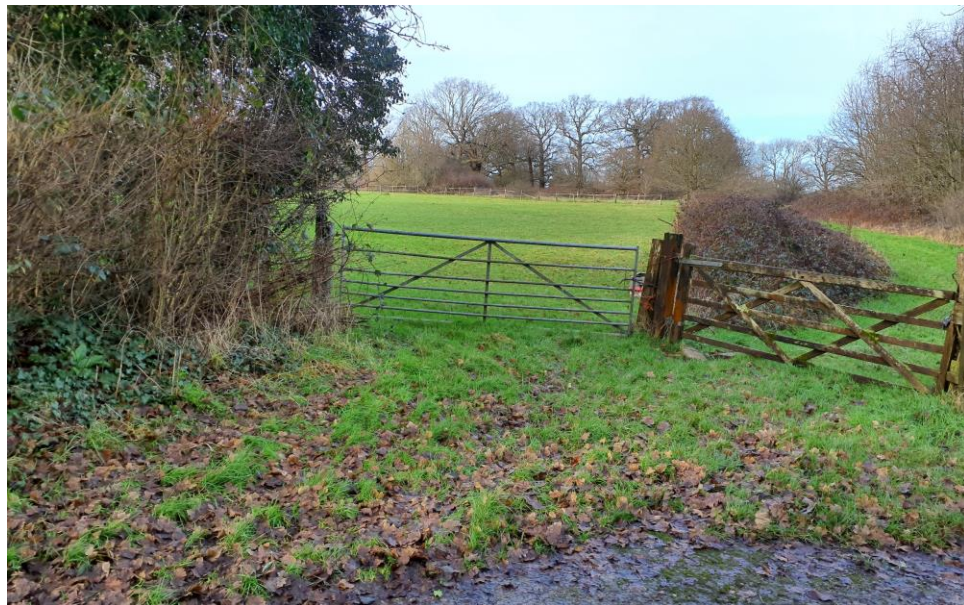
Plate 3: Access Gate into the site in the southeast corner

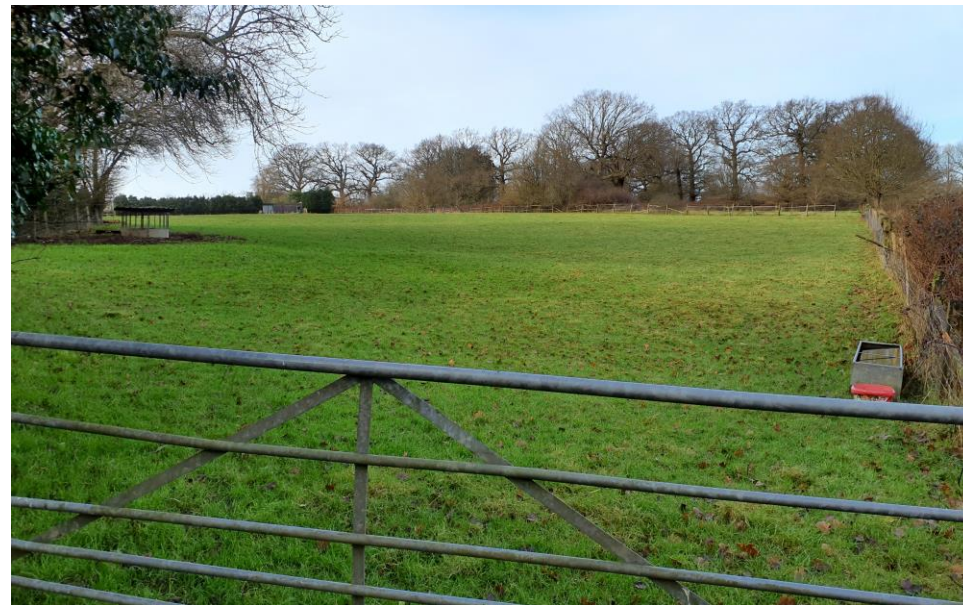
Plate 4: View into site from access gate

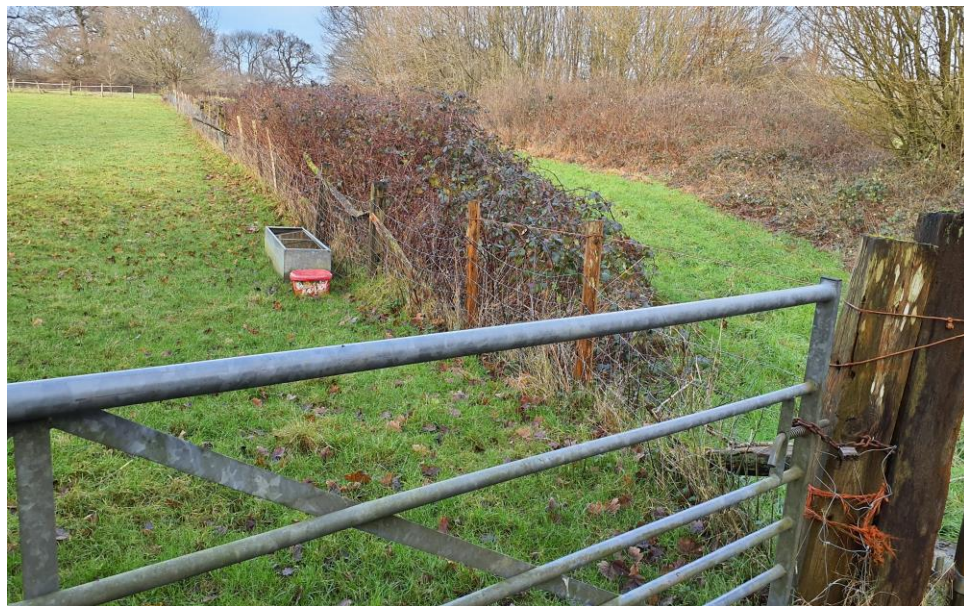
Plate 5: Fencing runs along boundary c.1m in height

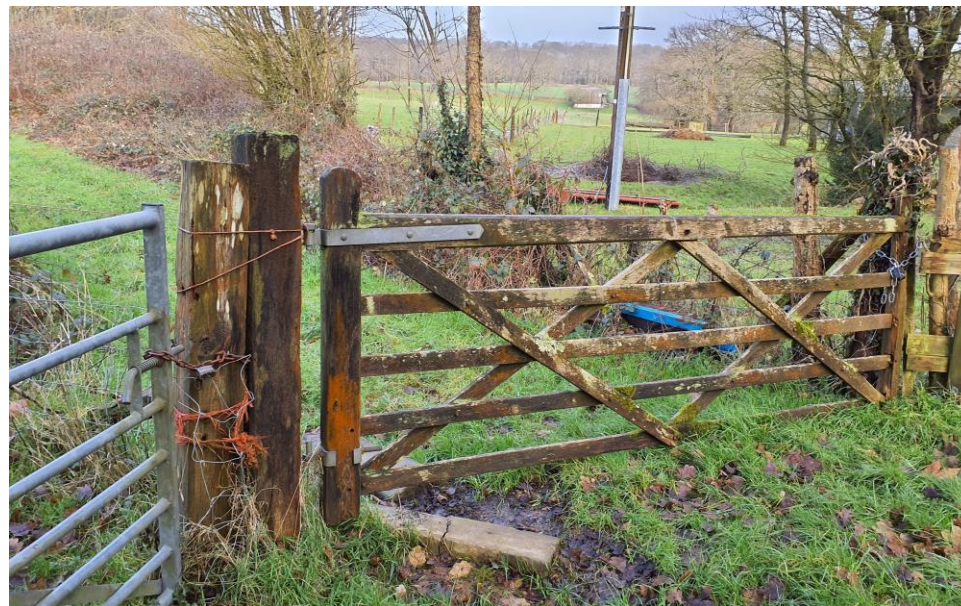
Plate 6: Adjacent access gate to pathway which runs adjacent to the site

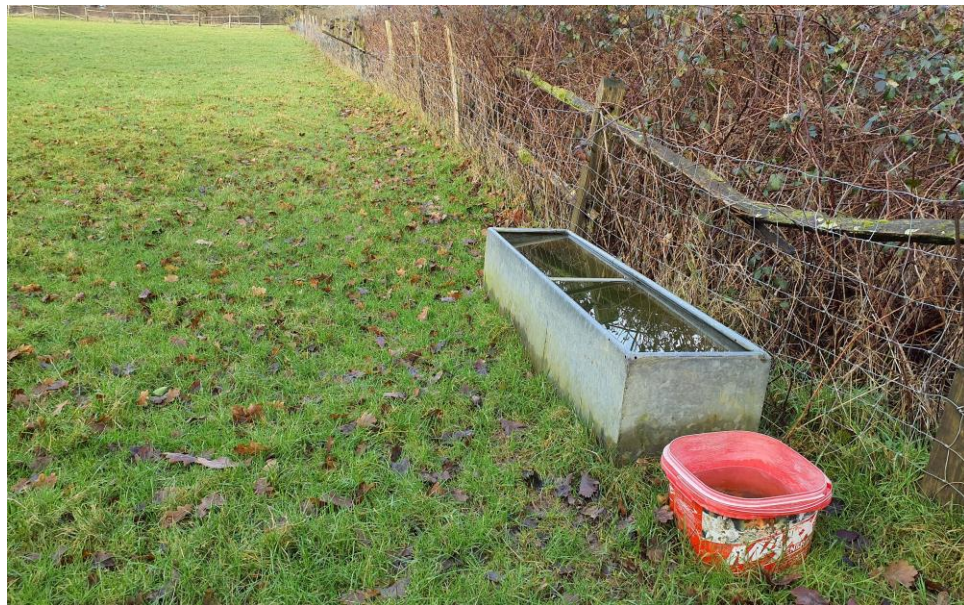
Plate 7: Trough located along eastern boundary

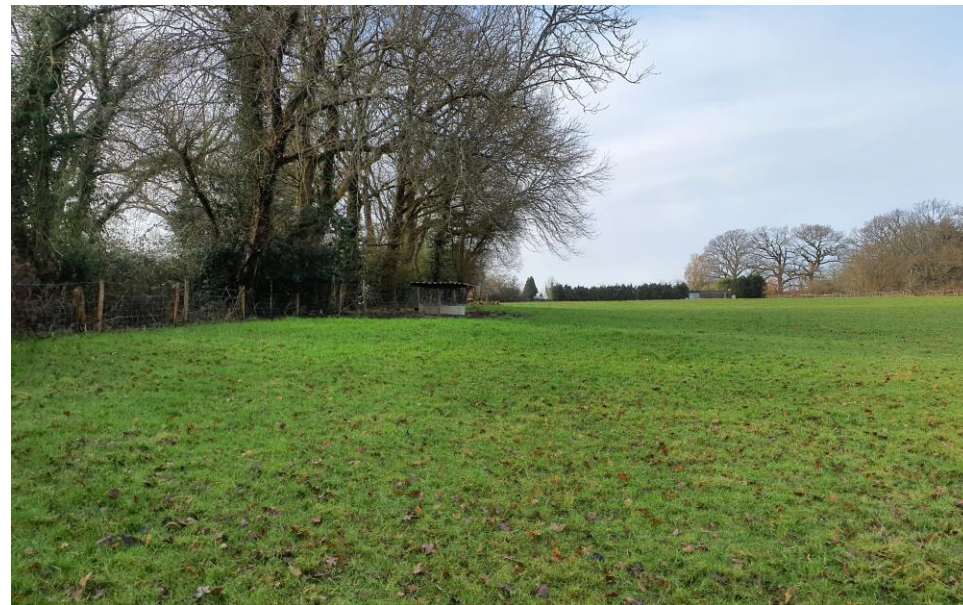
Plate 8: View from east looking west showing mature trees c.15m in height running along the southern boundary

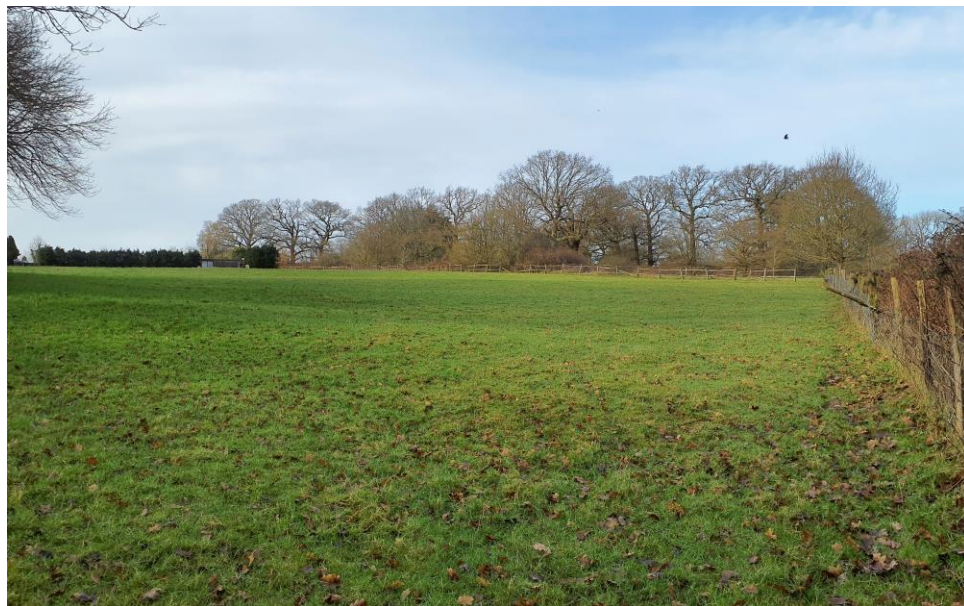
Plate 9: View from the southeast corner looking northwest showing mature trees c.12-15m in height running along the northern boundary

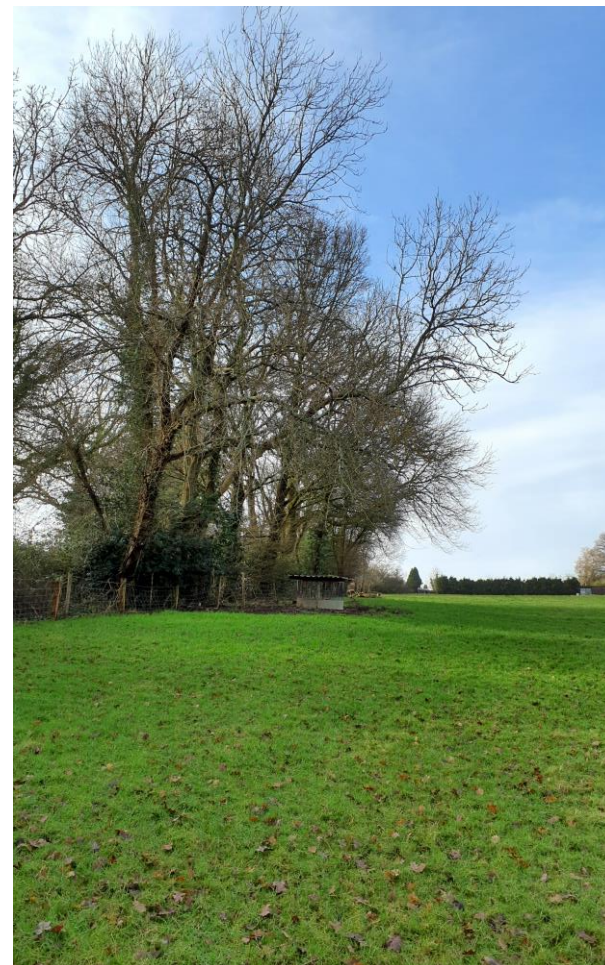
Plate 10: Mature trees c.15m in height along the southern boundary a feed trough is noted

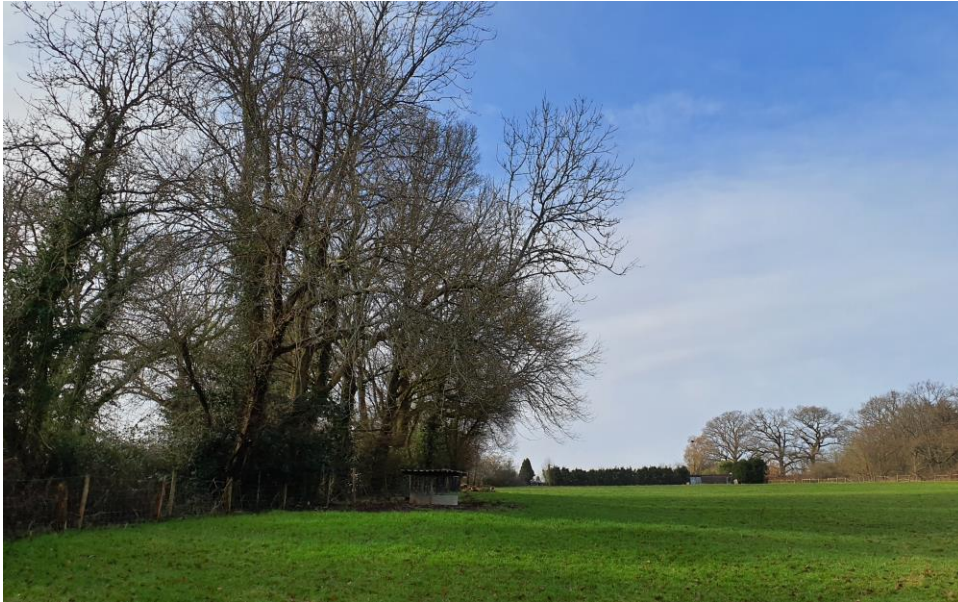
Plate 11: Mature trees along southern boundary

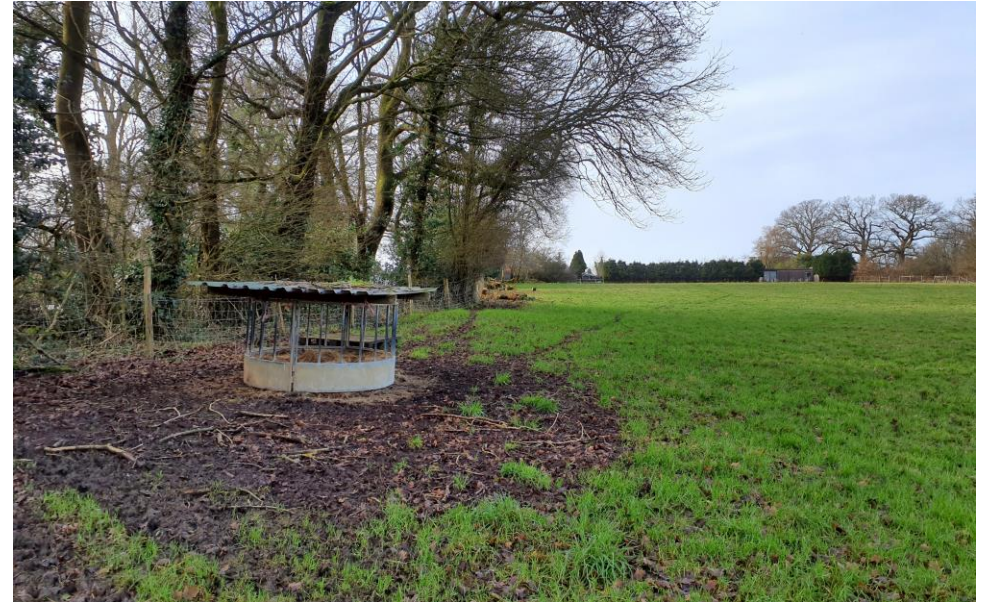
Plate 12: Feed trough along the southern boundary

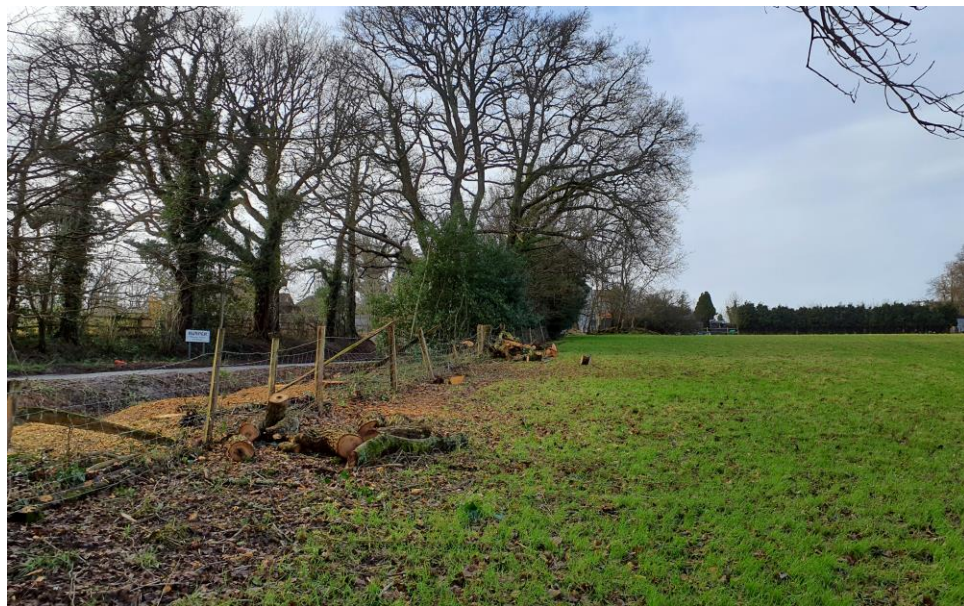
Plate 13: Southern boundary with East Street showing the boundary fence and signs of tree felling

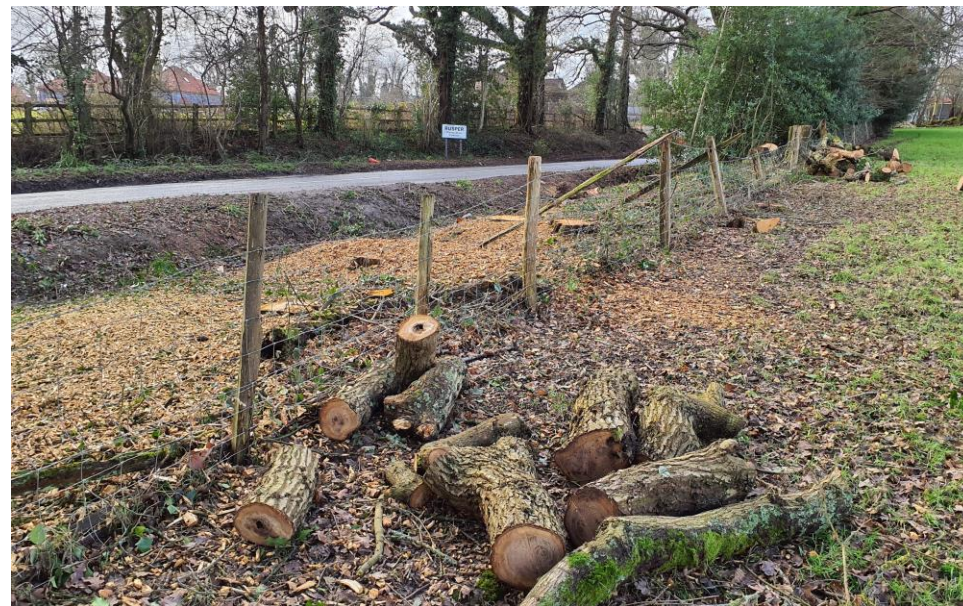
Plate 14: Timber left from removal of boundary trees

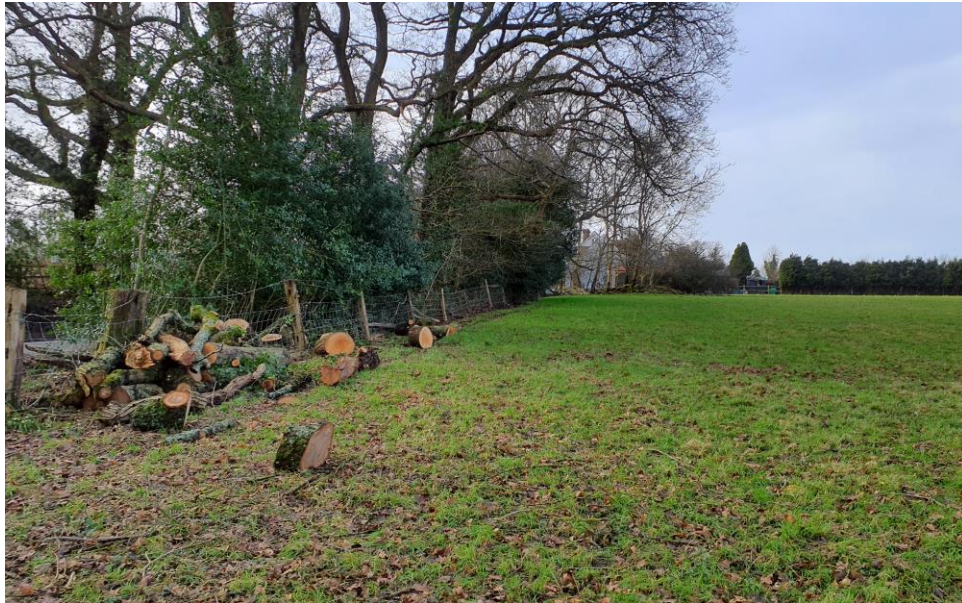
Plate 15: Further timber from tree removal. Southern boundary from the centre of site looking west

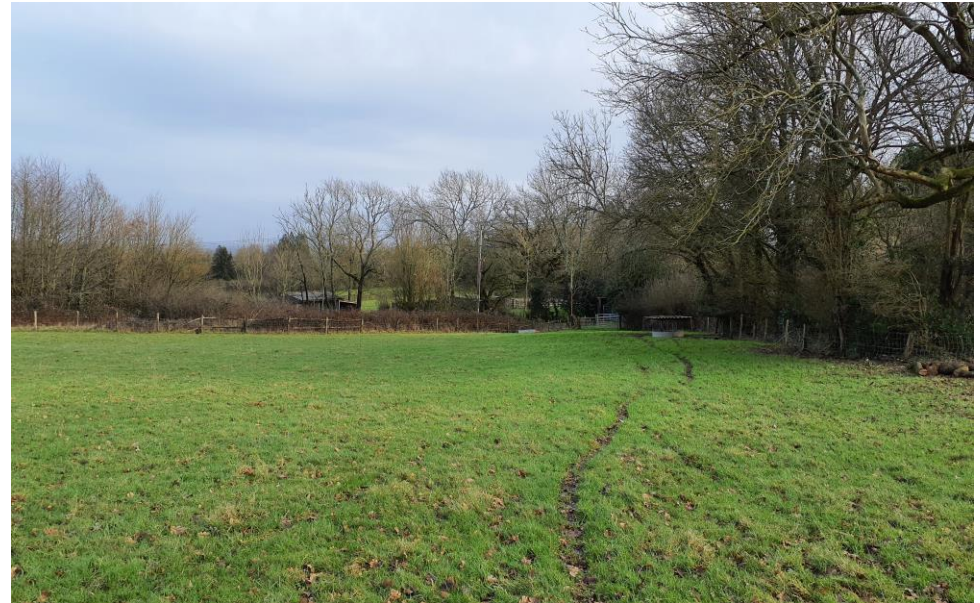
Plate 16: View from the centre of site looking east

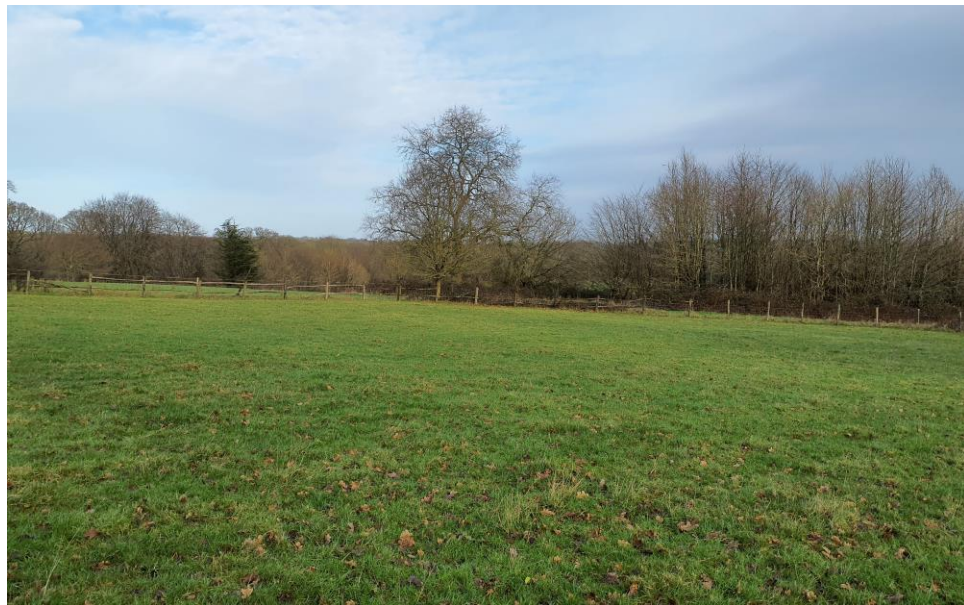
Plate 17: View from the centre of the site to the northeast corner

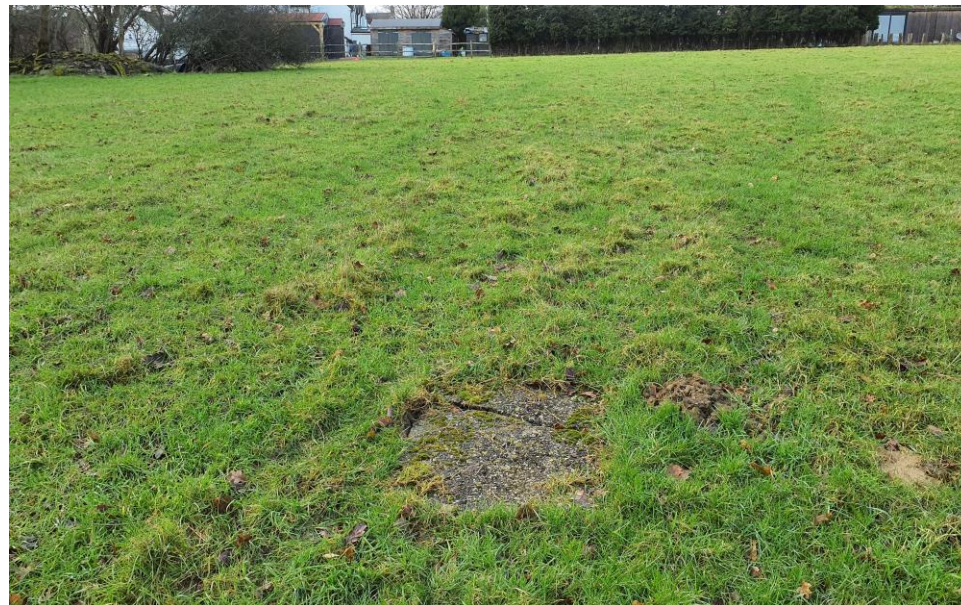
Plate 18: Concrete cover present in the centre of the site area

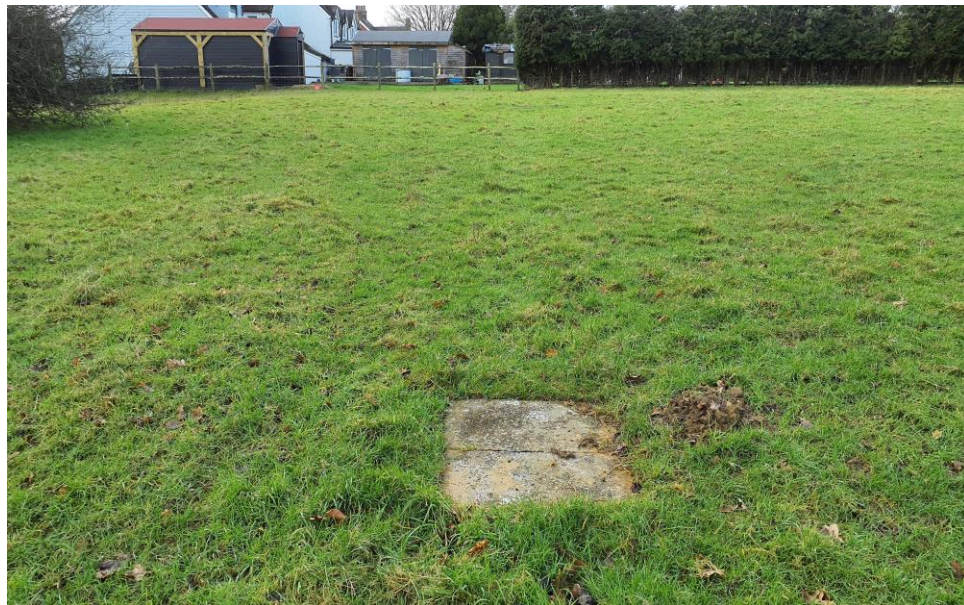
Plate 19: Second concrete cover

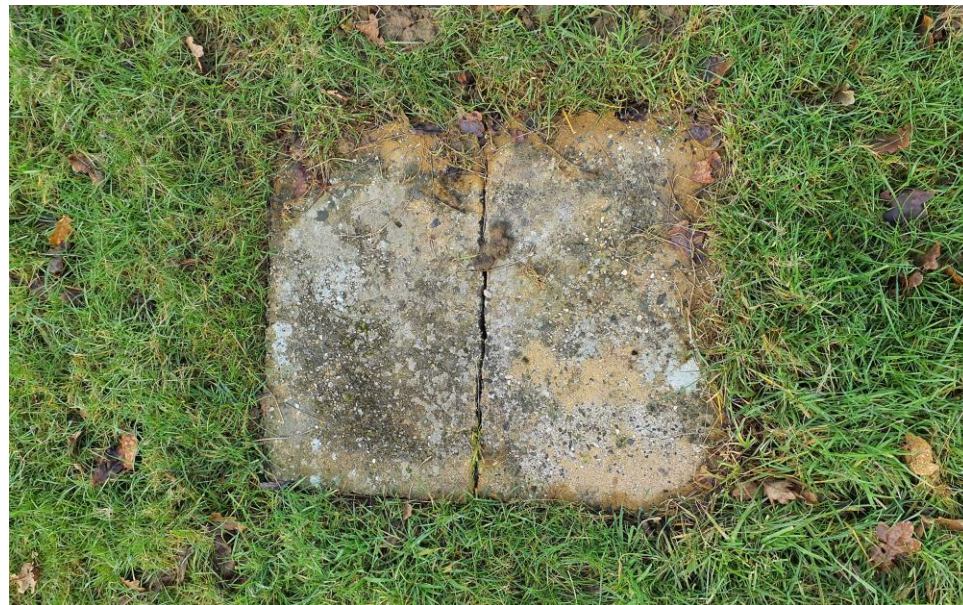
Plate 20: Concrete cover, could not be lifted

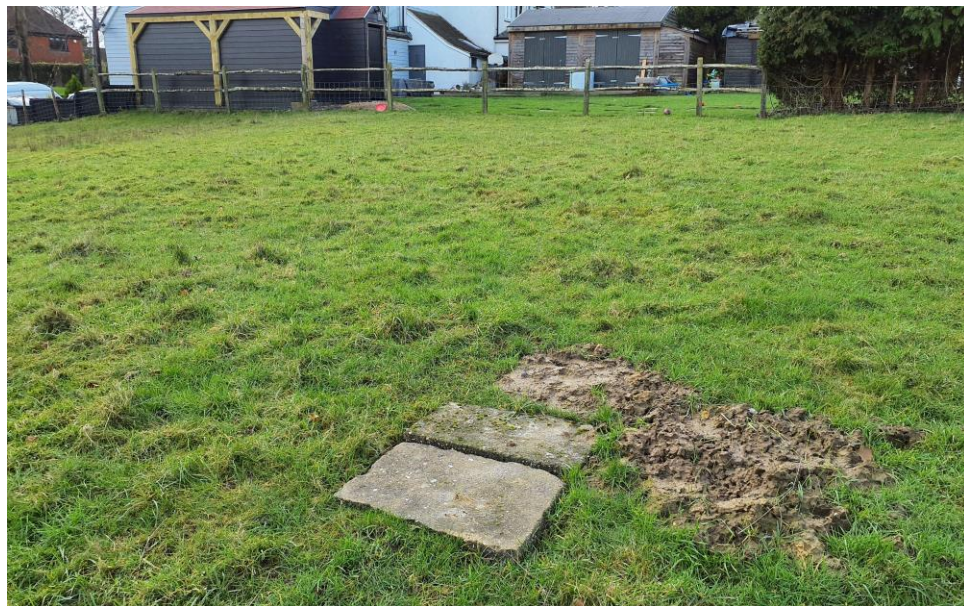
Plate 21: Third concrete cover could also not be lifted

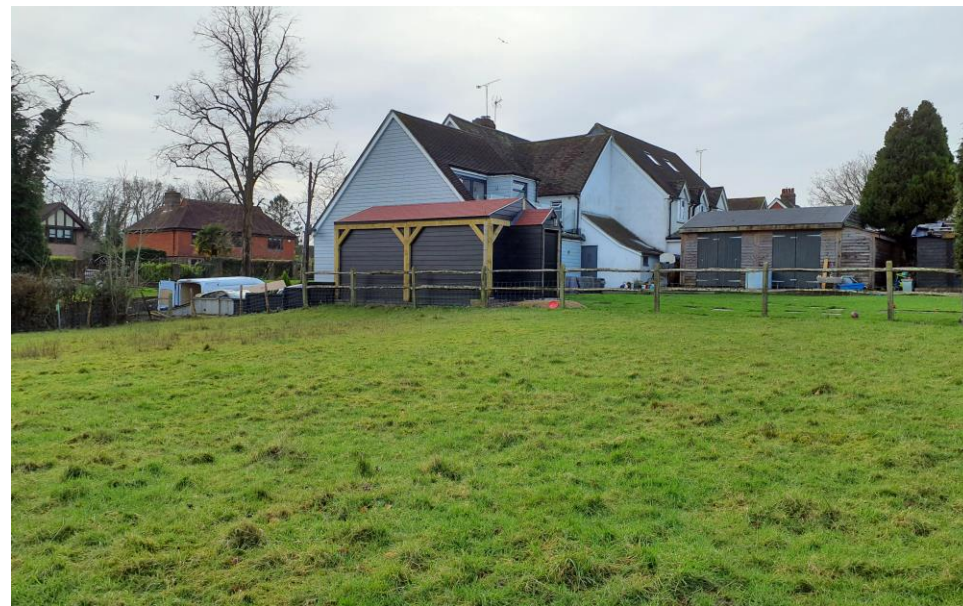
Plate 22: The western boundary is defined by a residential property with a wooden fence c.1.5m tall

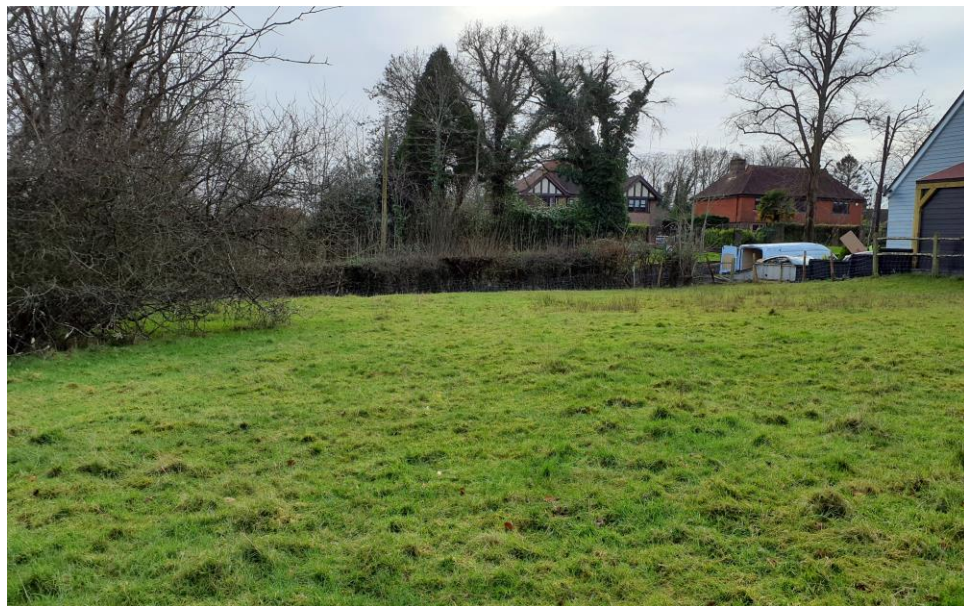
Plate 23: View of the southwestern corner of site, showing the boundary with East Street defined by a hedgerow c.2m in height

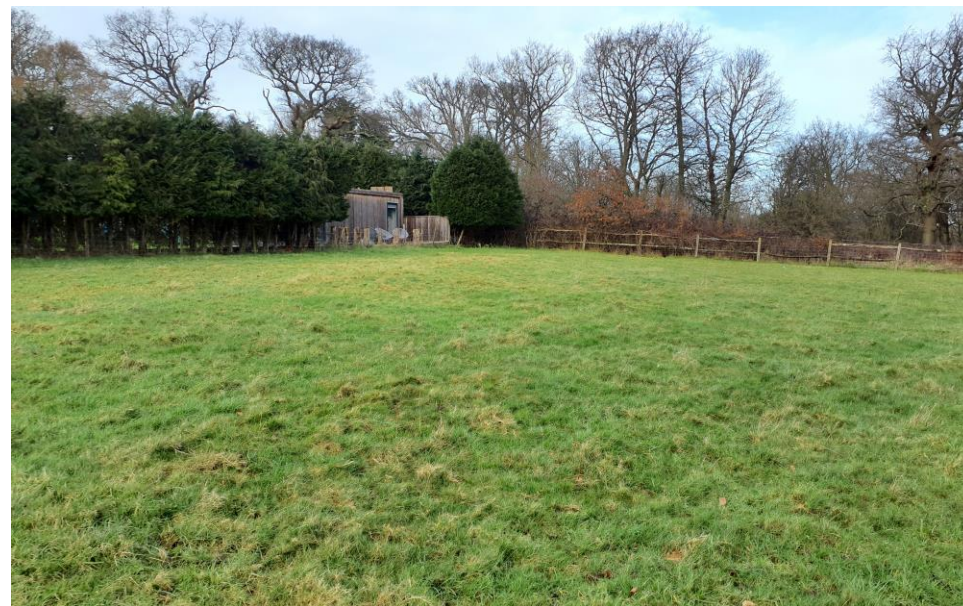
Plate 24: View of the northwestern corner of site, showing the northern boundary defined by vegetation and wooden fence. With the western boundary defined by a hedgerow and wooden fence

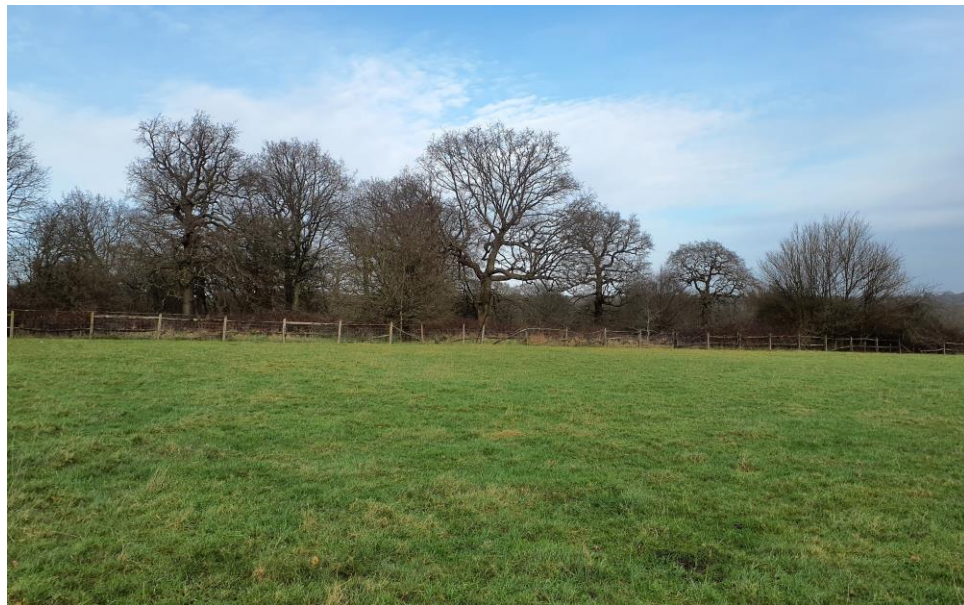
Plate 25: Northern boundary with mature trees and fencing

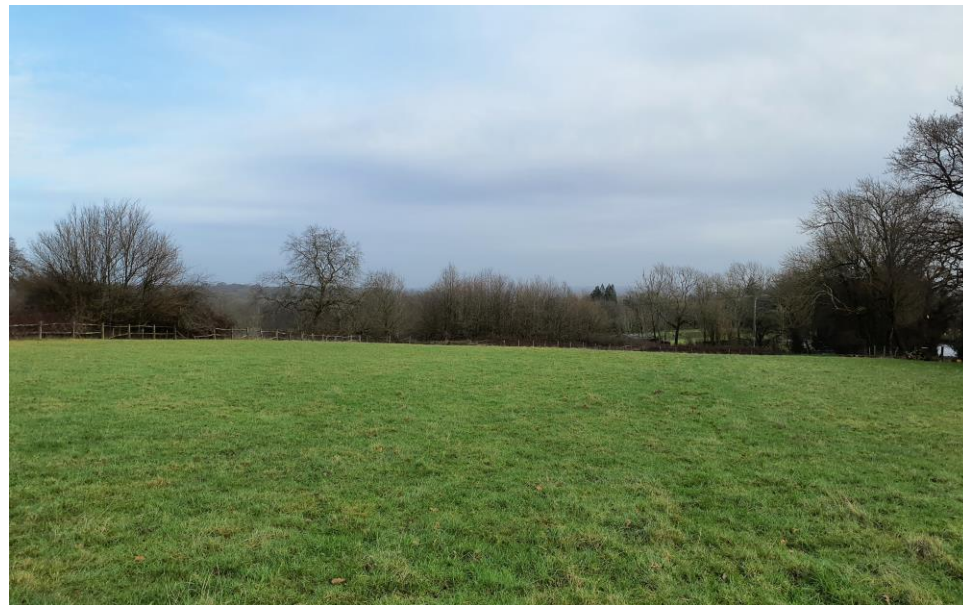
Plate 26: Northeast corner of the site

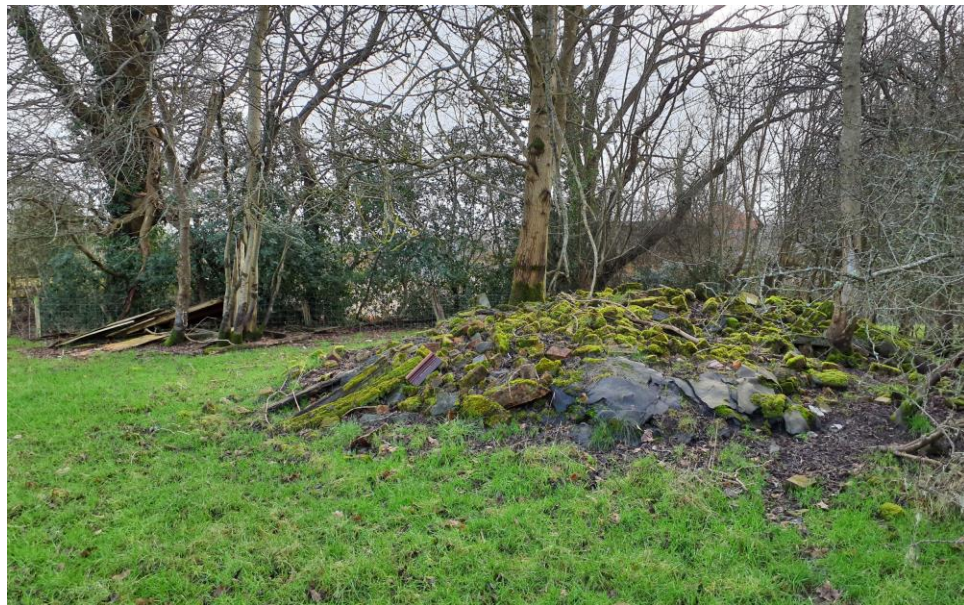
Plate 27: Made Ground Stockpile in the southern centre portion of site

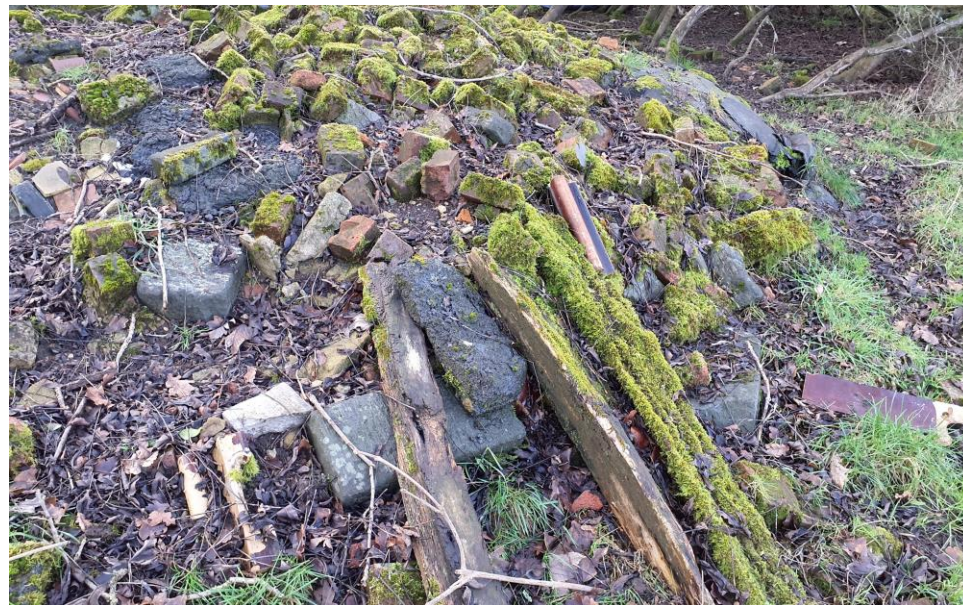
Plate 28: Made Ground in stockpile included brick concrete and wooden fragments among others

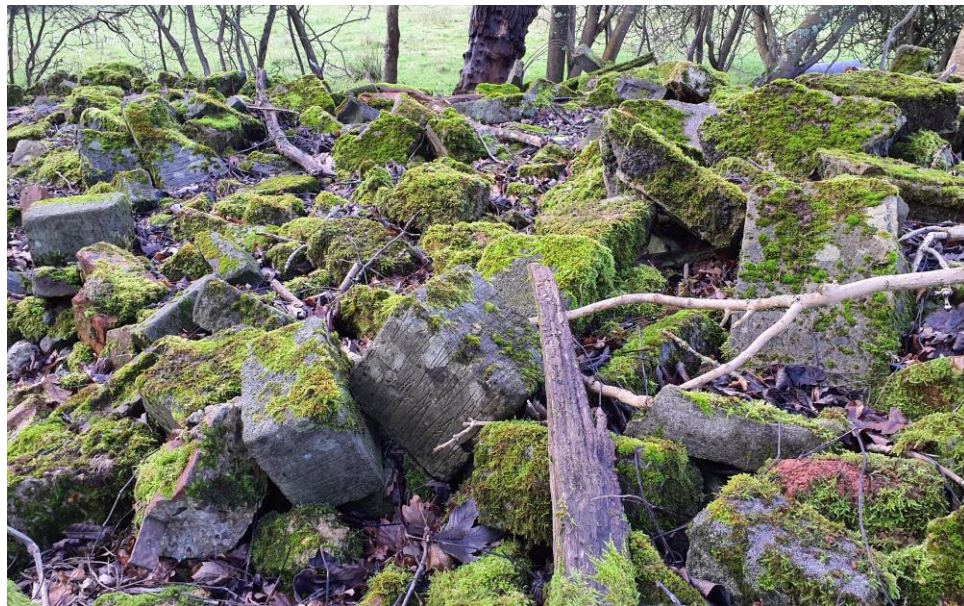
Plate 29: Further image of the made ground stockpile showing the materials

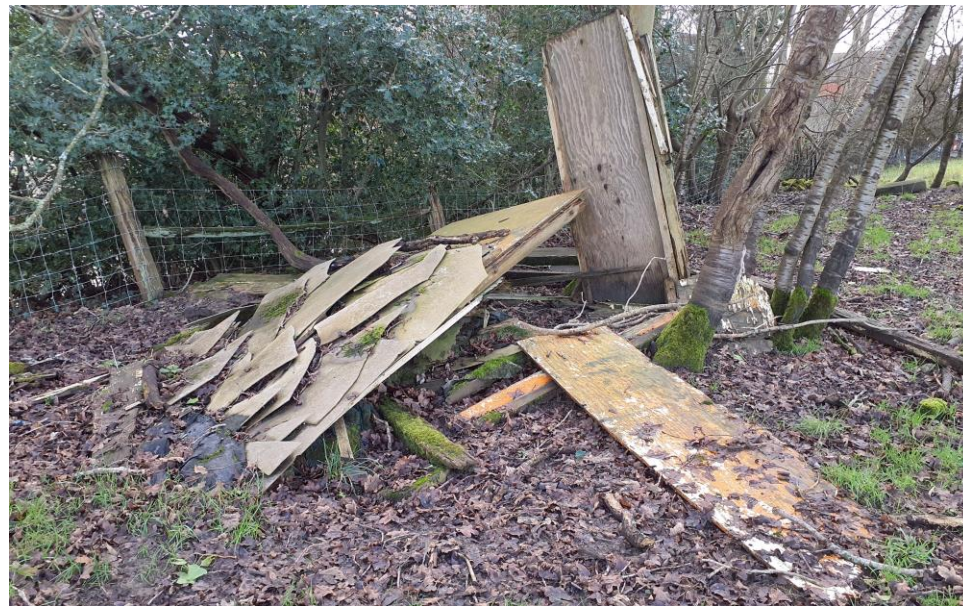
Plate 30: A further stockpile of sheeting material

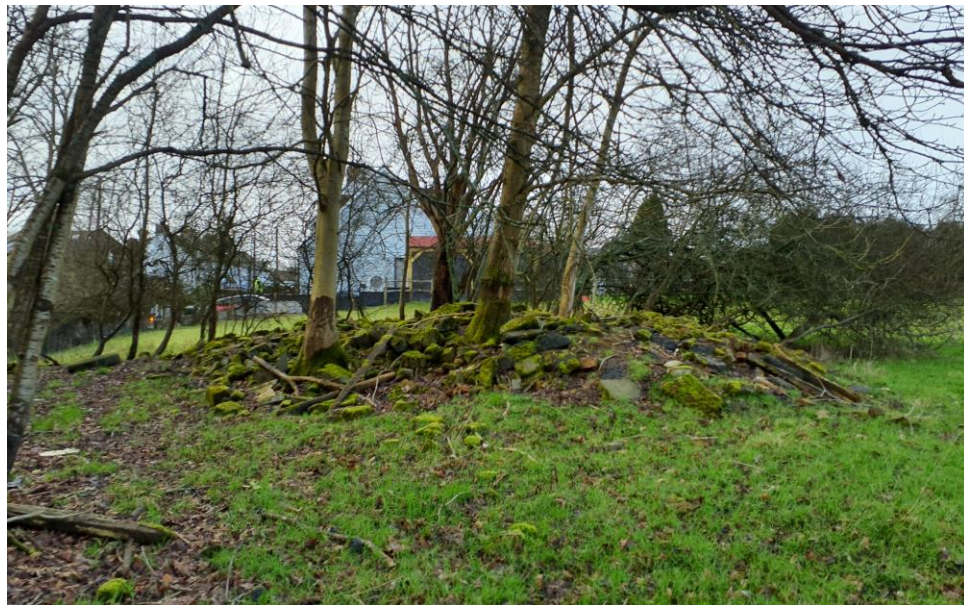
Plate 31: Made ground stockpile looking west

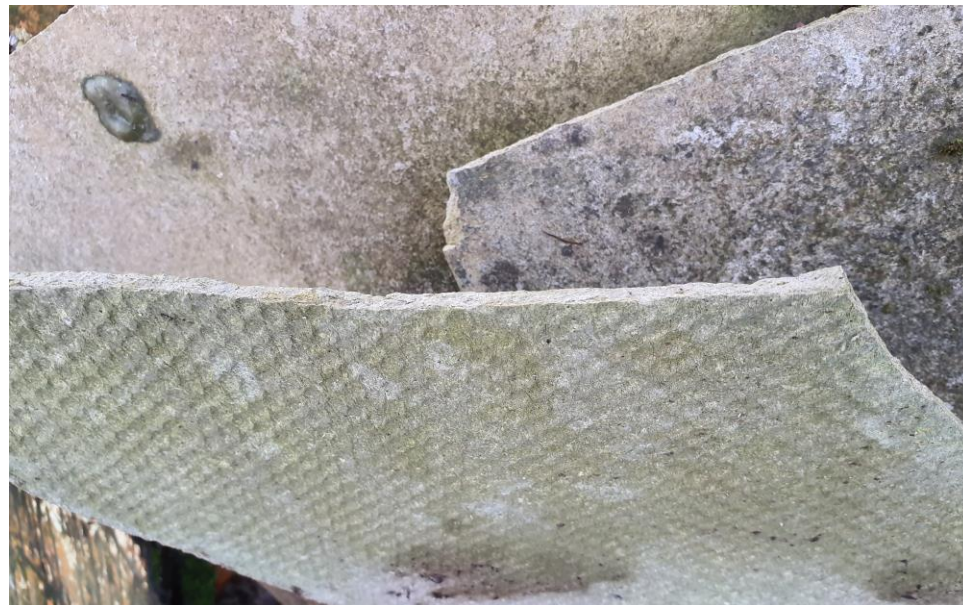
Plate 32: Close-up of potential Asbestos Containing Material (ACM) sheeting

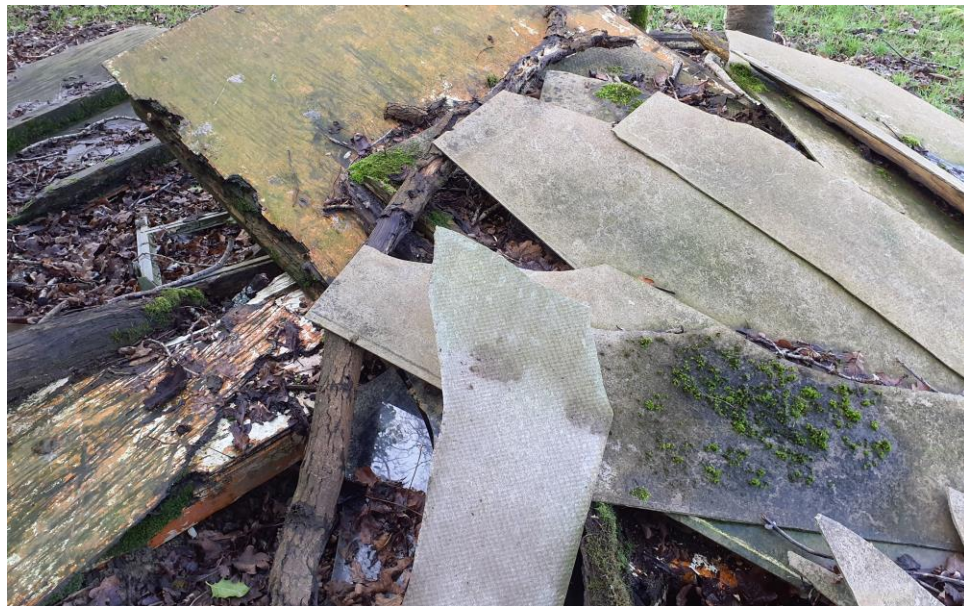
Plate 33: Wider shot of the potential ACM

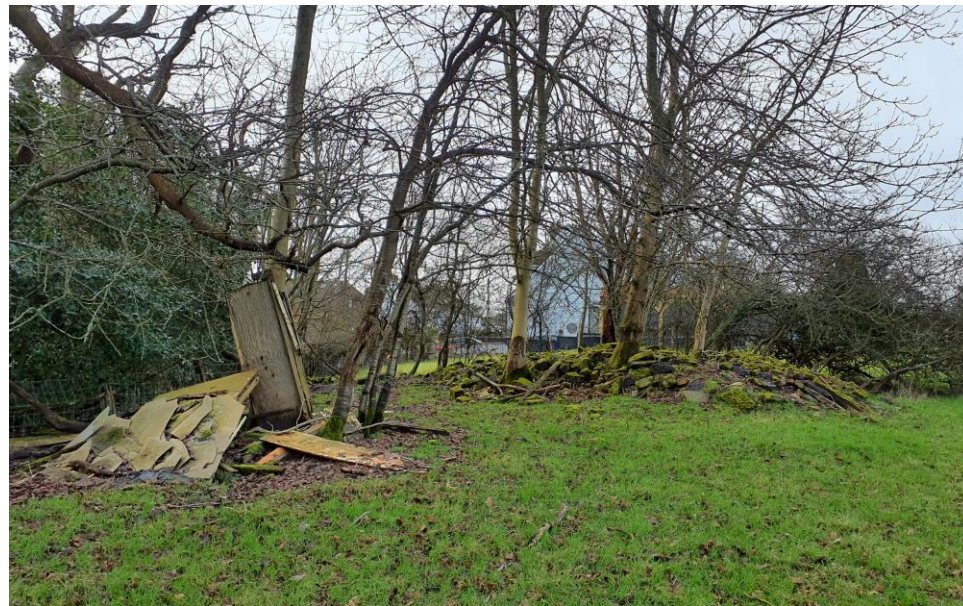
Plate 34: Wide shot of the two areas of made ground and potential ACM surrounded by mature trees c.15m in height

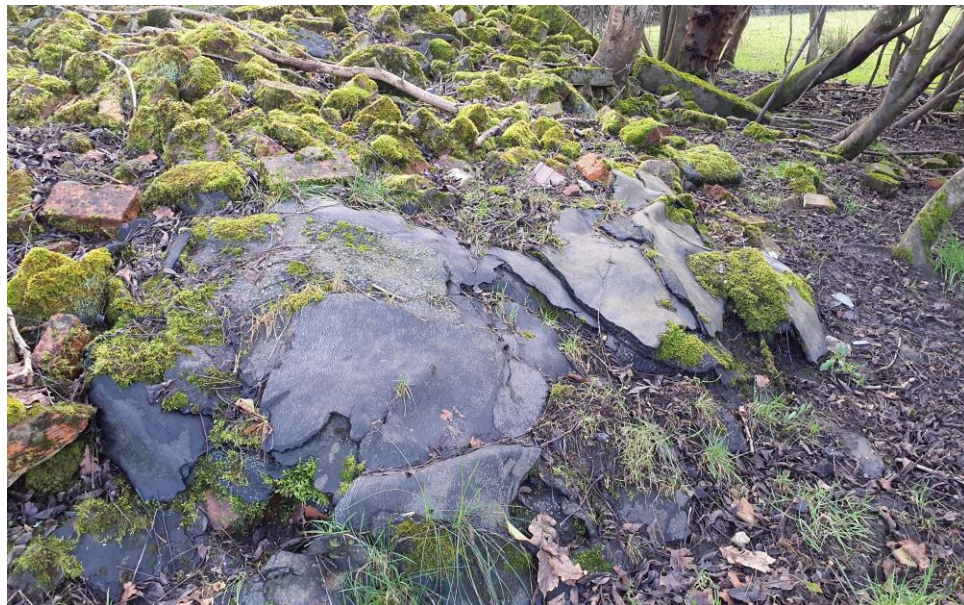
Plate 35: Further shot of the made ground

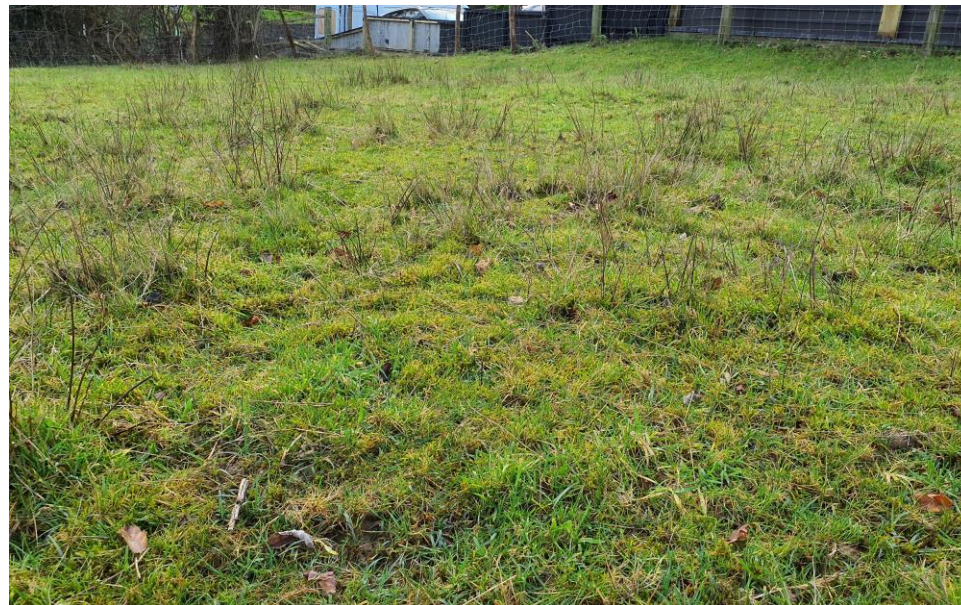
Plate 36: Low level vegetation

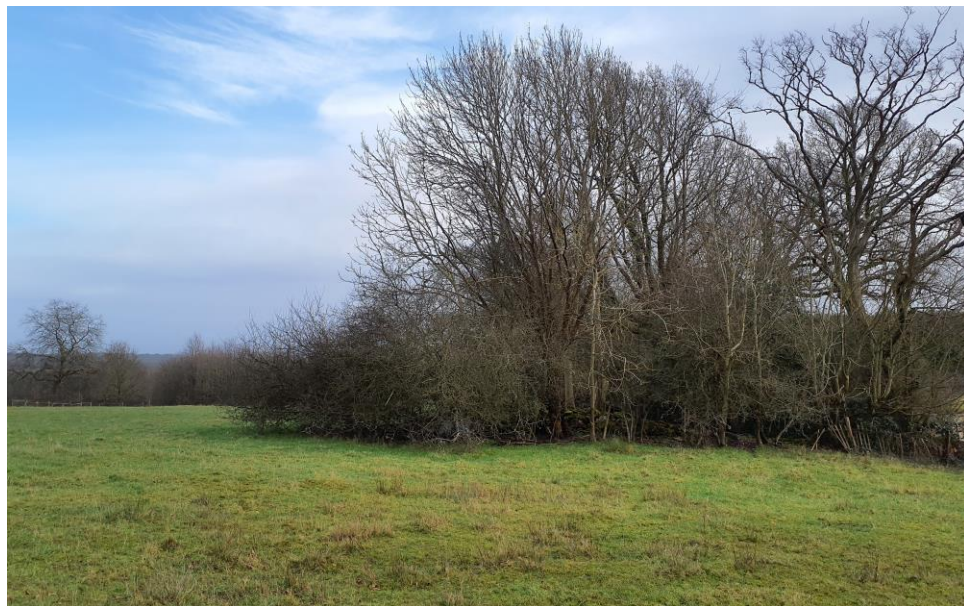
Plate 37: Area of vegetation in the southern central portion of the field

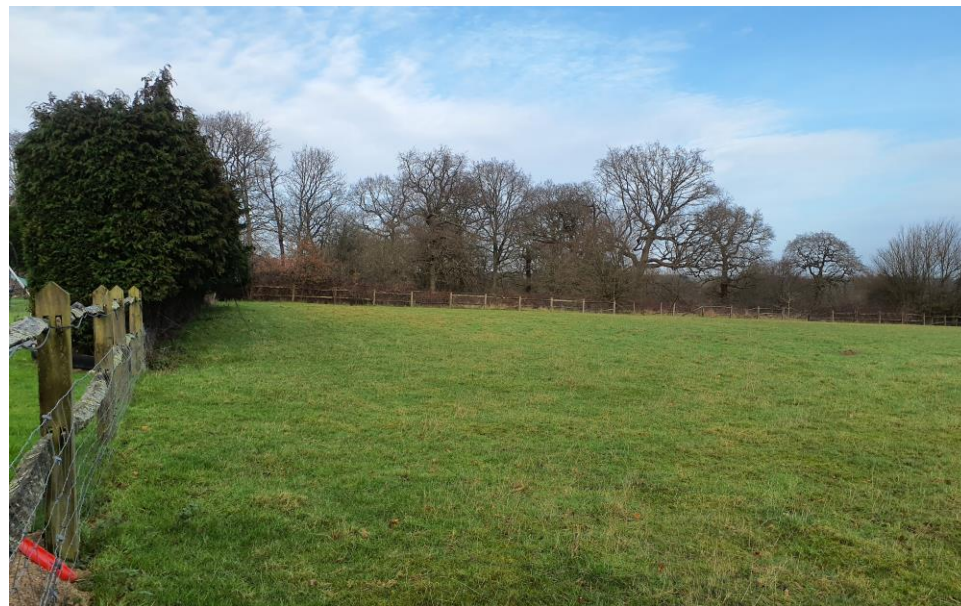
Plate 38: Southwest corner looking toward the northwest corner
