East Street, Rusper

**Client Ref:** GE22977 / PO-8160  
**Report Ref:** GS-QDH-REA-PUI-2QX  
**Grid Ref:** 520779, 137272

## **APPENDIX B**

### **Photographic Record**

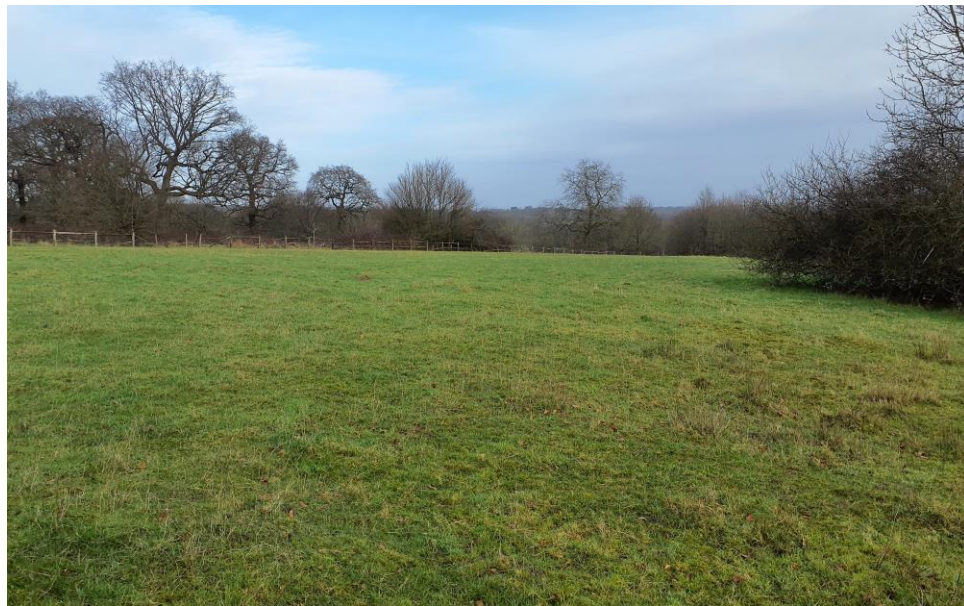
Plate 39: West boundary looking east

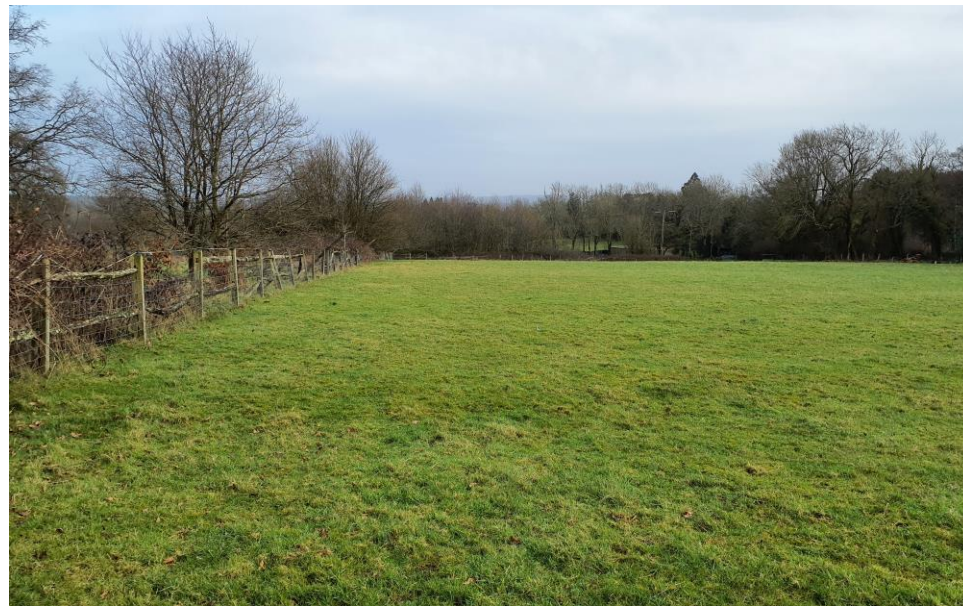
Plate 40: Northwest corner looking east

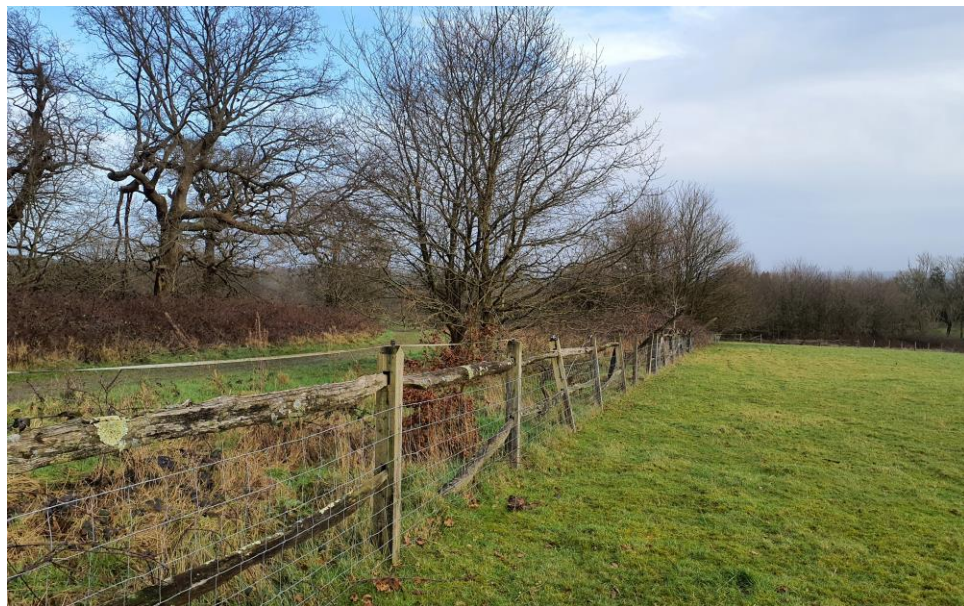
Plate 41: Northern boundary fence

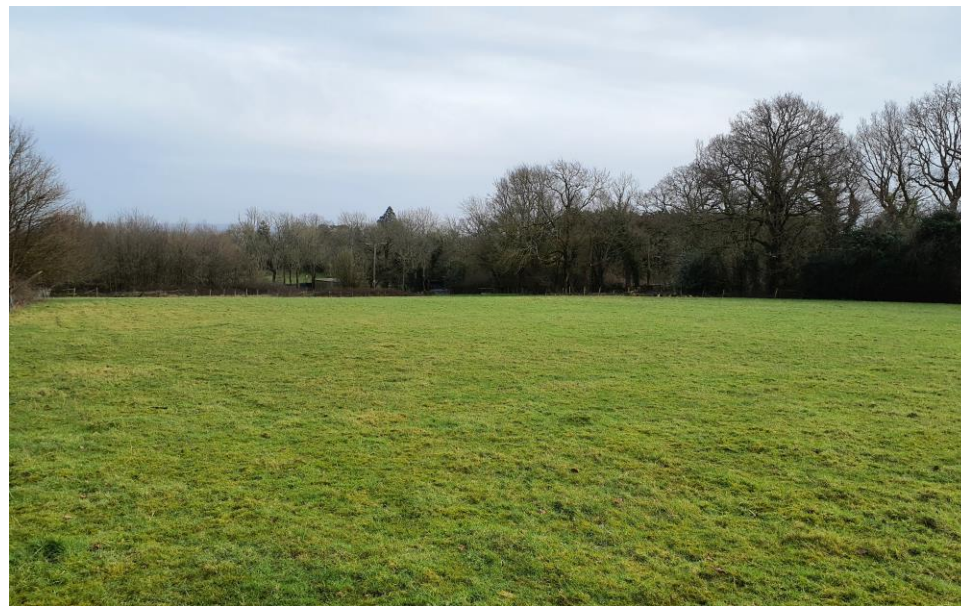
Plate 42: Northern centre of the site looking southeast

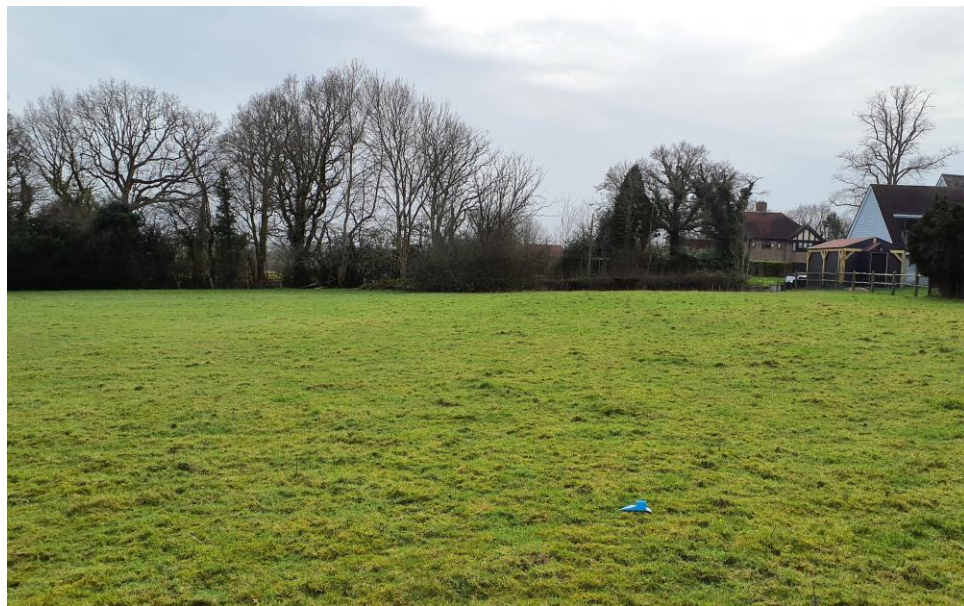
Plate 43: North looking south

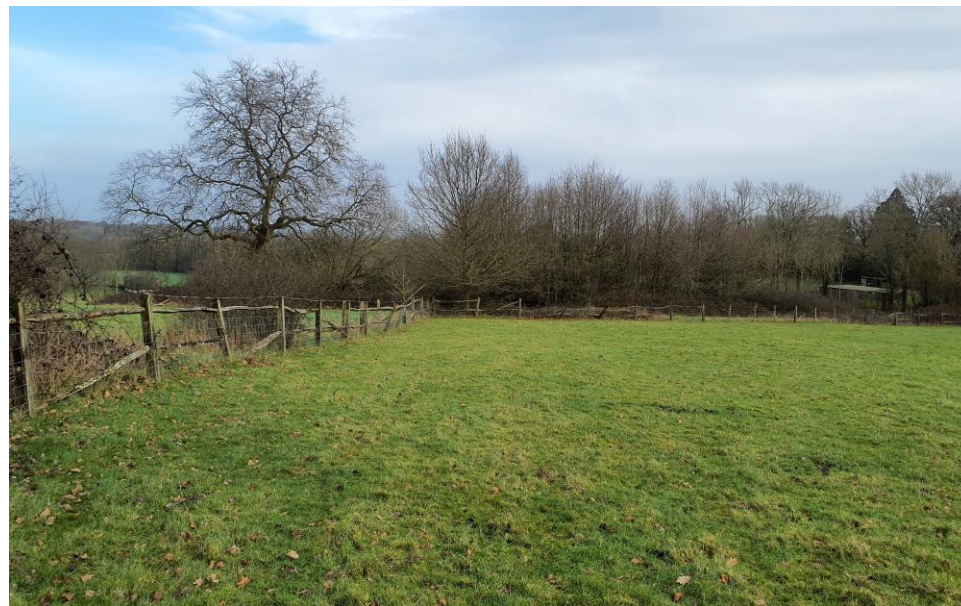
Plate 44: View of the northeast corner of the site

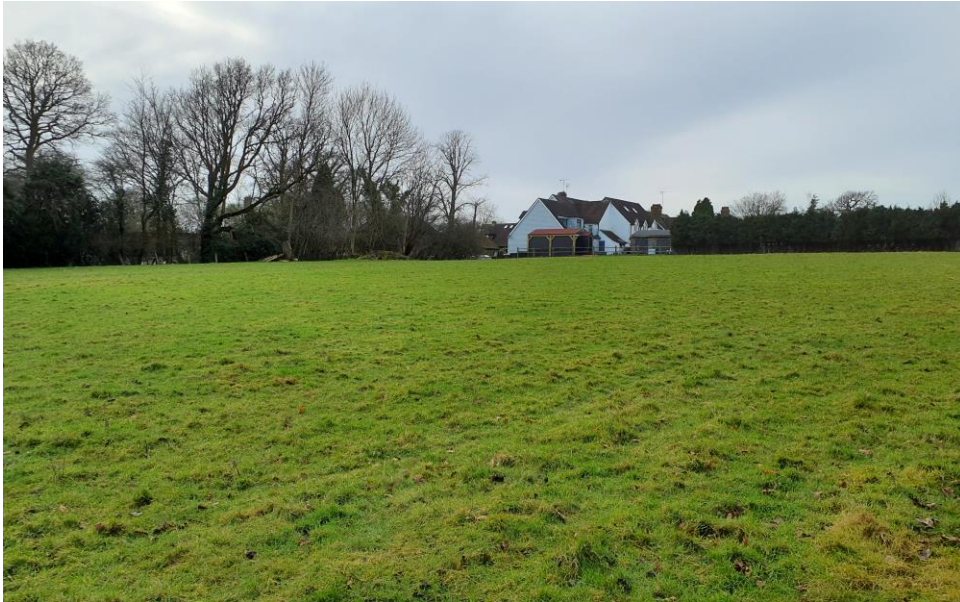
Plate 45: Northeast corner of the site looking southwest

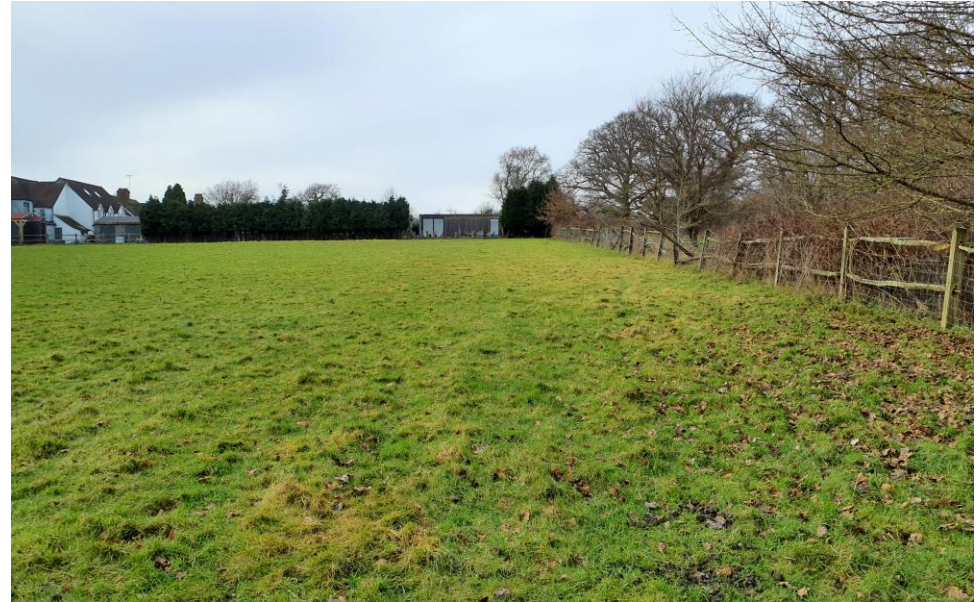
Plate 46: Northeast corner looking west
