Arboricultural Report
composed of
Arboricultural Impact Assessment
Arboricultural Method Statement
& Tree Protection Plan
for

Mr Tom White
Woodside Lodge
Picts Lane Cowfold RH13 8AT

19th January 2026

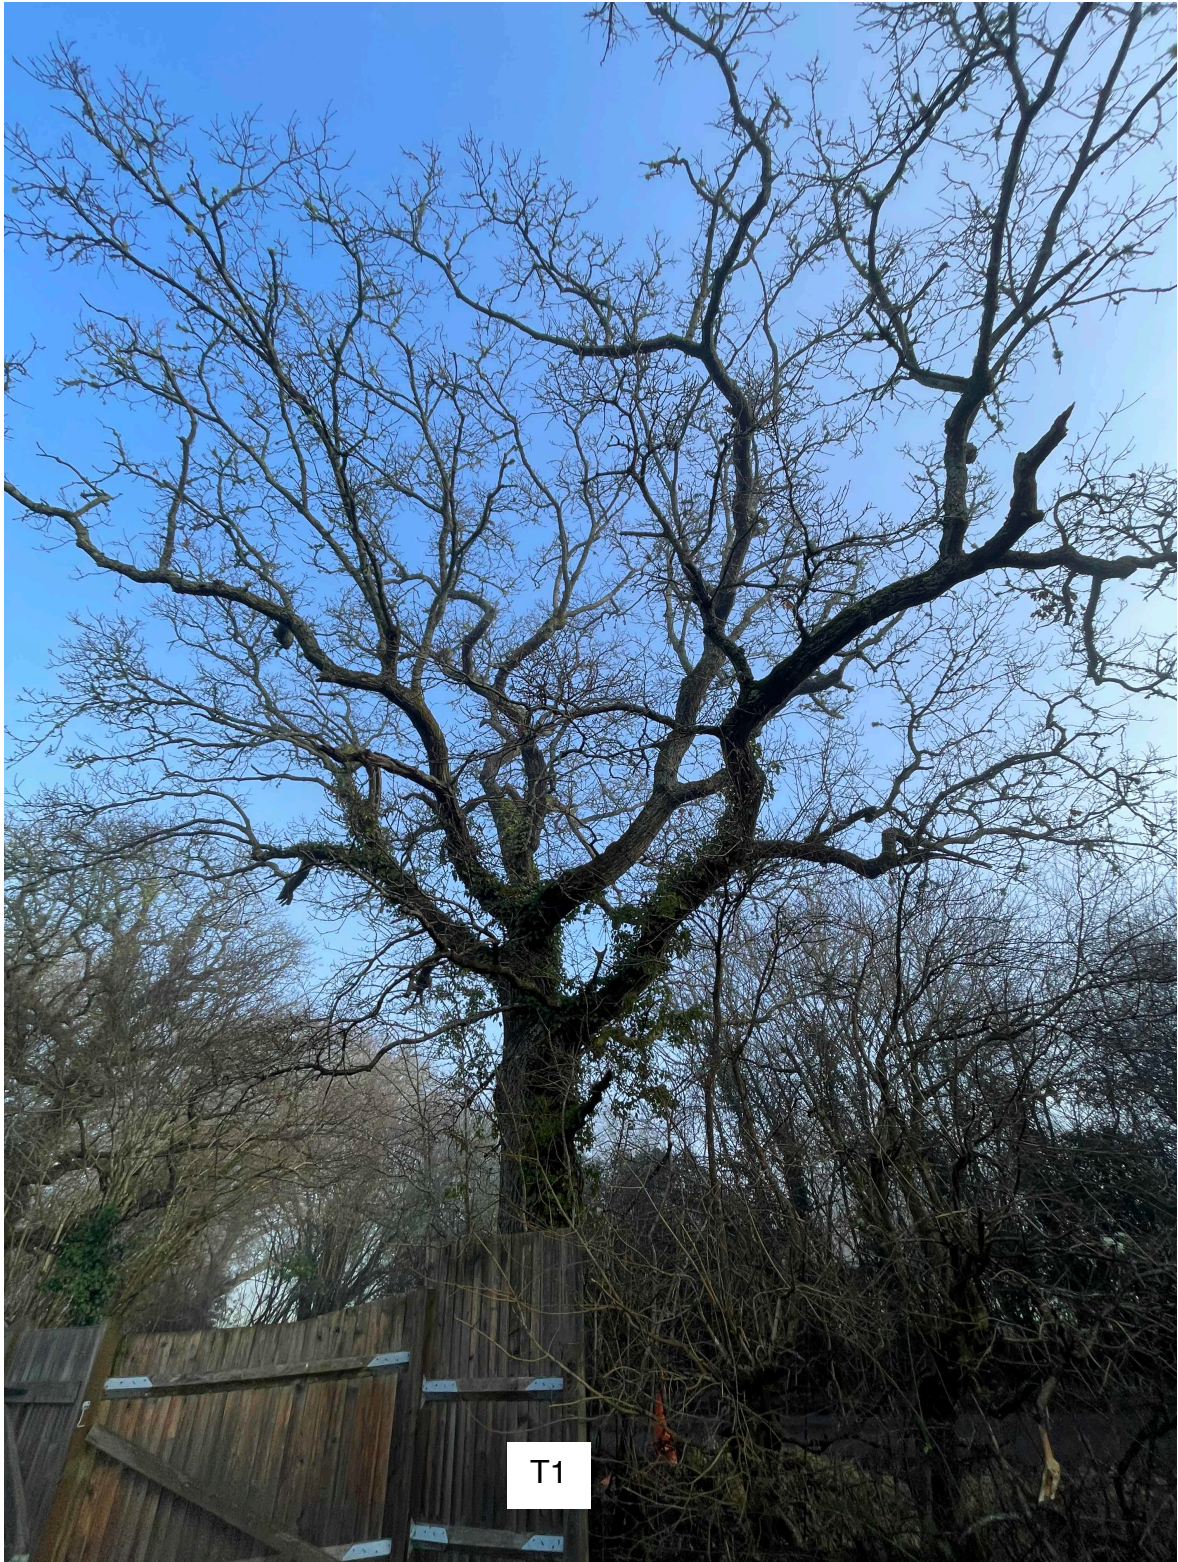
3.7.3. As the ground is soft at the entrance and the roots of T1 lie beneath this area it is advocated that ground protection is required (as shown on the Tree Protection Plan. Appendix 2) and heavy duty mats such as Hermes **Safe Trak Mats** are used that can take weights up to 80 tonnes on medium to soft ground. *These mats have a unique surface with one side being non-slip for pedestrians and the other side being a non-skid deep traction surface for vehicles. They are commonly used for moving large machinery and vehicles over soft ground in construction environments.*

Oak tree T1 set on bund hard by gateway into the site

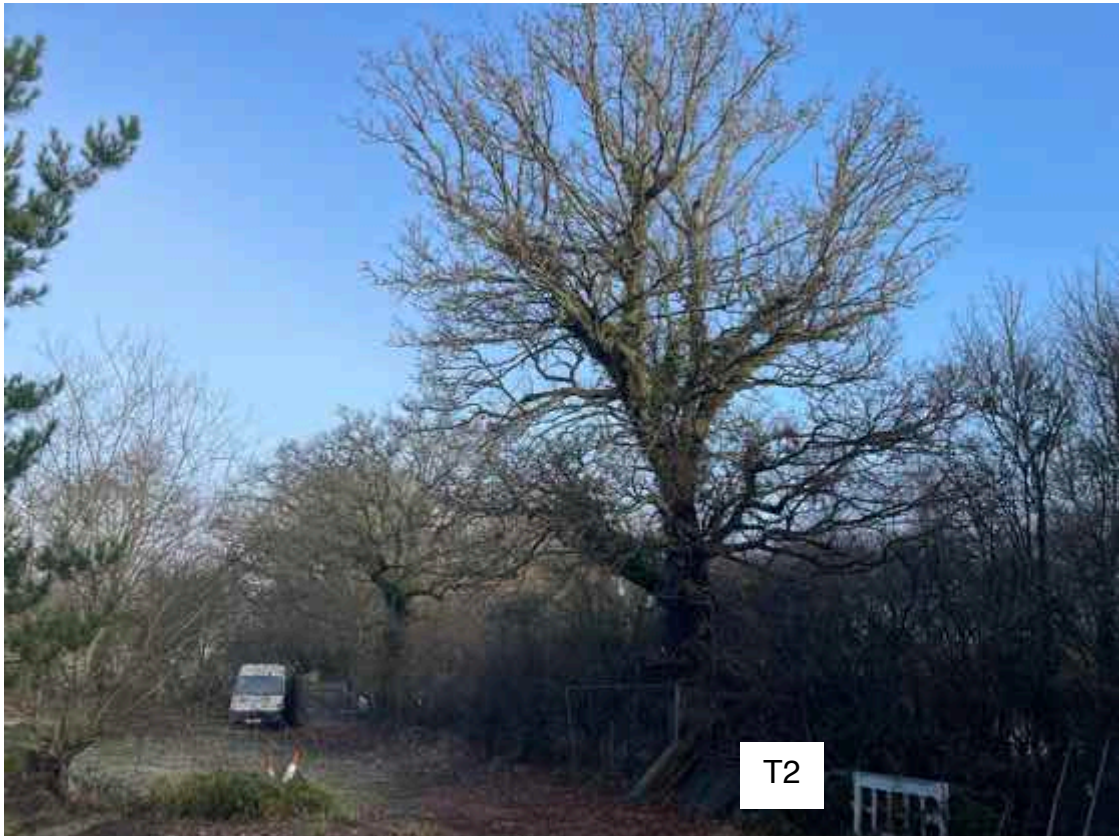
Oak tree T2 set on small bund along Picts Lane

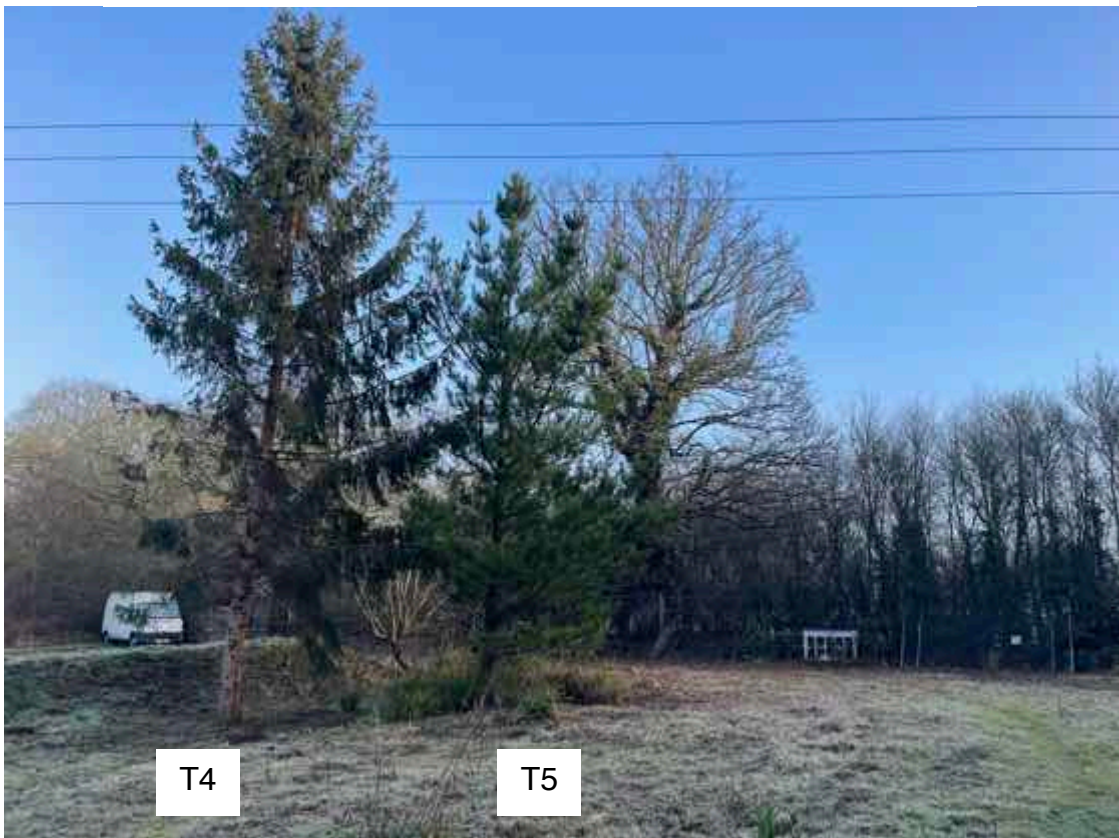
Cluster of trees T3, T4 and T5

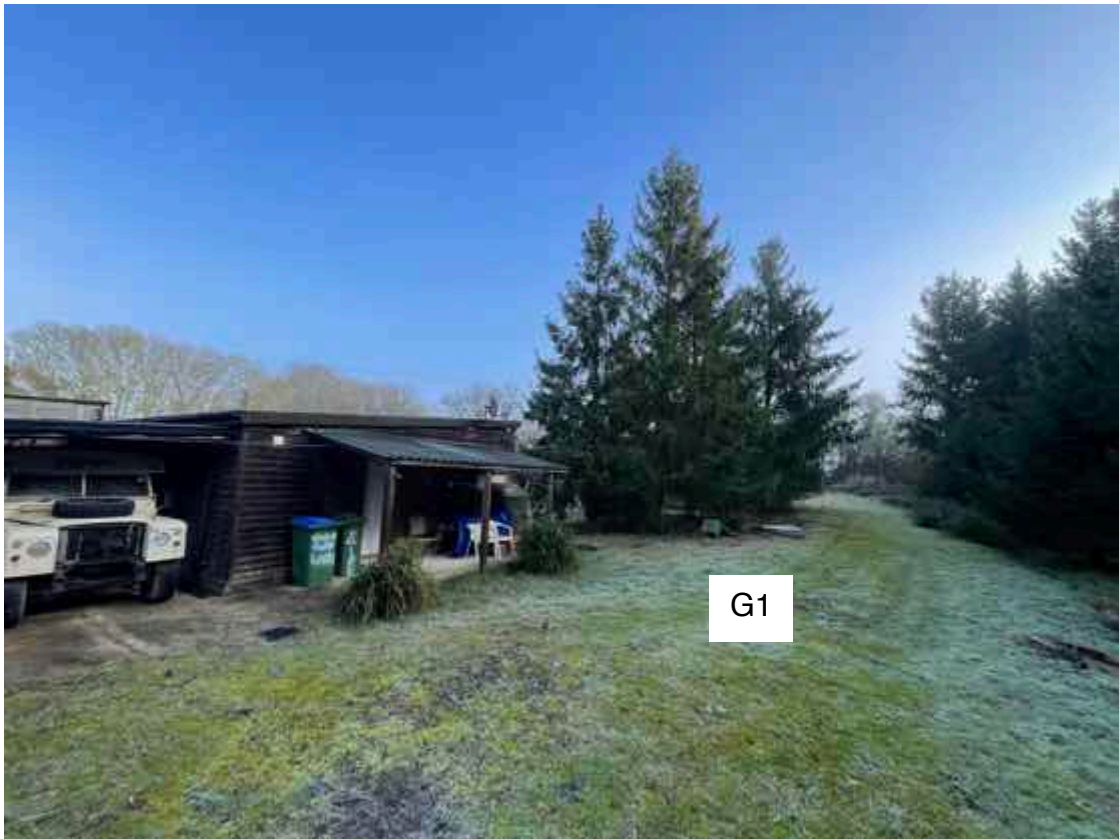
3.5.2. A number of trees are to be removed to enable this scheme to be implemented. These trees are the group of trees G1 in front of the existing building to the west, the group of self sown Willow to the east combined with the trees T6 and T7 set on the bund that will be removed to allow the new building too be constructed. Finally the two poor specimen Oak trees T8 and T9 set on the bund to the north of the site.

G1 trees and trackway into plantation

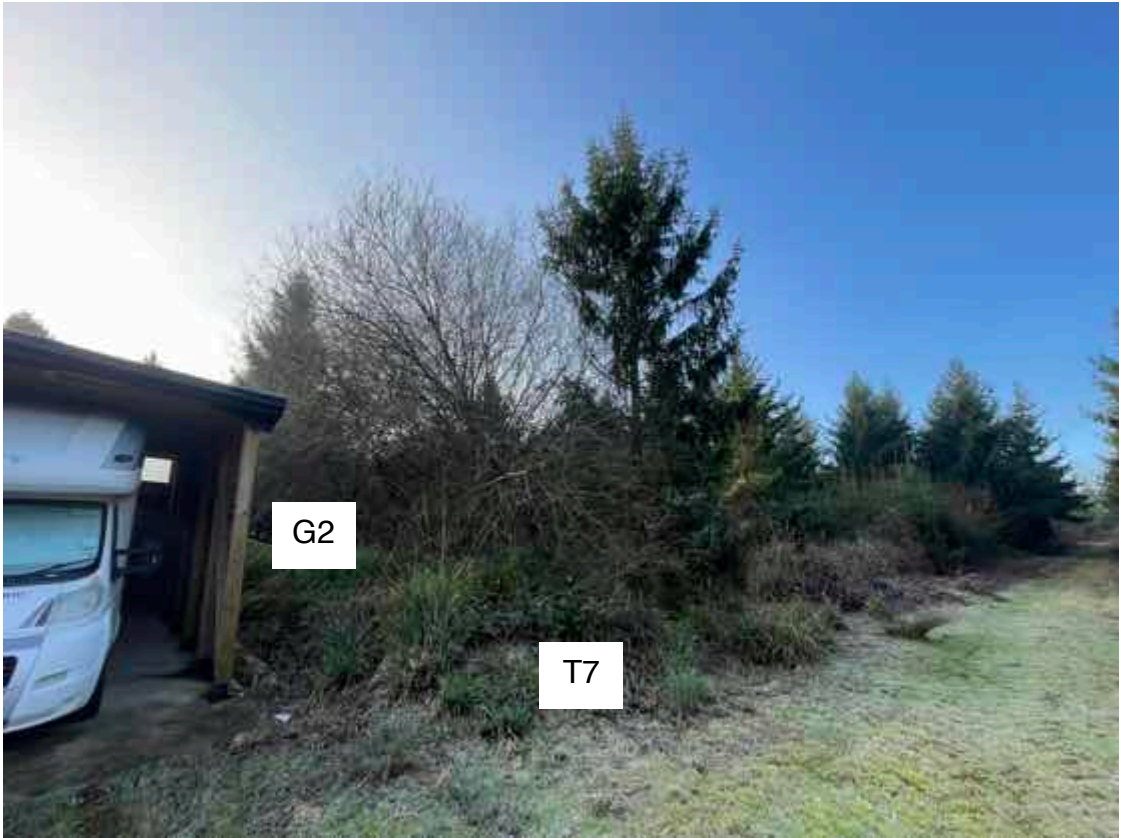
T7 tree and trackway into plantation

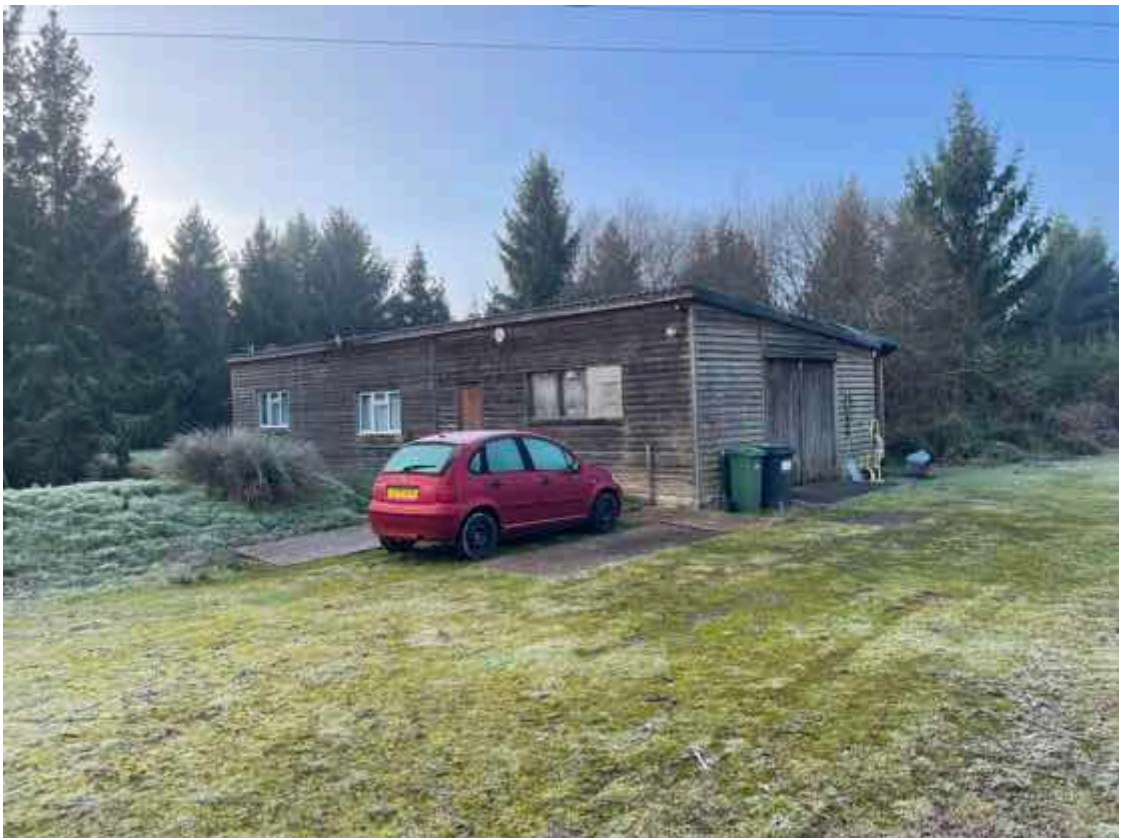
Frontage of existing building, hard standing and trackway into plantation

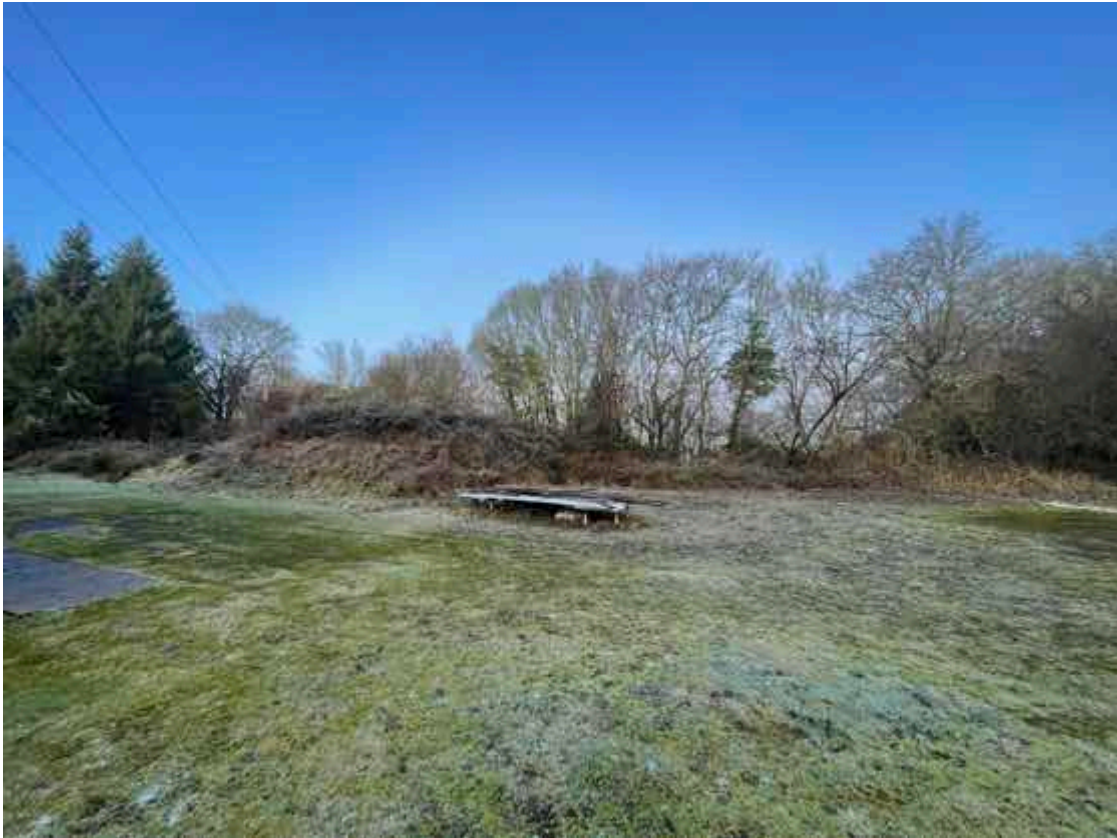
Northern bund and hard standing

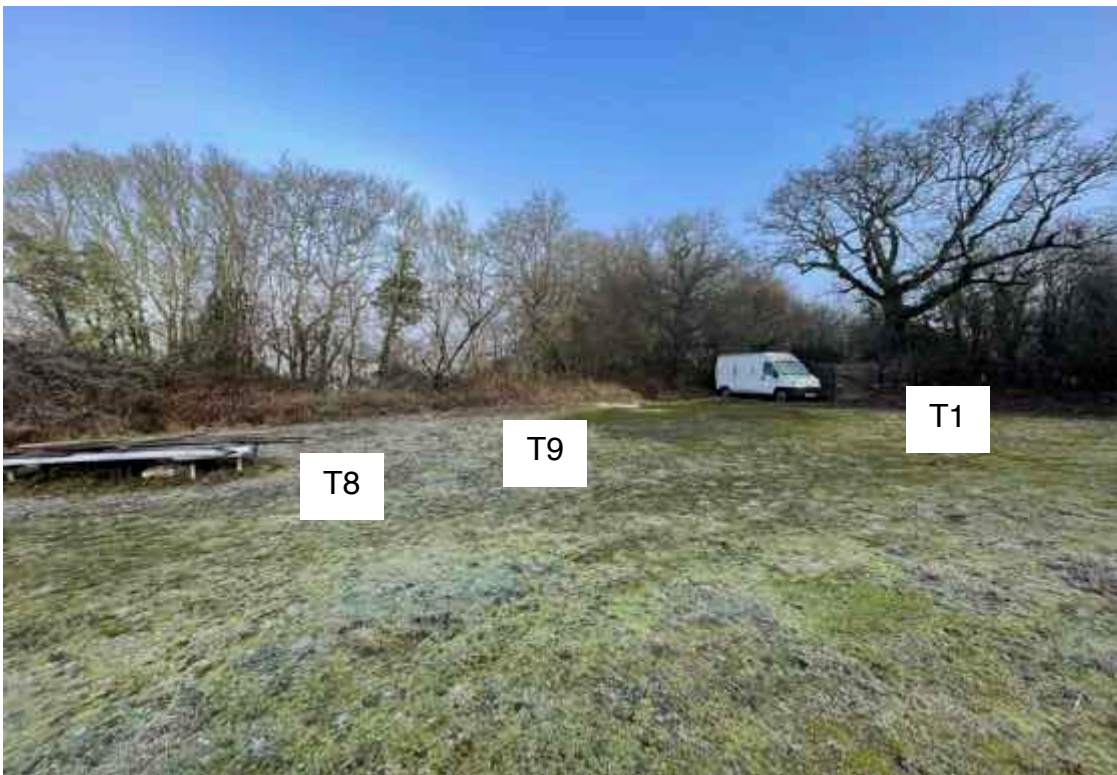
Hard standing and entrance by T1 where van is sited

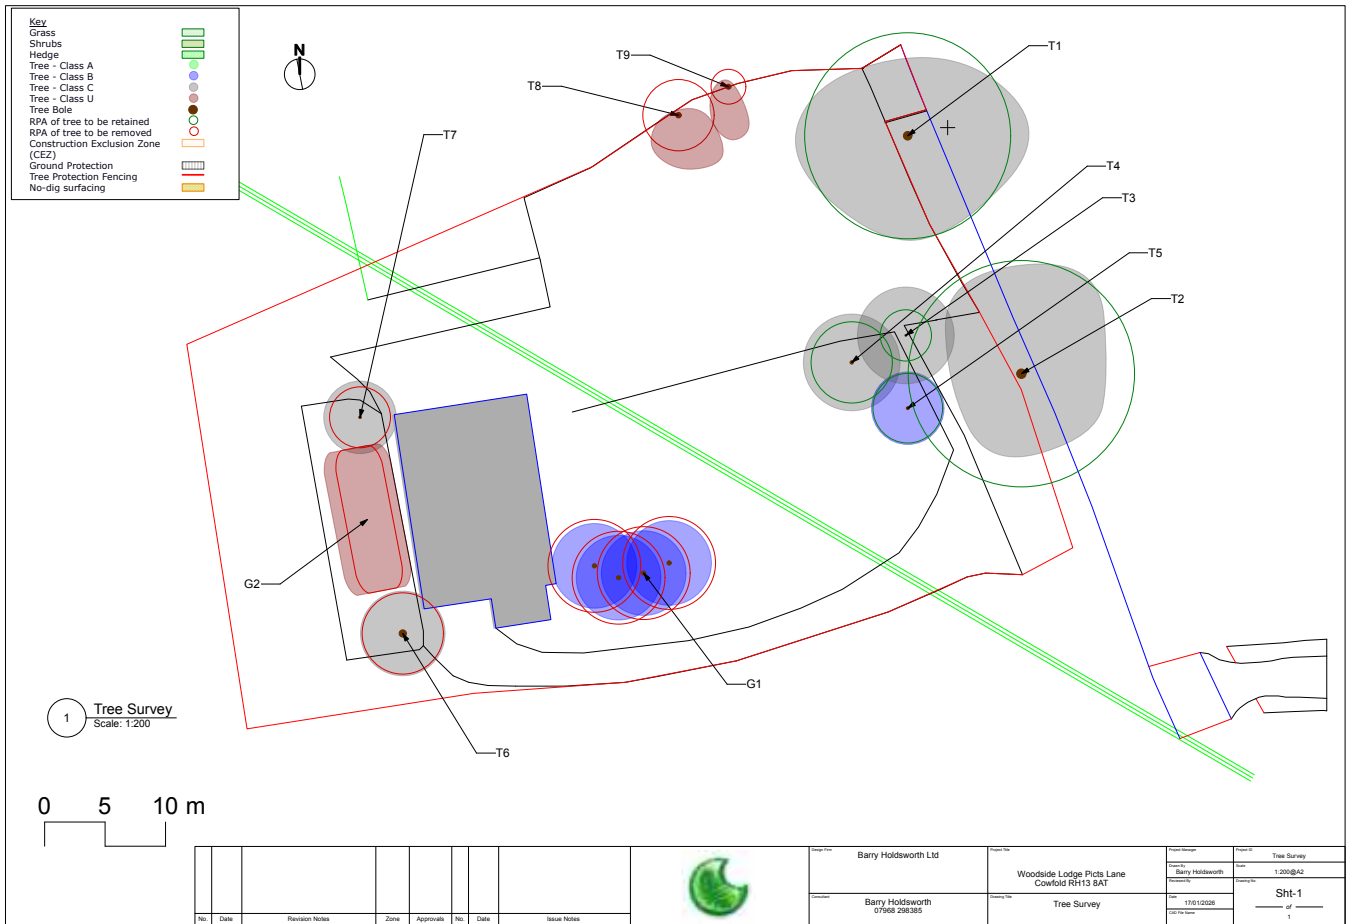
Appendix 1. Tree Survey Plan

3.5.1. The Tree Survey Plan by Barry Holdsworth Ltd indicates the trees on site, their Root Protection Area (RPA) and if they are to be retained (green outlined tree canopy) or removed (red

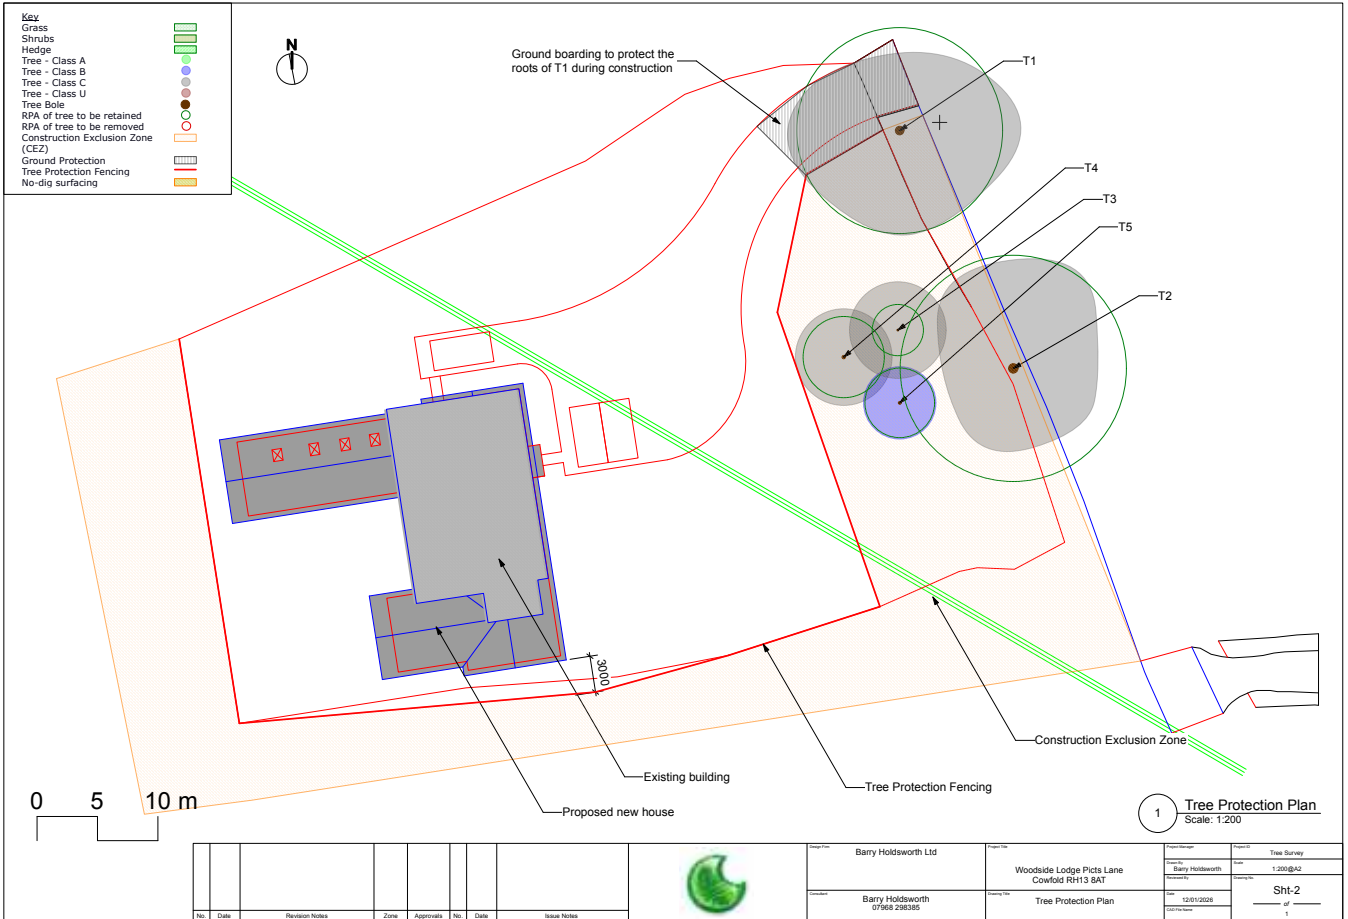
Appendix 2. Tree Protection Plan

3.7.2. The Tree Protection Fence will create a Construction Exclusion Zone (CEZ) and this is shown as orange hatching on the Tree Protection Plan (Appendix 2. Tree Protection Plan).
