Refurbishment & Demolition survey  
for asbestos materials at:

**Sir Roberts Farm- Workshop**  
**Goose Green Lane**  
**Pulborough**  
**West Sussex**  
**RH20 2LW**

**DATE:** 16<sup>TH</sup> OF JUNE 2022

**REFERENCE:** 01/16062022/DAS

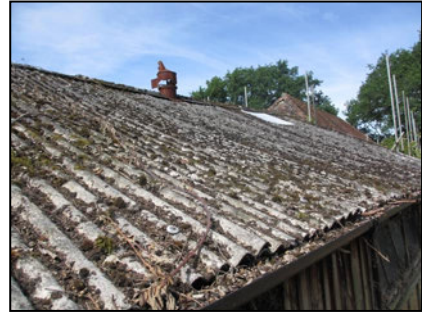
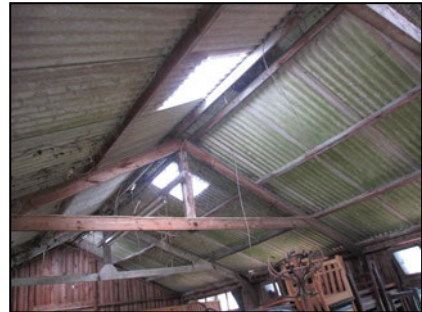
- 2.1 View of the asbestos cement panels to the pitched roof of the workshop.

- **The asbestos cement roof and the asbestos cement panels to the former chicken shed (mentioned in sections 2.1 & 2.2 and on the asbestos register and floor plan) can be managed and monitored if left in situ. If the asbestos cement is going to be removed this should be carried out by a licensed asbestos removal contractor.**

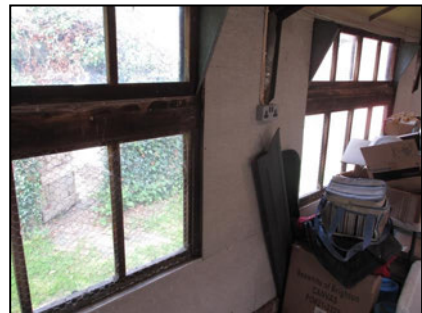
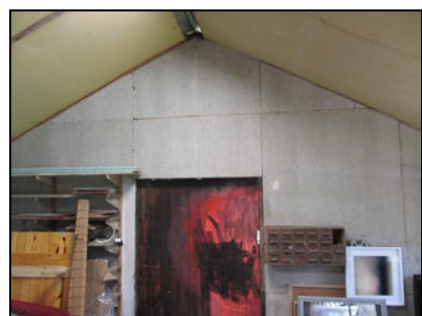
- 2.2 Views of the asbestos cement lining panels to the former chicken shed.

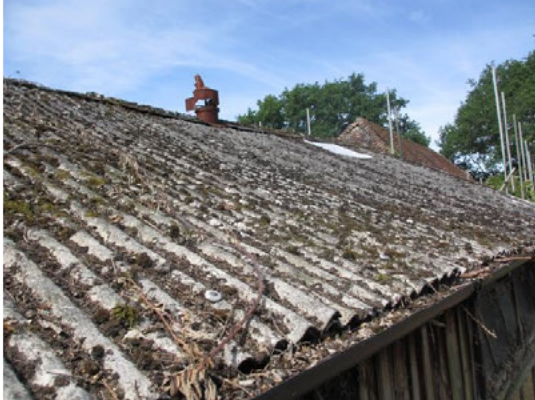
| Floor: Roof | Location: Pitched roof to workshop | Extent: 130 m2 |
| Area: External | Description: Asbestos cement sheet roof | |

| EOD: | 1. Low damage |

**Manage & monitor condition**

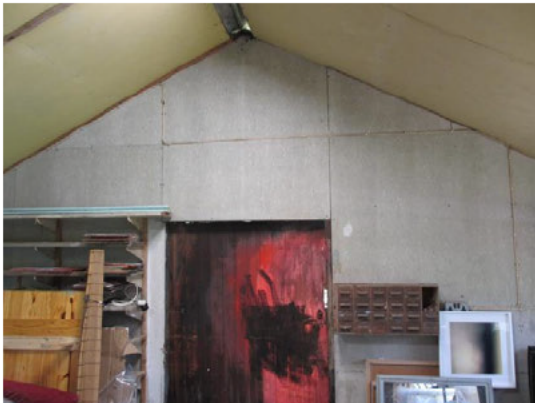
| Floor: Ground | Location: Former chicken shed | Extent: 32 m2 |
| Area: Internal | Description: Asbestos cement lining panels | |

| EOD: | 0. Good condition, no visible damage |

**Manage & monitor condition**

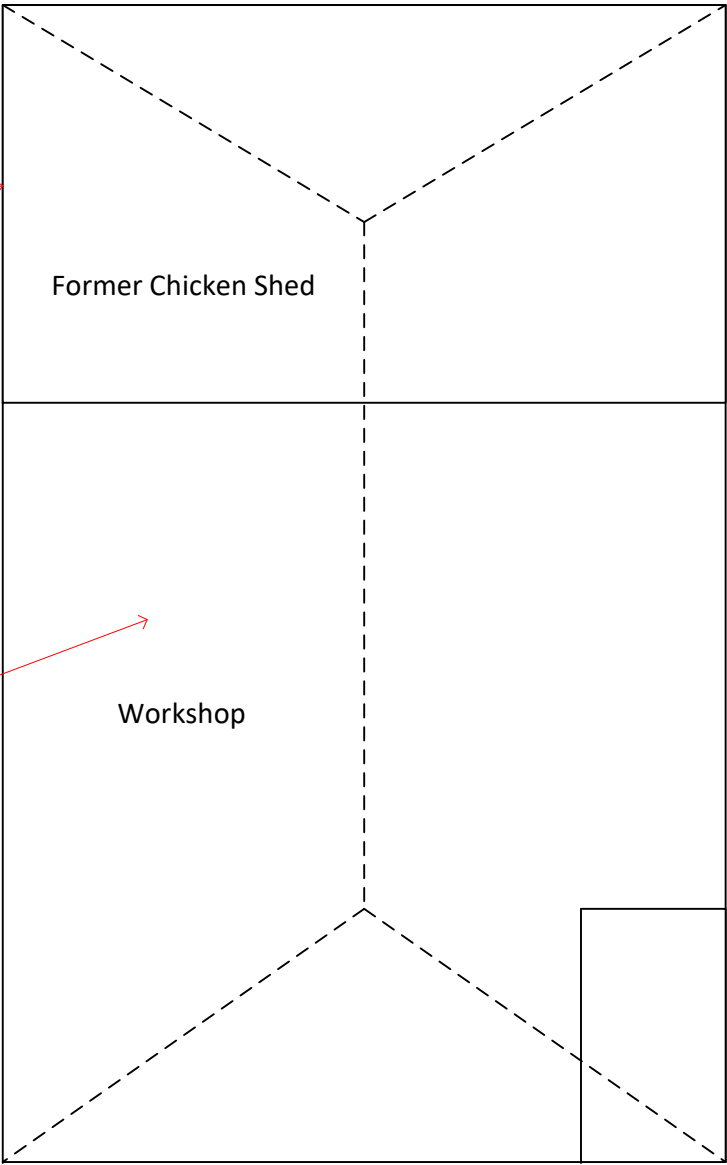
| | Annotated<br>floor plan | |

Item 002  
Asbestos cement sheet panels  
to walls

Item 001  
Asbestos cement sheet roof
