### DRAINAGE CCTV REPORT

# CCTV survey report

**Project Name** – Novartis site Horsham - CCTV Survey

**Project Number** – 60950

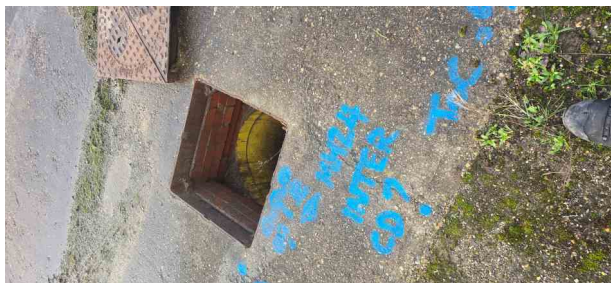
MH23X\_1657776c-ee6a-4a16-afa8-c539fb257ac9\_20241125\_100929.jpg, 00:00:03, 0.00 m  
 General remark, INTERCEPTOR REQUIRES EMPTYING TO SURVEY

| <b>Recommendations:</b> | REQUIRES SUCKING OUT TO EMPTY | | | | |

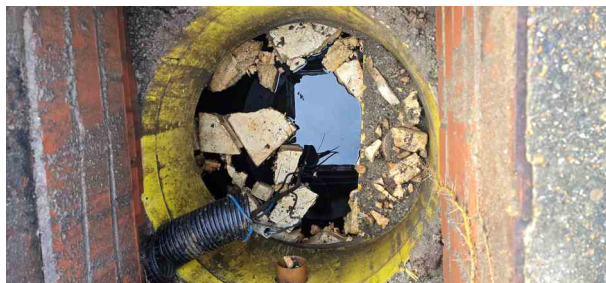
MH23X\_b2a02f52-d2a0-40f8-8de7-244e290f80c2\_20241125\_100934.jpg, 00:00:03, 0.00 m  
 General remark, INTERCEPTOR REQUIRES EMPTYING TO SURVEY

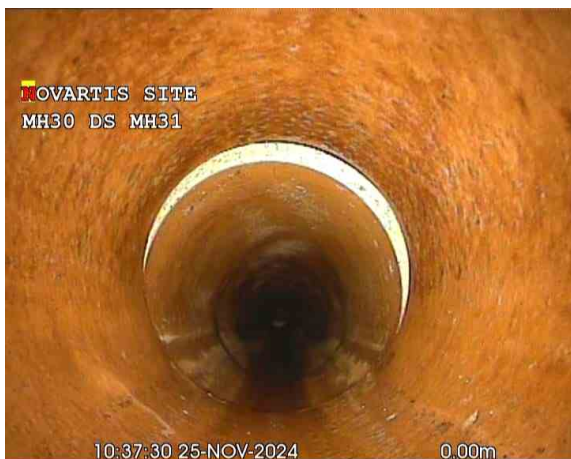
| Section | PLR | Grade | Description |
|---|---|---|---|
| 4 | MH30X | 4 | Joint displaced, large |

MH30X\_be1fa4e2-0bad-4938-8c7d-66491d64b79e\_20241125\_104944\_019.jpg, 00:00:10, 0.28 m  
 Joint displaced, large

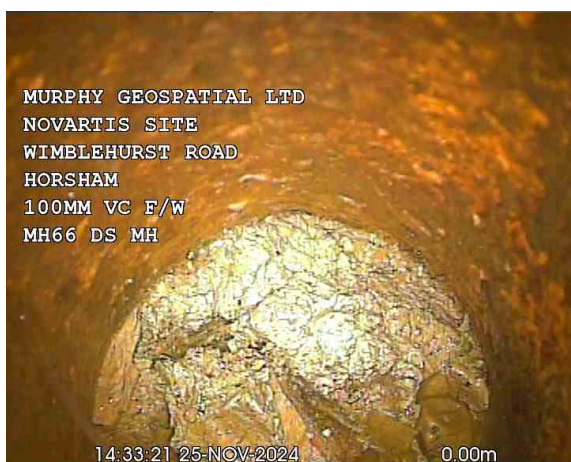
| Section | PLR | Grade | Description |
|---|---|---|---|
| 15 | MH66X | 5 | Collapsed drain or sewer, 100% cross-sectional area loss |

MH66X\_d5676fce-9e23-49c5-bd5e-e499d8c206ac\_20241125\_143652.jpg, 00:00:04, 0.00 m  
 General remark, LINE POSSIBLY COLAPSED

| <b>Recommendations:</b> | LINE REQUIRES DIG UP TO REPAIR | | | | |

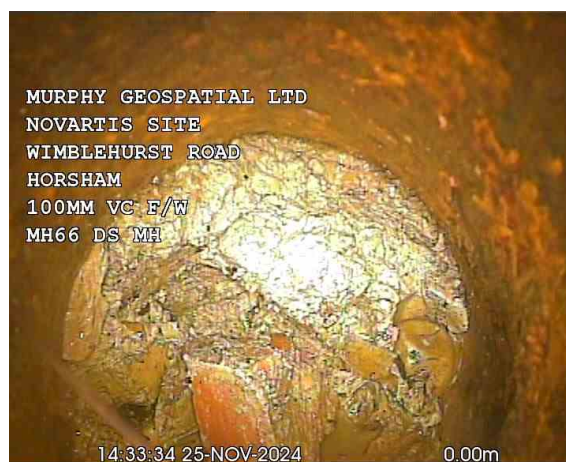
MH66X\_4c909935-10b8-4717-9372-7c1483778b32\_20241125\_143657.jpg, 00:00:04, 0.00 m  
 General remark, LINE POSSIBLY COLAPSED
