Client	Lake Investments Ltd		
Site	Jacksons, Hammerpond Road, Plummers Plain, Horsham, RH13 6PE	Revision	A
Date	22 December 2025		
Author	S Lower	Checked	C Barker

MS07260/DS

**Structural Appraisal of Proposed Conversion of 2 Barns at Stonehouse Farm,
Hammerpond Road, Plummers Plain**

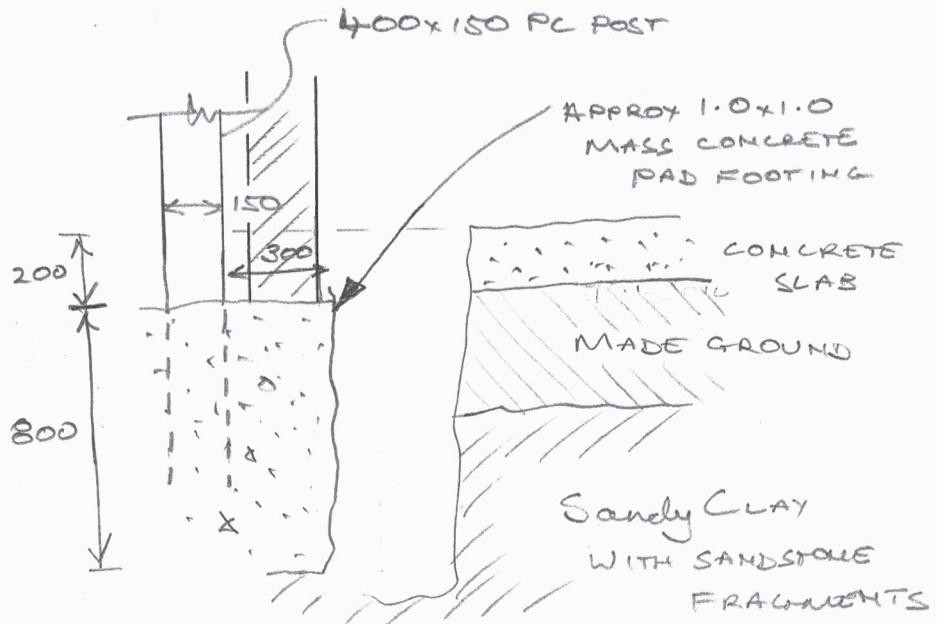
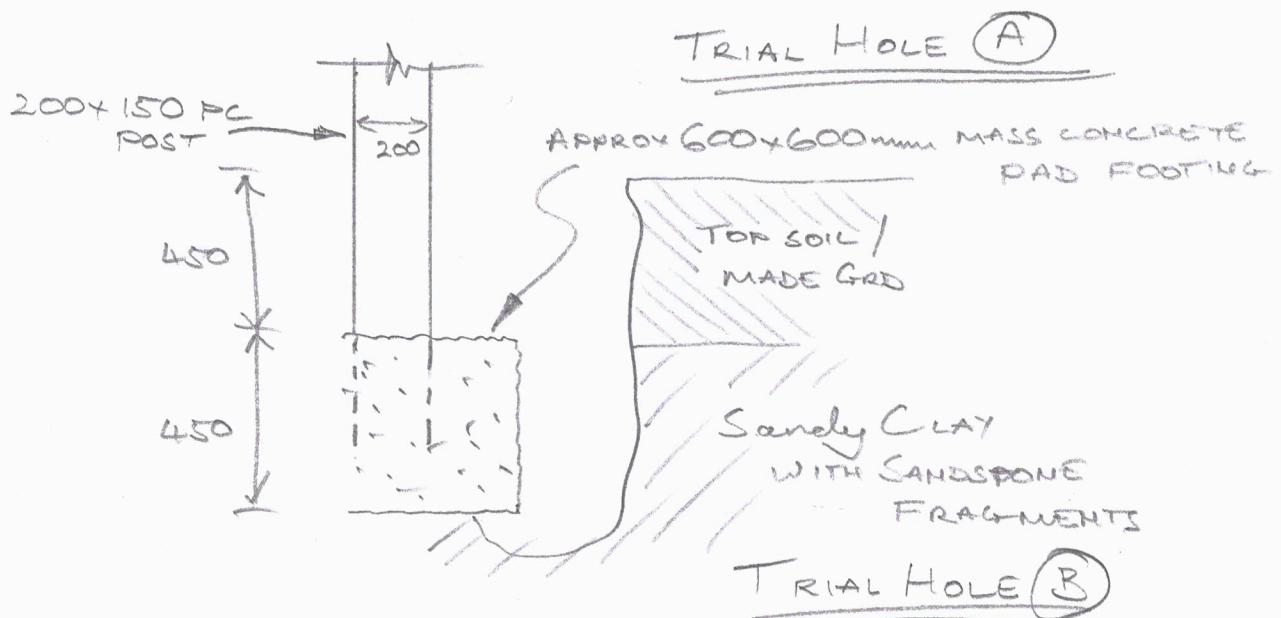
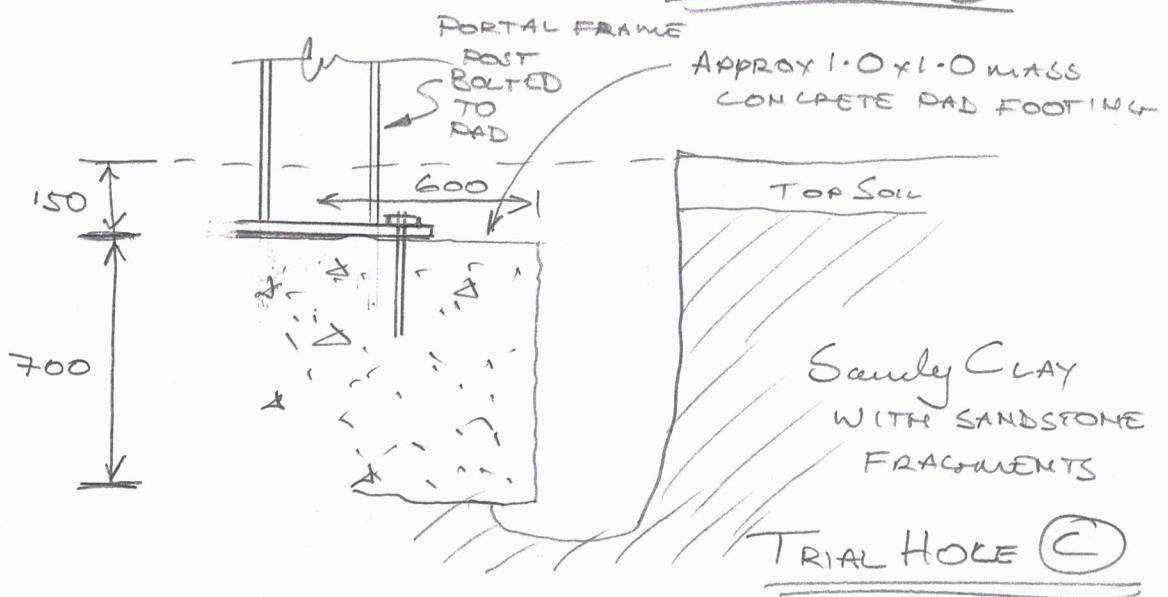
JOB TITLE		DATE
Farm barns, Stonehouse Farm, Plummer		Jan 2025
ITEM	JOB NO.	SHEET NO
Trial Hole Sections	MS07260	
PREPARED BY	CHECKED BY	
DS	SA

The main precast concrete portal frames were formed with 150 x 400 precast concrete posts with precast concrete duo-pitched portal frame beams spanning the 18m between the posts. Trial holes showed the main precast concrete posts to be supported on insitu concrete pad foundations approximately 1m square on plan and 800mm thick set approximately 1000mm deep to underside. To the west side of the main portal frame were 100 x 230mm deep precast concrete tee shaped rafters supported on the main frame posts and 150 x 200mm precast concrete posts on the west side of the barn. Similarly, on the east side were 100 x 380mm deep precast concrete rafter tee beams supported on the main portal frame posts and 150 x 200mm precast concrete posts on the east elevation. A trial hole indicated the 150 x 200 posts were supported on approximately 600mm x 600mm x 450mm deep mass concrete pad footings set around 900mm deep into the silty Clay subsoil. There were precast concrete purlins spanning between the precast concrete frames at approximately 1300mm centres which were supporting a corrugated fibre cement roof sheeting. The precast concrete frame and purlins were generally in a good condition with little sign of damage or movement. There was some spalling to the concrete in isolated areas to the principal rafters as indicated on the attached over-marked plans. There was also some damage to the eaves tie beams on the east side of the barn and a missing eaves tie beam on the east side, however, we understand the intention would be to reduce the barn width on the east side. Between the main adjacent portal frame 150 x 400 precast posts were tie beams, these appeared to have been removed in 3 locations, however, the proposed new internal wall panels to sub-divide the spaces will overcome any loss of tying action from these missing ties.

The main portal frame posts were 305 x 165 UB steel section. A trial hole was excavated on the east side of the barn showing these posts were supported on 1m x 1m x 700mm deep mass concrete pads set around 900mm below ground level. Attached is a soil sample test result indicating the subsoil is low plasticity clay.
