Client	Lake Investments Ltd		
Site	Jacksons, Hammerpond Road, Plummers Plain, Horsham, RH13 6PE	Revision	A
Date	22 December 2025		
Author	S Lower	Checked	C Barker

**DEMOLITION & MANAGEMENT SURVEYS  
TO IDENTIFY ASBESTOS PRODUCTS AT**

**STONEHOUSE FARM  
HAND CROSS ROAD  
PLUMMERS PLAIN  
RH16 6NZ**

**SURVEY REFERENCE NO. S0923/37**

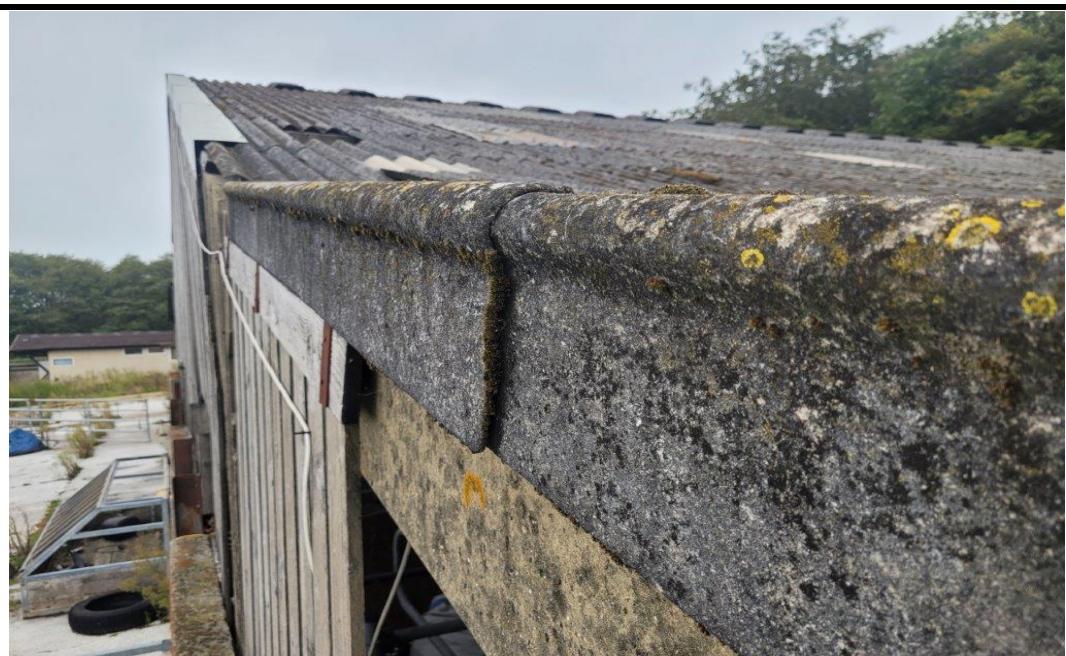
6.4.1 Corrugated asbestos cement roof sheets and asbestos cement fascia's were identified to Building B.

Photo Number:	3
Sample Number:	2
Material Type:	Cement
Level of Identification:	Identified
Location / Description:	Hammerpond Road Site - Building B - External fascia's

- 8.1 The asbestos cement materials were in good or fair condition. If these materials are likely to be significantly disturbed, they should be removed under controlled conditions and disposed of in accordance with Hazardous Waste Regulations (2005). This is not a licensed activity but the Control of Asbestos Regulations (2012) must still be adhered to. For further guidance on removal please see <http://www.hse.gov.uk/asbestos/essentials/>.

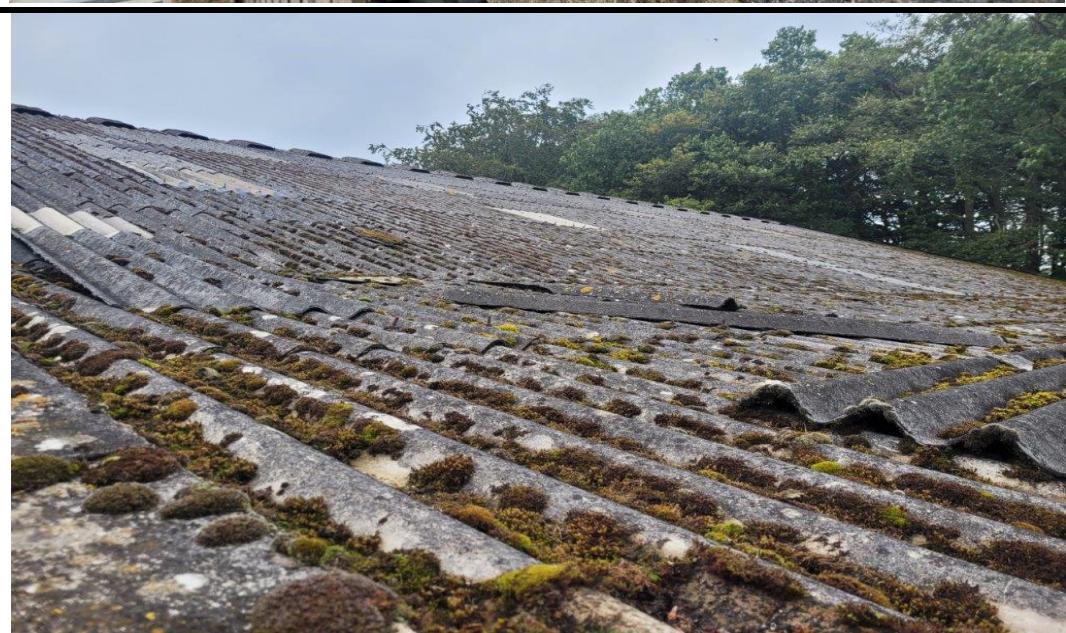
Photo Number:	4
Sample Number:	3
Material Type:	Cement
Level of Identification:	Identified
Location / Description:	Hammerpond Road Site - Building B - External roof sheets

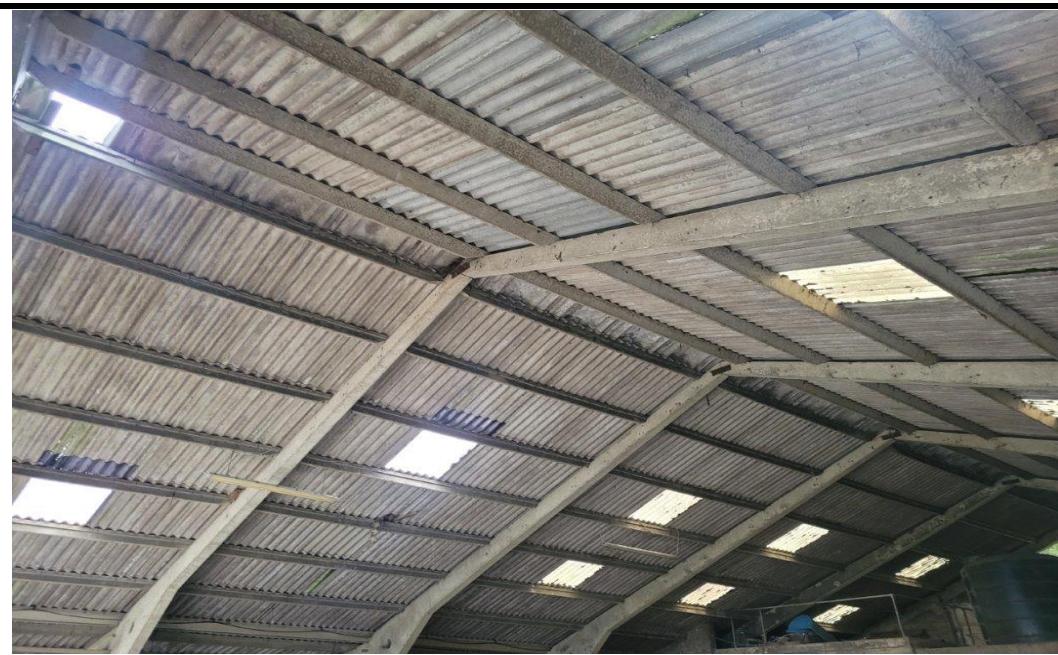
Photo Number:	5
Sample Number:	4
Material Type:	Cement
Level of Identification:	Identified
Location / Description:	
Hammerpond Road Site - Building B - External roof sheets

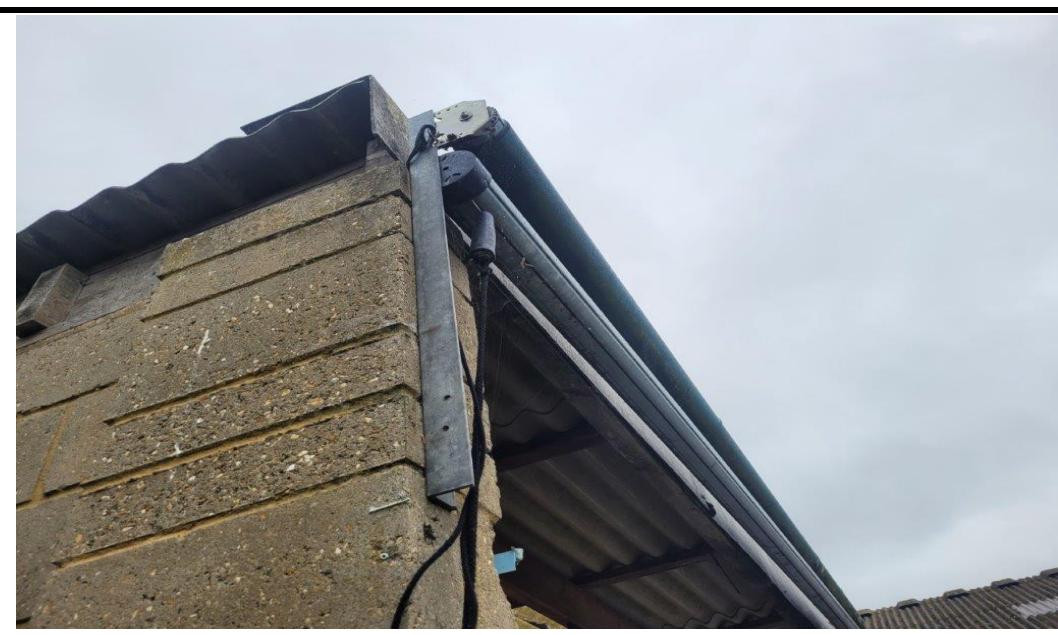
Photo Number:	6
Sample Number:	5
Material Type:	Cement
Level of Identification:	Asbestos not detected
Location / Description:	
Hammerpond Road Site - Building C - External fascia's

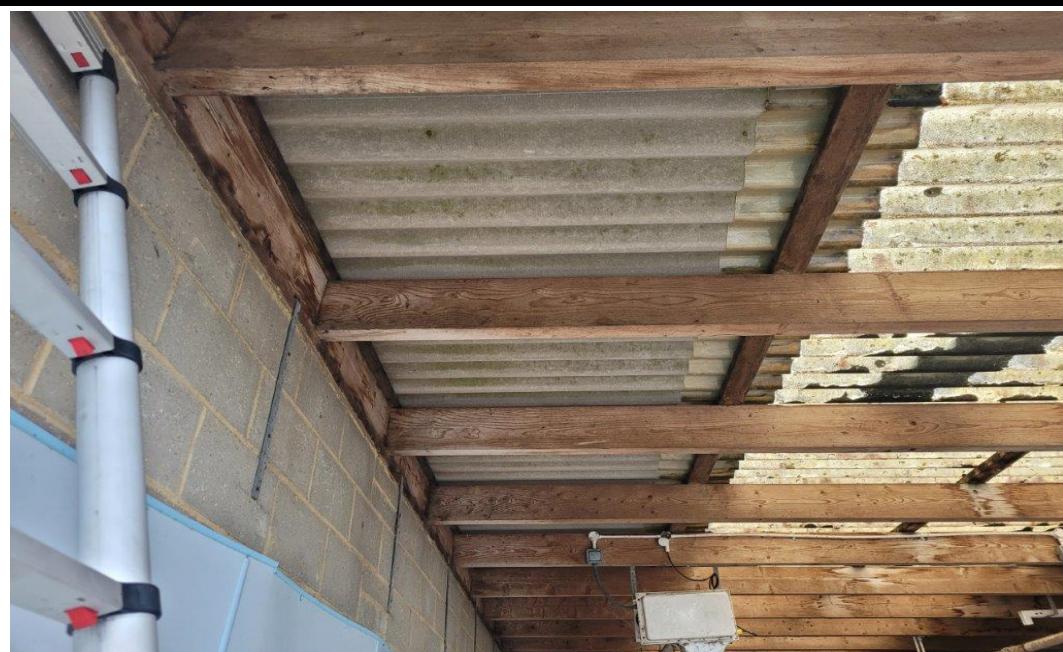
Photo Number:	7
Sample Number:	6
Material Type:	Cement
Level of Identification:	Asbestos not detected
Location / Description:	Hammerpond Road Site - Building C - External roof

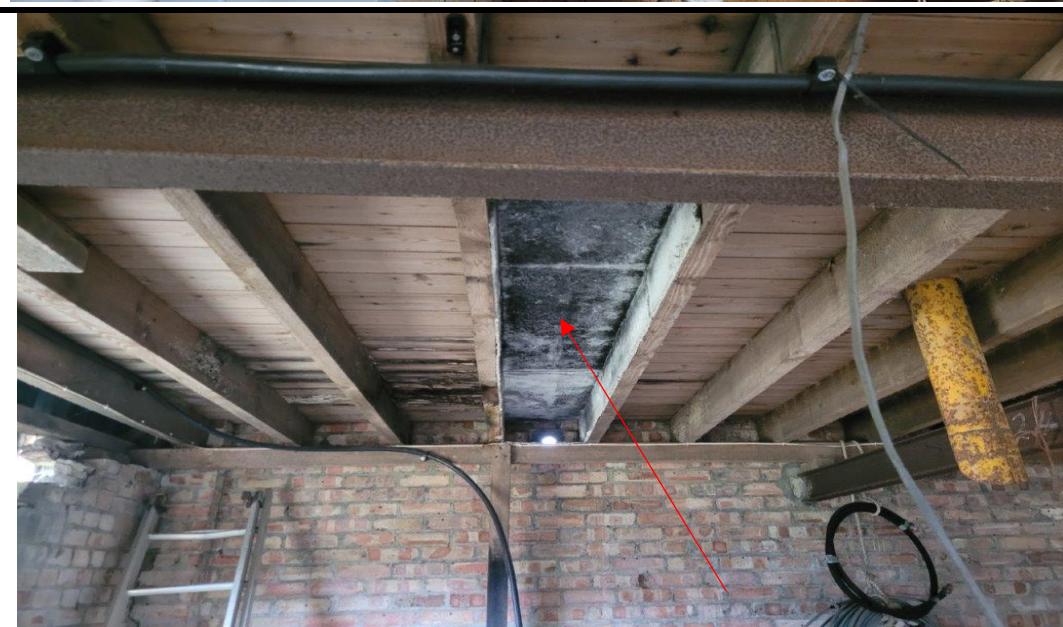
6.4.2 Asbestos millboard was identified to timber joists within Building D.

Photo Number:	8
Sample Number:	7
Material Type:	Millboard
Level of Identification:	Identified
Location / Description:	Handcross Road Site - Building D - Board to ceiling joists

- 8.2 The asbestos millboard was in fair condition and could remain in-situ but will require encapsulation. However if the material is likely to be disturbed it should be removed under fully controlled conditions by a licensed asbestos removal contractor. A 14 day notification to the relevant enforcement agency will be required prior to these works commencing. The Control of Asbestos Regulations (2012) and the Hazardous Waste Regulations (2005) must be adhered to.

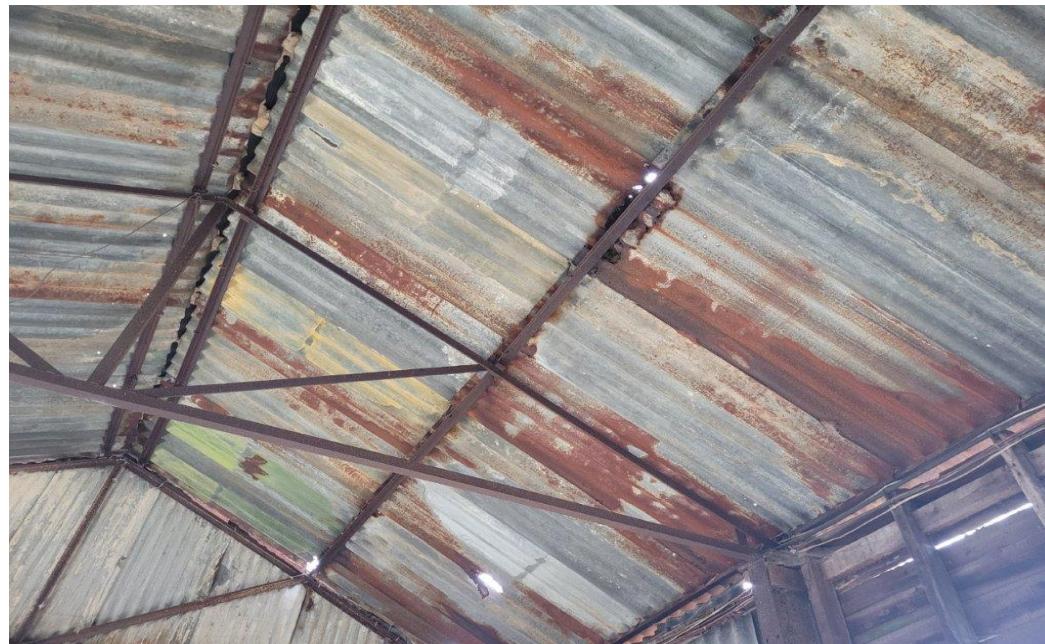
Photo Number:	9
Sample Number:	8
Material Type:	Bitumen felt
Level of Identification:	Asbestos not detected
Location / Description:	Handcross Road Site - Building D - Patch to metal roof

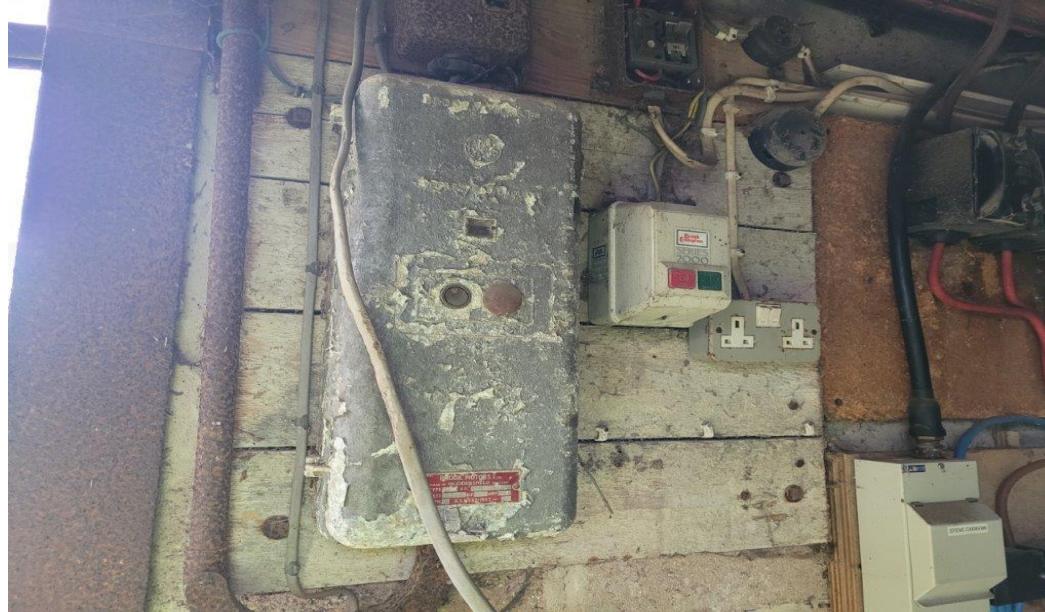
6.4.4 The mains electric units with Building D were presumed to contain asbestos textile flash guards.

Photo Number:	10
Sample Number:	
Material Type:	Textile
Level of Identification:	Presumed
Location / Description:	Handcross Road Site - Building D - Mains electric units - Flash guards

- 8.3 The asbestos textile flash guards were in good or fair condition. If these materials are likely to be significantly disturbed, they should be removed under controlled conditions and disposed of in accordance with Hazardous Waste Regulations (2005). This is not a licensed activity but the Control of Asbestos Regulations (2012) must still be adhered to. For further guidance on removal please see <http://www.hse.gov.uk/asbestos/essentials/>.

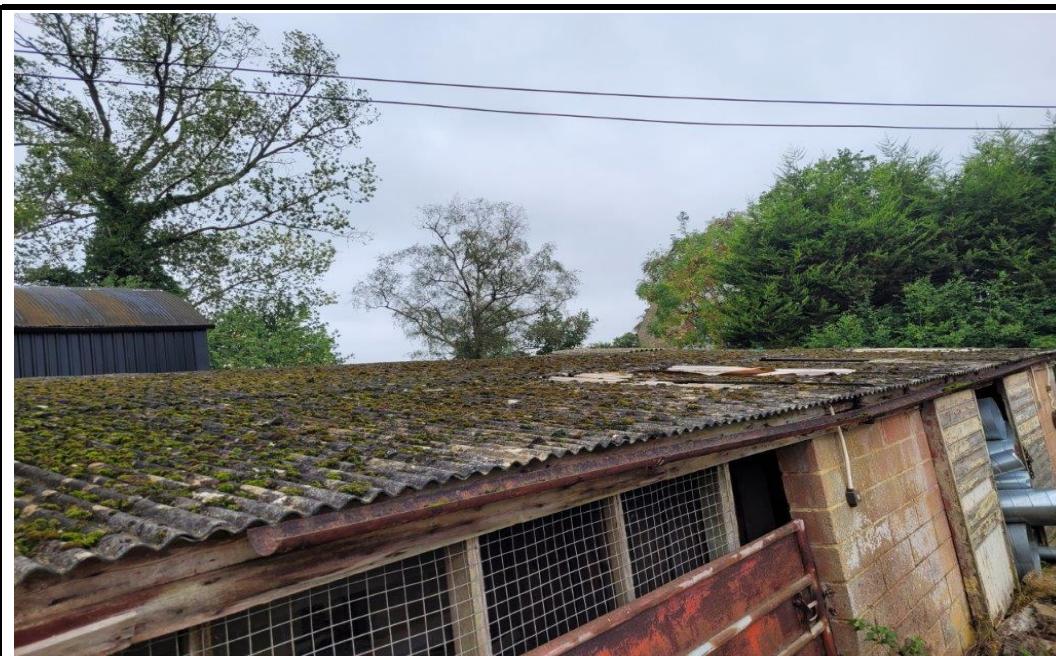
6.4.3 Corrugated asbestos cement roof sheets were identified to Building D.

Photo Number:	11
Sample Number:	9
Material Type:	Cement
Level of Identification:	Identified
Location / Description:

Handcross Road Site - Building D - Roof sheets

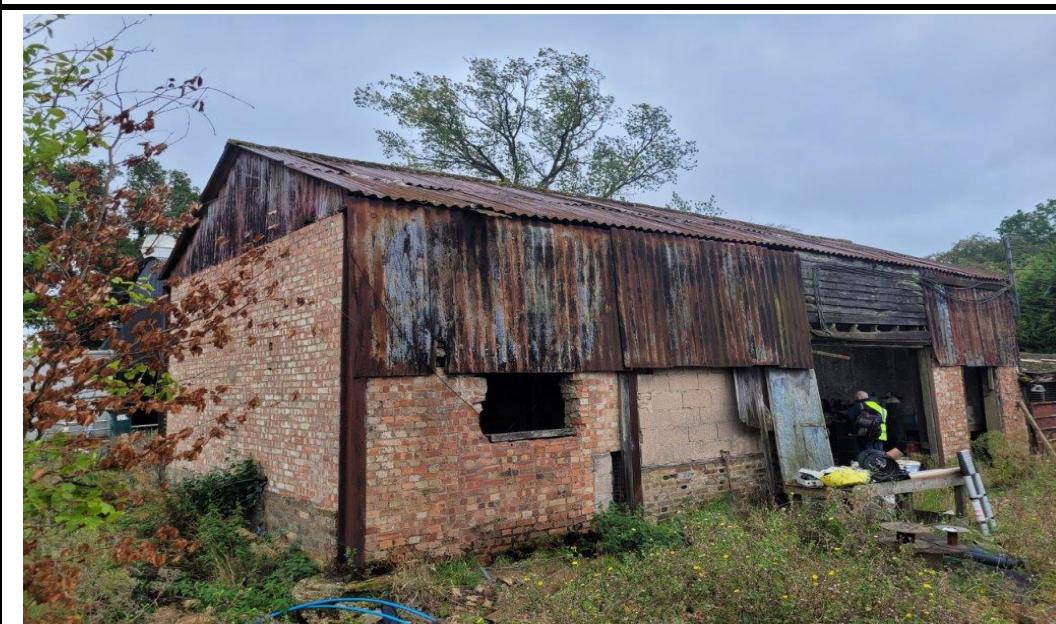
Photo Number:	12
Sample Number:	10
Material Type:	Bitumen
Level of Identification:	Asbestos not detected
Location / Description:

Handcross Road Site - Building D - Coating to metal roof

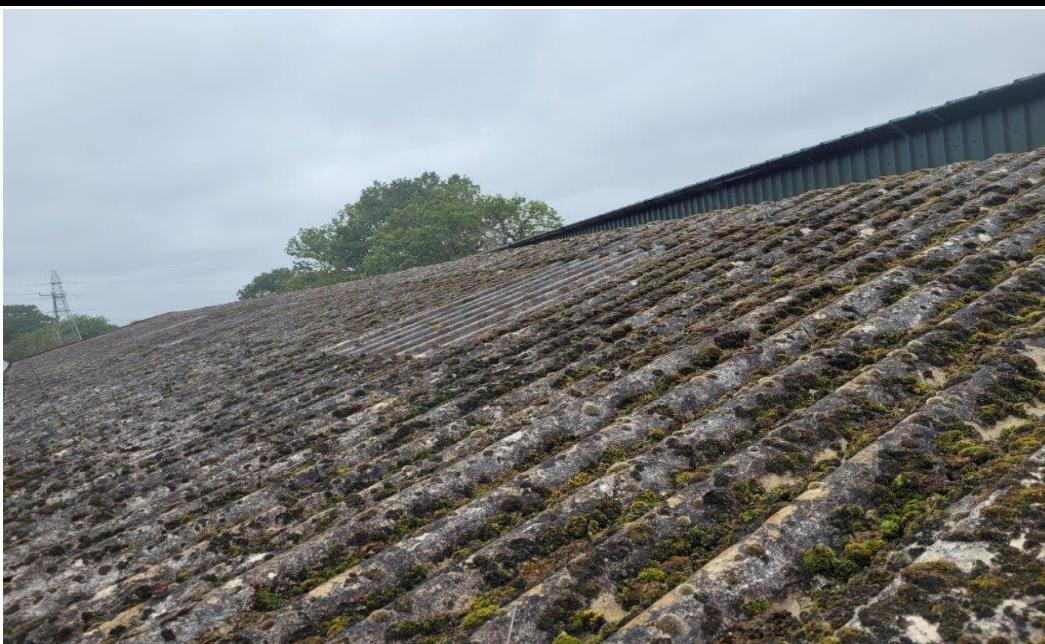
6.4.5 Corrugated asbestos cement roof sheets, asbestos cement fascia's and asbestos cement rainwater goods were identified to Building E.

Photo Number:	13
Sample Number:	11
Material Type:	Cement
Level of Identification:	Identified
Location / Description:	Handcross Road Site - Building E - Roof sheets / fascia's

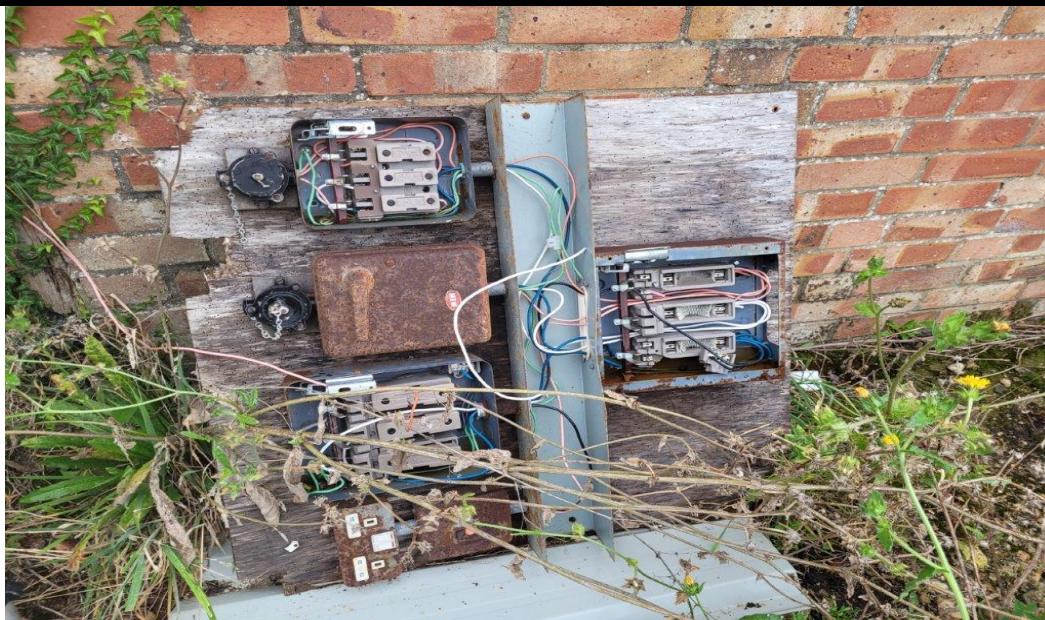
6.4.6 The mains electric units with Building E were found to contain asbestos textile flash guards.

Photo Number:	14
Sample Number:	12
Material Type:	Textile
Level of Identification:	Identified
Location / Description:	Handcross Road Site - Building E - Redundant electrical units - Flash guards

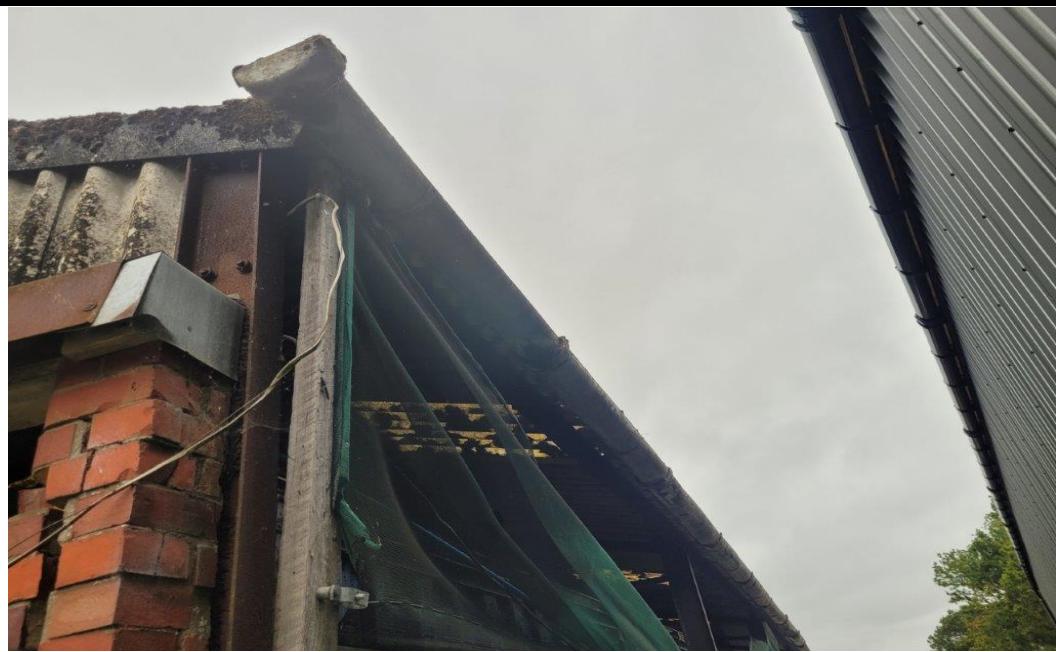
Photo Number:	15
Sample Number:	As 11
Material Type:	Cement
Level of Identification:	Visually identified
Location / Description:	Handcross Road Site - Building E - Rainwater goods

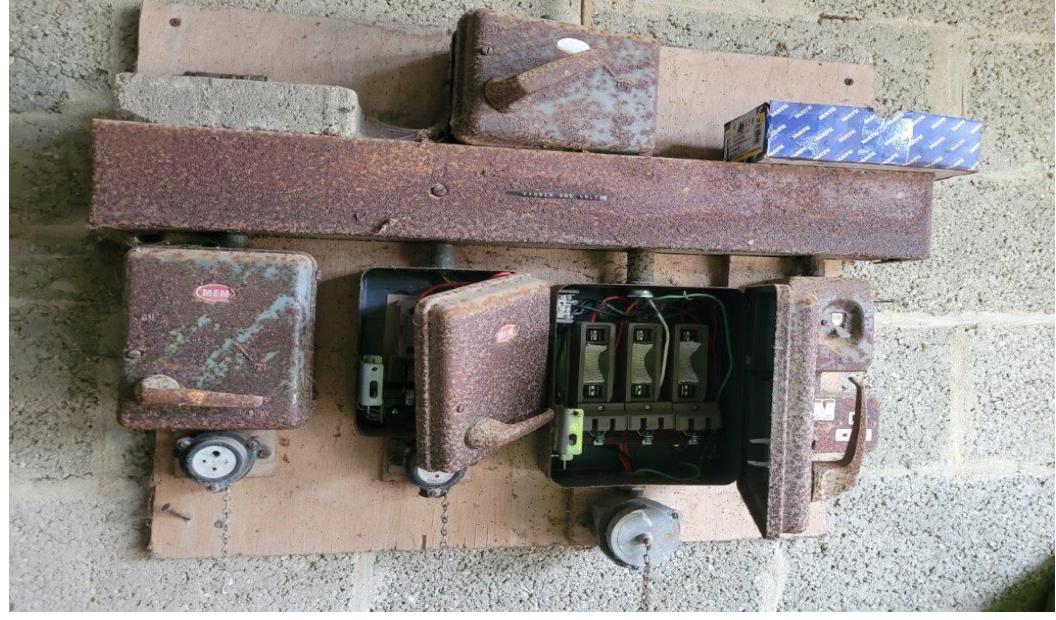
Photo Number:	16
Sample Number:	
Material Type:	Textile
Level of Identification:	Visually identified
Location / Description:	Handcross Road Site - Building E - Electrical units - Flash guards

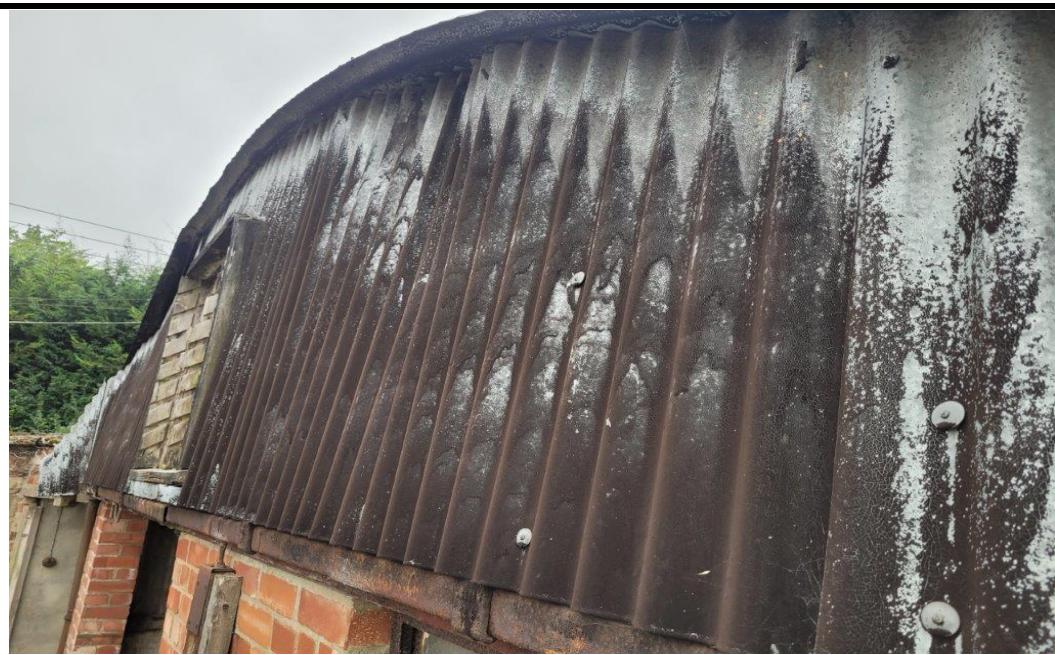
Photo Number:	17
Sample Number:	13
Material Type:	Bitumen
Level of Identification:	Asbestos not detected
Location / Description:	
Handcross Road Site - Building E - Coating to metal roof

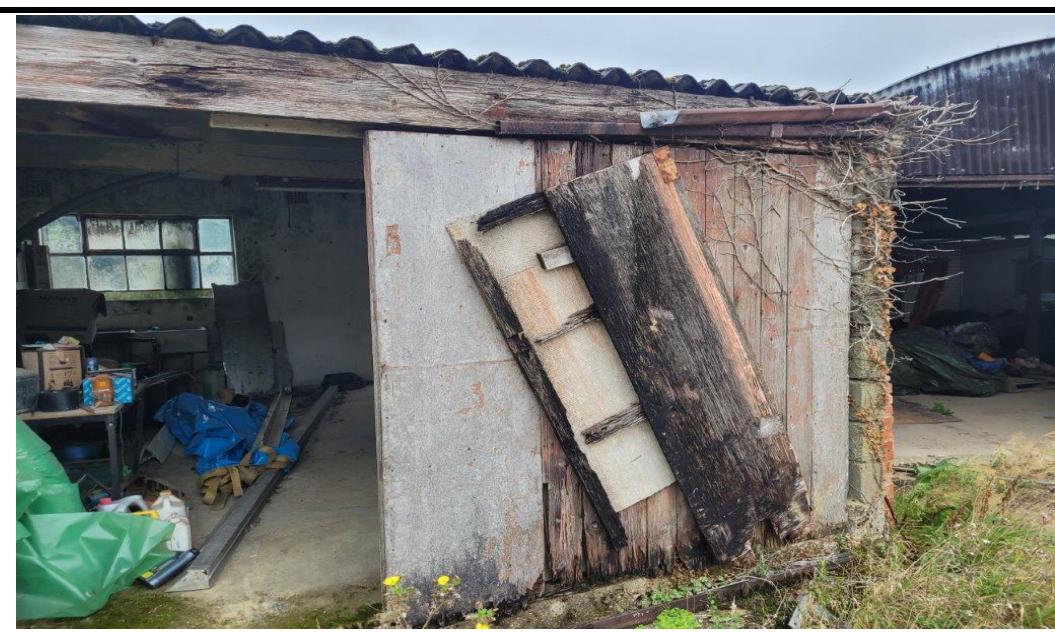
6.4.7 Asbestos cement ceilings, corrugated asbestos cement roofs sheets and asbestos cement door panels were identified within Building F.

Photo Number:	18
Sample Number:	14
Material Type:	Cement
Level of Identification:	Identified
Location / Description:	
Handcross Road Site - Building F - Door panels

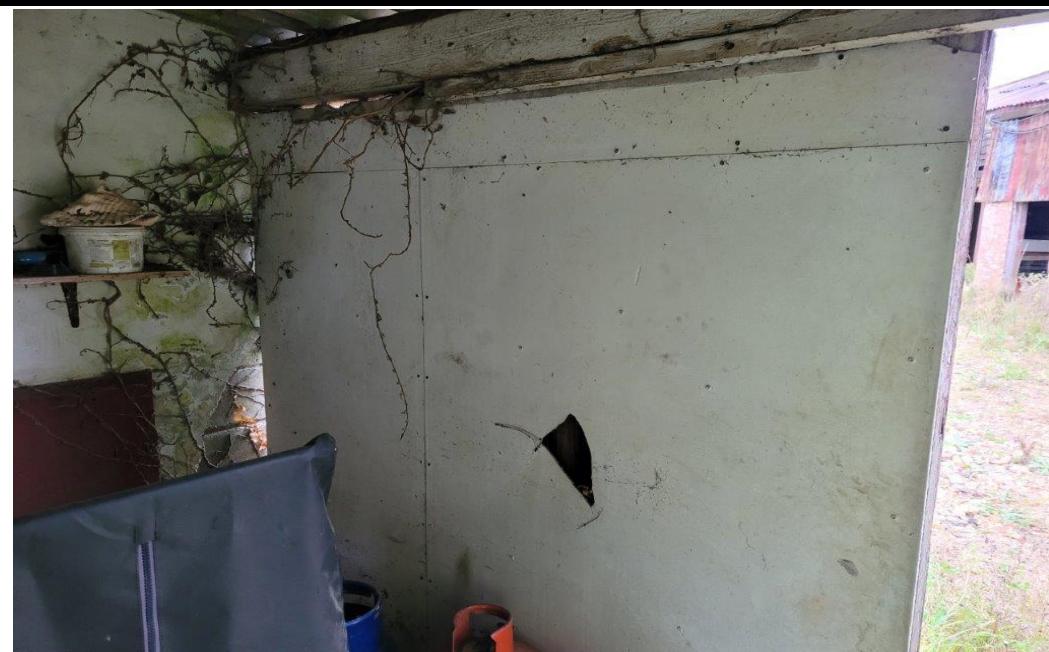
Photo Number:	19
Sample Number:	
Material Type:	Cement
Level of Identification:	Identified
Location / Description:	
Handcross Road Site - Building F - Door panels

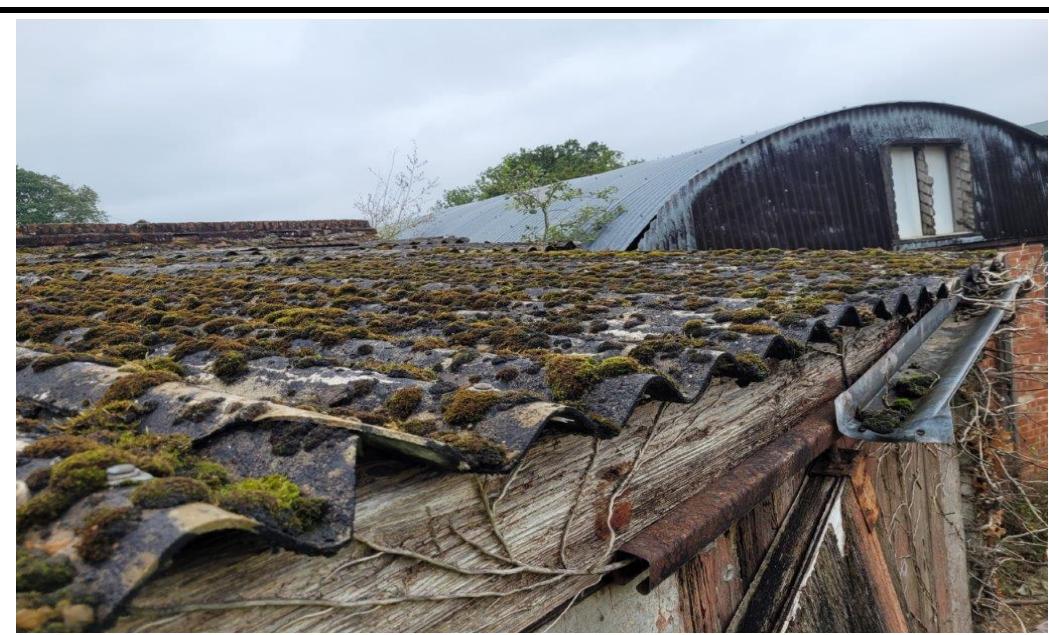
Photo Number:	20
Sample Number:	15
Material Type:	Cement
Level of Identification:	Identified
Location / Description:	
Handcross Road Site - Building F - Roof sheets

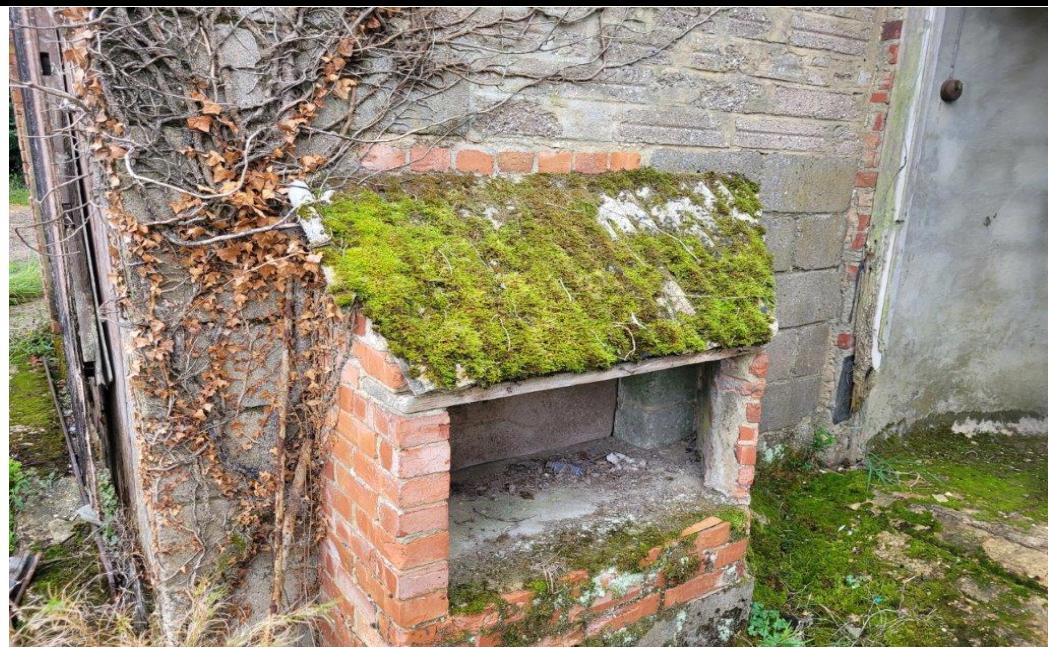
Photo Number:	21
Sample Number:	As 15
Material Type:	Cement
Level of Identification:	Identified
Location / Description:	
Handcross Road Site - Building F - Lean too - Roof sheets

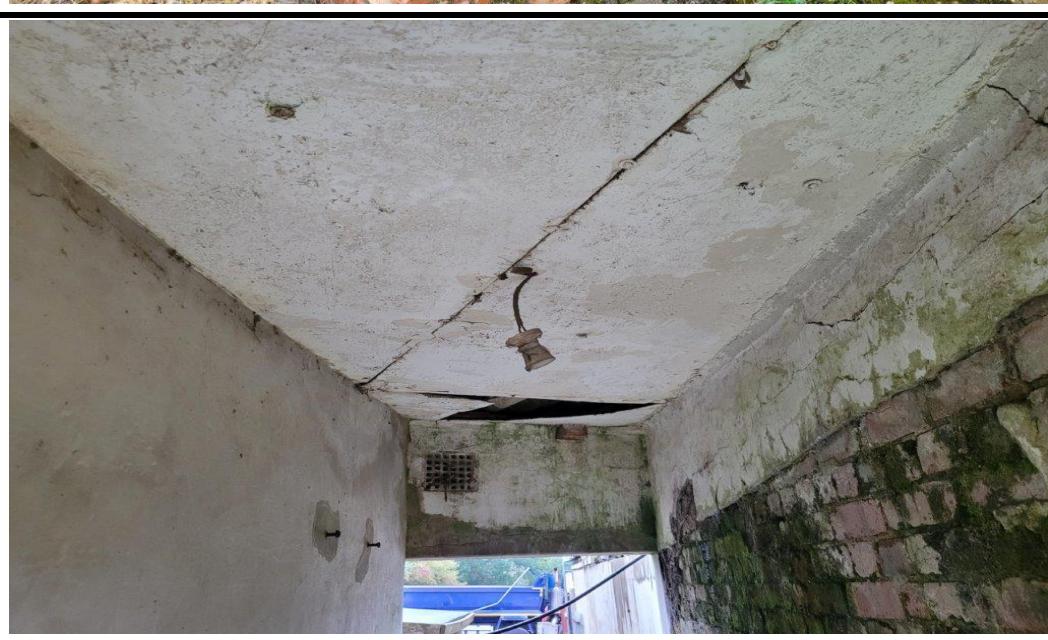
Photo Number:	22
Sample Number:	16
Material Type:	Cement
Level of Identification:	Identified
Location / Description:	
Handcross Road Site - Building F - Passage way - Ceilings

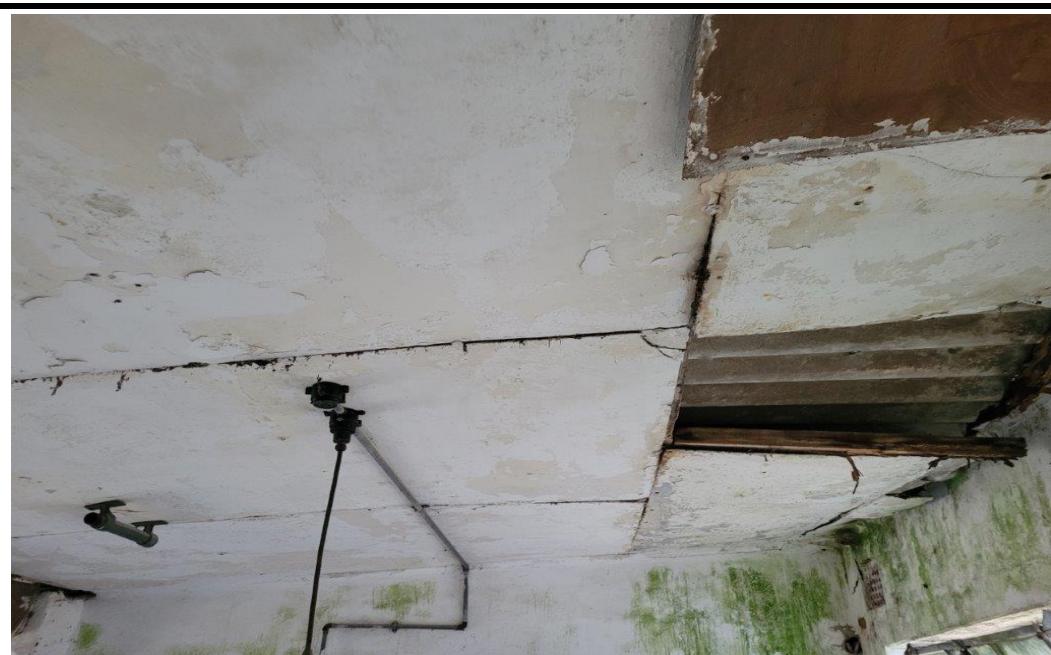
Photo Number:	23
Sample Number:	17
Material Type:	Cement
Level of Identification:	Identified
Location / Description:	Handcross Road Site - Building F - Ceilings

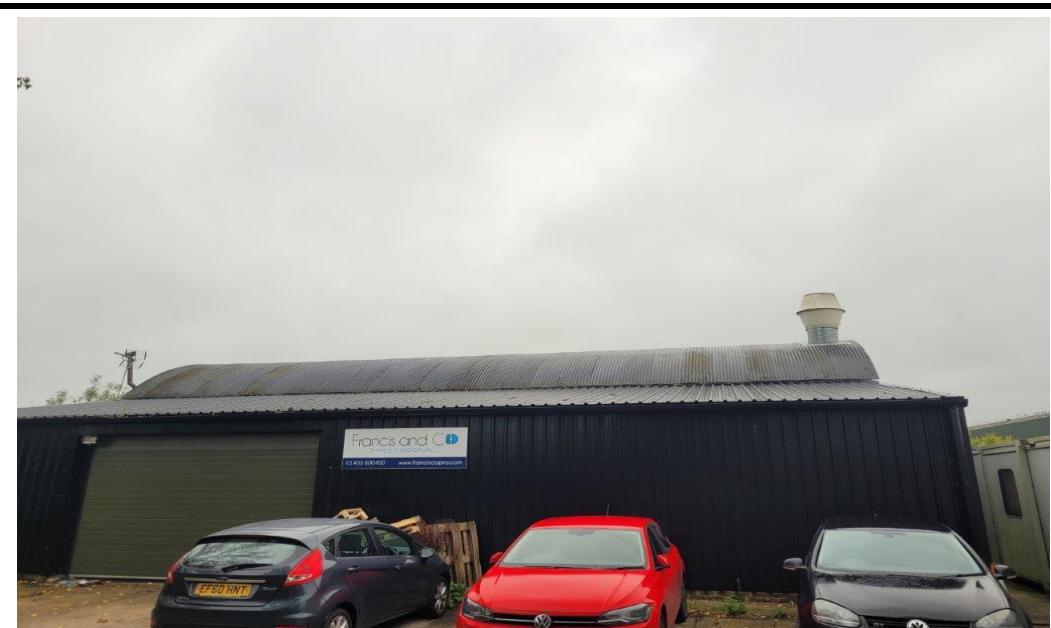
7.2.2 Access to the roof of Building G was not possible due to no safe access. See 8.5

Photo Number:	24
Sample Number:	
Material Type:	
Level of Identification:	Not accessible
Location / Description:	Handcross Road Site - Building G - Roof

- 8.5 The corrugated metal roof was not accessible as this was above safe ladder access height. The roof appears to have a bitumen coating which will require testing prior to any disturbance.
