Ref: 24/402

Toat Farm Barn, Itchingfield, West Sussex RH13 0PB

The purpose of my survey was to give advice on the condition of the timber framed barn and adjacent car port. It is proposed that these buildings be converted to a residential unit although details of the new dwelling are not yet available.

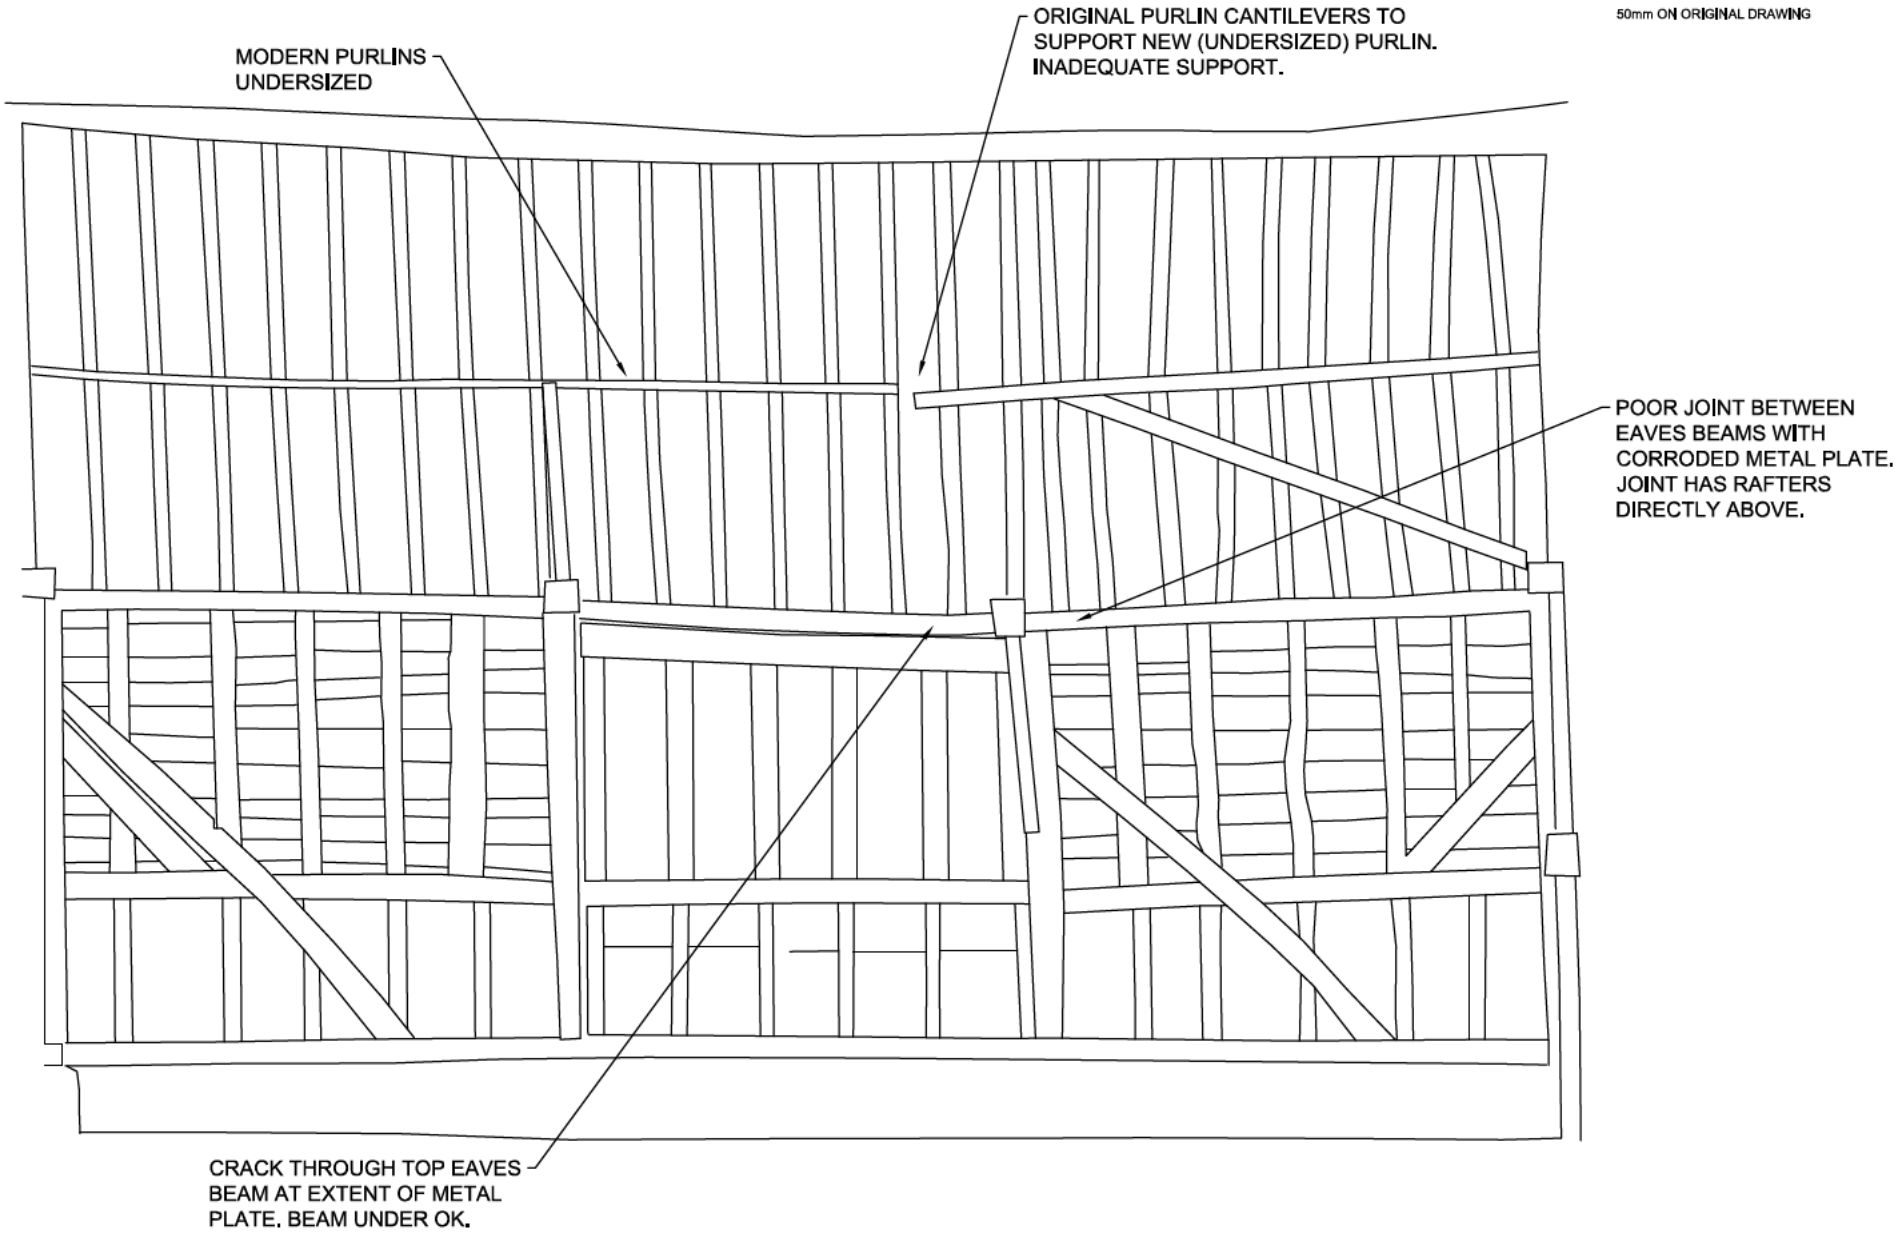
DRAWING TITLE
**INTERNAL REAR ELEVATION
 (SOUTH WEST)**

MODERN PURLINS
UNDERSIZED

ORIGINAL PURLIN CANTILEVERS TO
SUPPORT NEW (UNDERSIZED) PURLIN.
INADEQUATE SUPPORT.

POOR JOINT BETWEEN
EAVES BEAMS WITH
CORRODED METAL PLATE.
JOINT HAS RAFTERS
DIRECTLY ABOVE.

CRACK THROUGH TOP EAVES
BEAM AT EXTENT OF METAL
PLATE. BEAM UNDER OK.

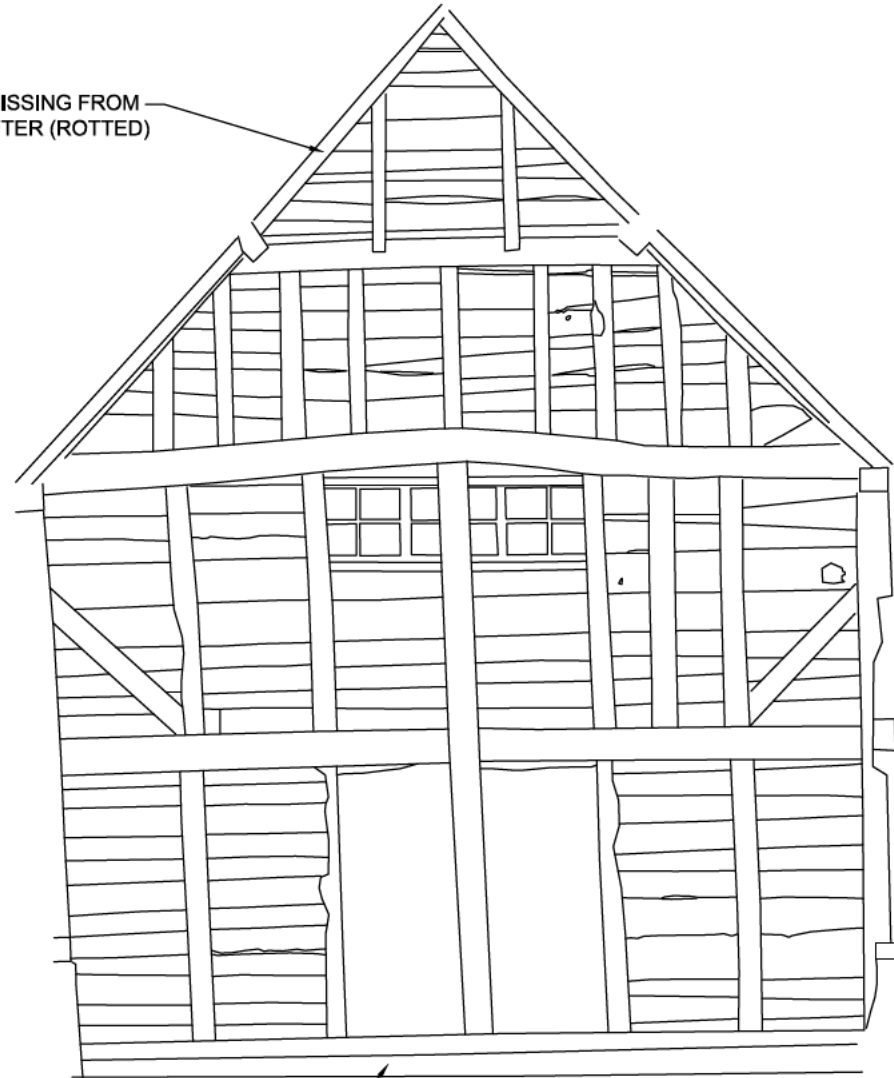
DRAWING TITLE
**INTERNAL RIGHT ELEVATION
 (NORTH WEST)**

- At the right side gable, studs and plate have suffered loss with repairs being infill mortar. Timber repairs should replace the mortar.
- Where new purlins have been installed these are obviously undersized.
- Older purlins from the right side bay cantilever, but provide poor support to new centre bay purlins.
- At the right side gable, the gable end rafter member has suffered from section loss.

SECTION MISSING FROM
GABLE RAFTER (ROTTED)

POSTS AND PLATE (AT SLAB LEVEL) HAVE BEEN
REPAIRED WITH MORTAR / CONCRETE.
