## Report on a Structural Inspection 11<sup>th</sup> October 2025

**Proposed conversion  
of existing stables to a dwelling at  
Oaklands Stud, Forest Grange,  
Horsham. RH13 6HX**

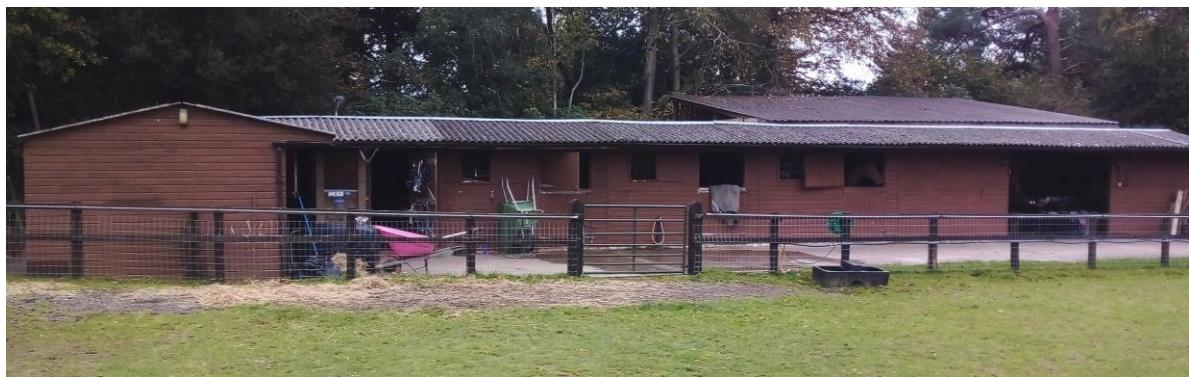
## General view of the stables

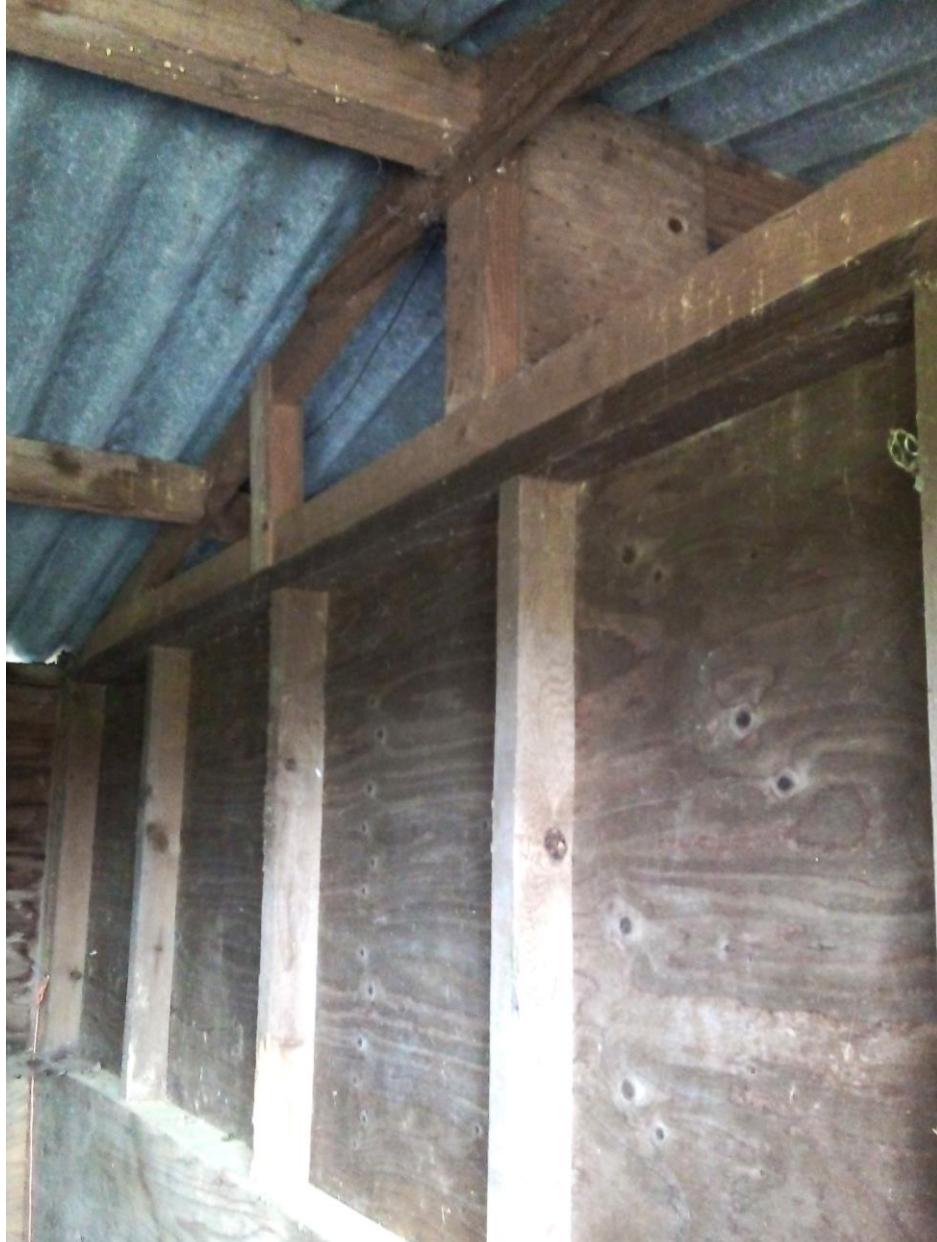
**General internal view of roof structure** - showing the internal partitions and purlins.

**Roof structure.** The existing roof structures has no signs of deformation. The timber purlins are sound

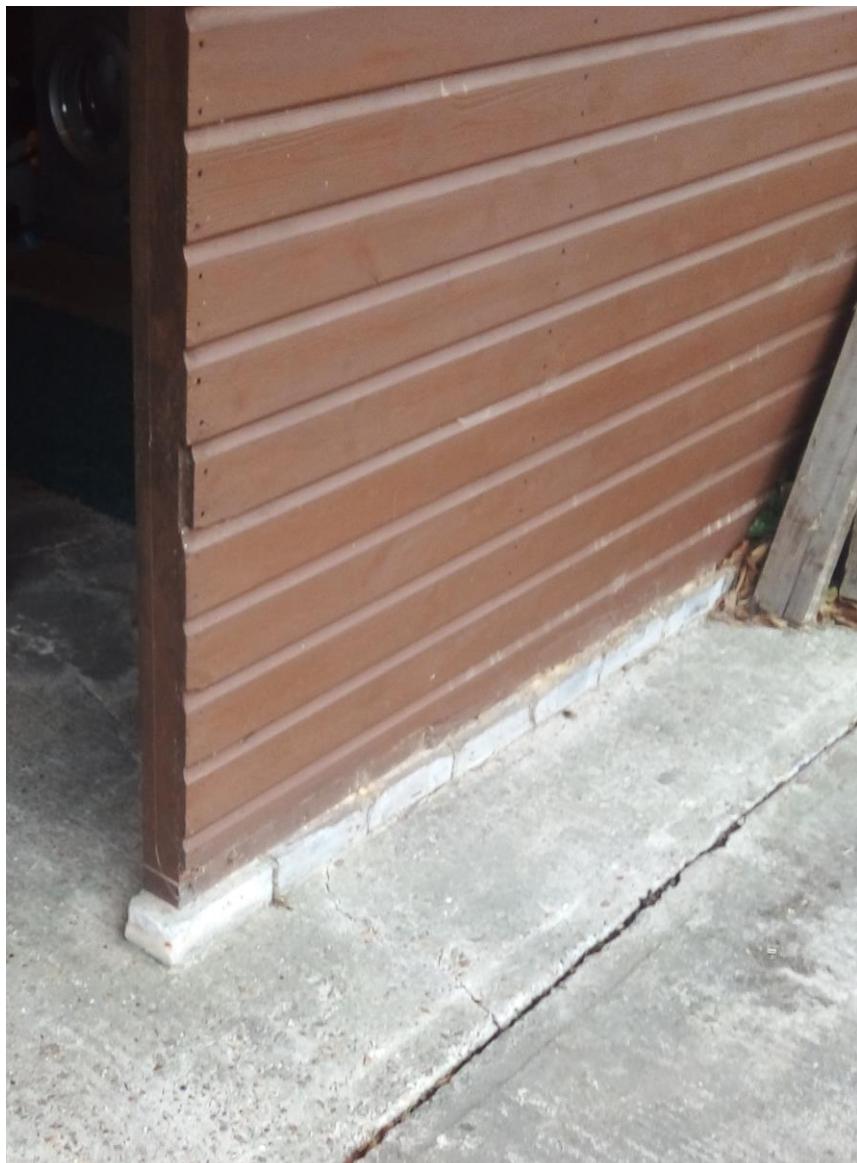
**Condition of the walls.** The timber framed walls were carefully inspected. The base of these walls is supported on bricks with ventilation to prevent rotting at the base. No major problems were found. The timber walls were sound and free of rot.

**This photograph shows the base of the timber wall with a brick course onto a solid concrete slab. All in good condition**

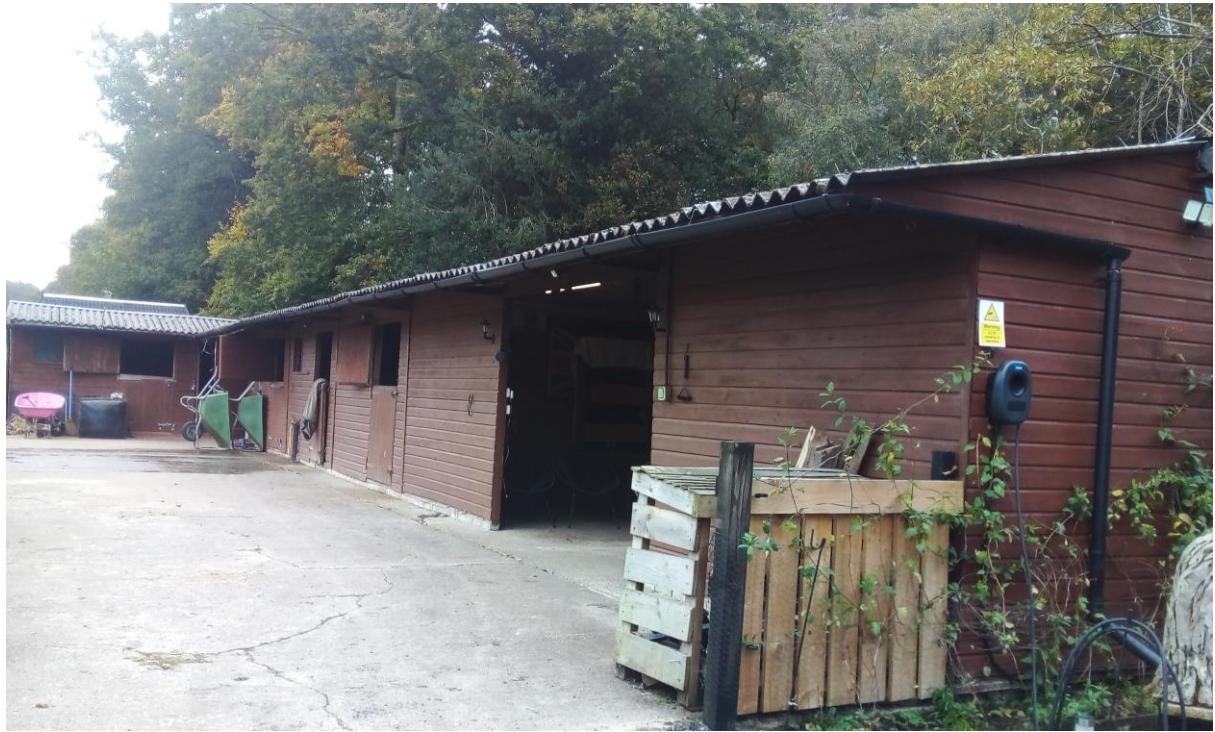
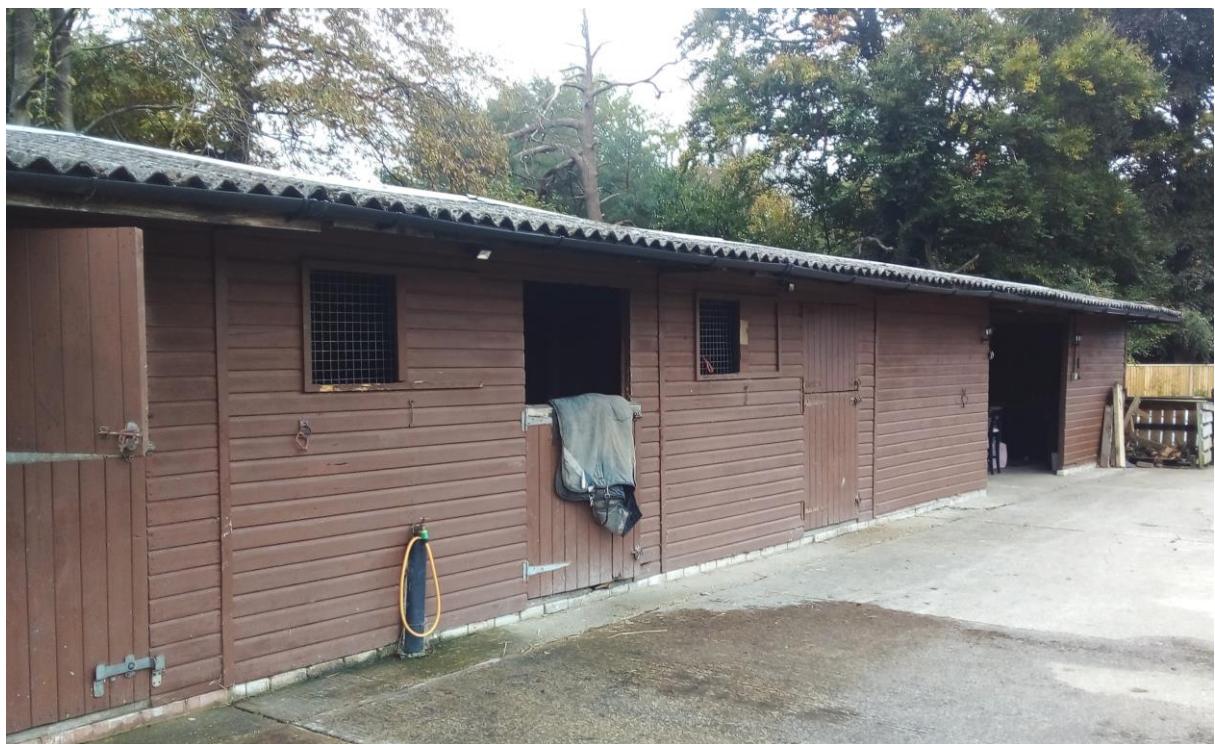
**Ground floor to the stables and the terrace** is a concrete slab. No serious cracking or deformation was found

**General views of stable units with concrete terrace slab**
