STRUCTURAL CONDITION REPORT – BUILDING 3, FORMER NOVARTIS SITE, HORSHAM

REPORT FOLLOWING Structural Investigation

At
The Former Novartis Site,
Horsham

PROJECT REFERENCE: 25.1774

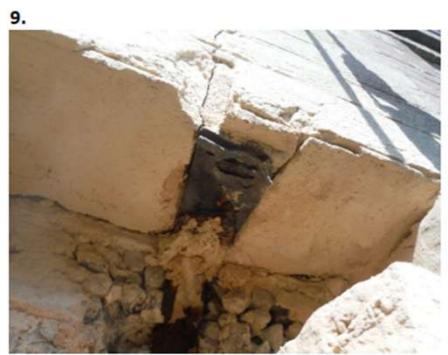
9. Corroded wall tie.

External brickwork cladding should be removed to allow removal of the wall ties and lintels to prevent further damage to the structure and to prevent potential collapse of the masonry outer leaf. New remedial stainless steel wall ties and lintels will be required.

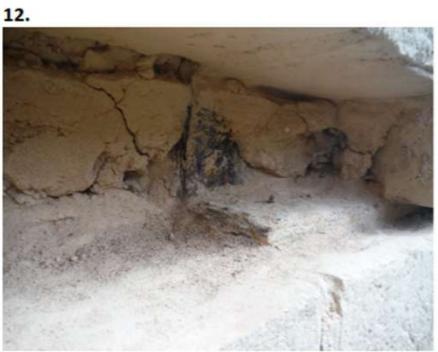
12. Corroded lintel over window.

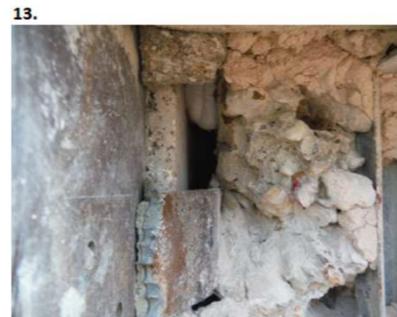
13. View of corroded bracket

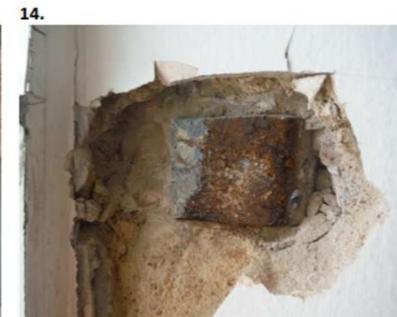
14. Corroded bracket in internal column.

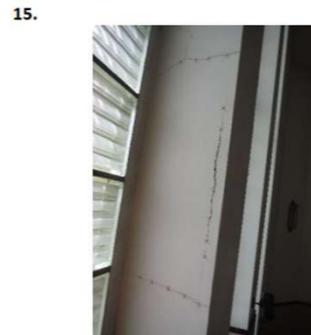
15. Cracking to internal column.

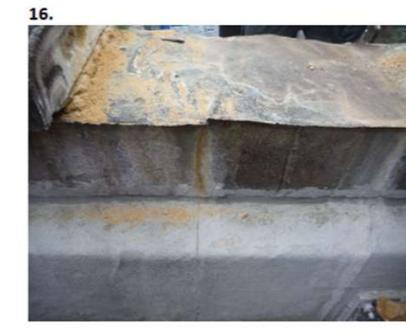
16. Removed coping stone.

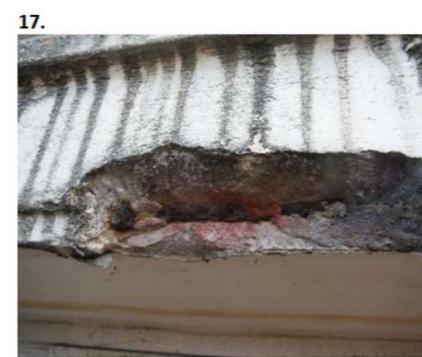
17. Spalling to lintel.

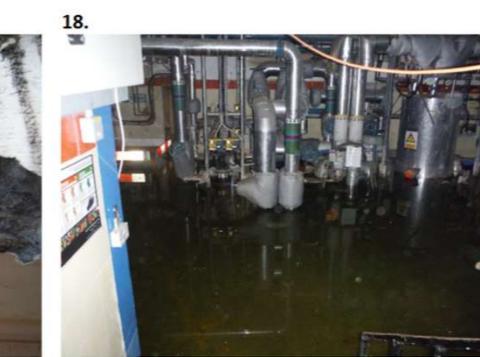
18. Flooded basement.

The basement of the building is now completely flooded, and this will need to be pumped out to allow a waterproofing system to be retrofitted. Suitable measures for draining of water should be provided and maintenance strategies will also be required to ensure the waterproofing system remains effective.
