### DRAINAGE CCTV REPORT

# CCTV survey report

**Project Name** – Novartis site Horsham - CCTV Survey

An investigative CCTV survey was carried out at Novartis site, Horsham in order to assist in the redevelopment of the site.

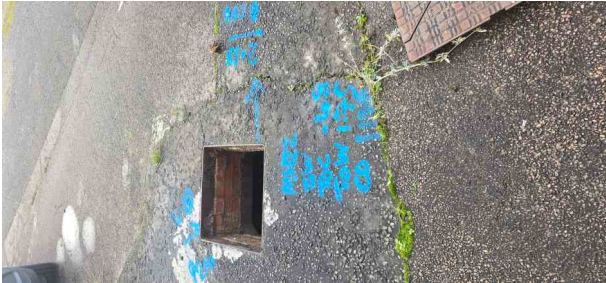
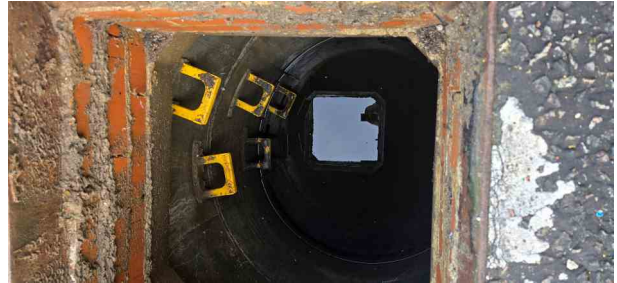
| Item No. | Inspection Direction | PLR | Client's Job Ref | Contractor's Job Ref |
|---|---|---|---|---|
| 1 | Downstream | MH22X | NOVARTIS SITE | NOVARTIS SITE |

MH22X\_85d67e76-ba9a-4451-bc9d-5637e654a12e\_20241125\_100811.jpg, 00:00:03, 0.00 m  
 General remark, LINE HOLDING, MH24 REQUIRES EMPTYING

MH22X\_36af7140-474c-43e1-a1e5-436e68e3ebf7\_20241125\_100827.jpg, 00:00:03, 0.00 m  
 General remark, LINE HOLDING, MH24 REQUIRES EMPTYING

| <b>Recommendations:</b> | INTERCEPTOR REQUIRES EMPTYING TO CLEAN | | | | |

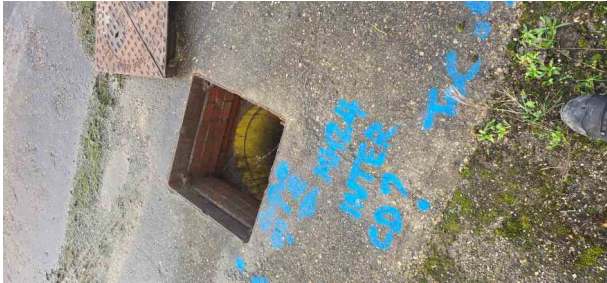
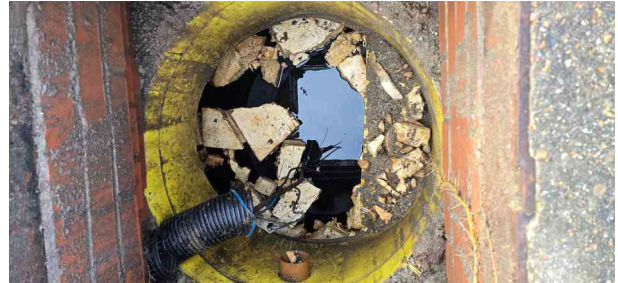
| Item No. | Inspection Direction | PLR | Client's Job Ref | Contractor's Job Ref |
|---|---|---|---|---|
| 2 | Upstream | MH23X | NOVARTIS SITE | NOVARTIS SITE |

MH23X\_1657776c-ee6a-4a16-afa8-c539fb257ac9\_20241125\_100929.jpg, 00:00:03, 0.00 m  
 General remark, INTERCEPTOR REQUIRES EMPTYING TO SURVEY

MH23X\_b2a02f52-d2a0-40f8-8de7-244e290f80c2\_20241125\_100934.jpg, 00:00:03, 0.00 m  
 General remark, INTERCEPTOR REQUIRES EMPTYING TO SURVEY

| <b>Recommendations:</b> | REQUIRES SUCKING OUT TO EMPTY | | | | |

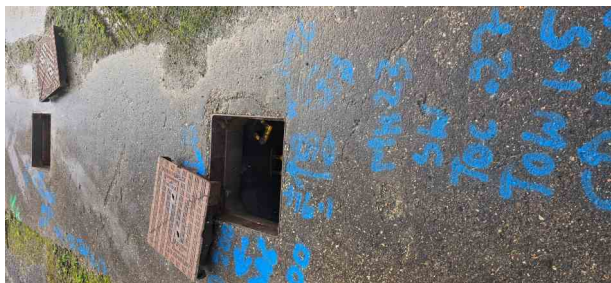
| Item No. | Inspection Direction | PLR | Client's Job Ref | Contractor's Job Ref |
|---|---|---|---|---|
| 2 | Downstream | MH23X | NOVARTIS SITE | NOVARTIS SITE |

MH23X\_7e7af6c9-528c-478b-9e05-63c4d5869097\_20241125\_100835.jpg, 00:00:03, 0.00 m  
 General remark, INTERCEPTOR MH24 REQUIRES EMPTYING TO SURVEY

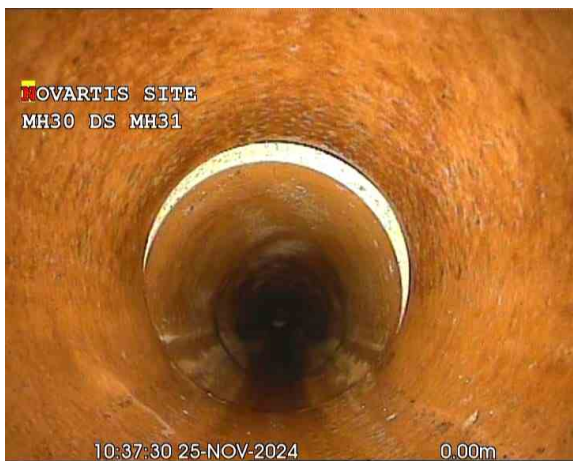
| Section | PLR | Grade | Description |
|---|---|---|---|
| 4 | MH30X | 4 | Joint displaced, large |

MH30X\_be1fa4e2-0bad-4938-8c7d-66491d64b79e\_20241125\_104944\_019.jpg, 00:00:10, 0.28 m  
Joint displaced, large

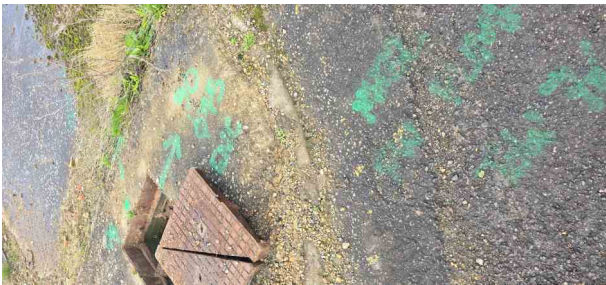
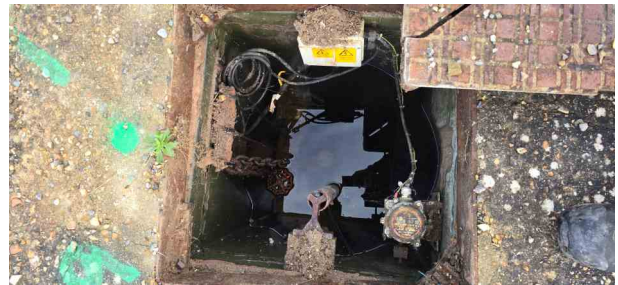
MH32X\_7bcfddd9-202f-4e2b-82db-48c6380e95e6\_20241125\_112750.jpg, 00:00:55, 14.78 m  
 Finish node, manhole, reference: MH32, PUMP IN CHAMBER, NOT WORKING

MH32X\_6476d4ac-80fb-4081-a5f3-cf29dca6fb3d\_20241125\_112757.jpg, 00:00:55, 14.78 m  
 Finish node, manhole, reference: MH32, PUMP IN CHAMBER, NOT WORKING

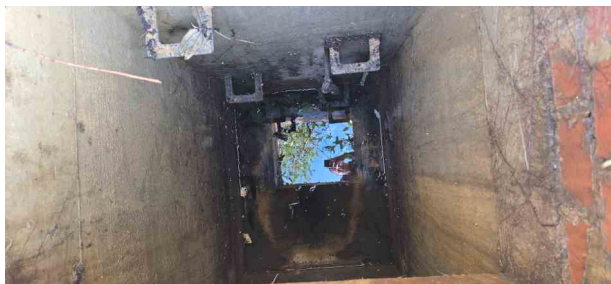
MH27X\_752d7050-5c7c-4b6d-8922-7f7d2ea637d2\_20241125\_113301.jpg, 00:00:03, 0.00 m  
 General remark, REQUIRES SUCKING OUT TO SURVEY

| <b>Recommendations:</b> | REQUIRES SUCKING OUT | | | | |

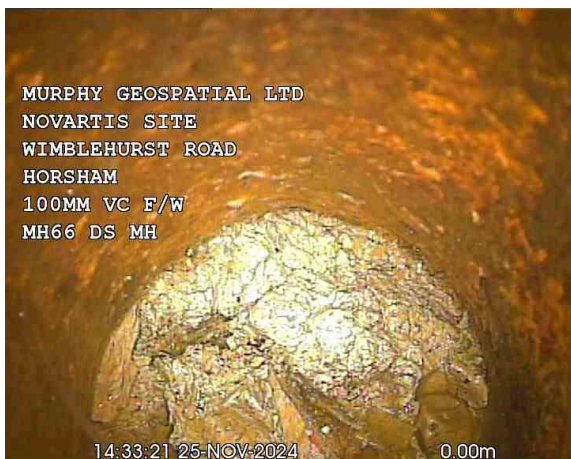
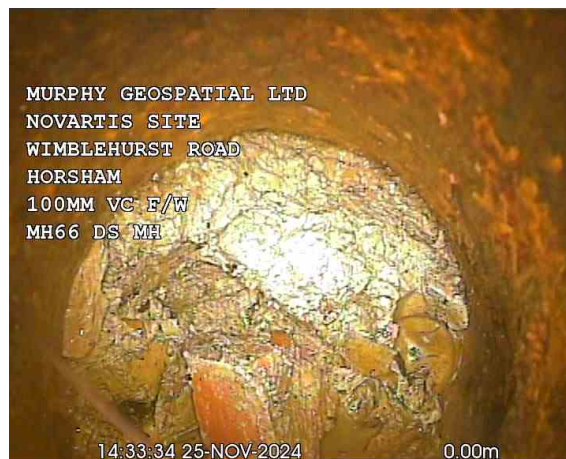
| Section | PLR | Grade | Description |
|---|---|---|---|
| 15 | MH66X | 5 | Collapsed drain or sewer, 100% cross-sectional area loss |

MH66X\_d5676fce-9e23-49c5-bd5e-e499d8c206ac\_20241125\_143652.jpg, 00:00:04, 0.00 m  
 General remark, LINE POSSIBLY COLAPSED

MH66X\_4c909935-10b8-4717-9372-7c1483778b32\_20241125\_143657.jpg, 00:00:04, 0.00 m  
 General remark, LINE POSSIBLY COLAPSED

| <b>Recommendations:</b> | LINE REQUIRES DIG UP TO REPAIR | | | | |
