Arboricultural Statement

Land to the west of Parsons
Field Stables, Pickhurst Lane,
Pulborough RH20 1DA

July 2025

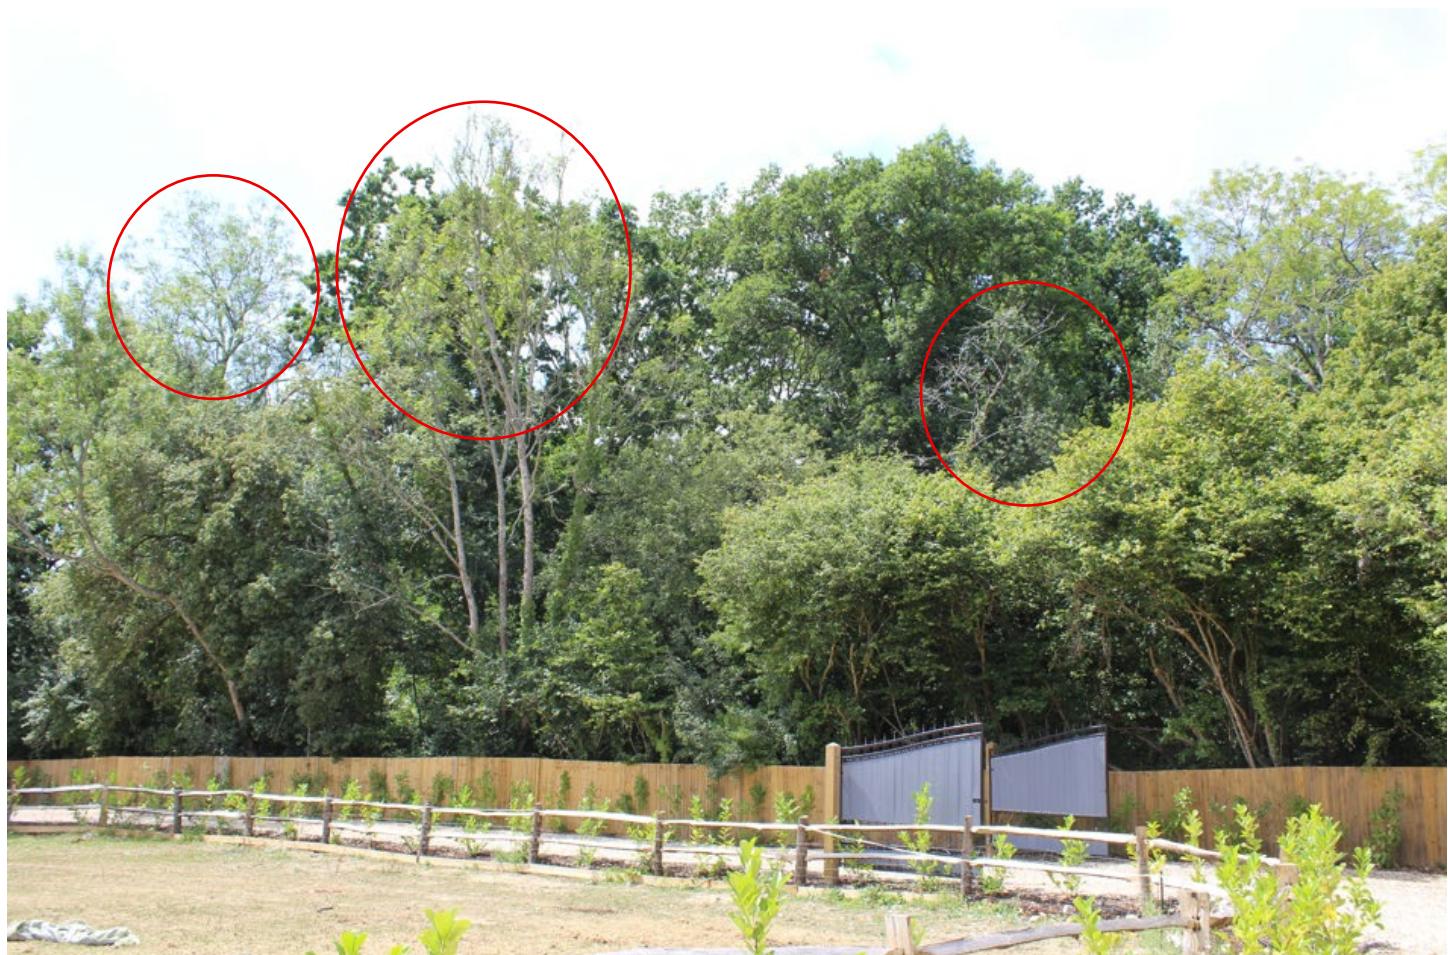
Fig. 1 – Image showing shrub layer & understorey of hazel, hawthorn, holly & field maple at the northern end of the site with mature oak and field maple in the background and ash showing symptoms of Chalara dieback circled in red.

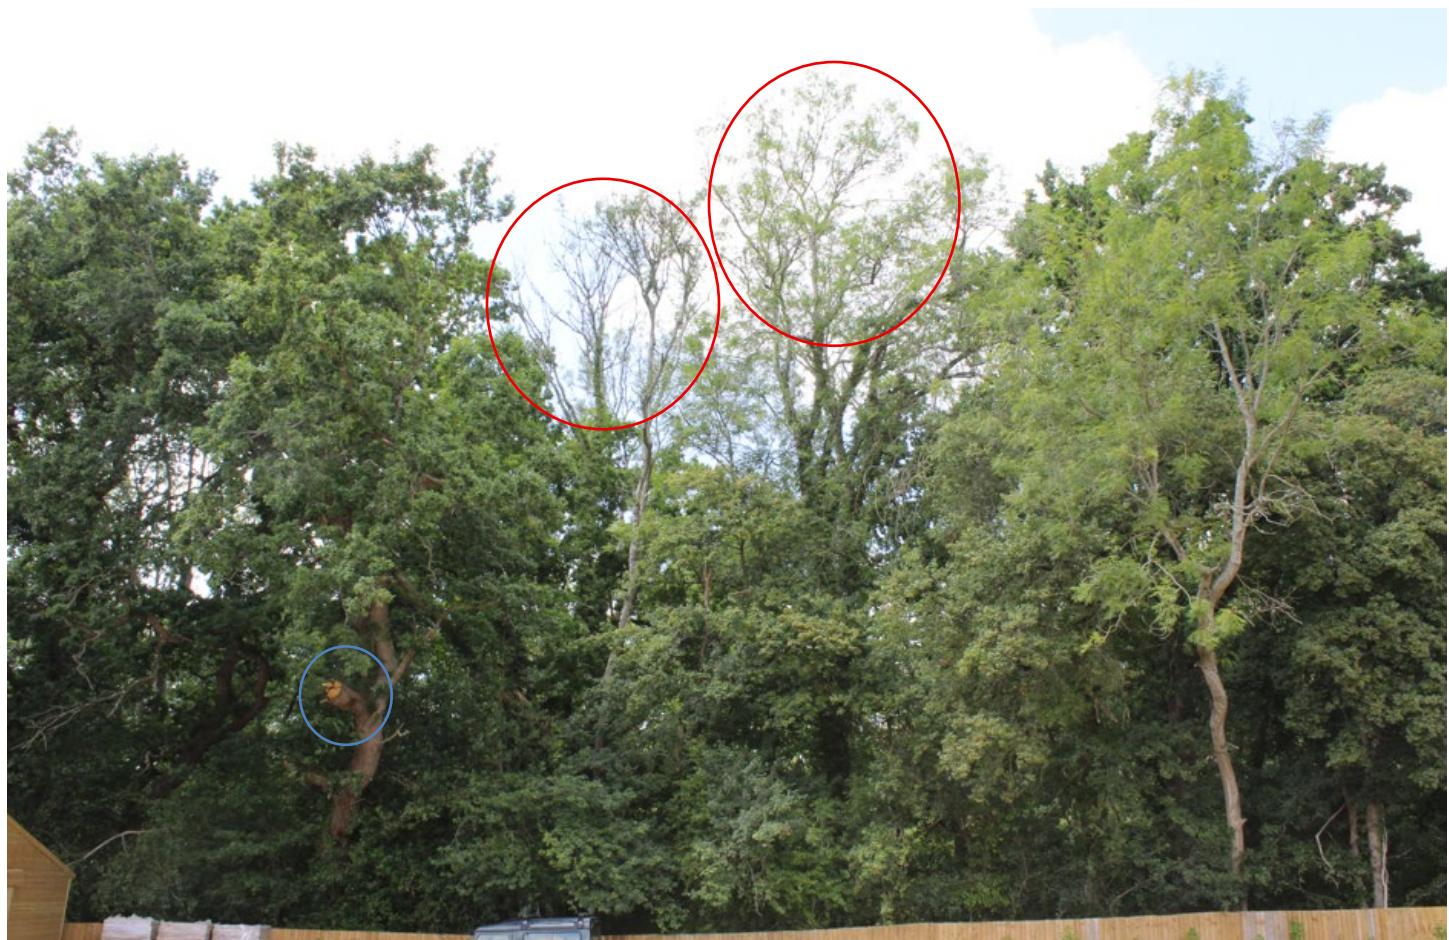
- There are no signs of decline at this point that can be attributed to the recently completed work;
- the dead oak where the west & south fences meet predates the change of site use;
- affected ash trees are showing typical symptoms of different stages of Chalara dieback of ash rather than from construction-related damage;
- the strip of woodland had standing dead trees, high volumes of deadwood, cavities, broken branches, tear-outs ivy-cover etc. that are typical & important features of woodlands and offer excellent habitat potential, however; dead & dying trees represent some risk to users of the track while the broken stem of the ash suspended in the crown of the English oak (T1) represents a greater risk to those on site now the use has changed;
- the branch stub on the English oak (T1) shows signs of fracture consistent with either Summer Branch Drop or whole branch removal.

Fig. 2 – Image showing shrub layer & understorey at the mid-point of the boundary with the branch stub on the English oak (T1) circled in blue and ash showing symptoms of Chalara dieback circled in red.

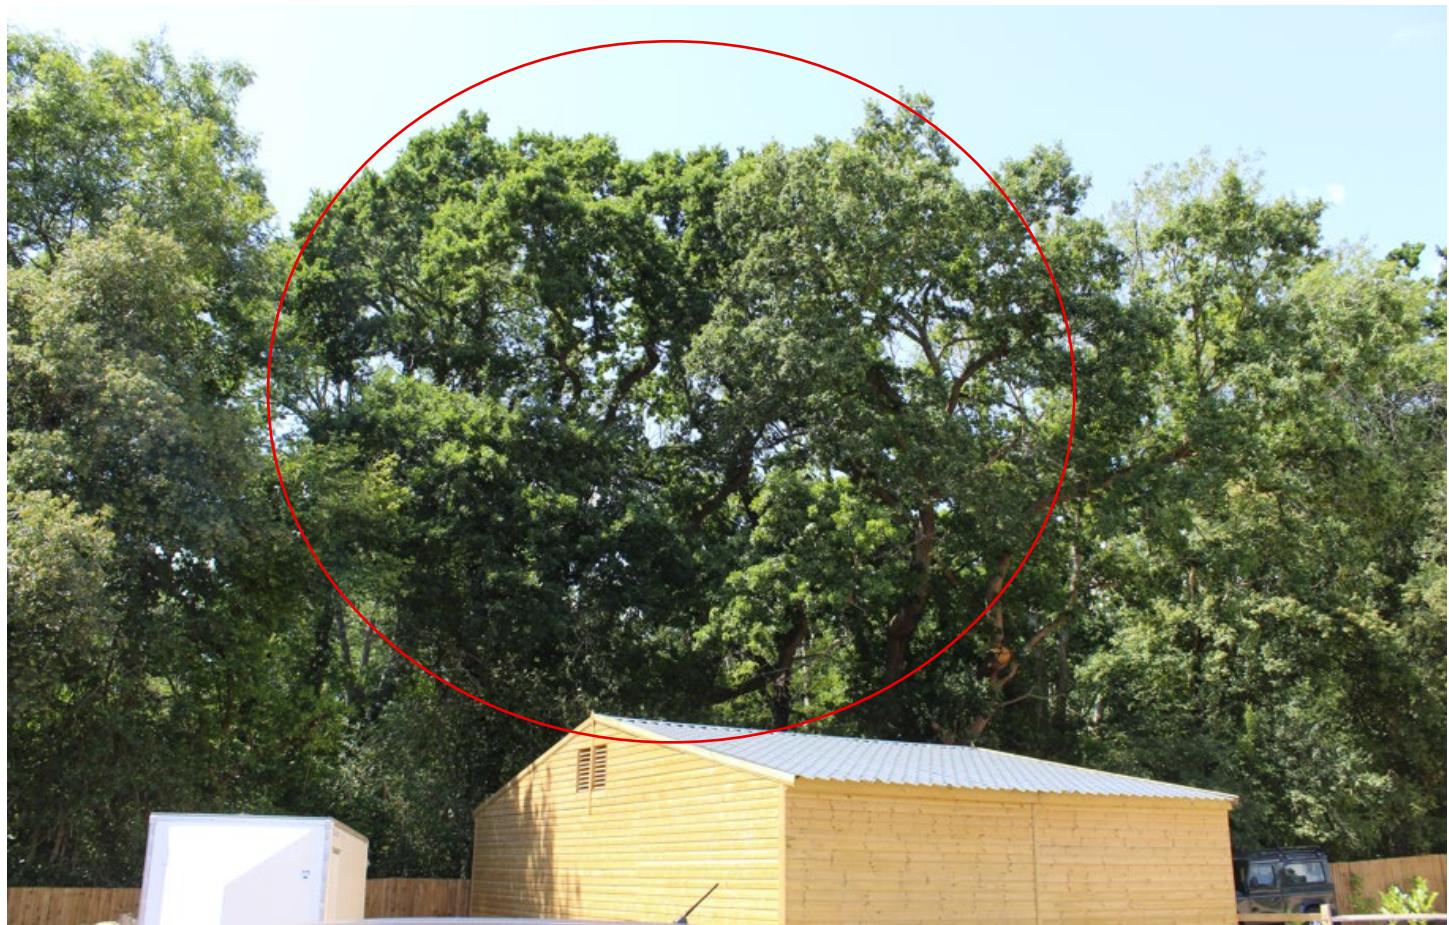
6.3 **New stable block** – the thin concrete pad foundation and loose aggregate sub-base for the stable block is located within the root protection area (RPA) of three mature English oaks. With the foundation above ground level I think it is unlikely that there has been any excavation or significant risk of direct root damage but again it is possible that compaction, impeded porosity and reduced oxygen levels will have an impact on long-term tree health. To determine the likely impact I recorded the stem diameter of the three trees to calculate their nominal RPA and concluded that the new stable block impacts directly on the RPA of T1 by around 9%, T2 by 8.5% and T3 by 13%.

- As with the access drive the foundation for the stable block is raised above ground level and I do not consider it likely there has been direct physical damage to roots during the installation;
- the thin concrete pad foundation and loose aggregate sub-base for the stable block foundation is not porous and will impede water infiltration and gaseous exchange with the potential to affect long-term tree health;
- the mature English oaks (T1-T3) are the closest mature trees to the stable block which impacts on their nominal RPA by around 9%, 8.5% & 13% respectively;
- with a fairly limited impact on the RPA the effects of the foundation may be negligible but again will only become apparent over time; the tree at greatest risk of long-term damage is the oak (T1) which is more likely to have been affected by both surfacing & foundation construction.

Fig. 3 – Image showing mature trees adjacent to the stable block with the English oaks (T1-T3) circled in red.

7.4 I recommend that an annual inspection, for the next five to ten years, is undertaken to assess tree condition and monitor possible decline of individual trees. Images at **Appendix 1** show the physiological condition of woodland edge trees on the 18th July 2025 and should form the basis for monitoring any decline. Tree losses attributable to the construction and landscape work should be replaced with appropriate native trees.

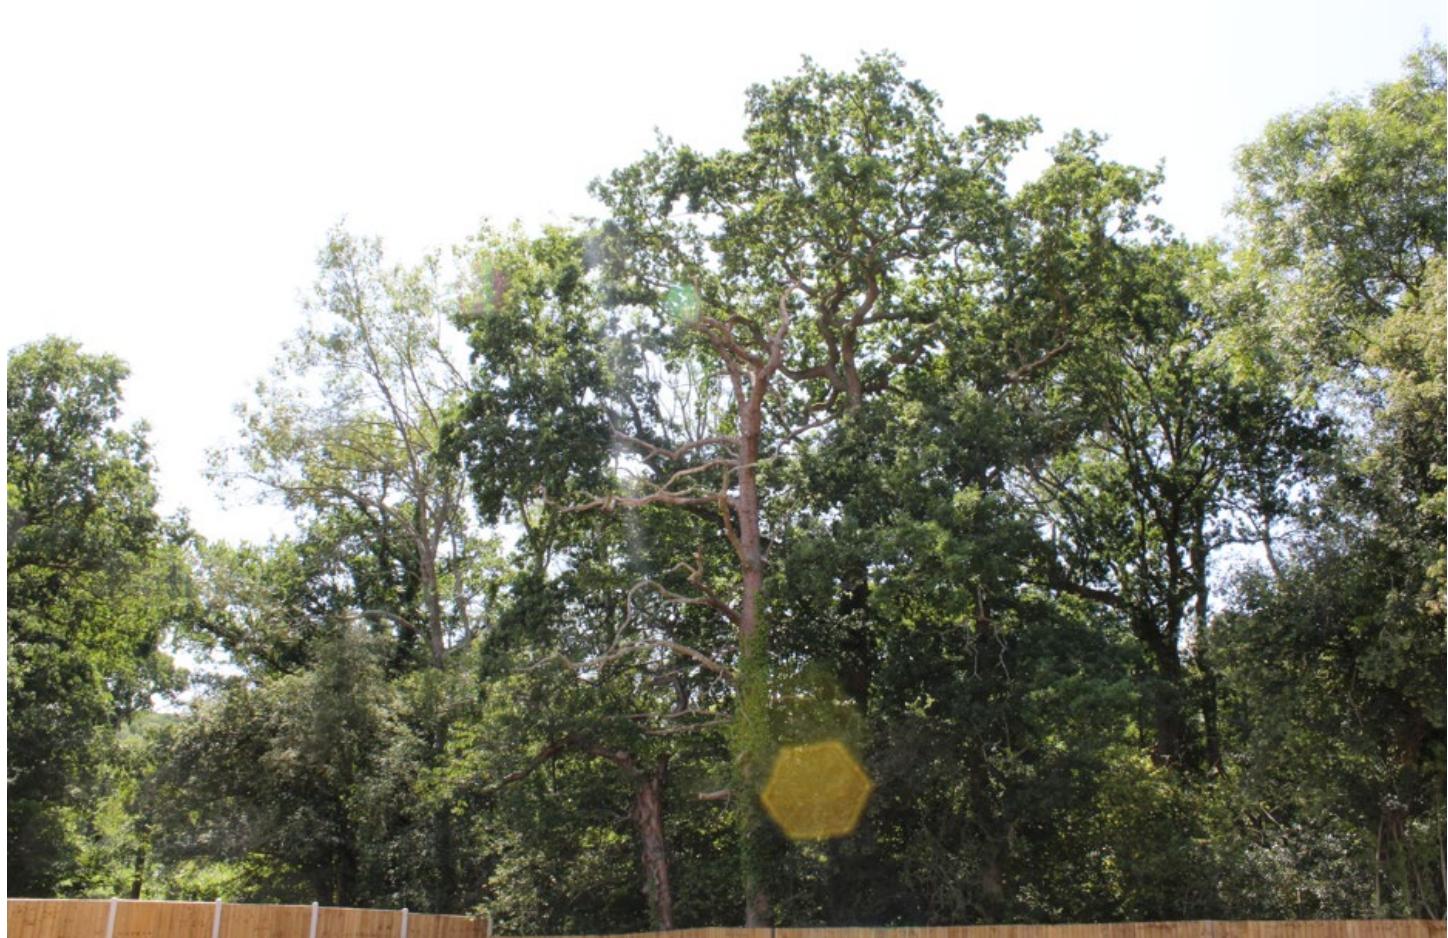
5.3 **Narrow strip of mixed woodland** – the strip of woodland on the western boundary, between the site and the track, is fairly narrow at the northern end where it meets Pickhurst Lane and gradually widens as the track slopes down to the bridge and culvert. The dominant trees were mature English oak, ash & field maple with an understorey of establishing field maple, hawthorn, hazel, holly and a shrub layer of natural regeneration in a woodland floor of bramble & ivy-cover. The mature trees were well-established with typical levels of deadwood and ivy-cover extending up into some of the crowns. The larger trees had stem diameters of around 450mm-750mm and would be considered BS5837 Category B with understorey trees classed as Category C based on stem diameters alone. Several of the ash were showing symptoms of Chalara dieback of ash - from early stage colonisation to entirely dead trees. A three-stemmed ash midway along the boundary had a broken stem hung up in the crown of the English oak (T1) and fungal brackets of *Inonotus hispidus* below a woodpecker hole at around 4m. The English oak (T1) had the remains of a broken branch stub at around 6m to the east and there was an entirely dead oak in the strip of woodland where the west and south boundary fences meet.

Fig. 4 – Image showing dead English oak where the west & south fences meet.

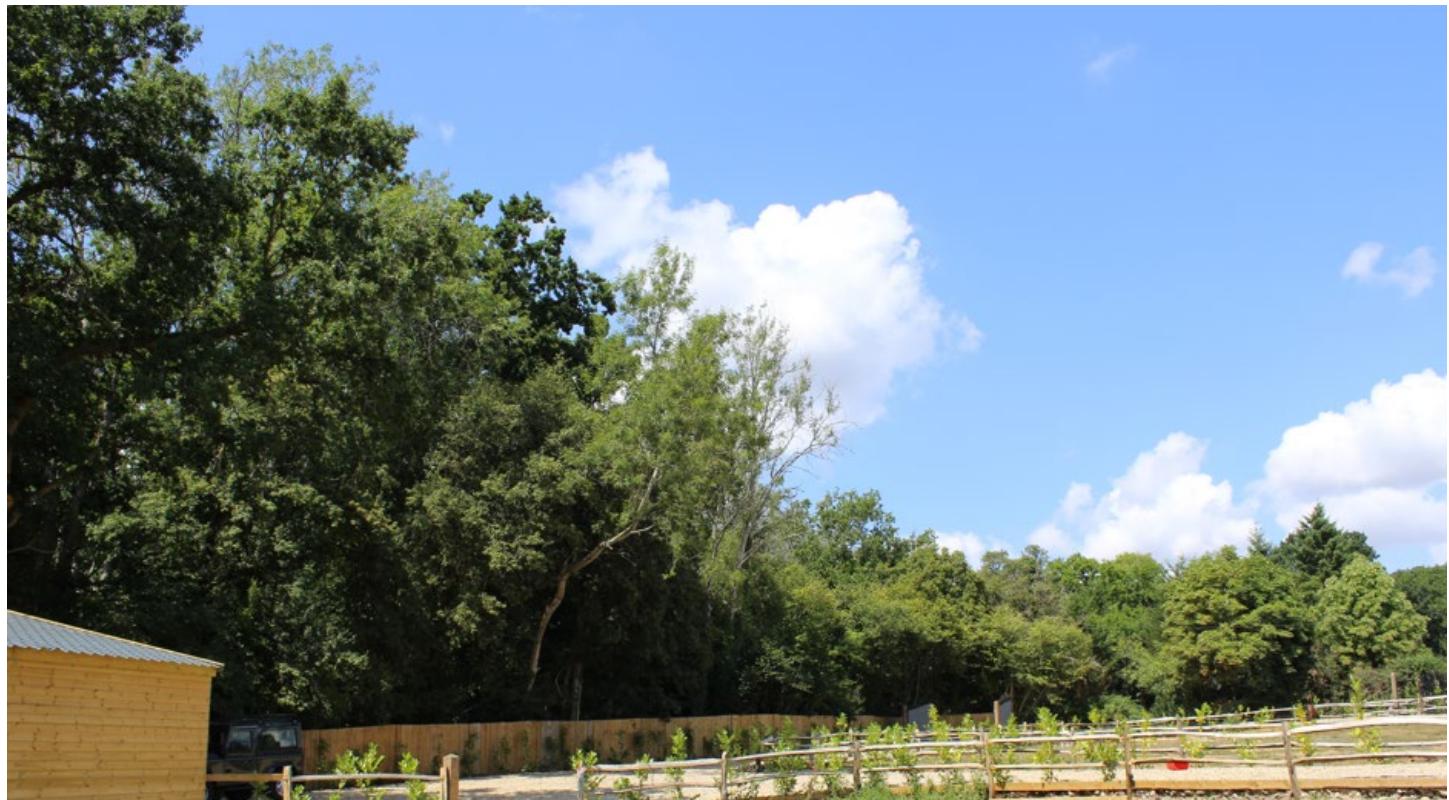
Fig. 5 – Image showing most of the trees within influence of the completed work in good physiological condition bar the ash with Chalara dieback.
