Refurbishment & Demolition survey
for asbestos materials at:

**Sir Roberts Farm- Three Garages
Goose Green Lane
Pulborough
West Sussex
RH20 2LW**

DATE: 16TH OF JUNE 2022

REFERENCE: 01/16062022/DAS

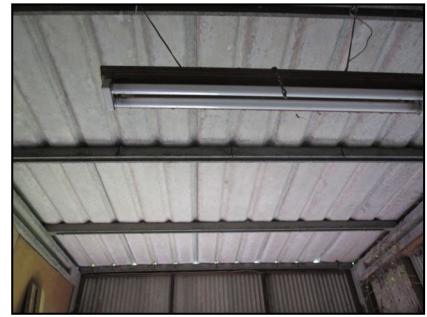
2.1 View of the asbestos cement panels to the roofs of the three garages.

- The asbestos cement roof and the asbestos cement cladding panels to the three garages (mentioned in sections 2.1 & 2.2 and on the asbestos register and floor plan) can be managed and monitored if left in situ. If the asbestos cement is going to be removed this should be carried out by a licensed asbestos removal contractor.

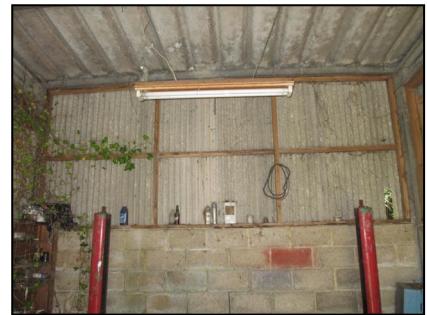
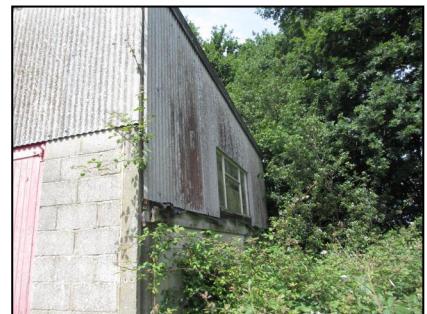
2.2 Views of the asbestos cement cladding to the three garages.

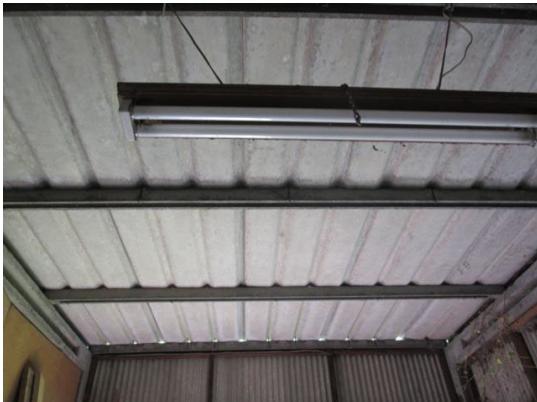
Date: 16 Jun 2022	Item No: 1	Building: 001	Sir Roberts Farm Garages	
Floor: Roof	Location: Garage roofs x3	Extent: 96	m ²	
Area: External	Description: Asbestos cement sheets to roof

Material Assessment		Sample Details	
PT: 1. Asbestos composites (Artex, floor tiles, cement etc.)		<input checked="" type="checkbox"/> Sampled	
EOD: 1. Low damage		Sample Reference: 01/16062022/DAS/003	
ST: 1. Enclosed sprays, lagging & AIB, asbestos cement		Type of Asbestos (TY): 1. Chrysotile (white asbestos)	
		Asbestos Content (ASB): 2. Substantial 2 - 50%

Manage & monitor condition

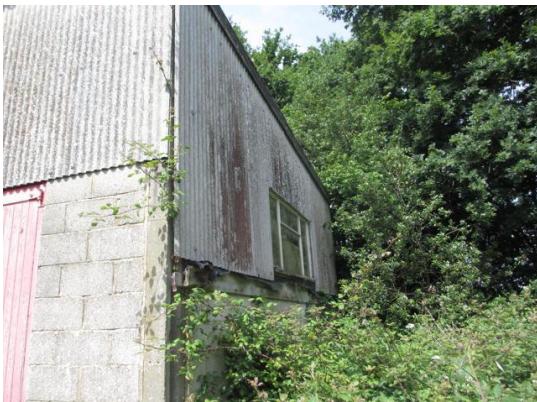
Date: 16 Jun 2022	Item No: 2	Building: 001	Sir Roberts Farm Garages	
Floor: Ground	Location: Garages x3	Extent: 42	m ²	
Area: External/Internal	Description: Asbestos cement vertical cladding panels

Material Assessment		Sample Details	
PT: 1. Asbestos composites (Artex, floor tiles, cement etc.)		<input checked="" type="checkbox"/> Sampled	
EOD: 1. Low damage		Sample Reference: 01/16062022/DAS/004	
ST: 1. Enclosed sprays, lagging & AIB, asbestos cement		Type of Asbestos (TY): 1. Chrysotile (white asbestos)	
		Asbestos Content (ASB): 2. Substantial 2 - 50%

Manage & monitor condition
