Flood Risk Assessment and Surface Water Drainage Strategy for Planning

January 2026

Units 4 to 5

Redkiln Close

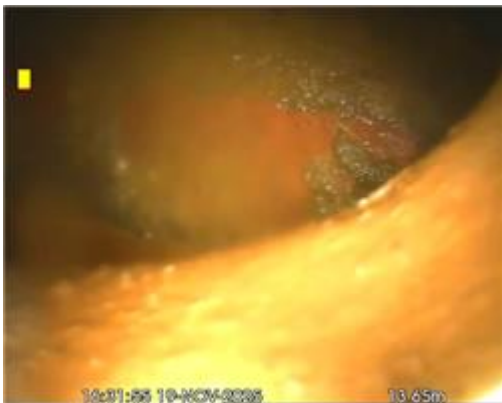
Pos	Video Ref	Code	Description	Image
13.65m		MHF	Finish node type, manhole LINE 1 ENTERS MH AT GATE UNABLE TO LIFT	<p>Image Provided - Ref: 0_9999</p>

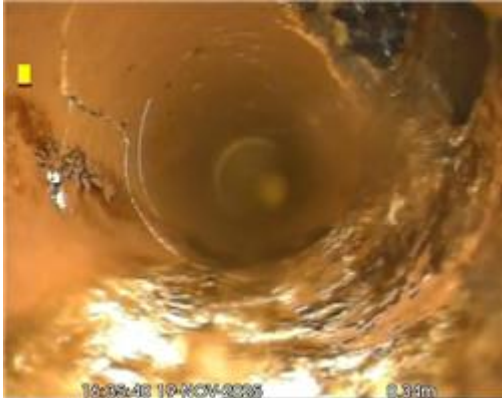
00.34m	0:00:04	CM	Cracks, multiple - Severity 2	Image Provided - Ref: 1_3

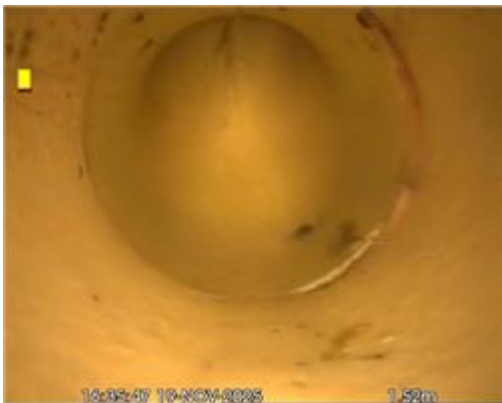
Pos	Video Ref	Code	Description	Image
01.54m	0:00:11	LUF	Line of drain/sewer deviates up [full]	<p>Image Provided - Ref: 1_4</p>

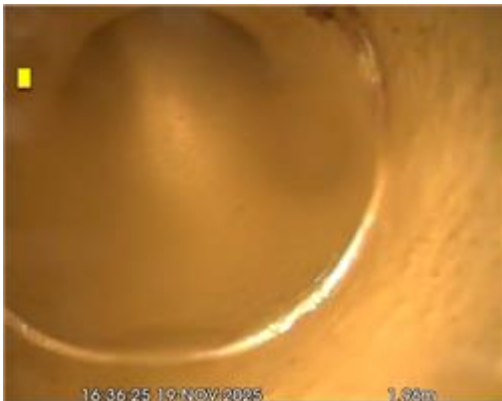
00.00m	0:00:00	WL	Water level: 0% Height/Diameter	
01.96m	0:00:06	LUF	Line of drain/sewer deviates up [full]	Image Provided - Ref: 2_2

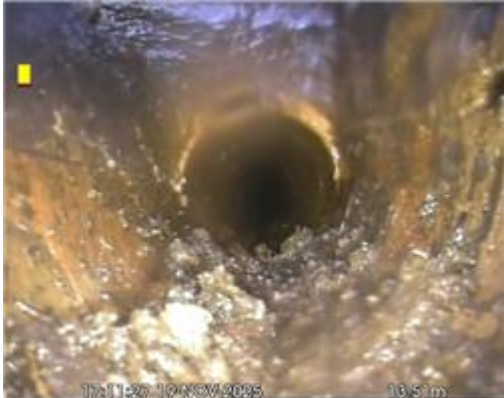
13.51m	0:01:28	REM	General remark ENTERS SW5	Image Provided - Ref: 13_3

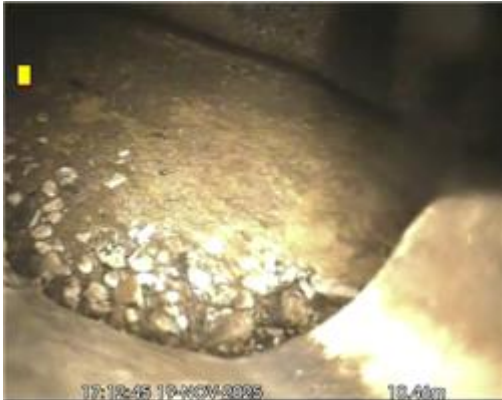
00.00m	0:00:00	WL	Water level: 0% Height/Diameter	
10.45m		MHF	Finish node type, manhole LINE 15 ENTERS MH UNDER SKIP	Image Provided - Ref: 14_9999
