WARNHAM PARISH COUNCIL CONSULTATION COMMENTS

TO:	Horsham District Council – Planning Dept
SITE ADDRESS:	Land East of Tilletts Lane Warnham
PROPOSAL:	Erection of 59 dwellings with associated open space, landscaping, parking, access, and drainage infrastructure.
REFERENCE:	DC/25/1155
RECOMMENDATION:	Objection

RDPO Investigation Report

RDPO Temp Confirm No.	None Raised
RDPO Officer	SW
Date Investigation Complete	11 July 2025
Road Name/No.	Tilletts Lane
Area/Town	Warnham
Riparian Issue?	Yes
Highway Flooding?	Yes

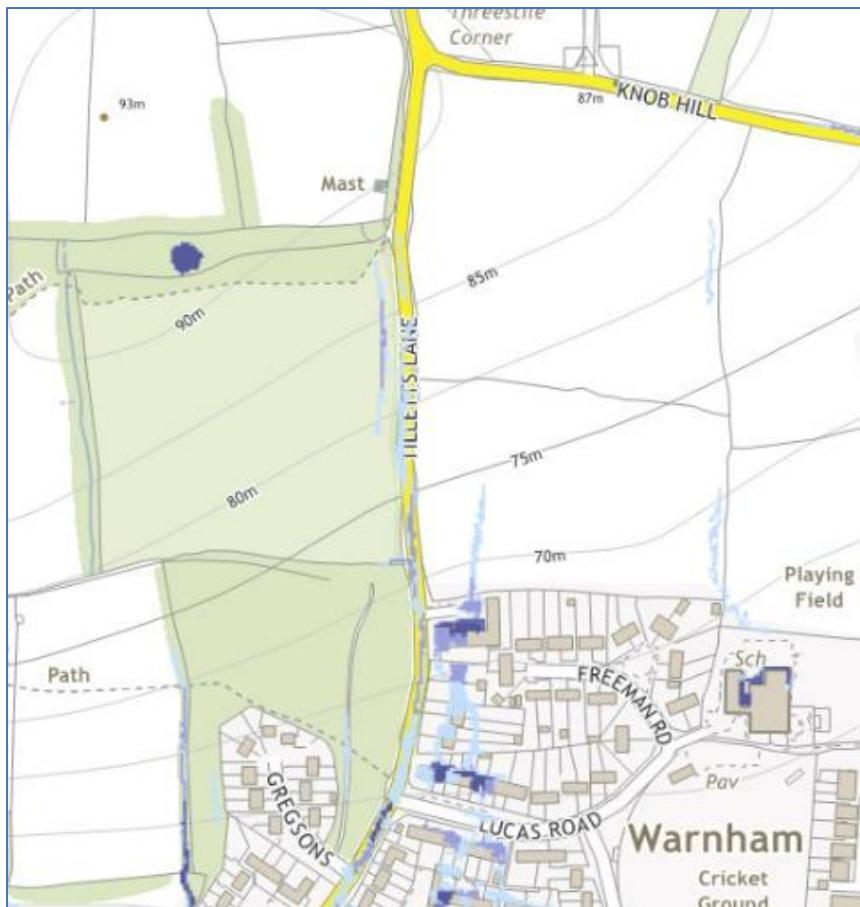
Image 2. Tilletts Lane area highway overlaid with surface water flood risk extents. Source: Ordnance survey mapping and Environment Agency surface water flood maps (extents). Accessed: 07/07/2025

The flood affected road is situated within an area of identified high to low surface water flood risk, as per Environment Agency surface water flood mapping (image 2).

This indicates that under rainfall conditions of up to the 1 in 100 chance of occurring, flooding is likely to occur to part of this road and some adjacent residential areas. It should therefore be expected that, even if all drainage systems are running clear and unobstructed, flooding can occur in this area as shown in the pluvial flood maps.

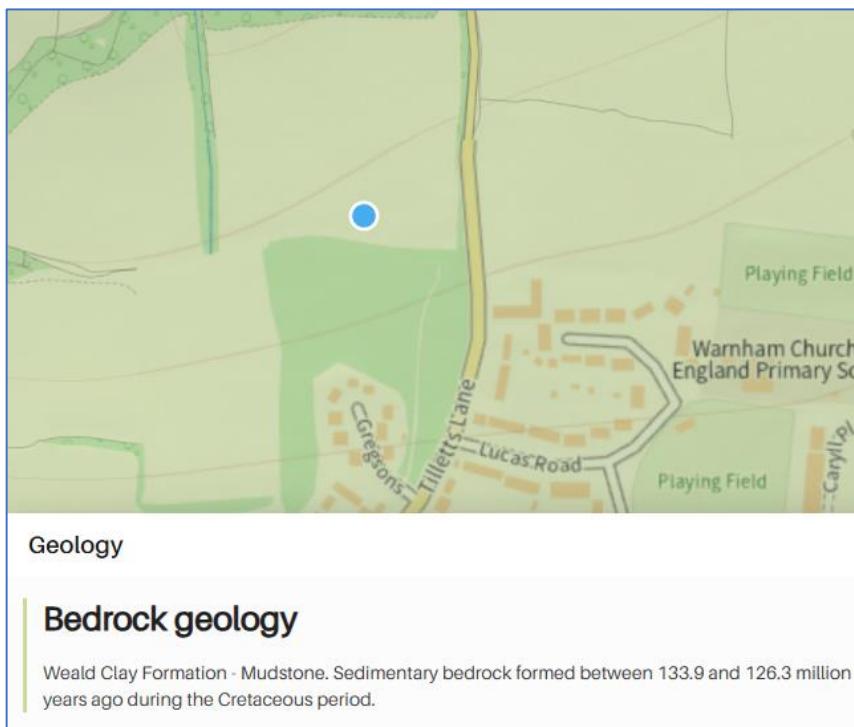
Image 5. Extracted image from British Geological Society (BGS) geology web viewer portal. Showing catchment area at Tilletts Raod being predominantly weald clay. Source: BGS Geology Web Viewer

The British Geological Society identifies this catchment area being predominantly made up of weald clay soils (image 5).

This means that the topsoil ground layer is likely to saturate with water quickly due to very low porosity (ability to allow water to soak downwards into the soil under gravity) in the clay layers just below. With these ground conditions, when prolonged or higher intensity rainfall occurs, surface water run-off is likely to manifest at the surface quickly. This catchment could therefore be considered as “flashy”, which means water levels within the watercourse systems are likely to rise quickly to flood under heavy and/or prolonged rainfall conditions. This can result in a fast-rising peak flow water level downstream.

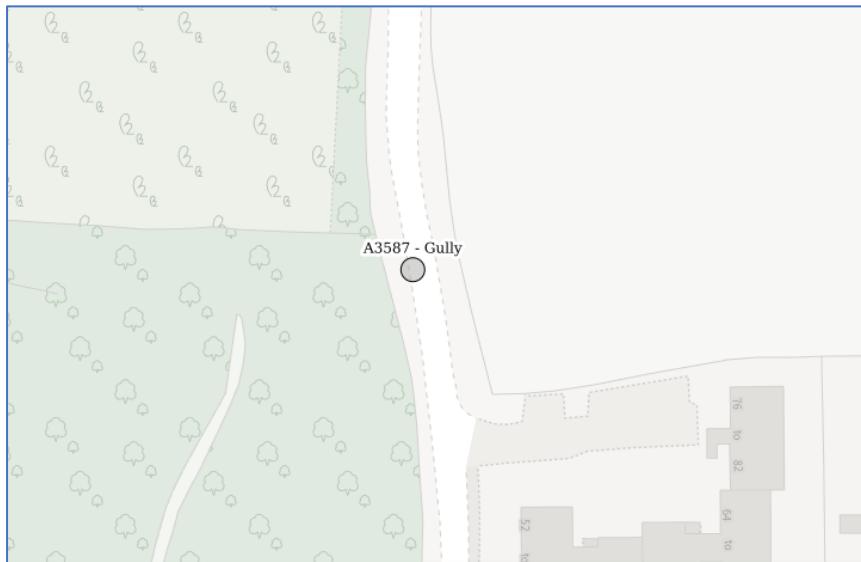
Image 7. Map 16 mapping image showing location of roadside gully at Tilletts Lane. Source: Map 16 image tool. Accessed 09/07/2025

The Map 16 mapping at Tilletts Lane confirms the location of a roadside gully—asset A3587 (Image 7).

This shows the existence of a gully at Tilletts Lane. It is noted that this is the first and highest gully along this steep road.

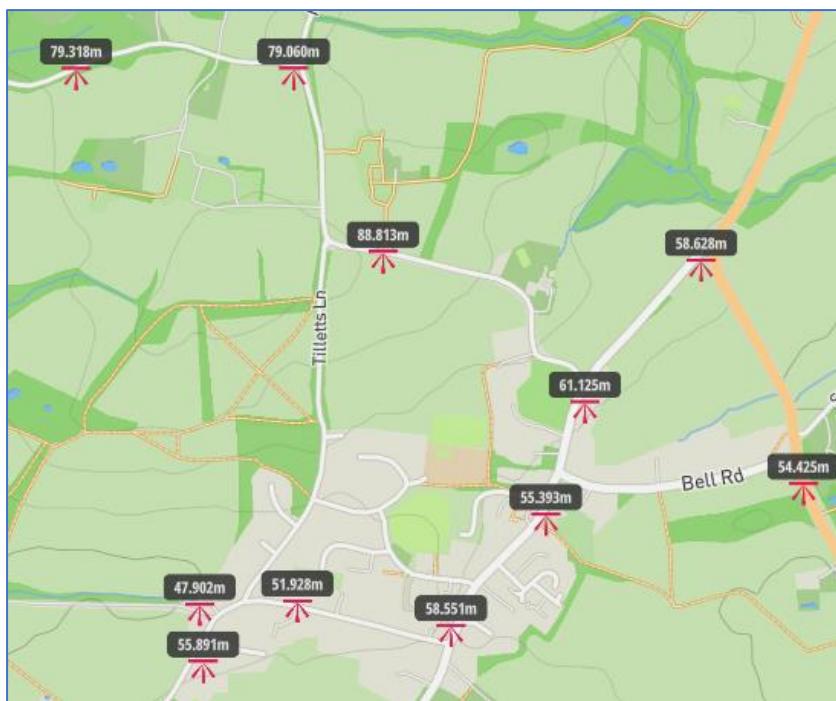
Image 9. Ordnance Survey Benchmark at Tilletts Lane. Source: [Ordnance Survey Benchmark Archive](#) [OS Benchmark Archive](#), Accessed 07/07/2025

It has been found that the affected area of Tilletts lane falls from approximately 89.0 metres AOD to 48.0 metres AOD (image 9).

With a height difference of 41 metres over a linear distance of 734 metres, the hydraulic fall is calculated as approximately 1:18 ($734/41=17.9$).

This is a steep fall and would be expected to generate fast surface flows in heavy rainfall conditions.

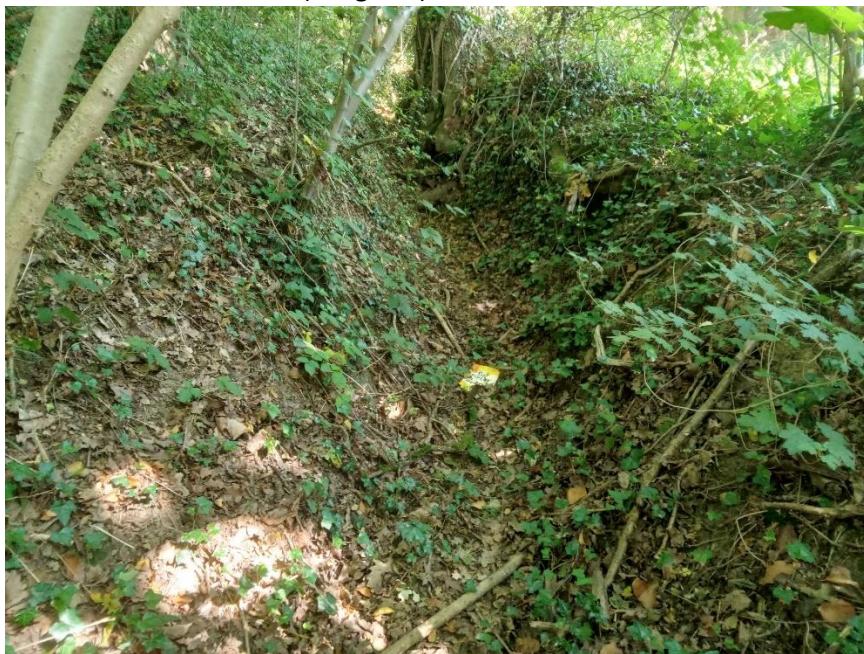
Image 10. Site observation photo – Field Short Ditch, Tilletts Lane. Source: Image taken 09/07/2025

- A deeper and shorter ditch flows adjacent with the highway ditch. It is assumed that this ditch has been formed to intercept overland surface water flows from the adjacent field to its west.
- This ditch was found to be deep and well-formed, providing a clear interception.
- Leaf debris and detritus has formed in the ditch but unlikely to be limiting capacity and flow due to ditch size (image 10).

- This ditch communicates with the highway ditch and the east ditch.

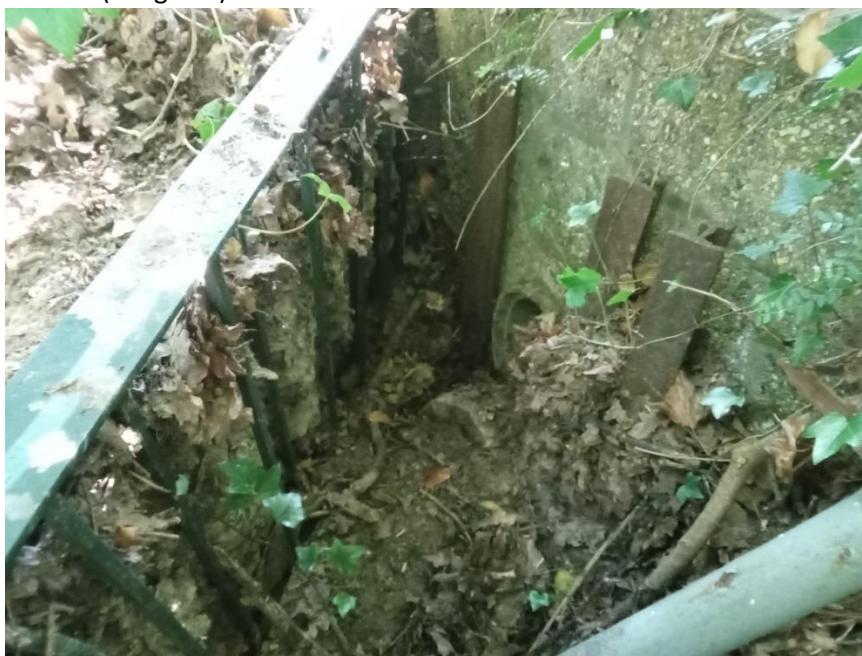
Image 11. Site observation photo – Culvert Headwall, Tilletts Lane. Source: Image taken 09/07/2025

- The inlet to a piped watercourse (culvert) is positioned adjacent to the highway and appears to accept flows from three feeds:
 1. highway ditch,
 2. field short ditch
 3. field east ditch.
- The route and destination of this culvert is unknown. However, it is expected to flow southwards in-line with the topography, and currently assumed to run within proximity to the highway.
- The entrance to this culvert is protected by a non-compliant trash screen arrangement—freestanding iron bars.
- The screen was found to be completely blocked with soil and detritus, meaning that it was not effective in filtering debris from entering the culvert pipe.
- In addition, the culvert pipe behind the screen was blocked with more debris and a log (image 11).

The primary exacerbator of highway flooding at Tilletts Lane appears to be the blocked trash screen and culvert adjacent to the road. The surrounding field, underlain by low-permeability clay soil, can generate rapid surface water runoff during rainfall events. Although the associated ditches are designed to intercept and convey this runoff southwards via gravity, the unmanaged and obstructed condition of the trash screen and culvert leads to water spilling onto Tilletts Lane.

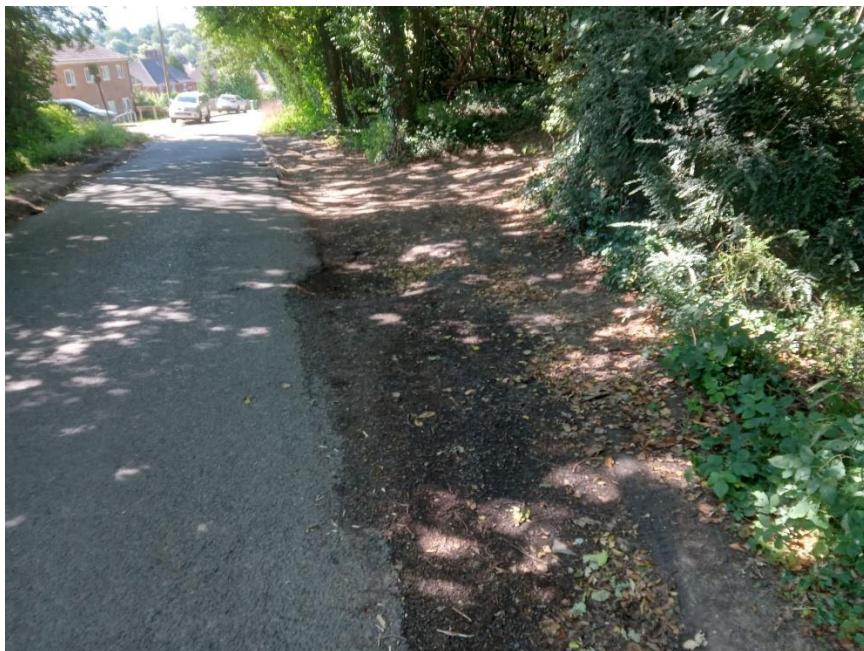
Image 12. Site observation photo – possible road scour, Tilletts Lane. Source: Image taken 09/07/2025

- It is likely that this culvert is severely blocked and water draining to it will back up and spill over into the highway of Tilletts Lane.
- The tarmacadam surface of the highway, adjacent to the culvert inlet, appears to be degraded—likely from seasonal waterflows surcharging the culvert (image 12).

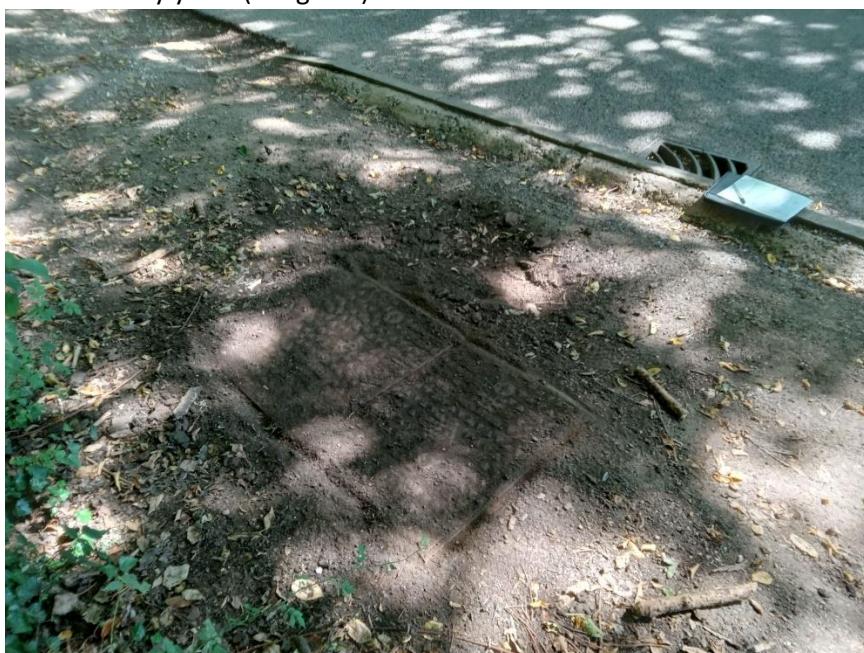
Image 13. Site observation photo – Highway Gully and Access Chamber, Tilletts Lane. Source: Image taken 09/07/2025

- Approximately 15 metres downhill of the blocked culvert headwall is a roadside gully on the western side of the road.
- This gully was observed to be full of soil, unable to take any flows. It is likely this condition has occurred quickly as it is the first drainage item intercepting any overland flows from the blocked culvert and the un-gripped road above.
- Within the verge, approximately 1.5 metres west of the gully, a double cover access chamber was discovered. This cover was buried under soil and appears to have not been opened for many years (image 13).

- It is assumed that this double cover provides access to the connection between the gully and the culvert, believed to flow south adjacent to the road.

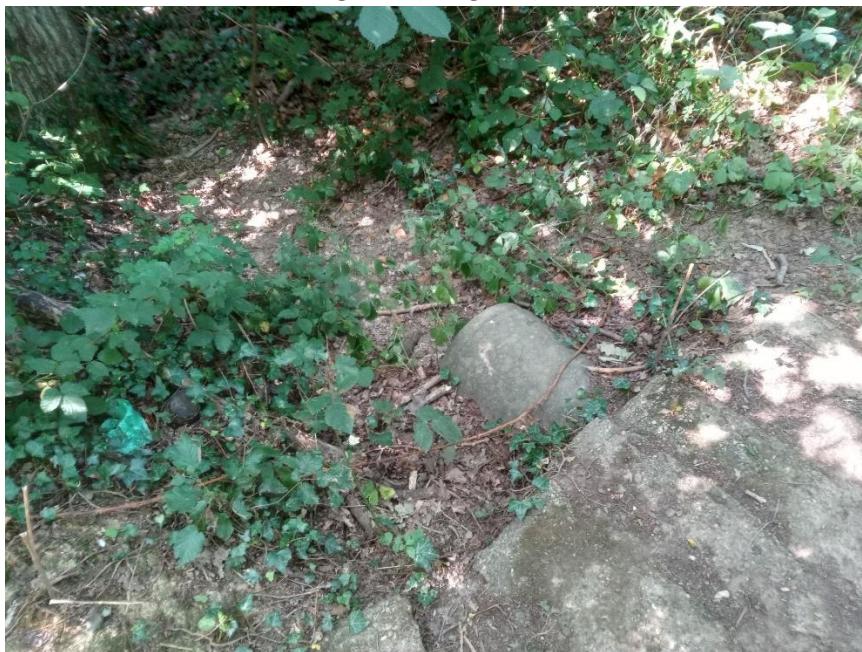
Image 14. Site observation photo – Short Culvert Outlet Under Footpath, Tilletts Lane. Source: Image taken 09/07/2025

- An open watercourse flows through the woodland between the Gregsons cul-de-sac and the Tilletts Lane highway.
- The ditch appears to intercept local overland flows from the adjacent woodland.
- A short culvert, approximately 0.3 metres diameter, maintains flow under a footpath. However, the inlet and outlet of this small culvert were found to be heavily restricted by soil and detritus, limiting flow (image 14).

A secondary contributing factor is the condition of the watercourse between Tilletts Lane and Gregsons cul-de-sac. Like the field, the woodland area also exhibits low-permeability clay soils, which can generate rapid surface runoff. This runoff is intercepted by the woodland ditch, but again, due to an unmanaged and blocked culvert, overflow can occur into both Gregsons and Tilletts Lane.

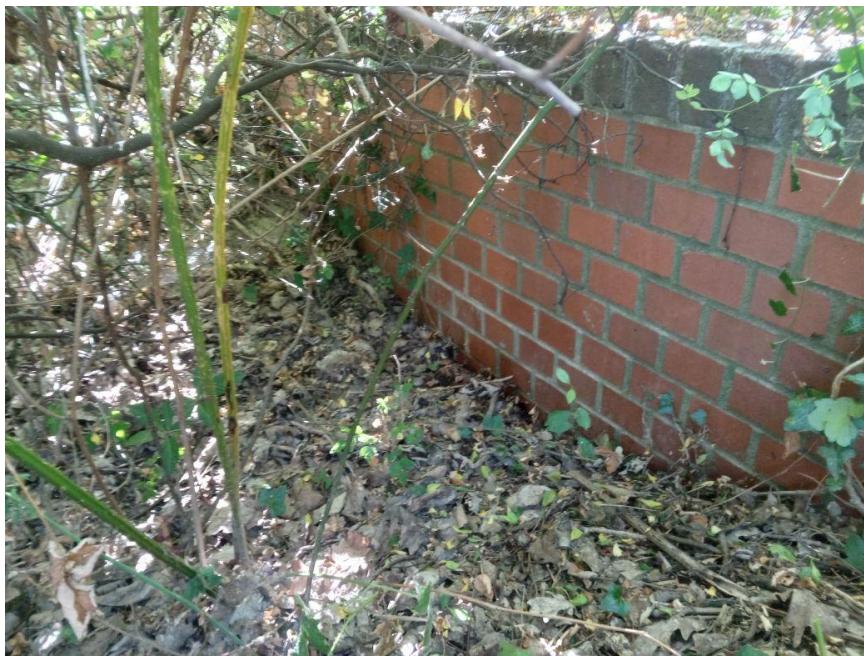
Image 15. Site observation photo – Culvert Headwall nr Gregsons, Tilletts Lane. Source: Image taken 09/07/2025

- The Gregsons ditch discharges into a culvert adjacent to the Gregsons cul-de-sac development.
- A brick headwall was discovered at the interface of the open ditch and the culvert (image 15). A significant amount of soil and debris has accumulated here, burying the culvert inlet.
- Under heavy rainfall conditions, it is expected that water will overflow and drain into the highway of Gregsons and Tilletts lane.
- The exact route and destination of the Gregsons culvert is unknown at the time of writing.

The culvert adjacent to the property known as Gregsons is also obstructed. Similar to the Tilletts Lane culvert, this blockage is expected to cause surcharging and overland flow onto the road during heavy rainfall events.
