# Structural Investigation Report

New Place Farm  
Pulborough

| Document title | Structural Investigation Report |
| Document ref. | 15065-AWA-XX-ZZ-SE-RP-00001 |

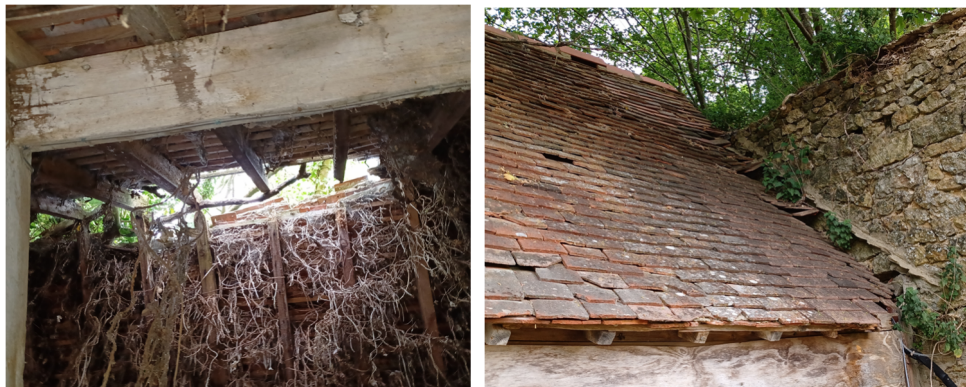
The roof covering is in **poor** condition. Tiles are missing or dislodged and the surrounding trees have grown into the roof pushing off the ridge tiles and allowing water to penetrate into the barn at the ridge. There has been significant movement at the eastern gable end as the purlins have rotted out, resulting in the roof structure falling away from the wall.

*Figure 1: Images showing condition of the roof covering*

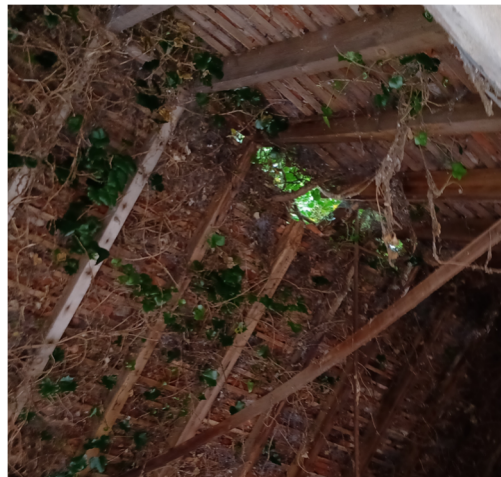
The roof structure is in **poor** condition. Water has penetrated into the structure over a long period of time and thus structural elements have completely rotten through with significant loss of section. The ridge board is severely rotten as are the commons at the ridge point. Purlins appear to be in moderate condition having largely been kept dry and are still proving midspan support to the rafters.

*Figure 2: Image showing the ends of the commons rotten through*

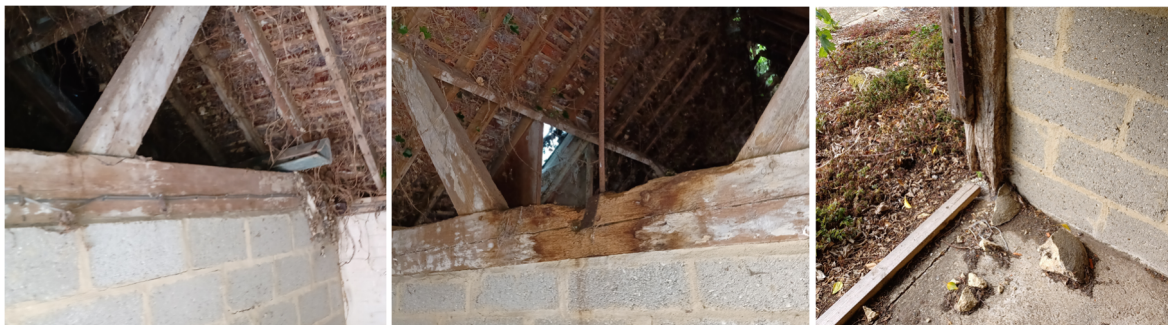
The frames are also in **poor** condition. They consist of timber king tie trusses supported on timber posts. There does not appear to be a principal rafter; instead, the tie is fixed to a central common rafter. The frames were originally clear-spanning between posts but have since been infilled with concrete blockwork. The beam ends are generally rotten, although the tie beam is still adequately supported by the infill panels. The king ties themselves no longer hang from the rafters as the rafters have rotten through. The king ties no longer suspend from the rafters due to degradation of the rafter. Water has also tracked down the ties, causing decay to the upper surface of the tie beam.

*Figure 3: Images showing the condition of the main frames*

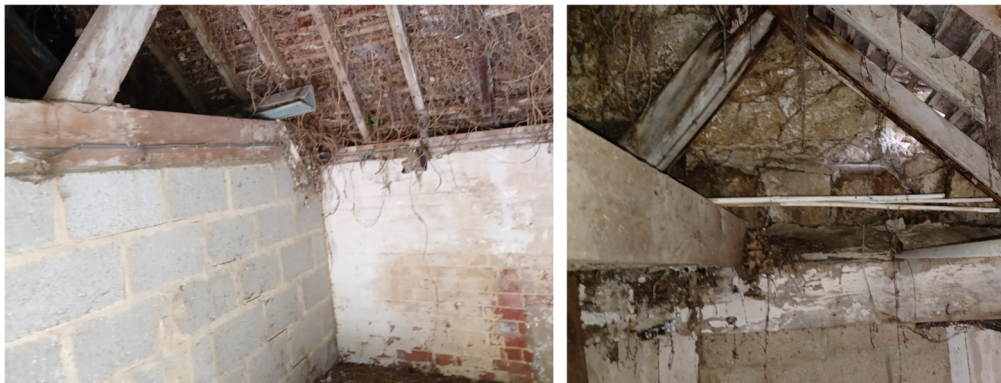
Access to the structure was limited, preventing a full inspection from being undertaken. However, the walls appear to be in **moderate** condition, with no significant cracking observed. Localised decay of the purlins built into the stonework wall on the eastern elevation has led to the purlins slipping off the bearing resulting in localised damage to the stonework

*Figure 4: Image showing the walls of the barn*

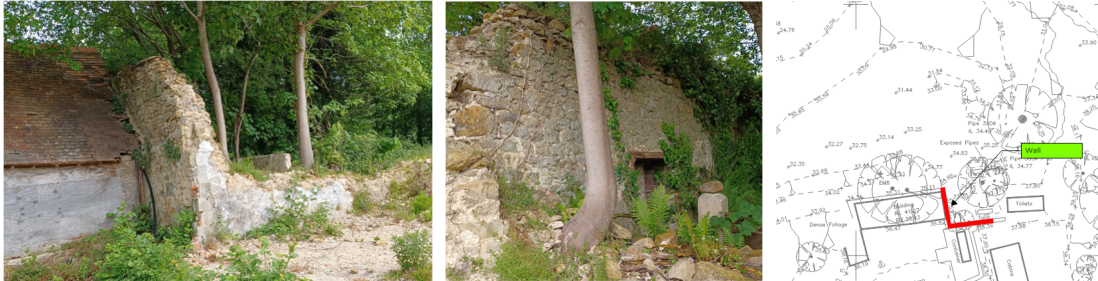
The stone wall at Pulborough is approximately 500 mm thick and reaches a maximum height of 3.5 m. Part of the wall forms the eastern gable of the barn and it is located adjacent to a steep slope that descends into a local valley.

The wall is generally in **good** condition; however, retaining it without some intervention may be difficult to justify, and some strengthening measures are recommended. Any existing timber lintels should be removed, and all openings should be infilled using stone and lime mortar. To improve the wall's stability, the wing walls should be raised and properly bonded into the existing masonry, providing vertical restraint at both ends of the structure. The wing walls should be constructed with a stepped profile as they return.

In addition, given the wall's proximity to the adjacent slope, the foundations should be inspected once vegetation clearance has been completed. Some soft landscaping works may also be required in this area to help maintain the long-term stability of the wall which may involve locally raising the ground level around the wall.
