| Project Name: | Old Clayton Kennels, Storrington |
| Document Reference: | 024.5063/SVR 2 |
| Document Name: | SuDS Verification Report |

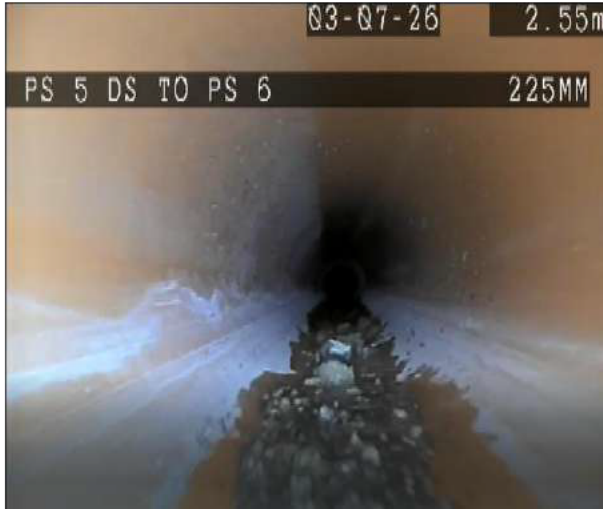
| Ref | Defect Images | Comments |
|---|---|---|
| 03Jul_001 | | <p>Sediment accumulation was observed at the downstream end of the pipe.</p> <p>It appears that the pipe rises towards manhole S4, see below images, whereas it should fall to the manhole invert. The report recommends simply cutting back the pipe; however, the connection will need to be reconstructed correctly to the manhole invert with appropriate benching. This may require a section of the pipework to be re-laid to achieve an adequate gradient and ensure the flow discharges correctly into the manhole.</p> |

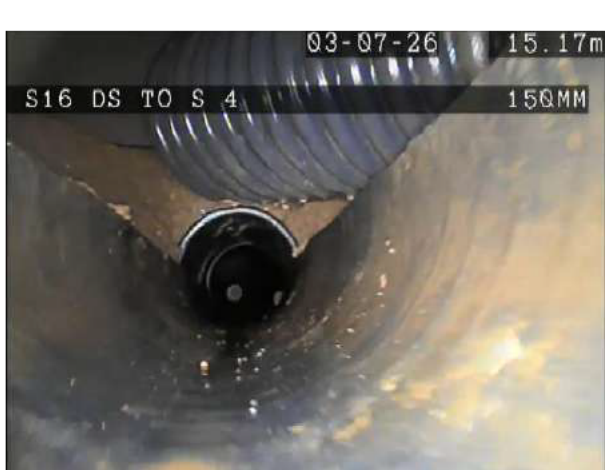
| | | <p>It appears that the pipe rises towards manhole S4, whereas it should fall to the manhole invert. The Inspection report recommends simply cutting back the pipe; however, the connection will need to be reconstructed correctly to the manhole invert with appropriate benching. This may require a section of the pipework to be re-laid to achieve an adequate gradient and ensure the flow discharges correctly into the manhole.</p> <p>See below remedial works undertaken in Section 6 of this report.</p> |

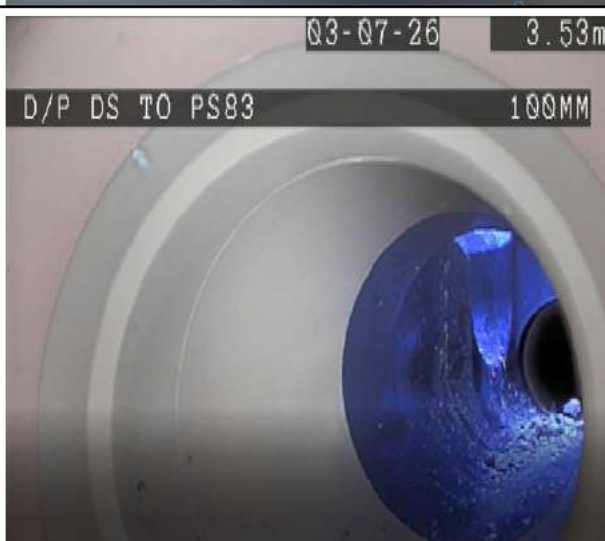
| 03Jul_001 | | Sediment build-up was observed within the pipework. The accumulation of material has the potential to reduce the effective hydraulic capacity of the pipe and may impede the efficient conveyance of surface water flows. To restore the pipe to optimum operating condition, it is recommended that the affected section is cleaned by high-pressure water jetting to remove the deposited sediment and any associated debris. |

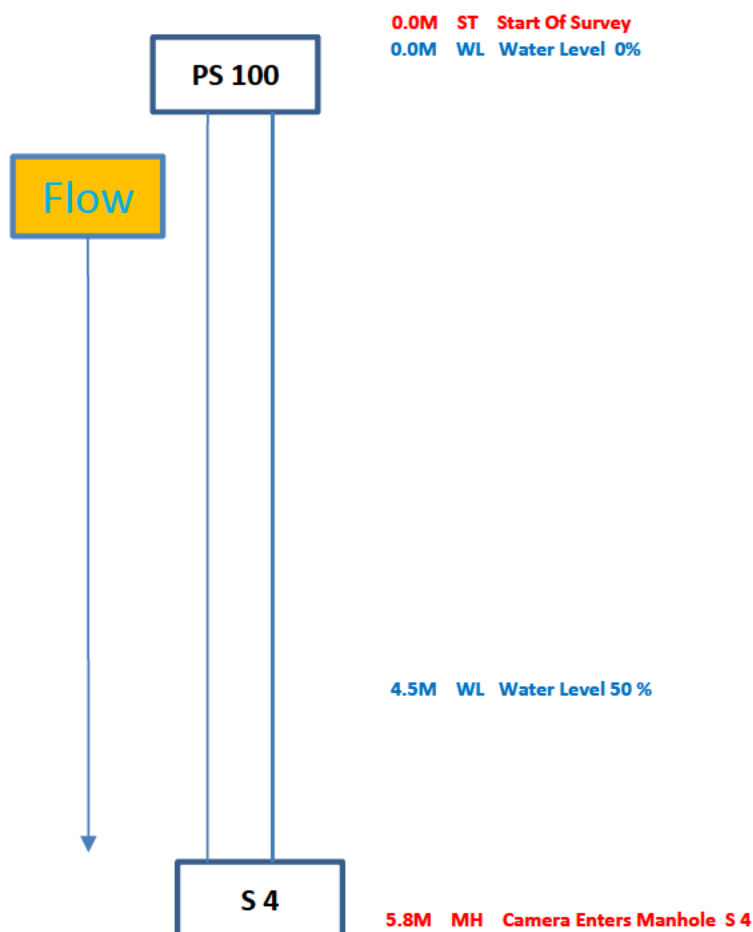
REM; THE PLASTIC PIPE RUNS TO FAR INTO MANHOLE S4 WHICH IS CAUSING WATER TO LAY ON THE PIPE, THE PIPE NEEDS CUTTING BACK IN THE MANHOLE
