## Asbestos Demolition Report

Denver  
Okehurst Lane  
Billingshurst  
RH14 9HR

Denver Commercial LLP

Reference: C-31048

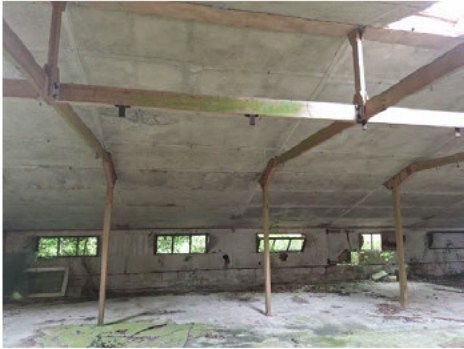
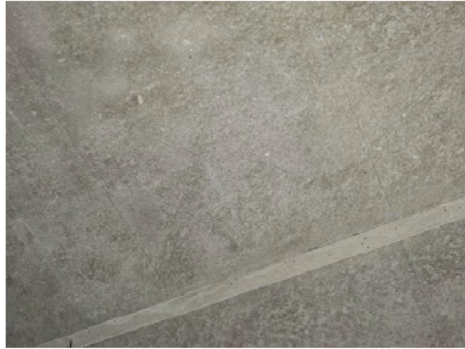
| Condition | Medium Damage | | 2 | | |
| Comments | Ceiling panels covering 3 quarters of roof.<br>Nailed to timber | | | | |

| Recommendation | Remove - NON-Licensed Material Removal by an asbestos contractor. This material is not licensed however may still be notifiable to the HSE prior to removal works taking place. All works must conform to the Control of Asbestos Regulations 2012. | | | | |

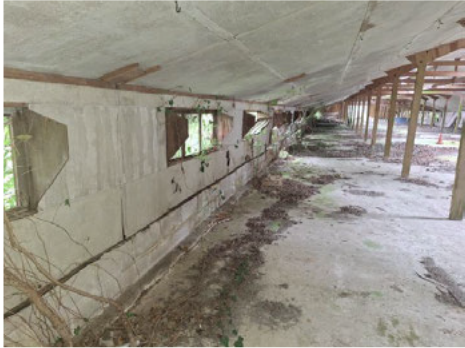
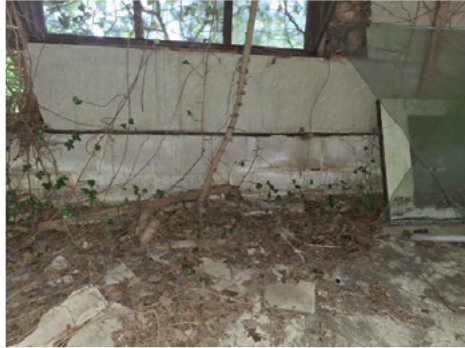
| Condition | High Damage | | 3 | | |
| Comments | Debris from wall sheets present throughout unit include within debris litter pick<br>Laid on concrete | | | | |

| Recommendation | Remove - NON-Licensed Material Removal by an asbestos contractor. This material is not licensed however may still be notifiable to the HSE prior to removal works taking place. All works must conform to the Control of Asbestos Regulations 2012. | | | | |

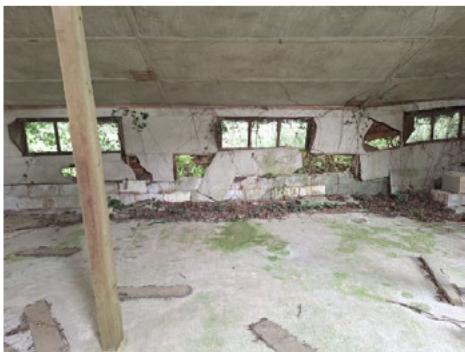
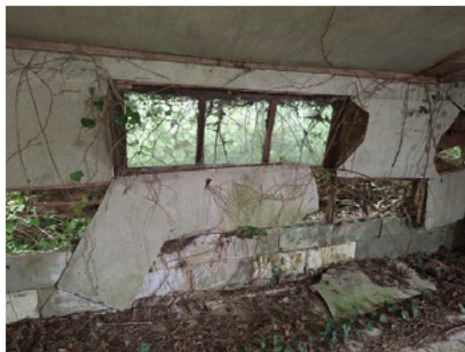
| Condition | High Damage | | 3 | | |
| Comments | Wall sheets damaged and debris present below<br>Nailed to timber | | | | |

| Recommendation | Remove - NON-Licensed Material Removal by an asbestos contractor. This material is not licensed however may still be notifiable to the HSE prior to removal works taking place. All works must conform to the Control of Asbestos Regulations 2012. | | | | |

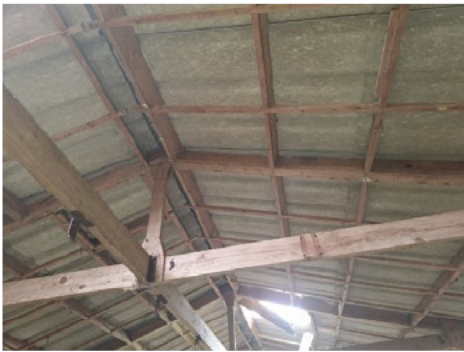
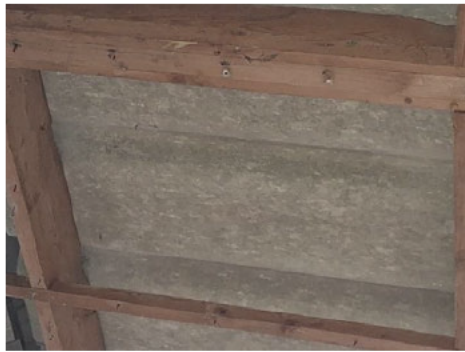
| Condition | Medium Damage | | 2 | | |
| Comments | Bolted to timber | | | | |

| Recommendation | Remove - NON-Licensed Material Removal by an asbestos contractor. This material is not licensed however may still be notifiable to the HSE prior to removal works taking place. All works must conform to the Control of Asbestos Regulations 2012. | | | | |

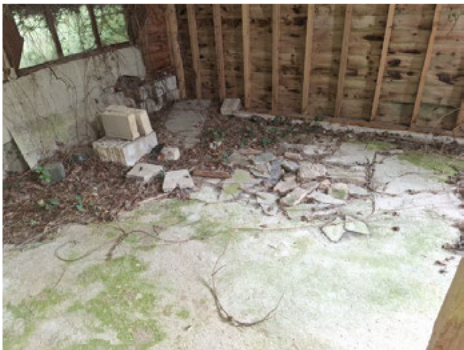
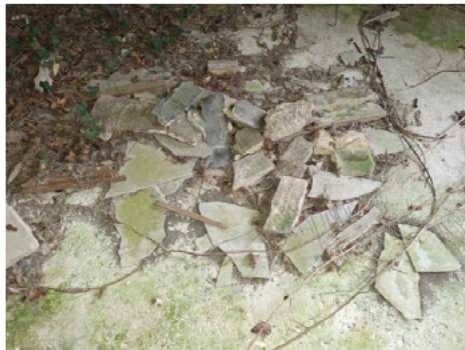
| Condition | High Damage | | 3 | | |
| Comments | Laid on concrete floor | | | | |

| Recommendation | Remove - NON-Licensed Material Removal by an asbestos contractor. This material is not licensed however may still be notifiable to the HSE prior to removal works taking place. All works must conform to the Control of Asbestos Regulations 2012. | | | | |

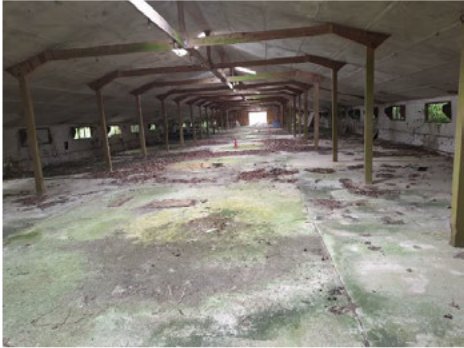
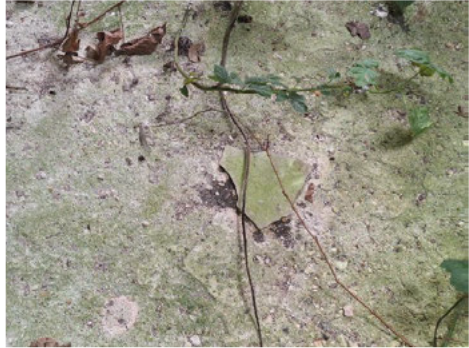
| Condition | High Damage | | 3 | | |
| Comments | Debris present throughout extent estimated based on size of unit recommend litter pick of present debris.<br>Laid on concrete | | | | |

| Recommendation | Remove - NON-Licensed Material Removal by an asbestos contractor. This material is not licensed however may still be notifiable to the HSE prior to removal works taking place. All works must conform to the Control of Asbestos Regulations 2012. | | | | |

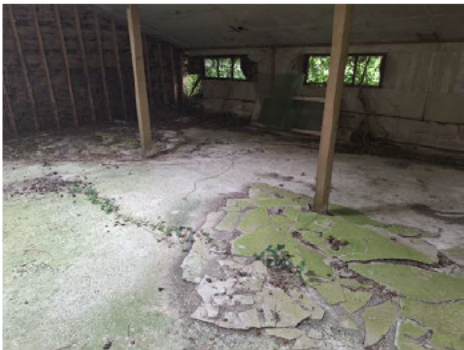
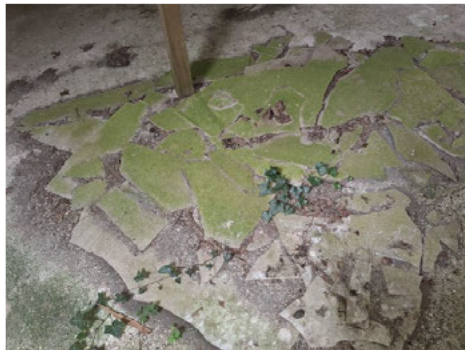
| Condition | High Damage | | 3 | | |
| Comments | Laid on concrete | | | | |

| Recommendation | Remove - NON-Licensed Material Removal by an asbestos contractor. This material is not licensed however may still be notifiable to the HSE prior to removal works taking place. All works must conform to the Control of Asbestos Regulations 2012. | | | | |

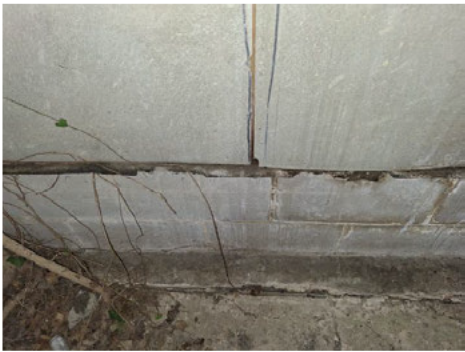
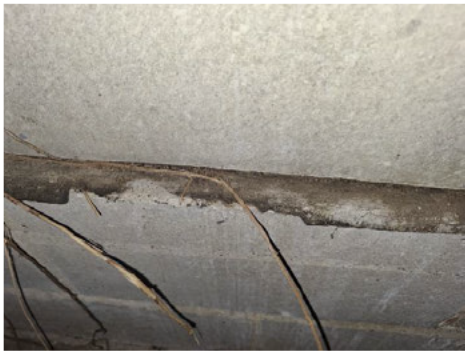
| Comments | Nailed to brick and below cement panels | | | | |

| Recommendation | No action required | | | | |

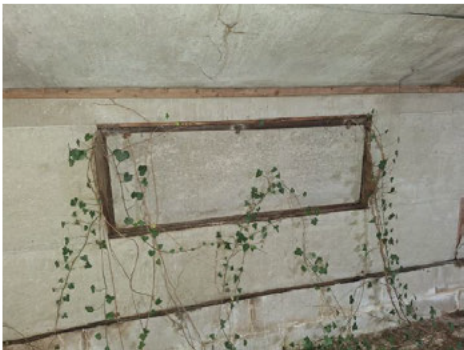
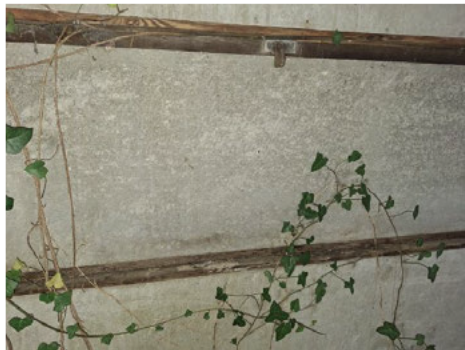
| Condition | High Damage | | 3 | | |
| Comments | Panels nailed to timber frames | | | | |

| Recommendation | Remove - NON-Licensed Material Removal by an asbestos contractor. This material is not licensed however may still be notifiable to the HSE prior to removal works taking place. All works must conform to the Control of Asbestos Regulations 2012. | | | | |

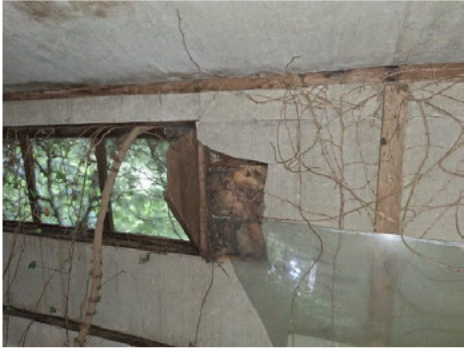
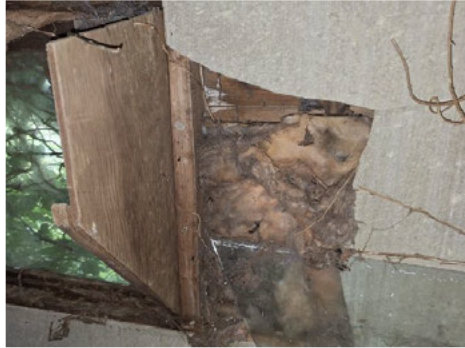
| Comments | Between timber external wall and cement panels | | | | |

| Recommendation | No action required | | | | |

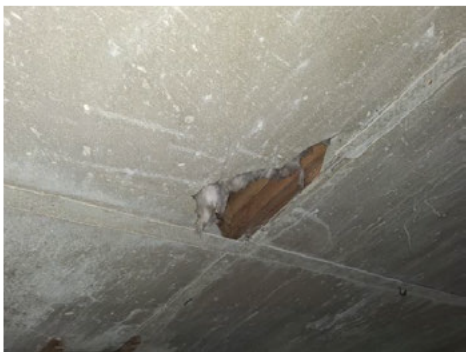
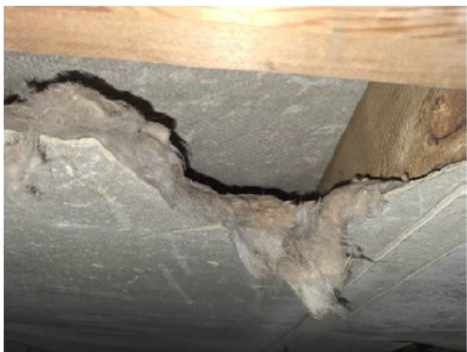
| Comments | Between roof sheets and ceiling panels | | | | |

| Recommendation | No action required | | | | |

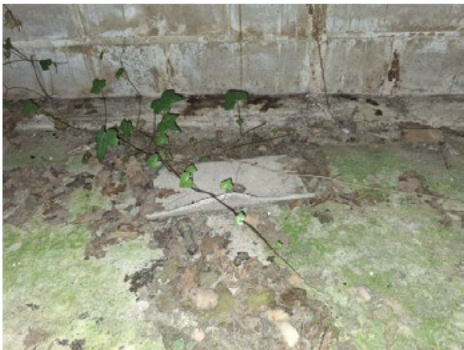
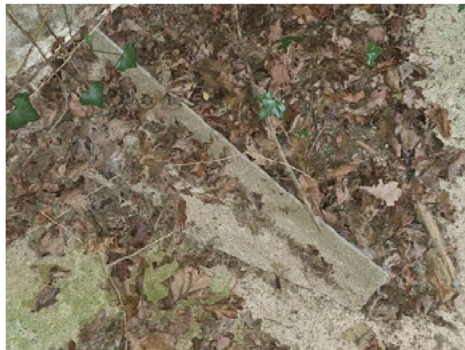
| Condition | High Damage | | 3 | | |
| Comments | Laid on concrete | | | | |

| Recommendation | Remove - NON-Licensed Material Removal by an asbestos contractor. This material is not licensed however may still be notifiable to the HSE prior to removal works taking place. All works must conform to the Control of Asbestos Regulations 2012. | | | | |

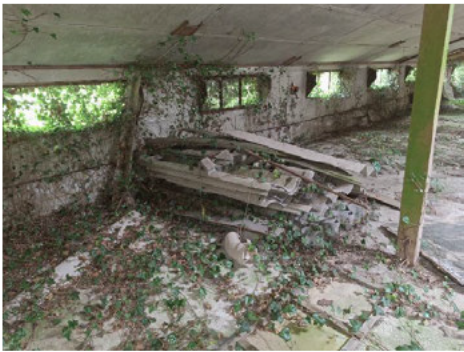
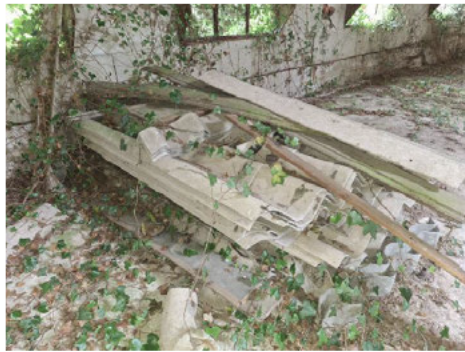
| Condition | Medium Damage | | 2 | | |
| Comments | Laid on concrete in tidy pile | | | | |

| Recommendation | Remove - NON-Licensed Material Removal by an asbestos contractor. This material is not licensed however may still be notifiable to the HSE prior to removal works taking place. All works must conform to the Control of Asbestos Regulations 2012. | | | | |

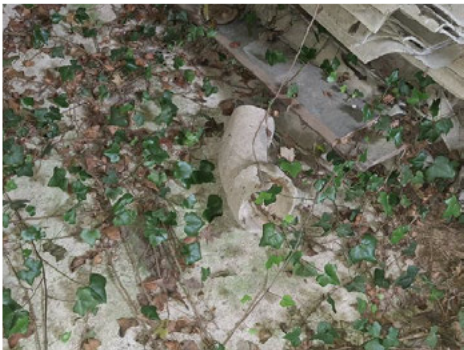
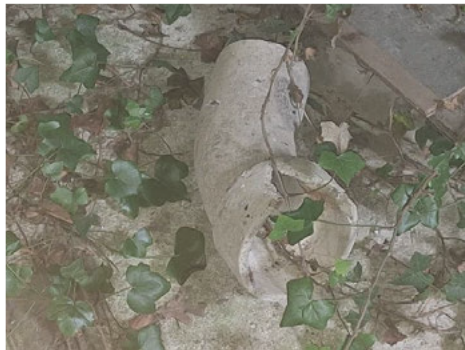
| Condition | Medium Damage | | 2 | | |
| Comments | Laid on concrete | | | | |

| Recommendation | Remove - NON-Licensed Material Removal by an asbestos contractor. This material is not licensed however may still be notifiable to the HSE prior to removal works taking place. All works must conform to the Control of Asbestos Regulations 2012. | | | | |

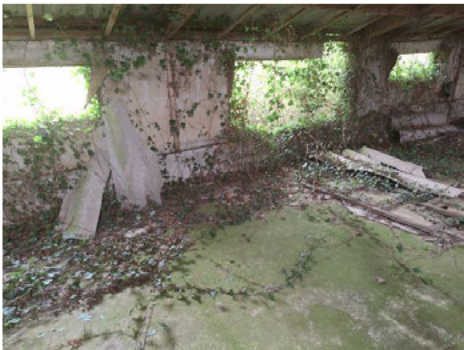
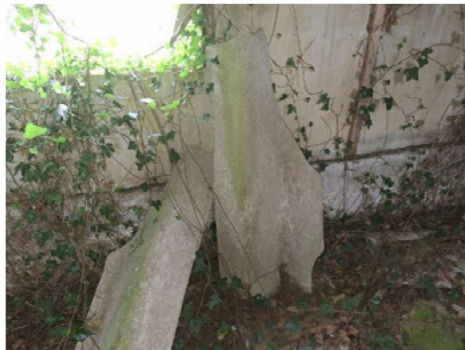
| Condition | High Damage | | 3 | | |
| Comments | Extent estimated due to present of debris include within litter pick<br>Laid on concrete | | | | |

| Recommendation | <b>Remove - NON-Licensed Material Removal by an asbestos contractor. This material is not licensed however may still be notifiable to the HSE prior to removal works taking place. All works must conform to the Control of Asbestos Regulations 2012.</b> | | | | |

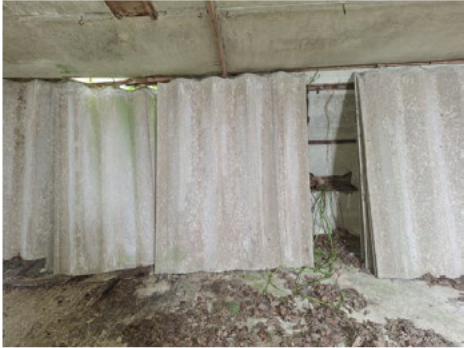
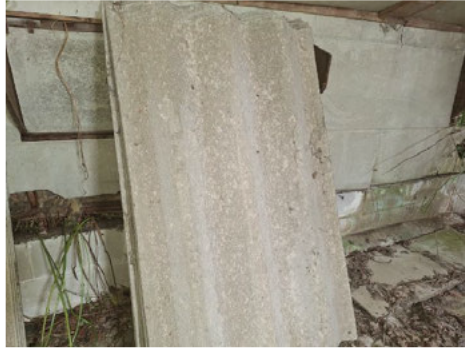
| Condition | Low Damage | | 1 | | |
| Comments | Laid on cement sheets and concrete | | | | |

| Recommendation | Remove - NON-Licensed Material Removal by an asbestos contractor. This material is not licensed however may still be notifiable to the HSE prior to removal works taking place. All works must conform to the Control of Asbestos Regulations 2012. | | | | |

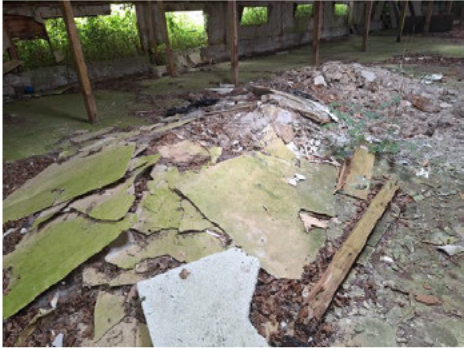
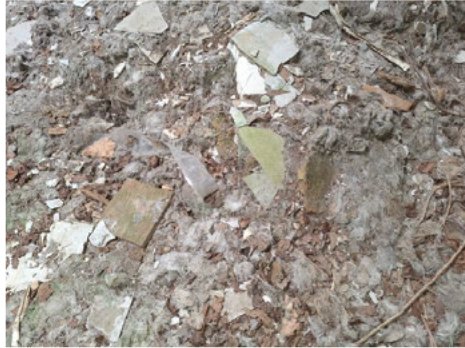
| Condition | High Damage | | 3 | | |
| Comments | Laid on concrete | | | | |

| Recommendation | Remove - Licensed Material Removal by a licensed asbestos contractor. This material is licensed therefore is subject to a 14 notification to the HSE prior to removal works taking place. All works must conform to the Control of Asbestos Regulations 2012. | | | | |

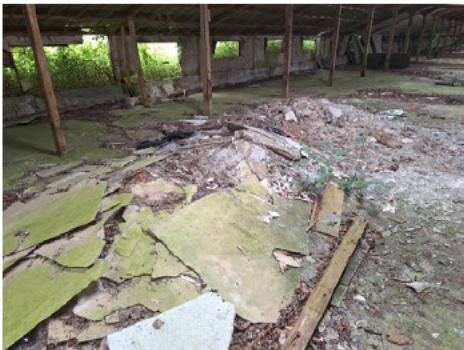
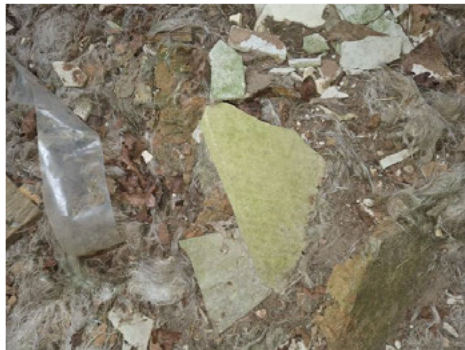
| Condition | High Damage | | 3 | | |
| Comments | Fibrous pile has debris throughout recommend pile be removed as contaminated waste<br>Laid on fibrous pile | | | | |

| Recommendation | <b>Remove - NON-Licensed Material Removal by an asbestos contractor. This material is not licensed however may still be notifiable to the HSE prior to removal works taking place. All works must conform to the Control of Asbestos Regulations 2012.</b> | | | | |

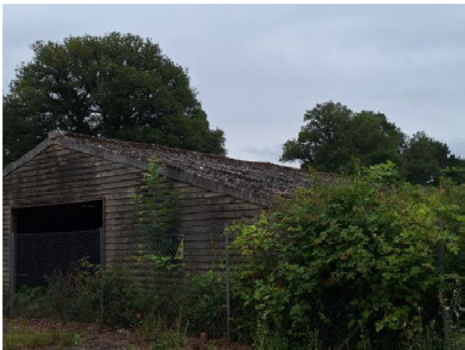
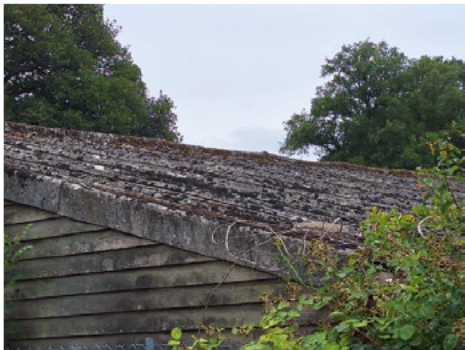
| Condition | Medium Damage | | 2 | | |
| Comments | Bolted to frame within | | | | |

| Recommendation | Remove - NON-Licensed Material Removal by an asbestos contractor. This material is not licensed however may still be notifiable to the HSE prior to removal works taking place. All works must conform to the Control of Asbestos Regulations 2012. | | | | |

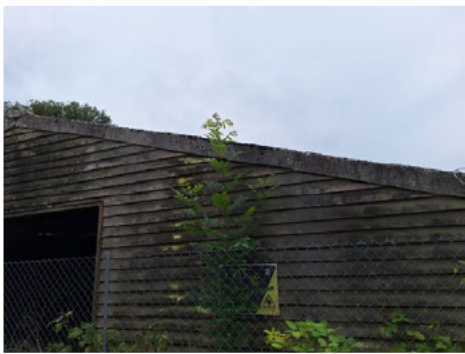
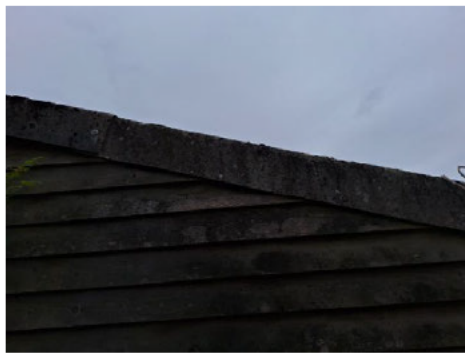
| Condition | Low Damage | | 1 | | |
| Comments | Bolted to frame | | | | |

| Recommendation | Remove - NON-Licensed Material Removal by an asbestos contractor. This material is not licensed however may still be notifiable to the HSE prior to removal works taking place. All works must conform to the Control of Asbestos Regulations 2012. | | | | |
