# Structural Report

Oxcopse Farm,  
Hooklands Lane,  
Shipley,  
Horsham, RH13 8PY

David Wood & Peter Sennitt | 21<sup>st</sup> May 2026  
Studio 22, River Road, Arundel,  
West Sussex BN18 9DH  
01903 410408  
07889 646595

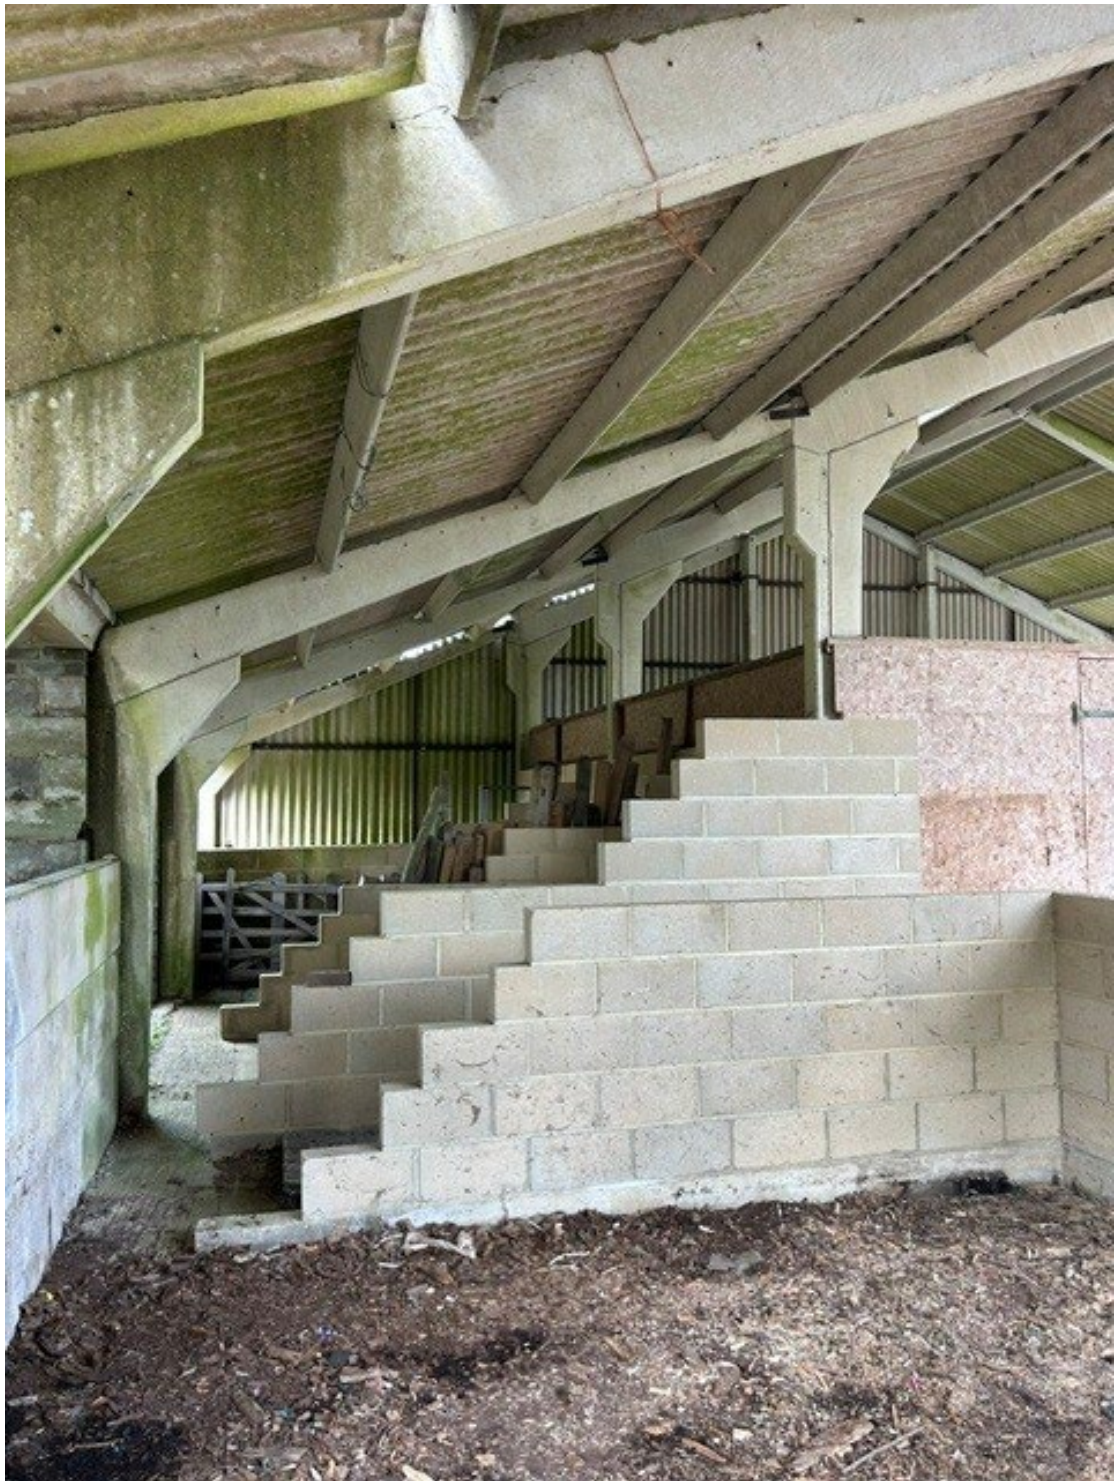
**1Internal view of low separating walls**

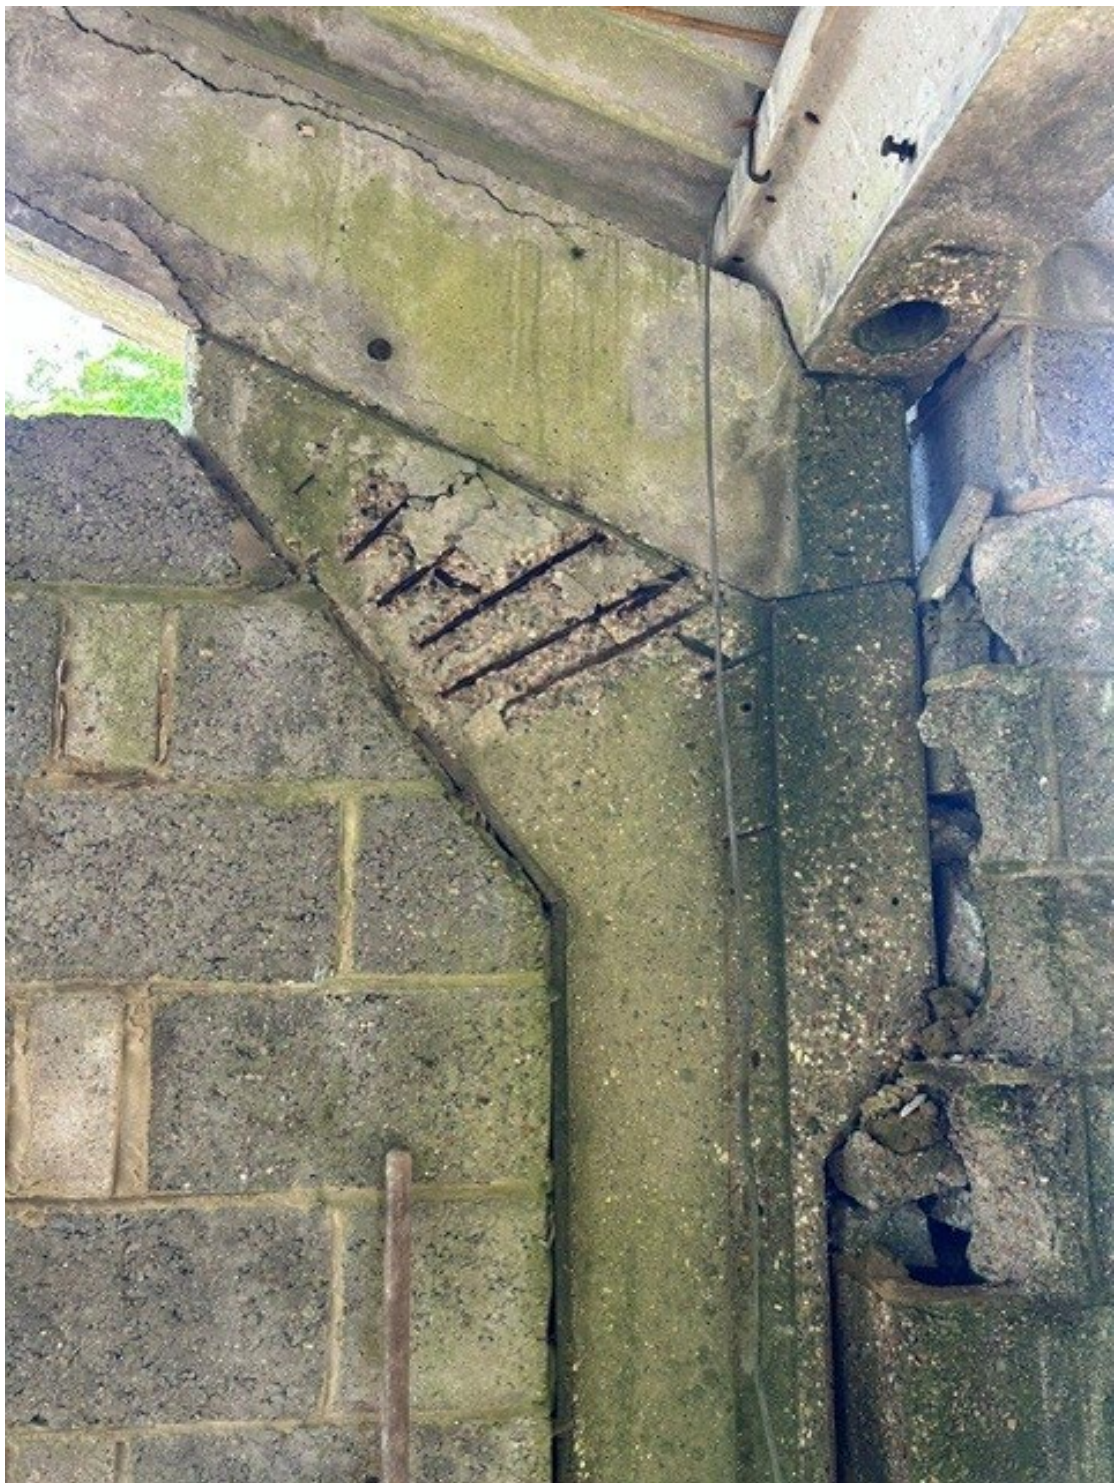
There are numerous areas of concrete spalling to the corners of columns with rusty reinforcement exposed, but all appear to be superficial and could be treated with rust inhibitor and specialist render.

**2 Spalling on face of column**

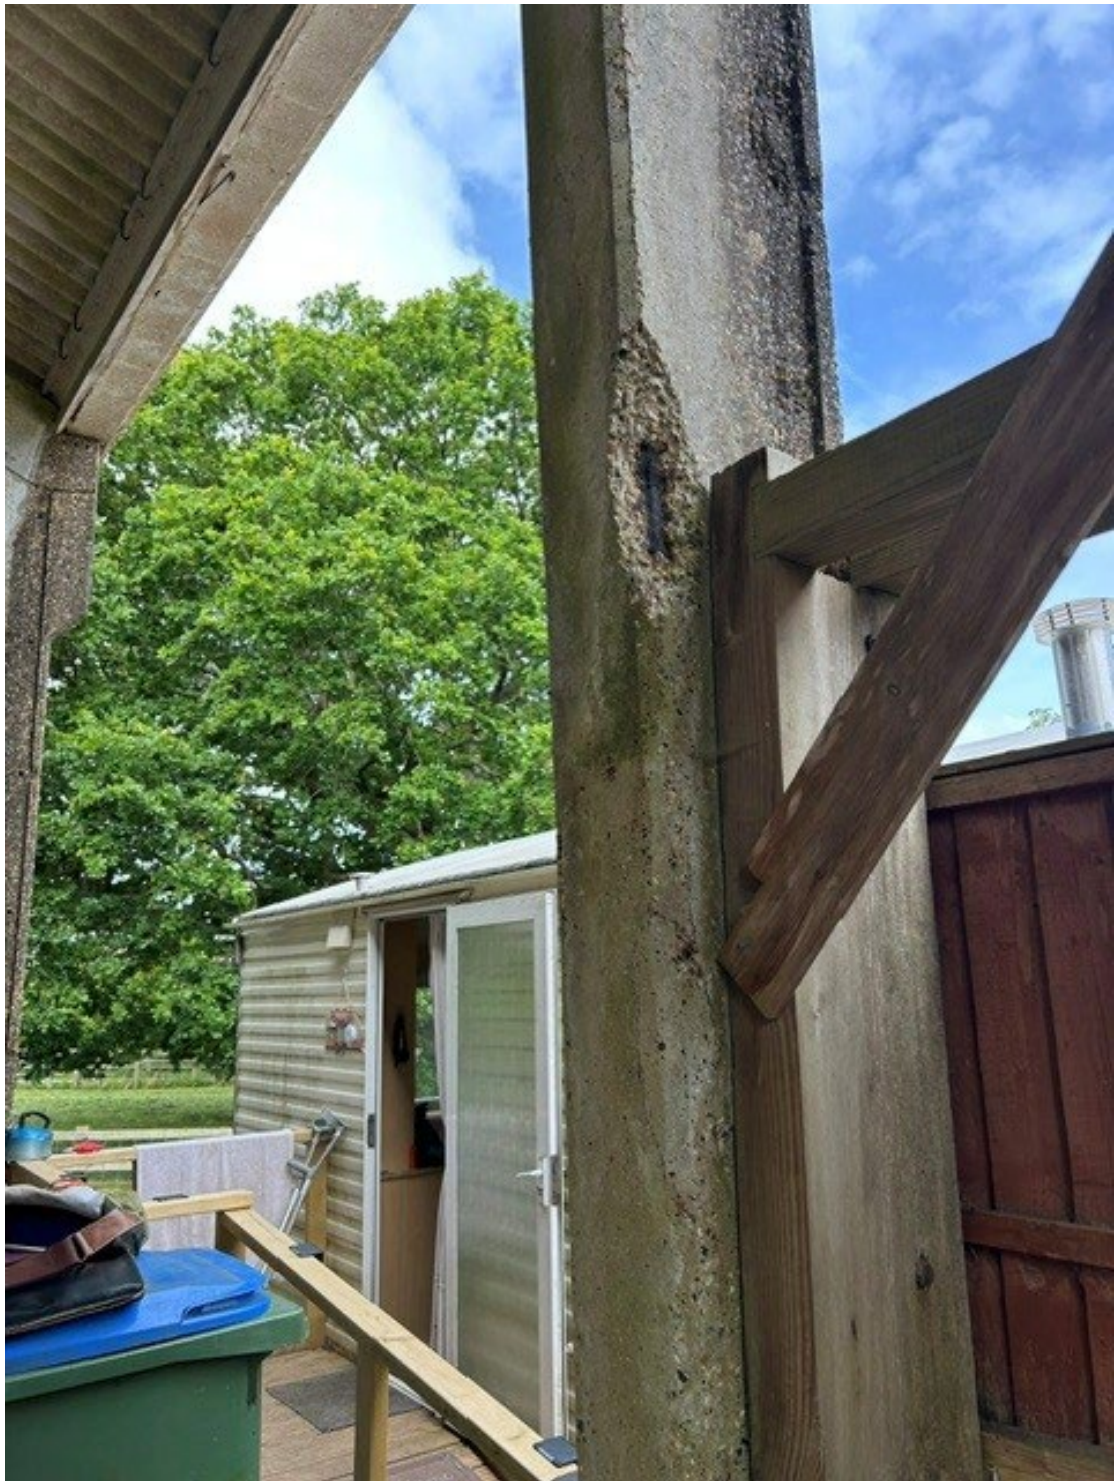
**Figure 3**Column next to Mobile home
