*Project ref: TV260608*

SITE: Land Northwest of Southwater

# ***CCTV Survey Report***

*Sewer Inspection, Cleaning and Repair*

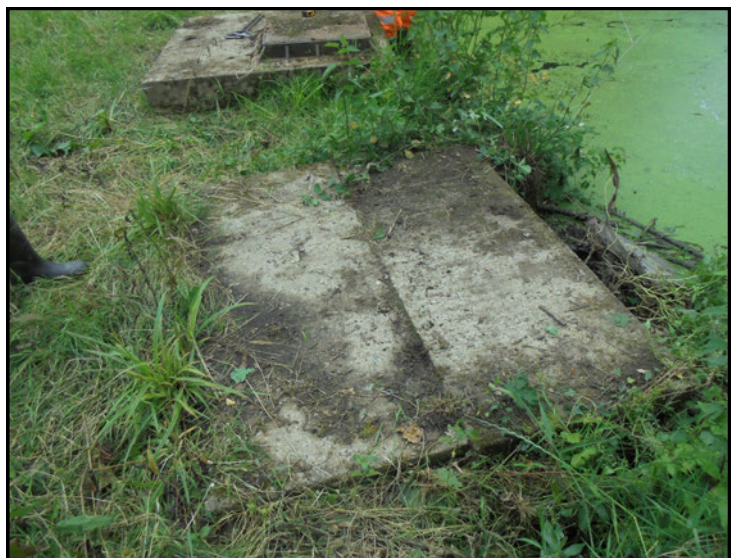
OF2 SLABBED NO ACCESS

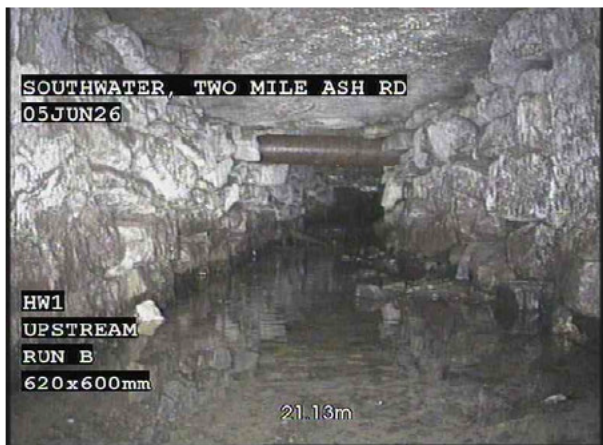
| Item No. | PLR | Grade | Description |
|---|---|---|---|
| 1 | IC3X | 5 | Missing bricks from 12 o'clock to 12 o'clock |

| Scale: | 1:227 | Position [m] | Code | Observation | Grade | |
|---|---|---|---|---|---|---|
| | | 21.13 | MB | Missing bricks from 12 o'clock to 12 o'clock | 5 | |

1, 00:02:31, 21.13 m  
Missing bricks from 12 o'clock to 12 o'clock

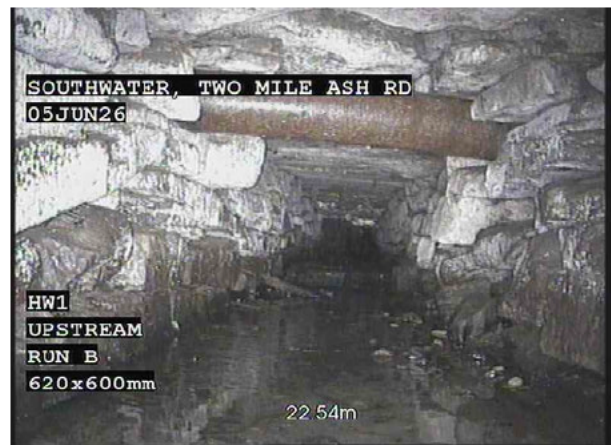
| Item No. | PLR | Grade | Description |
|---|---|---|---|
| 1 | IC3X | 5 | Other obstacles, external pipe or cable from 10 o'clock to 2 o'clock, 20% cross-sectional area loss |

| Scale: | 1:227 | Position [m] | Code | Observation | Grade | |
|---|---|---|---|---|---|---|
| | | 22.54 | OBP | Other obstacles, external pipe or cable from 10 o'clock to 2 o'clock, 20% cross-sectional area loss | 5 | |

2, 00:03:06, 22.54 m  
Other obstacles, external pipe or cable from 10 o'clock to 2 o'clock, 20% cross-sectional area loss

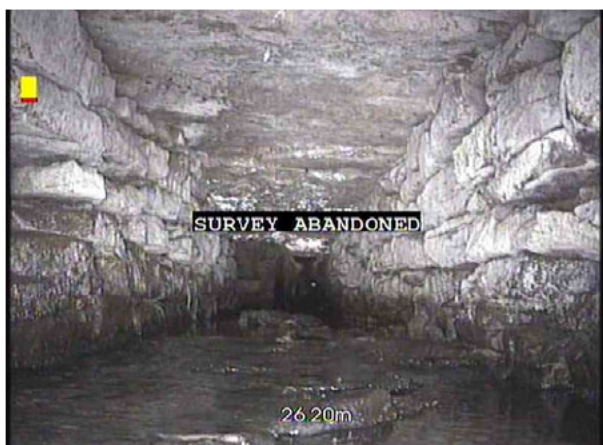
3, 00:04:55, 26.20 m  
Survey abandoned, Unable to continue

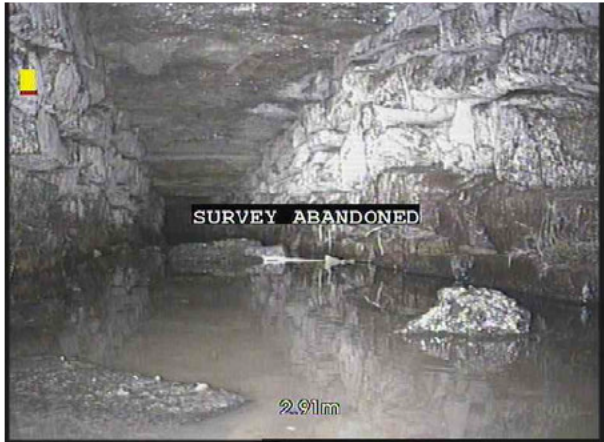
1, 00:00:29, 2.91 m  
Survey abandoned, Unable to pass

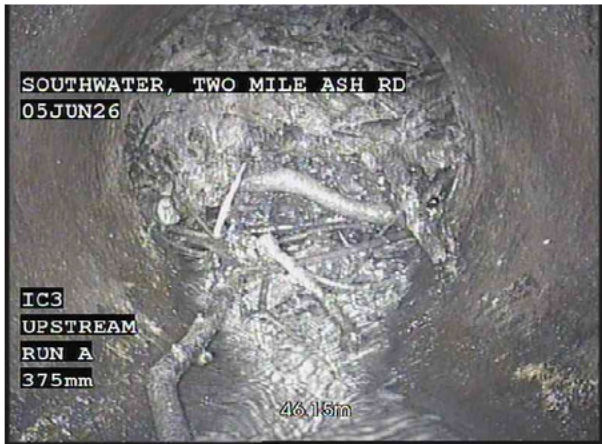
| Item No. | PLR | Grade | Description |
|---|---|---|---|
| 3 | OF2X | 5 | Settled deposits, coarse, 100% cross-sectional area loss |

| Scale: 1:400 | Position [m] | Code | Observation | Grade |
|---|---|---|---|---|
| 46.15 | DER | Settled deposits, coarse, 100% cross-sectional area loss | 5 | |

1, 00:04:00, 46.15 m  
Settled deposits, coarse, 100% cross-sectional area loss

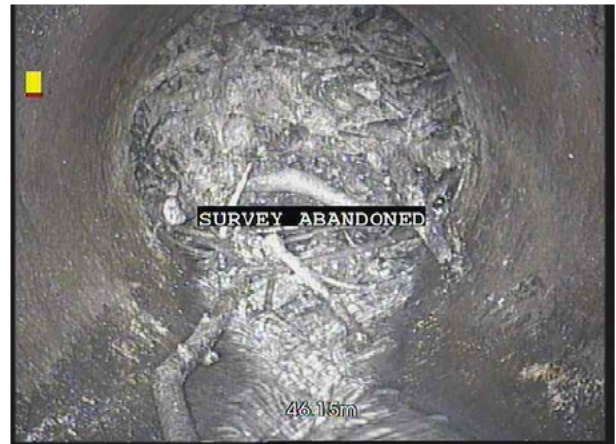
2, 00:04:08, 46.15 m  
Survey abandoned, At OF2 chamber - debris filled

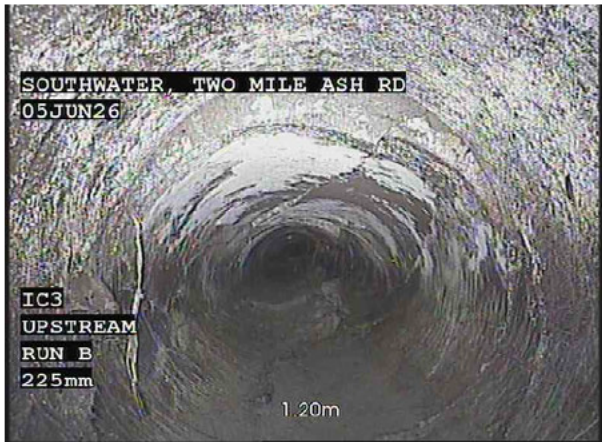
| Scale: 1:50 | Position [m] | Code | Observation | Grade |
|---|---|---|---|---|
| | 1.20 | S01 | Fractures, multiple from 12 o'clock to 12 o'clock, start | 4 / 2 |

1, 00:00:12, 1.20 m  
Fractures, multiple from 12 o'clock to 12 o'clock, start

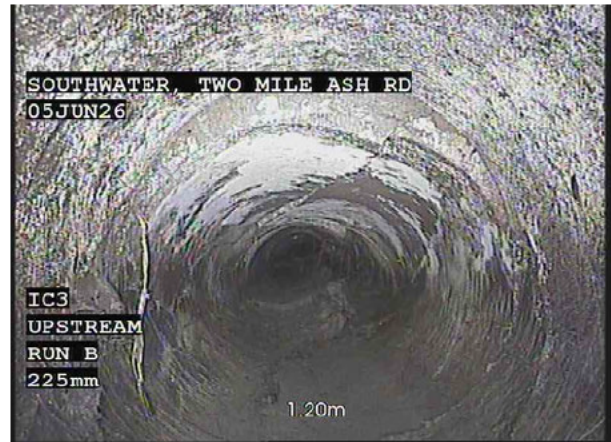
| Scale: 1:50 | Position [m] | Code | Observation | Grade |
|---|---|---|---|---|
| | 1.20 | S02 | Deformed sewer or drain, 20%, start | 5 / 4 |

2, 00:00:18, 1.20 m  
Deformed sewer or drain, 20%, start

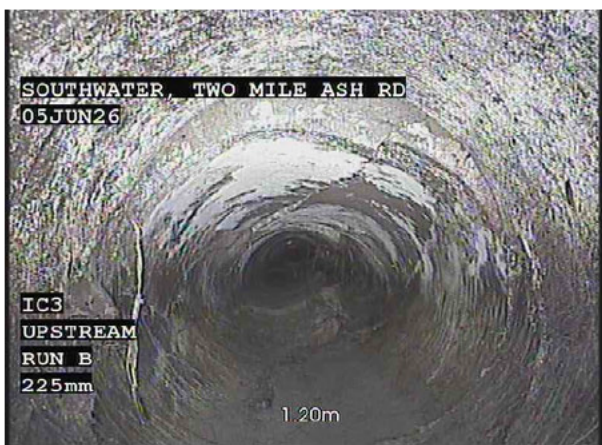
| Scale: 1:50 | Position [m] | Code | Observation | Grade |
|---|---|---|---|---|
| | 1.20 | S03 | Settled deposits, fine, 10% cross-sectional area loss, start | 3 |

3, 00:00:25, 1.20 m  
Settled deposits, fine, 10% cross-sectional area loss, start

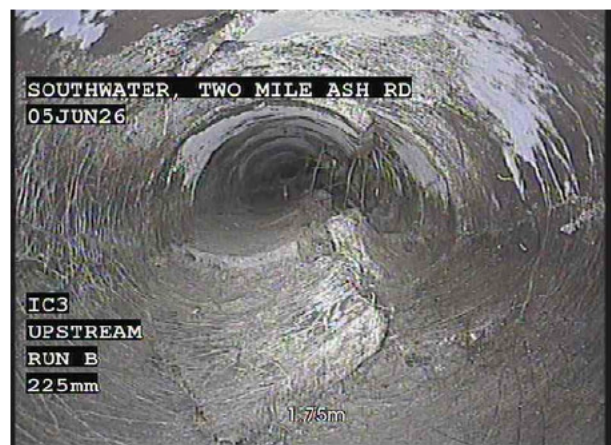
| Scale: 1:50 | Position [m] | Code | Observation | Grade |
|---|---|---|---|---|
| | 1.75 | D | Deformed sewer or drain, 50% | 5 / 4 |

4, 00:00:42, 1.75 m  
Deformed sewer or drain, 50%

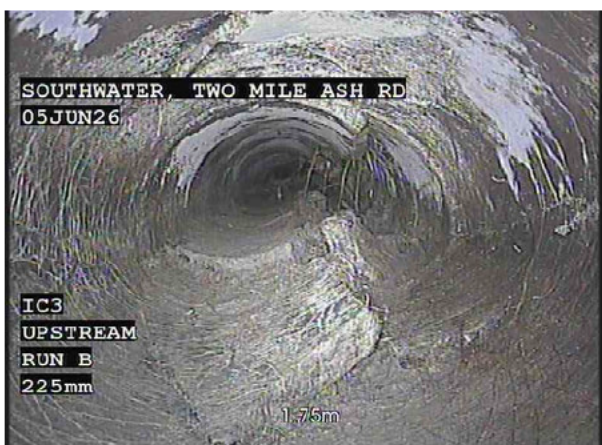
| Scale: 1:50 | Position [m] | Code | Observation | Grade |
|---|---|---|---|---|
| | 1.75 | B | Broken pipe from 12 o'clock to 12 o'clock | 4 |

5, 00:00:49, 1.75 m  
Broken pipe from 12 o'clock to 12 o'clock

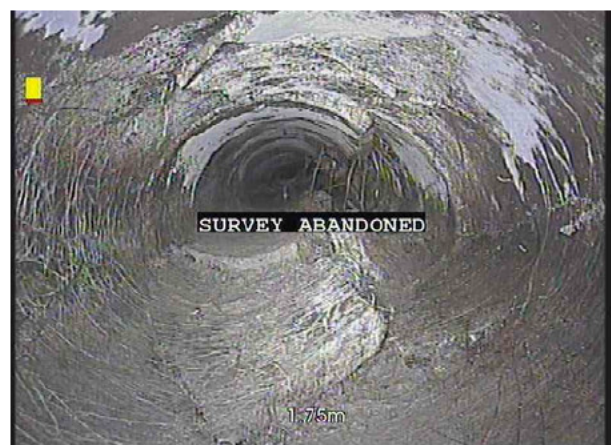
6, 00:00:57, 1.75 m  
Survey abandoned, Unable to pass - assumed redundant

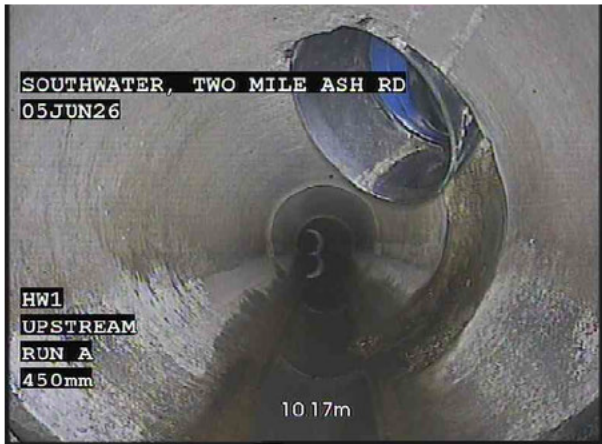
| Item No. | PLR | Grade | Description |
|---|---|---|---|
| 5 | IC1X | 4 | Connection defective, connecting pipe is intruding at 2 o'clock, 150mm dia intrusion: 20% |

1, 00:00:57, 10.17 m  
Connection defective, connecting pipe is intruding at 2 o'clock,  
150mm dia, intrusion: 20%

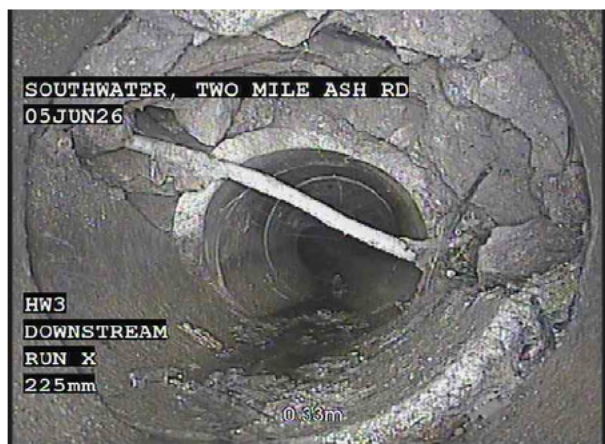
| Scale: 1:106 | Position [m] | Code | Observation | Grade |
|---|---|---|---|---|
| 0.33 | VV | Void visible beyond defect | | |

1, 00:00:32, 0.33 m  
Void visible beyond defect

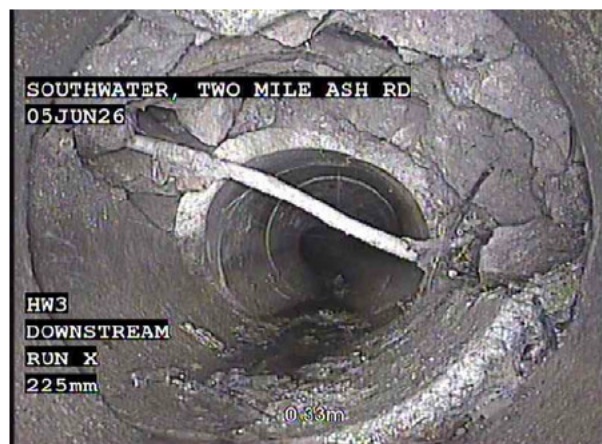
| Scale: 1:106 | Position [m] | Code | Observation | Grade |
|---|---|---|---|---|
| 0.33 | B | Broken pipe from 10 o'clock to 4 o'clock | 4 | |

2, 00:00:40, 0.33 m  
Broken pipe from 10 o'clock to 4 o'clock

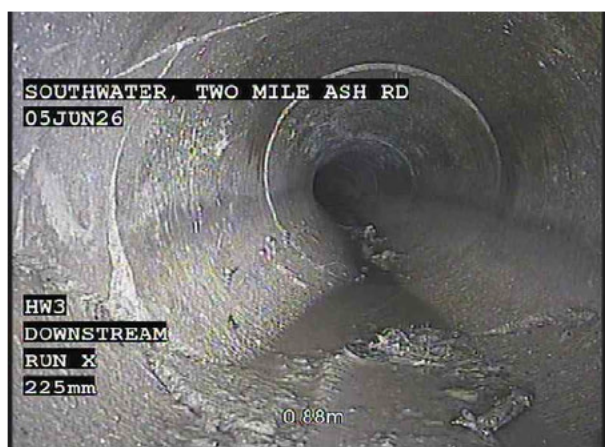
| Scale: 1:106 | Position [m] | Code | Observation | Grade |
|---|---|---|---|---|
| 0.88 | FM | Fractures, multiple from 12 o'clock to 12 o'clock | 4 / 2 | |

3, 00:01:02, 0.88 m  
Fractures, multiple from 12 o'clock to 12 o'clock
