# Gale Tree Consultancy

## Tree Condition Report

Wildwood, Mannings Heath, RH13 6LZ

November 2025

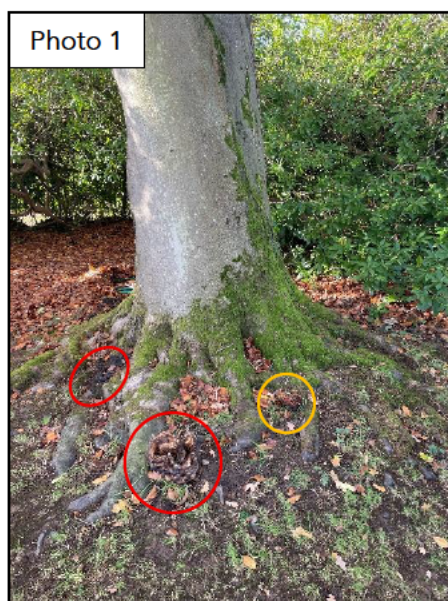
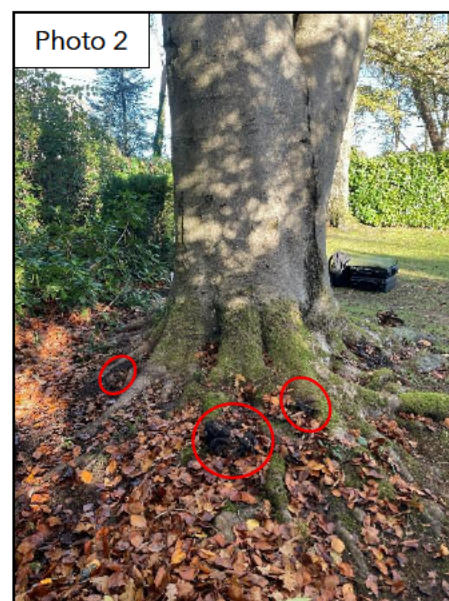
- The tree has developed surface roots which merge into buttress root around the stem
- Decaying fruiting bodies of the decay fungus *Meripilus giganteus* (Giant polypore) are present within the surface roots and buttress roots on the east, southeast, southwest, west, and northwest buttress roots circled red in Photo 1 and 2 below

- Also within the surface roots on the east side of the tree is a fruiting body of *Podoscypha multizonata* (Zoned rosette) fungus fruiting body on the east side circled yellow in Photo 1 below

- The main stem forks c.2.5m into a west primary stem section and an east secondary stem section
- The union is included and appears to extend down to ground level

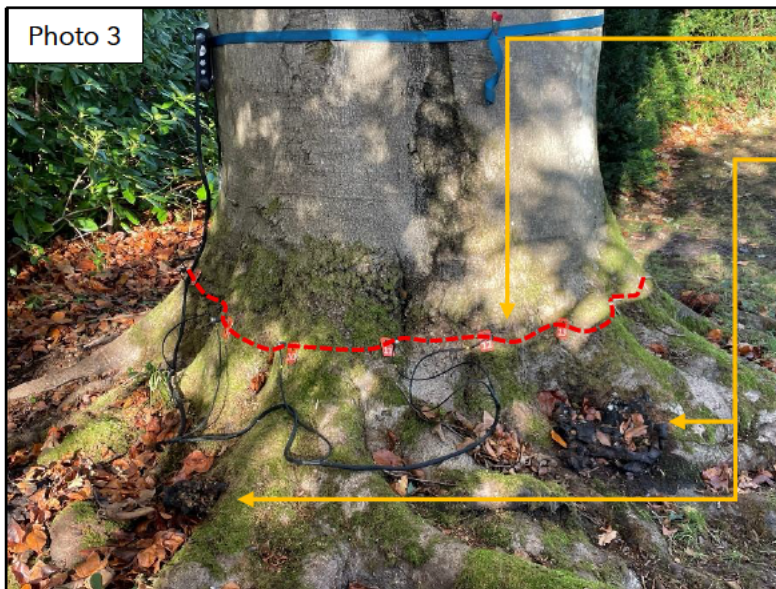
Photo 3

Height of assessment c.30cm above ground level

Note the decaying fruiting bodies of the *Meripilus giganteus* fungus

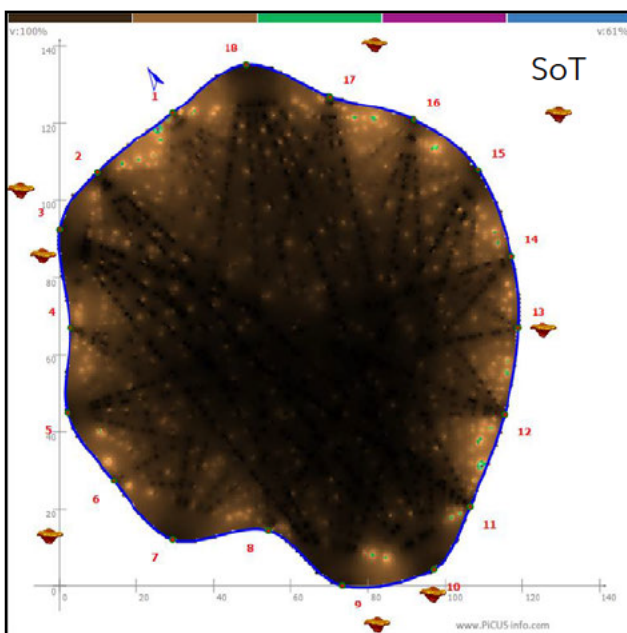
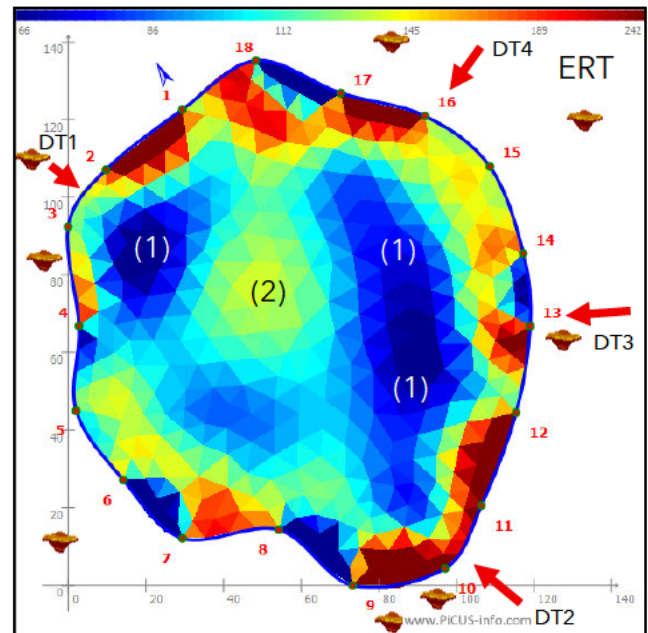
- The SoT assessment indicates an area of high sonic velocity, and as such sound wood, across the level of assessment as shown by the brown colour present

- The ERT assessment shows an area of high electrical conductivity, and as such low electrical resistance, as shown by the blue colouration adjacent to MP3 and between MP11 and MP17 (see number 1 on the tomogram)
- The faint red/yellow colour (2) shows an area of low electrical conductivity and slightly increased electrical resistance
- The red around the outer edge references the high electrical resistance and low electrical conductivity of the sound wood of the buttress areas, whilst the blue patches around the outside shows the sapwood
- To confirm the tomogram, the Resi PD400 was used in three locations, at the level of assessment - please see the red arrows on the ERT result on the previous page and the drill traces below:

- The SoT results shows sound wood across the assessed plane as shown by the brown colouration
- However, the ERT result shows that beneath the assessment level, decay is beginning to establish, as evidenced by the blue colouration (1) along the east and northwest side of the stem

- The faint yellow/red area (2) on the tomogram shows that the central area of the root crown is beginning to become degraded as this area is typically only red on Common beech trees

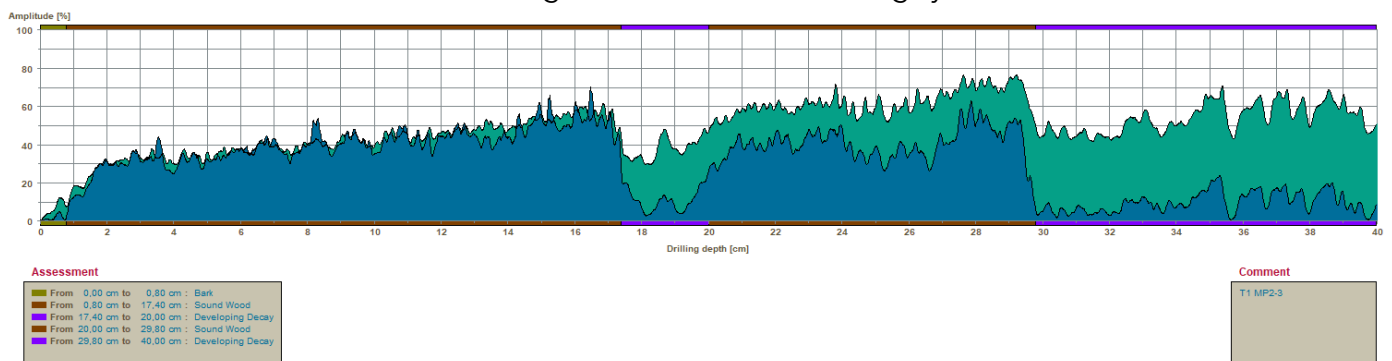
### Drill Trace 1 - between MP2 and MP3 angled at -30° into the rooting system

- This was confirmed by Drill Traces 1, 2 and 3 which all show the quality of the wood is beginning to wane after initially showing a good depth of sound wood. Drill Trace 4 shows sound wood is present along the entire 40cm assessment length

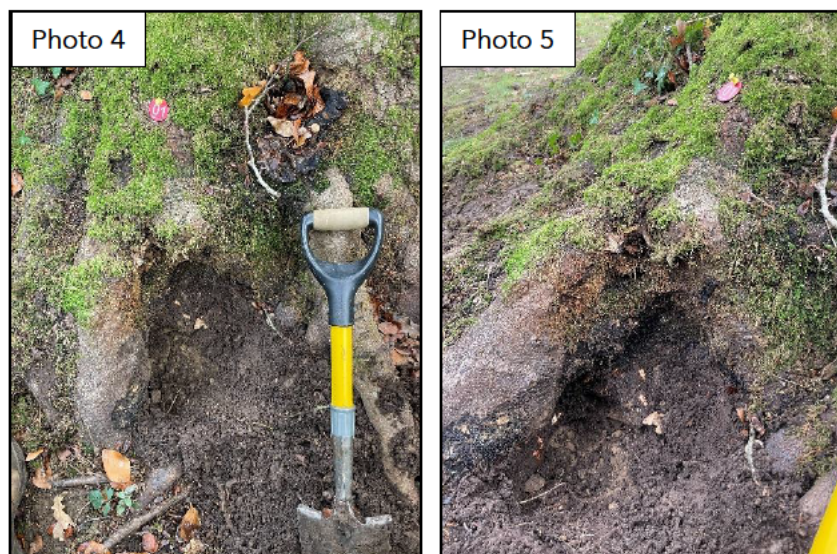
### Buttress Root North - fungal fruiting body beneath MP2 and MP3

- The exposed roots appeared hard with no deterioration of the wood structure visible
- See Drill Trace 1 which was performed slightly above the excavated area

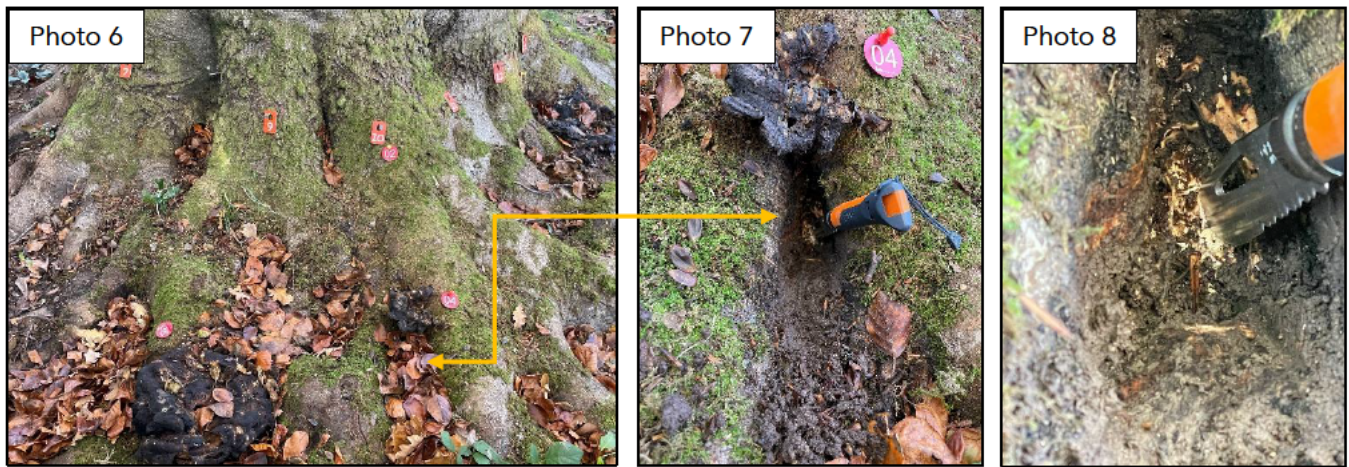
## Buttress Root South - fungal fruiting body beneath MP10

- Soft wood was found to the side of the buttress root suggesting possible decay - see Photo 8 above

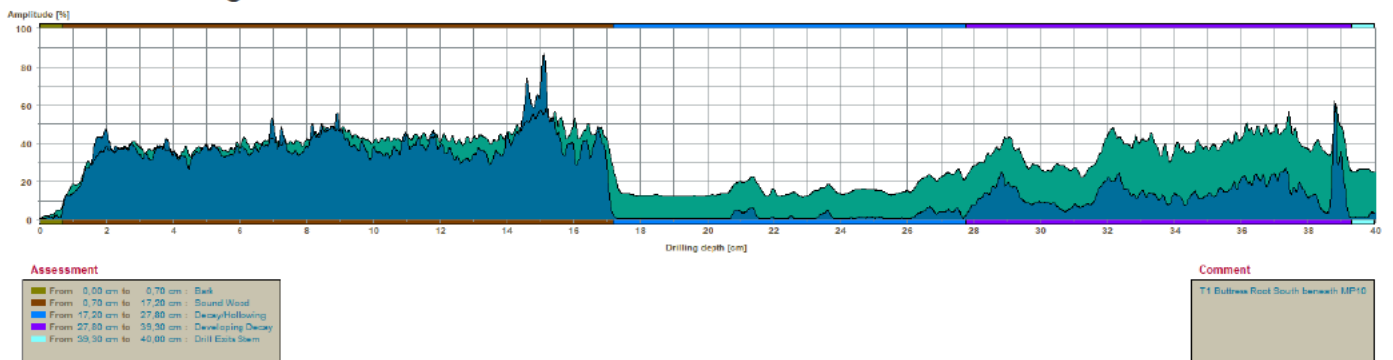
## Drill Trace 5 - angled at -30° into the buttress root

- Drill Traces 5, 6 and 7 shows varying stages of decay on the underside of the root assessed

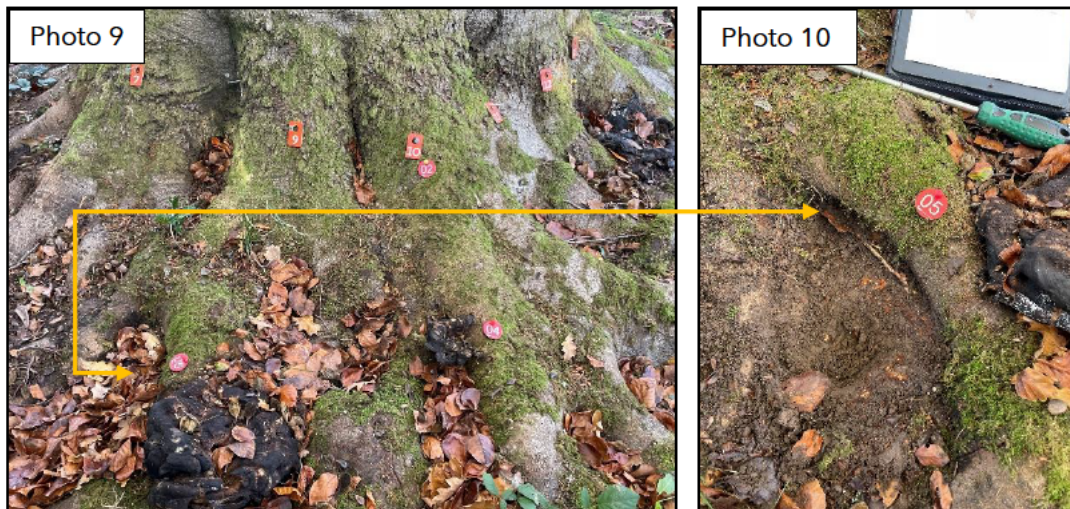
## Buttress Root South - fungal fruiting body beneath MP9

- The exposed roots appeared hard with no deterioration of the wood structure visible

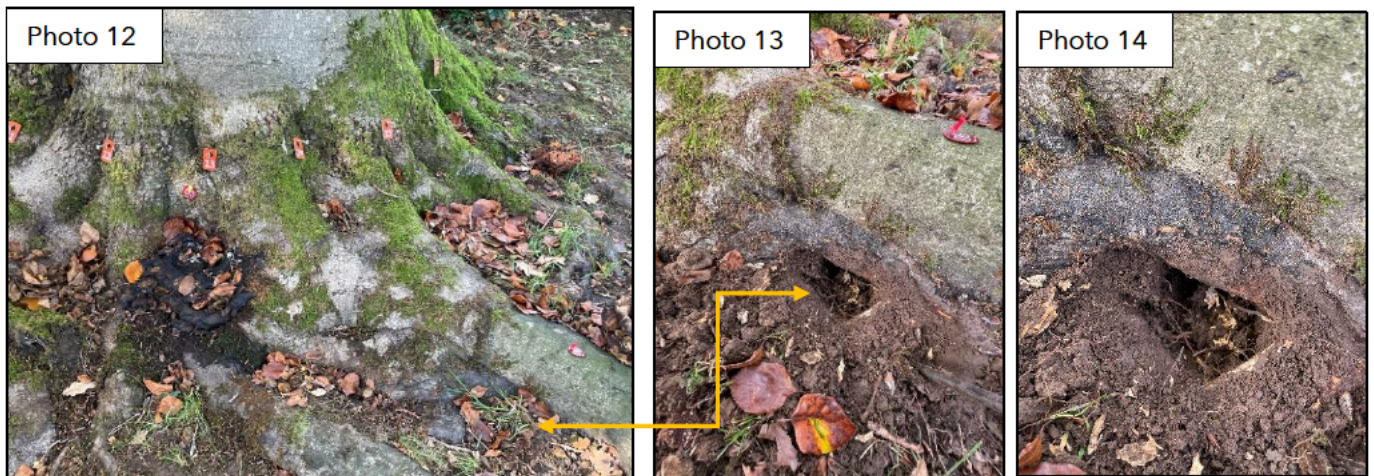
## Buttress Root East - fungal fruiting body beneath MP14 and MP15

- Soft wood was found to the side of the buttress root suggesting possible decay - see Photo 14 above
