**MARK AND JO ROBINSON**

MILL FARM, MILL LANE, ITCHINGFIELD, HORSHAM,  
WEST SUSSEX RH13 0NP

**Preliminary Contamination Risk Assessment**

February 2026

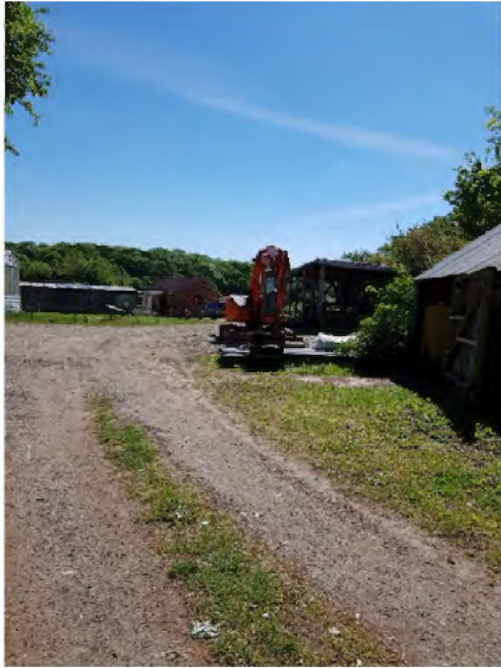
**Photograph 1:**

The site is accessed from Mill Lane to the west of the site via a new access route which cuts across the northwest corner of a field before joining the original shared access from a neighbouring residential property on Mill Lane.

The access up to and around the buildings (pictured left) is surfaced with compressed road planings. There is little hard surfacing across the site, grass surrounds the buildings.

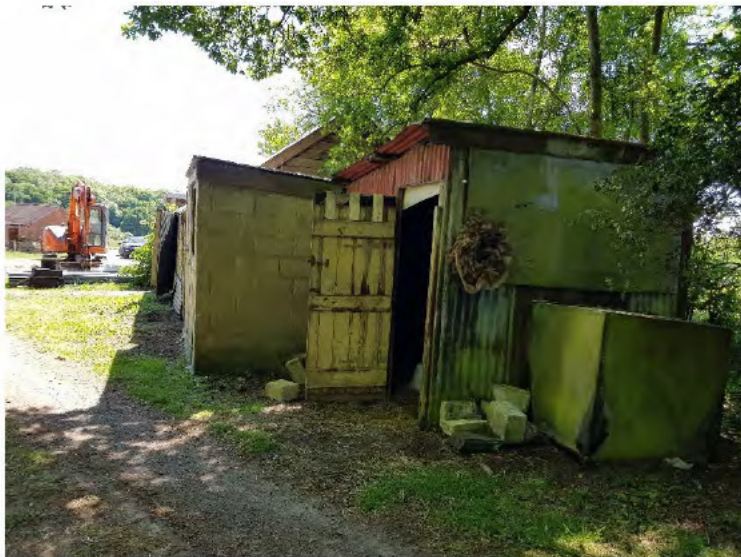
**Photographs 2 and 3:**

A small, single pitched 'shed' constructed from corrugated metal (left) and a concrete block stable with corrugated metal roof, located to the south of the access road. A metal fuel tank is located adjacent to the western façade of the shed. Inspection of the tank identified a small quantity of diesel at the bottom of the tank.

- iii. The diesel tank to the west of the yard has been removed. The soil within the vicinity of the tank should be removed and replaced with clean topsoil from an uncontaminated source.

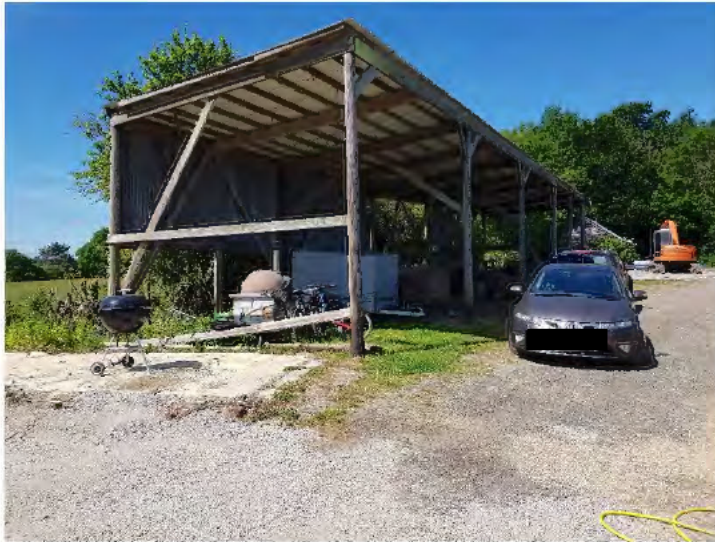
**Photograph 8:**

To the east of the hay barn is the remaining concrete base of a single garage. The garage included asbestos containing materials and has been removed from the site.

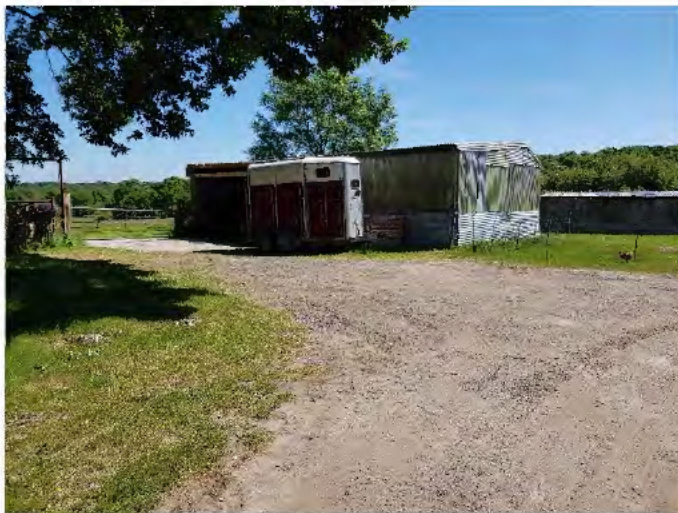
**Photograph 14:**

To the west of this stable building, north of the site access road, is a corrugated metal building currently used for the storage of household items. This building has a compressed dirt floor.

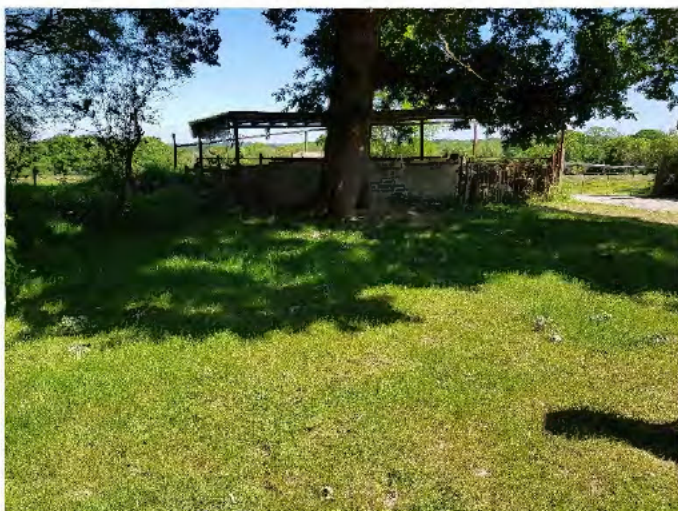
**Photograph 15:**

The final building is small cattle shelter within the field to the north of the access road.

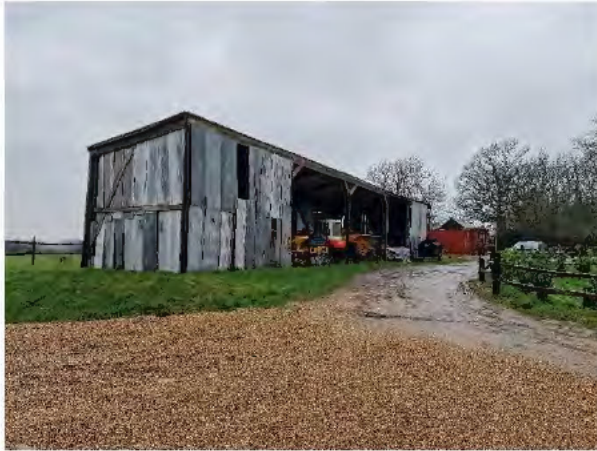
**Photograph 1 - 3: Hay Barn**

Hay barn located to the east of the site, to be removed to make way for the redevelopment of the site.
