# GEOTECHNICAL

## for Subsidence Management Services

22 Princess Anne Road, Horsham, RH12 3HR

## Drainage Investigation Report

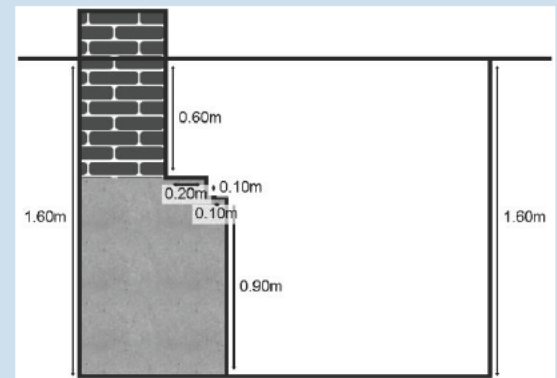
## TP/BH2 Foundation Detail and Borehole Log

House foundation was partially exposed and comprised of brick wall to 600mm bgl, bearing on stepped concrete to a depth of at least 1600mm bgl, with a total projection of 300mm from the elevation.

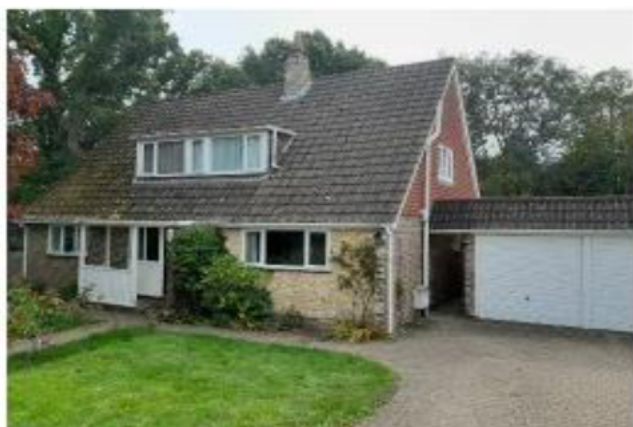
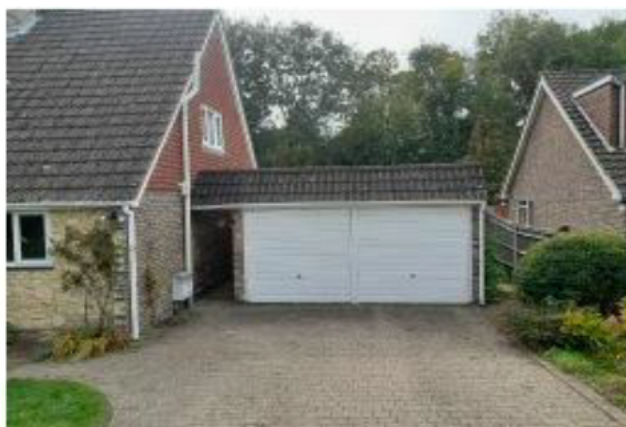
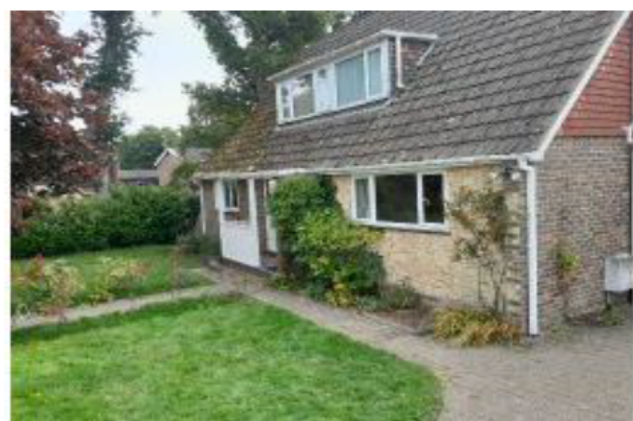
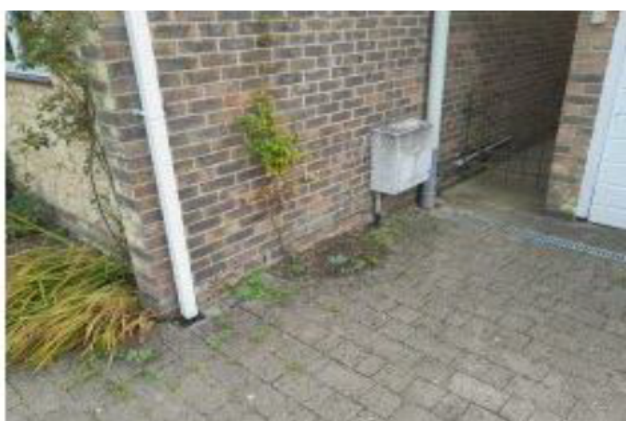
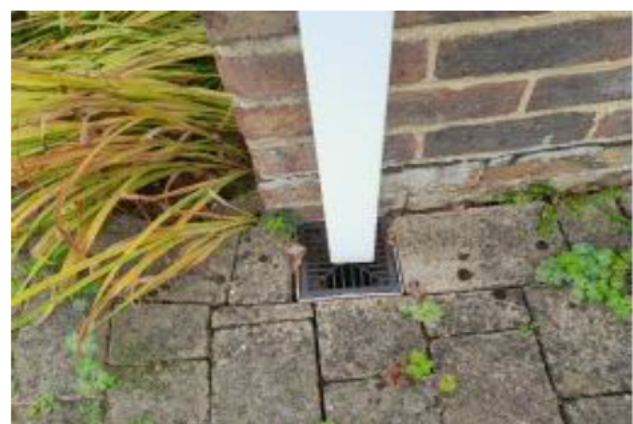
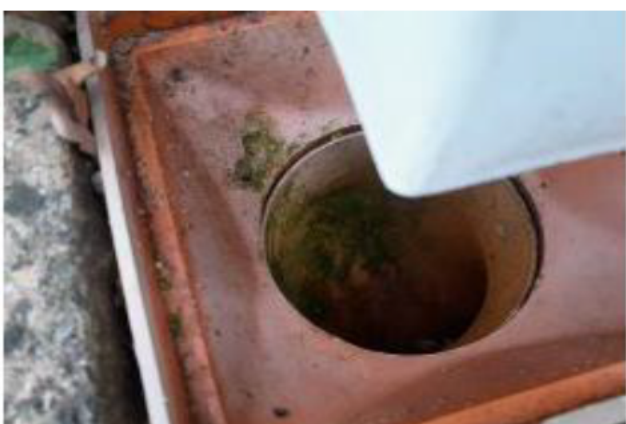
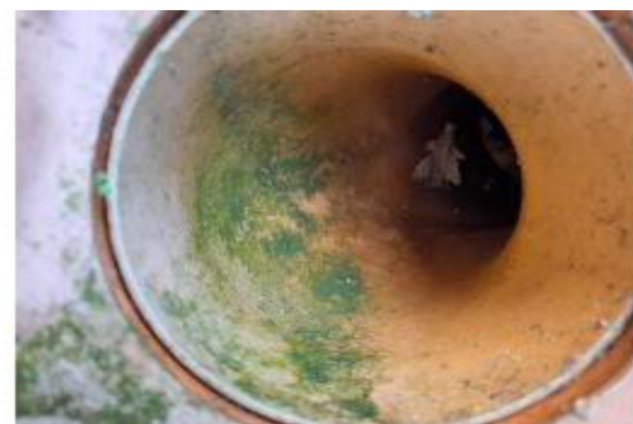
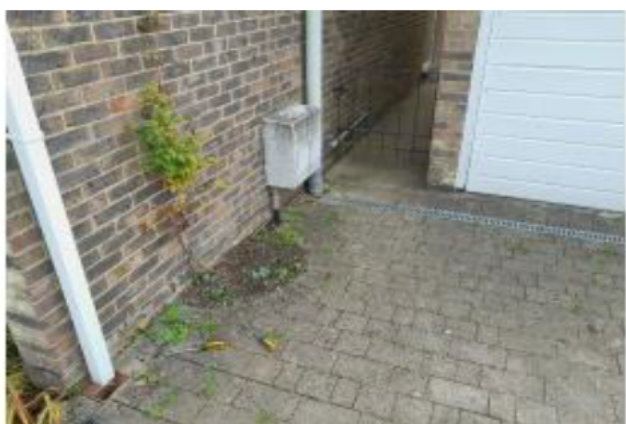
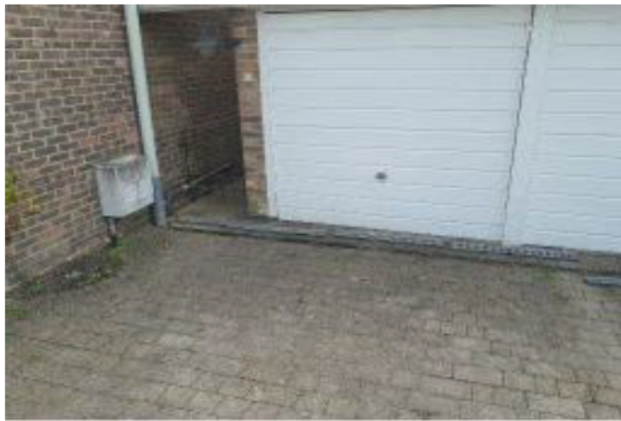
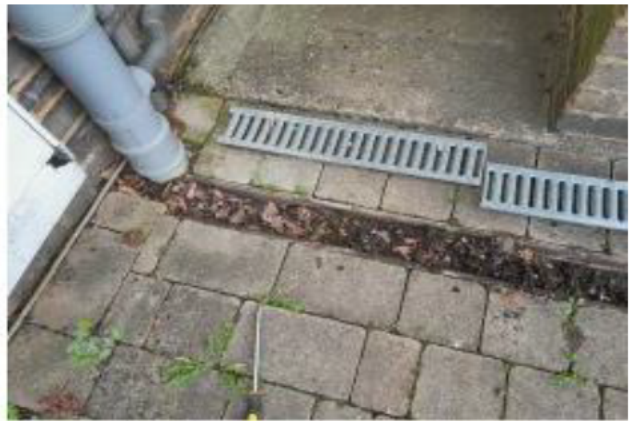
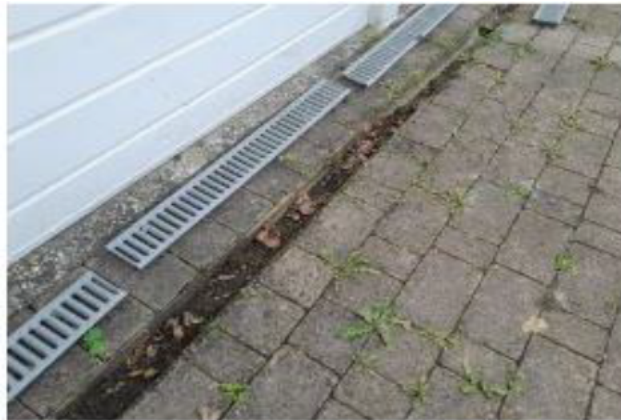
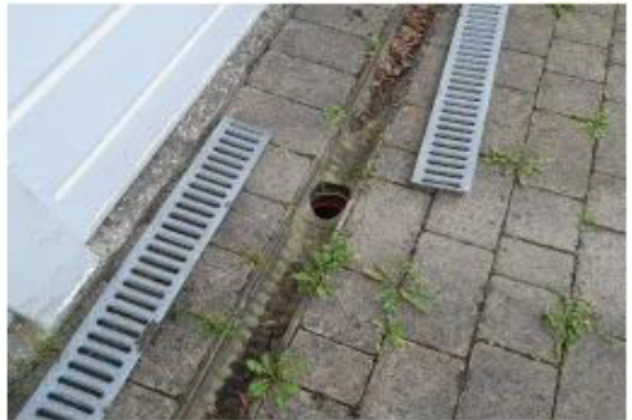
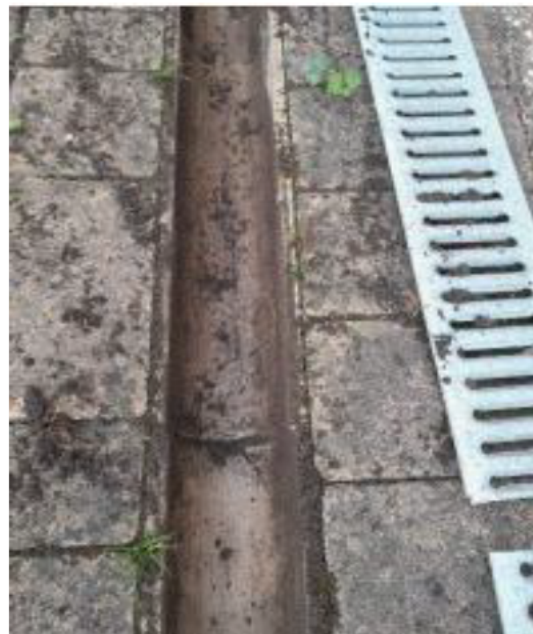
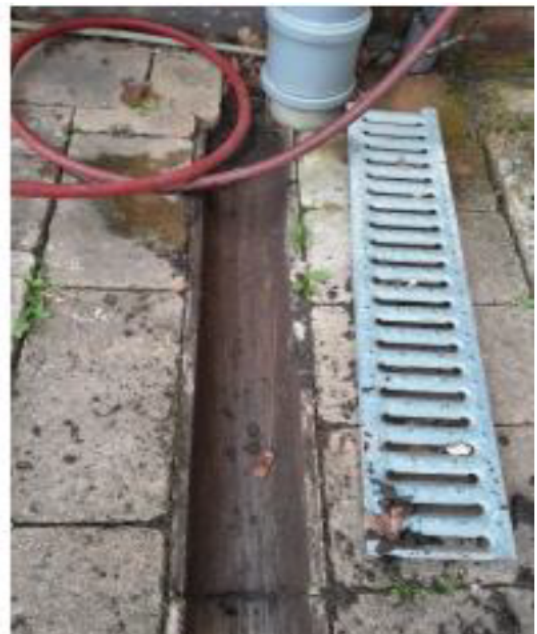
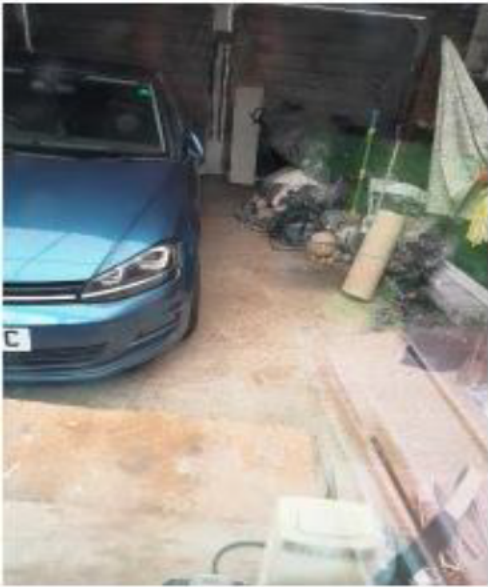
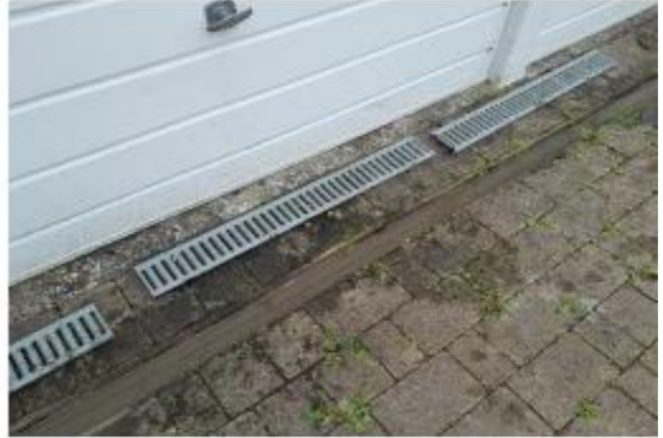
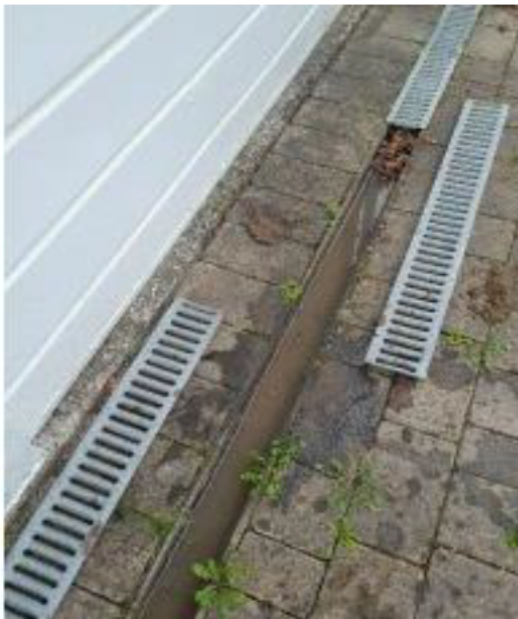
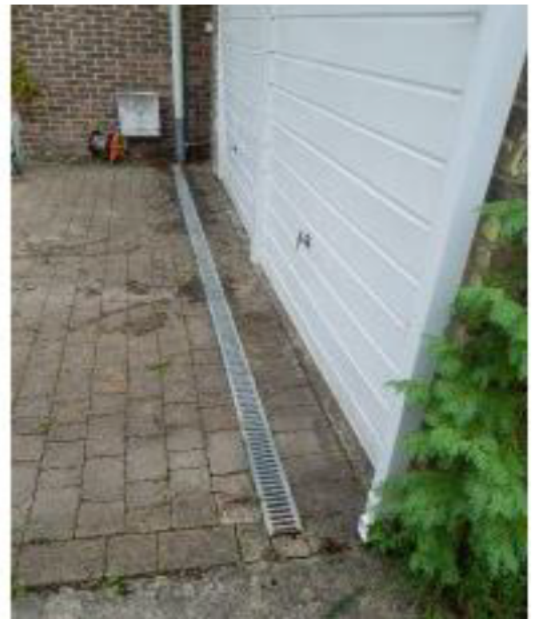
**CCTV Survey Result:** Structural damage

**CCTV Survey Result:** No structural damage. Drain affected with high water level. Drain is holding downstream from aco. HPWJ was attempted but stopped at 4m and drain was holding after jetting.

To excavate and replace existing Rest bend at base of SVP including 1m of adjacent pipework

To prepare the drain line and insert 6m of structural liner to cover defects downstream to MH1

Trace and excavate 4m downstream from ACO outlet (inside garage?)

Further HWPJ to clear drain required

**ACO:** It is recommended to cement in a section of the ACO near the SVP (see pics)
