# ARBORICULTURAL CONDITION AND HAZARD ASSESSMENT REPORT

## Protected Oak Tree (TPO) Oaken Brick, Threals lane, West Chiltington, RH20 2rf.

**Inspection Date:** 21 July 2026

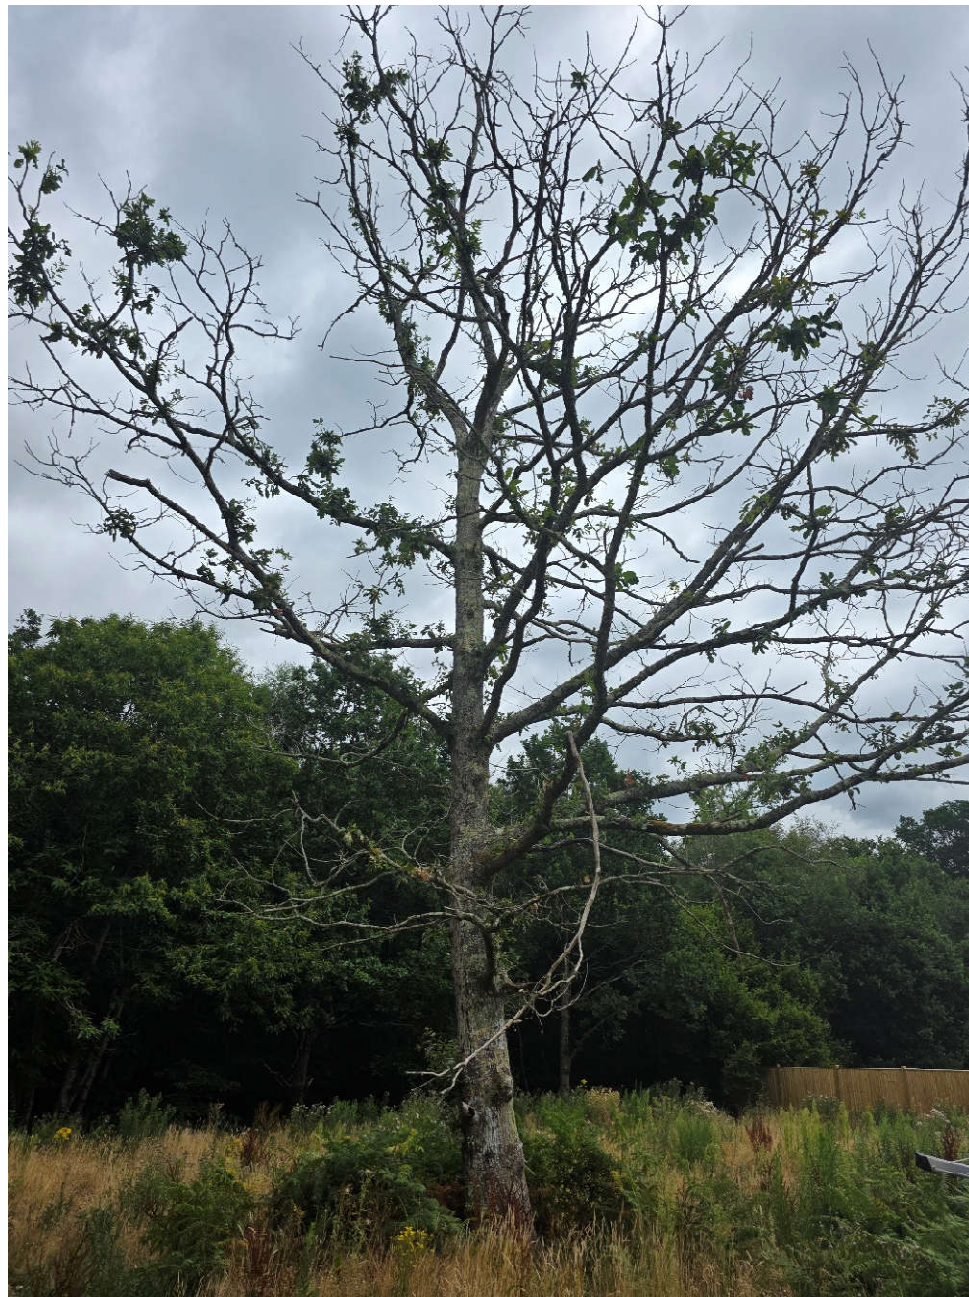
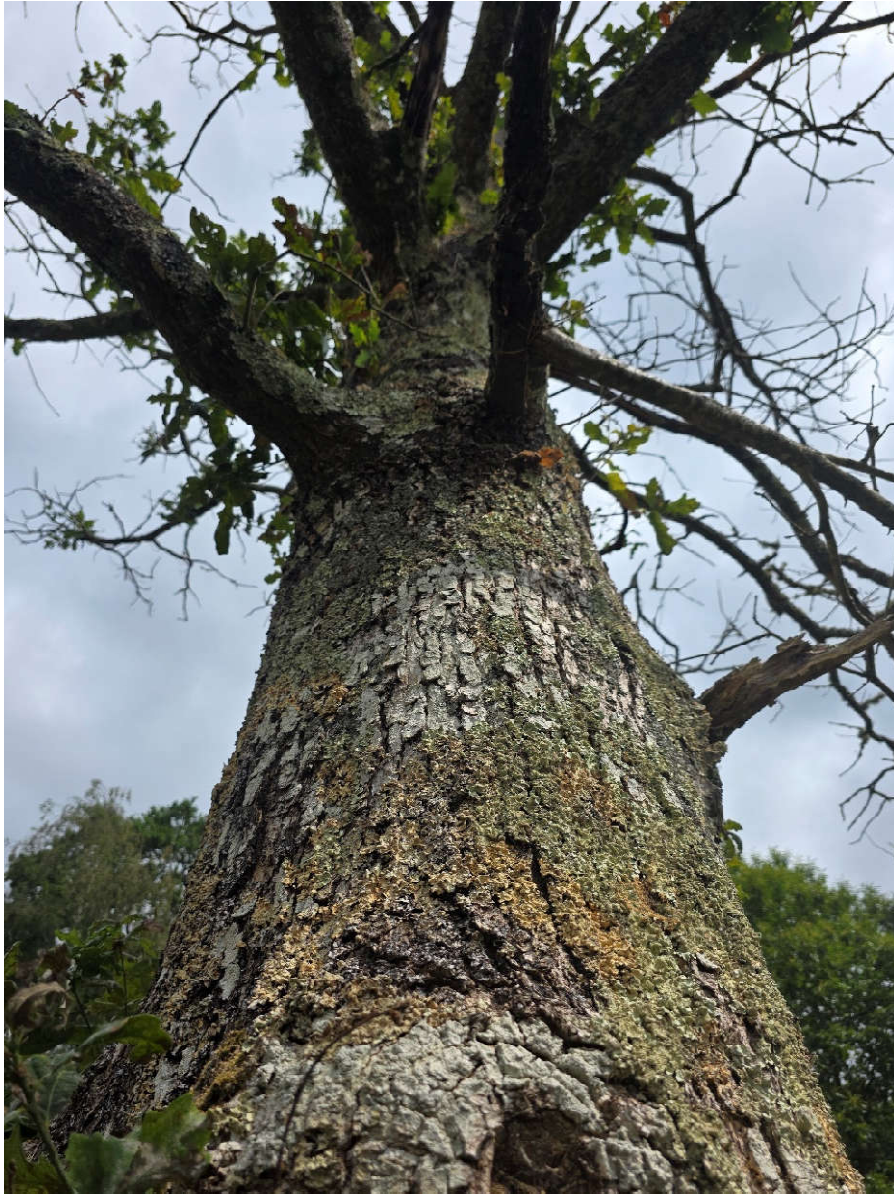
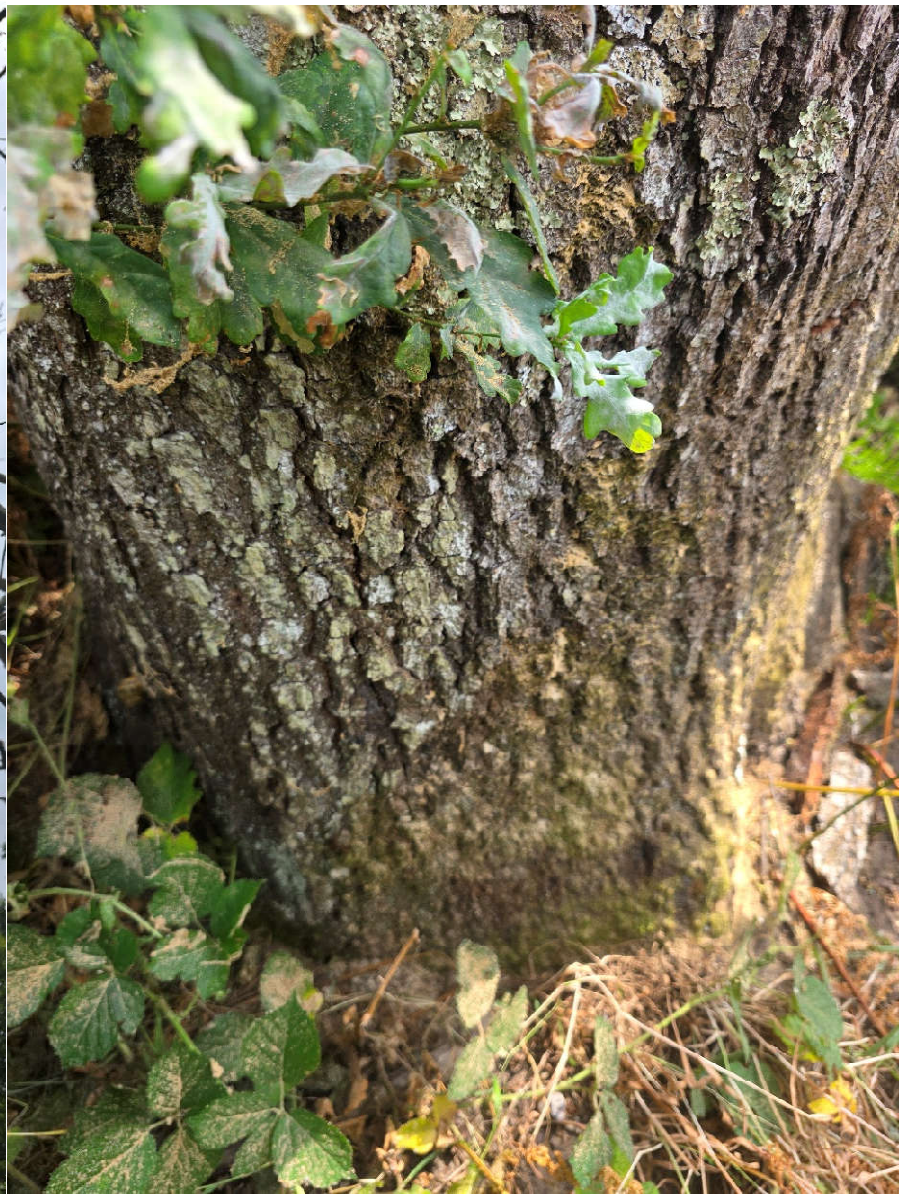
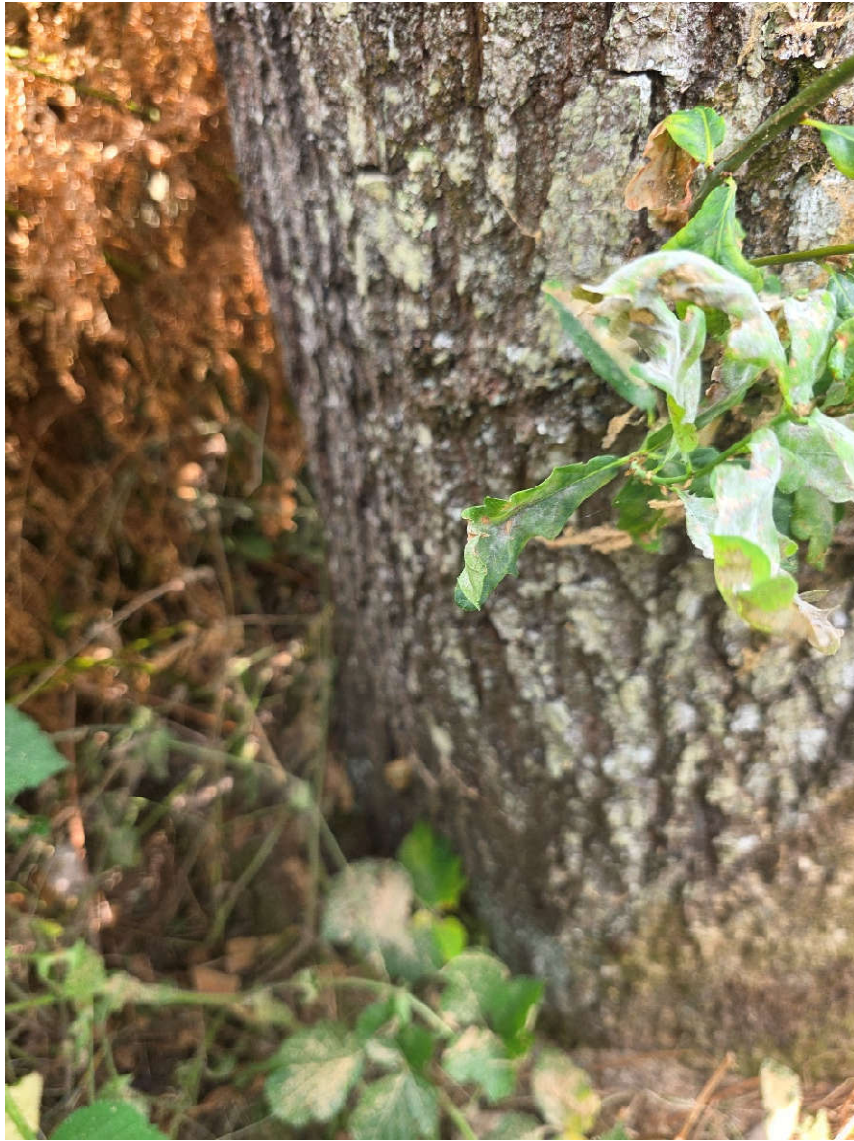
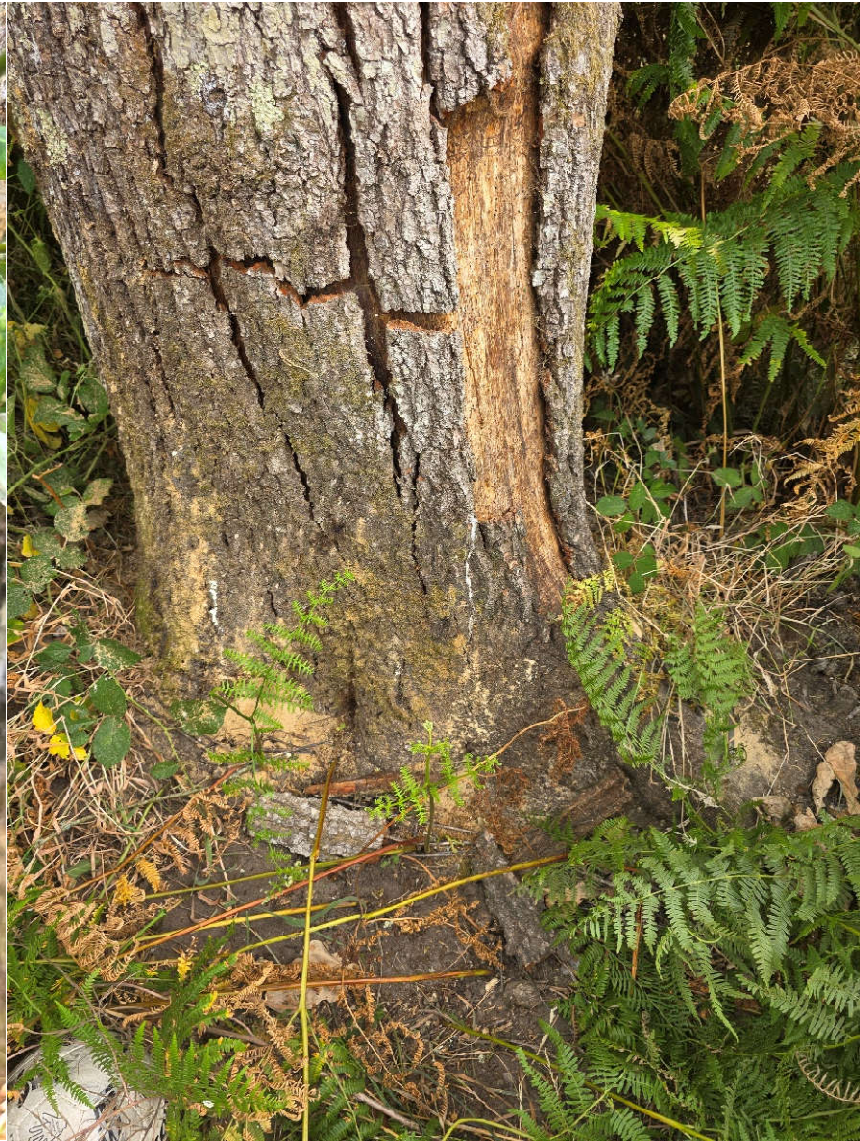
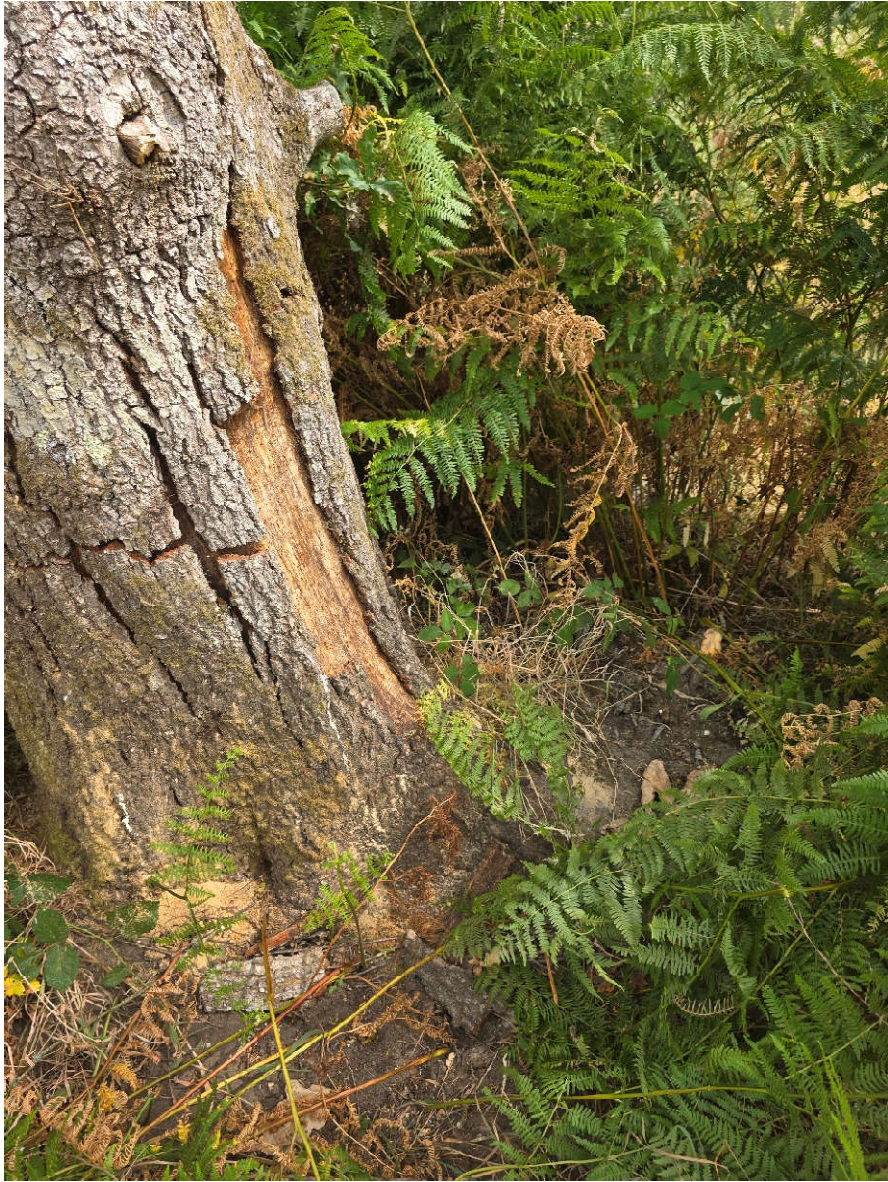
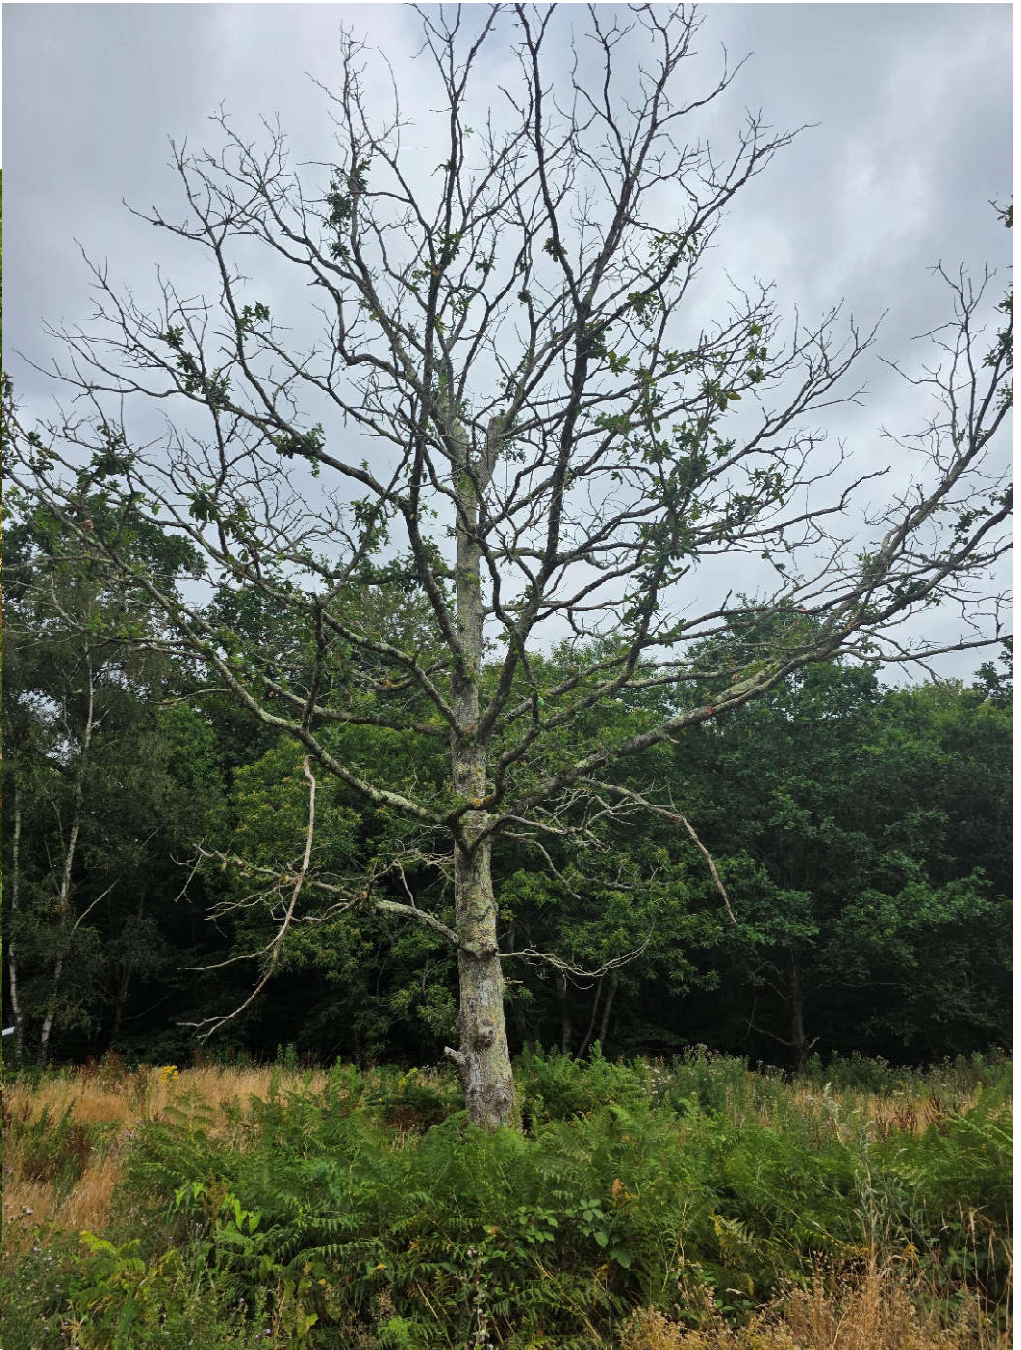
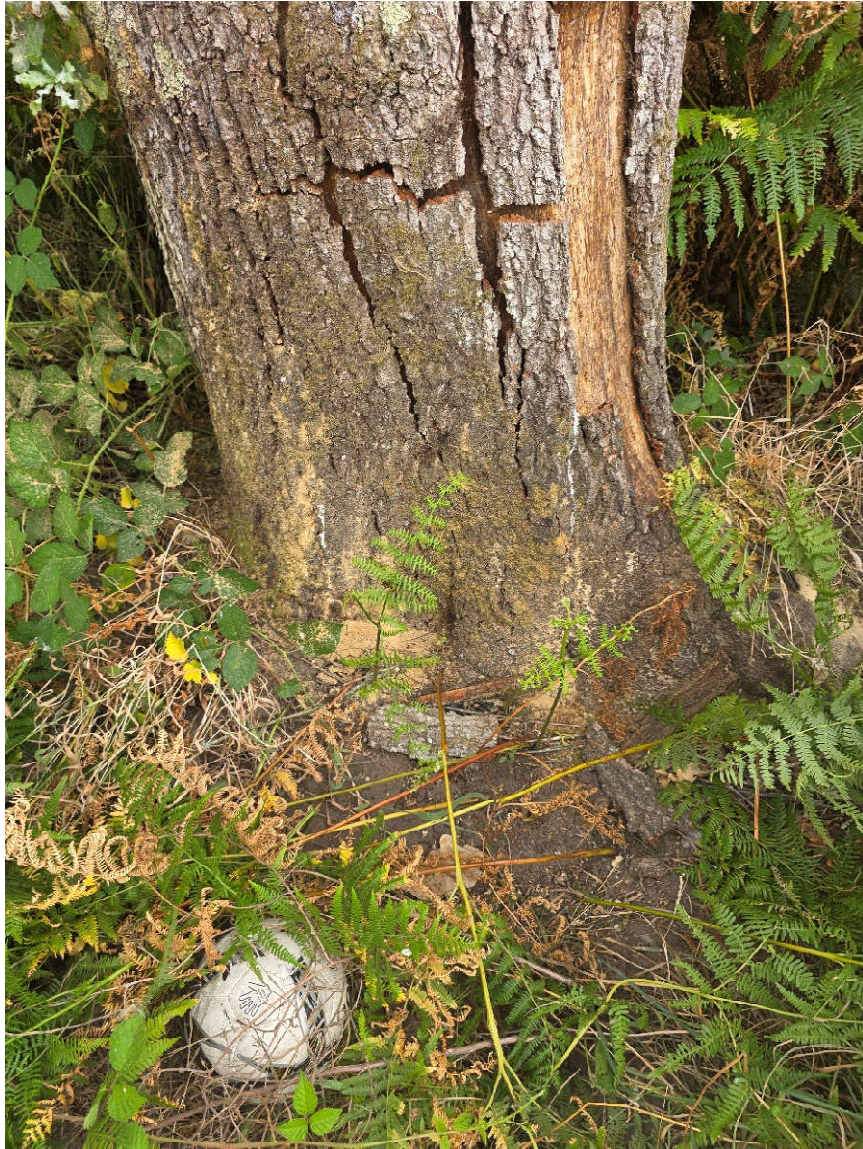
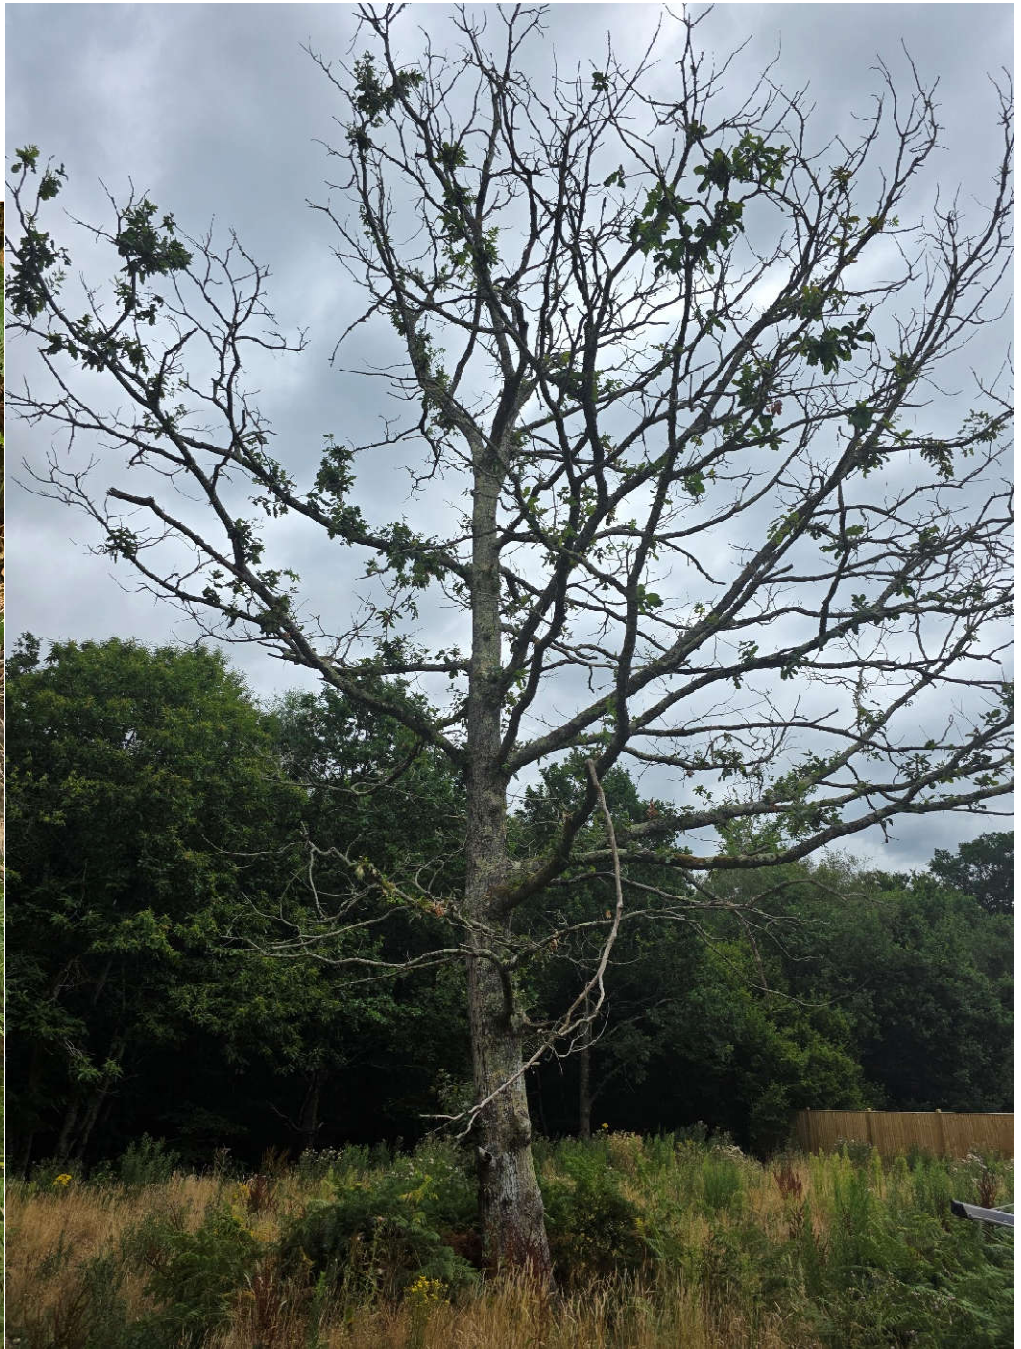
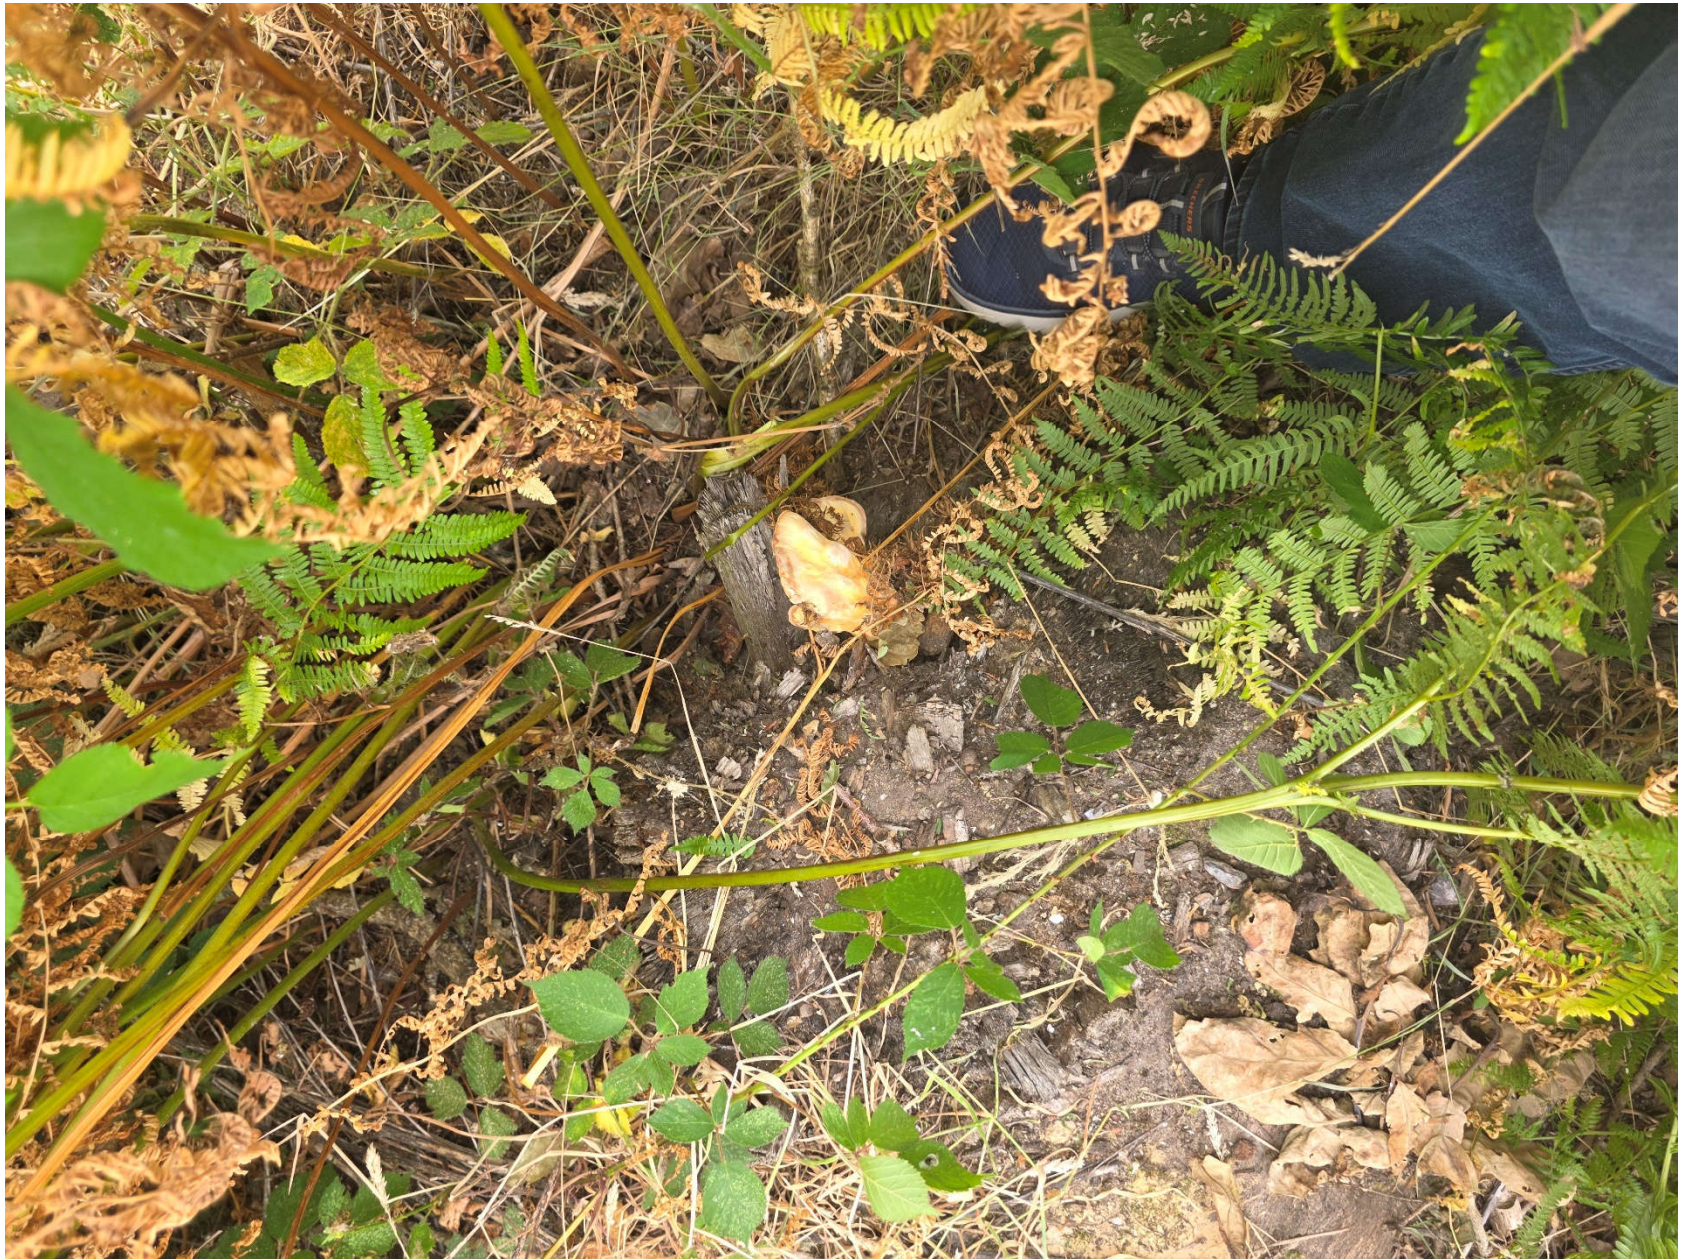
The crown exhibits extensive dieback throughout, with the majority of the canopy now consisting of dead branches and only isolated areas of live foliage remaining. Physiological vigour is very low and the tree is visually in advanced decline.

The western side of the stem exhibits extensive bark necrosis, bark lifting and delamination. Areas of detached bark and exposed wood are evident extending vertically up the stem. The affected area is estimated to encompass approximately 30% of the stem circumference/diameter at the point of assessment.

The exposed wood beneath the detached bark appears desiccated and non-functional, indicating extensive cambial dysfunction and loss of conductive tissue.

Numerous sap exudations are present on the main stem. Such symptoms are frequently associated with dysfunction of the vascular system and may indicate progressive xylem failure and underlying decay processes.

Evidence of insect activity is also present at the base of the stem in the form of frass deposits, suggesting colonisation of weakened or decaying woody tissues by secondary insect species.

A fungal bracket was observed on the southern side of the tree approximately 500 mm from the base, associated with a damaged buttress root. The presence of fungal fruiting bodies at the stem base is indicative of active wood decay and raises concerns regarding the integrity of the root buttress system and lower stem.

It is therefore recommended that the tree be **removed as soon as reasonably practicable** to mitigate the risk of structural failure.
