### **Bramber Brook – Archaeological Condition Discharge Submission**

This letter is submitted in support of the discharge of the archaeological planning condition associated with the Bramber Brook compensatory habitat works (planning reference DC/25/1324).

**Conditions Photo Log - 20/10/25**

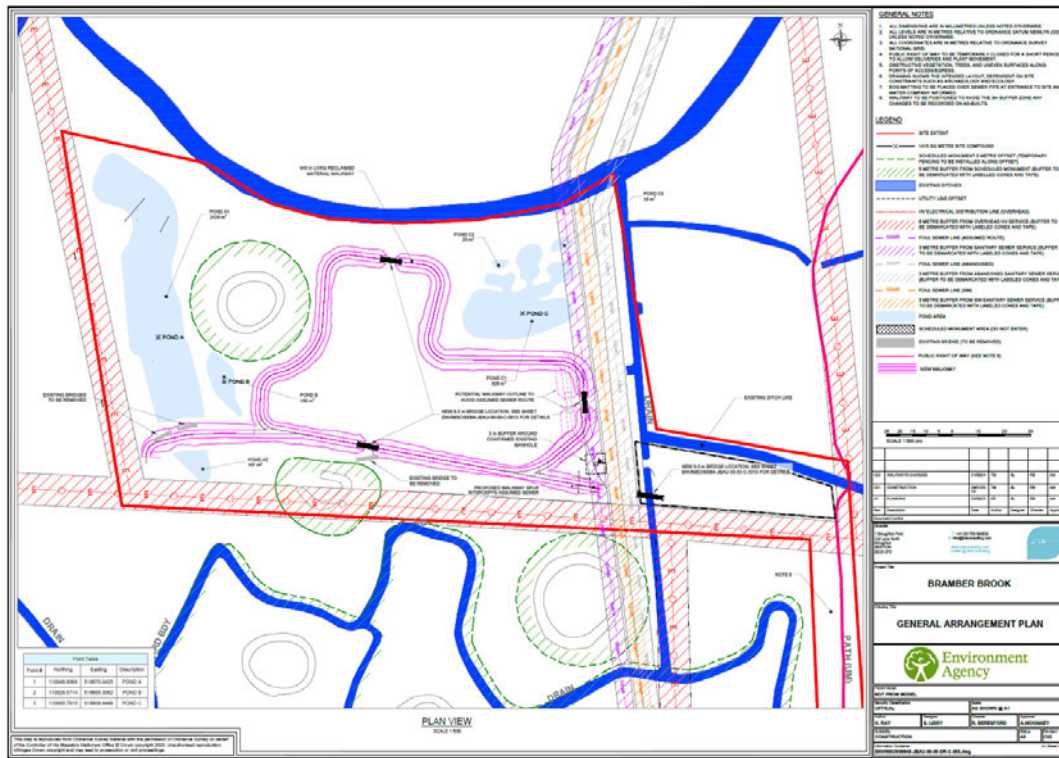
**Figure 2 – General arrangement drawing depicting the buffer zone around the Scheduled monument prior to construction.**

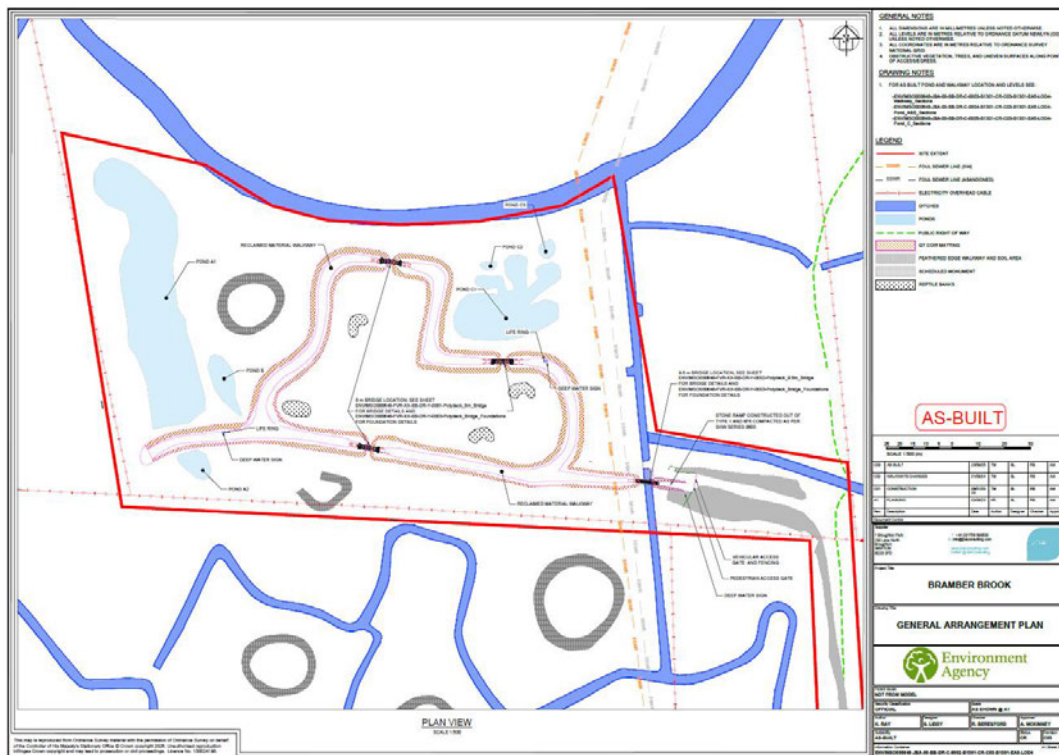
**Figure 3 – The As-Built General arrangement drawing.**

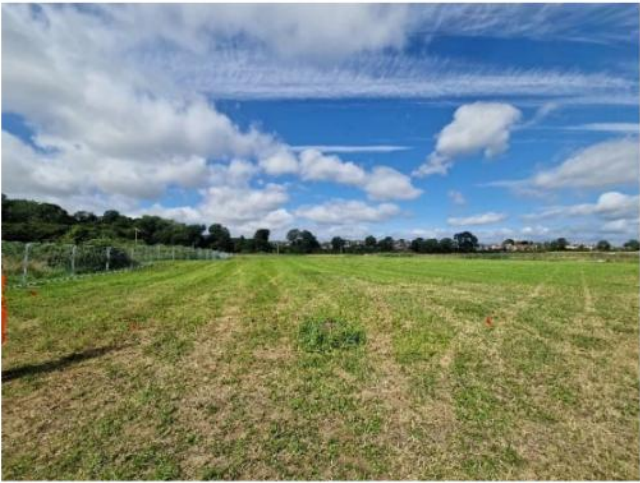
| <p><b>Image 1:</b> View of working area taken from south-east corner of site (access gate). No construction yet occurred.</p> | <p><b>20/08/2024:</b><br/><b>Image 1</b></p> <p><b>Perimeter fencing for entire Site</b></p> |

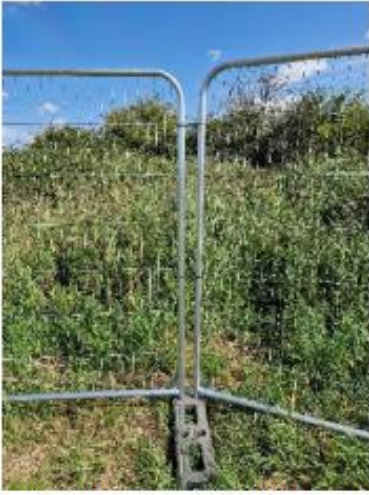
| <p><b>Image 1:</b> Example of cable tied perimeter fence mentioned in appended checklist</p> | <p><b>22/08/2024:</b><br/><b>Image 1</b></p> <p><b>Cable tied Perimeter Fencing</b></p> |

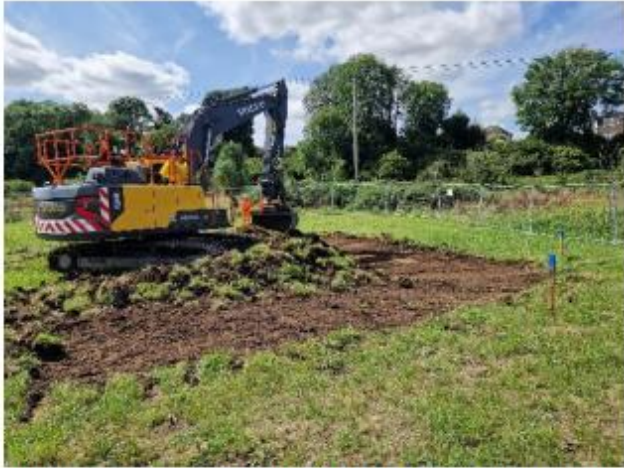
| <p><b>Image 3:</b> Excavation of Pond A1 commenced</p> | <p><b>23/08/2024:</b><br/><b>Image 3</b></p> <p><b>Perimeter Fencing in place at A1</b></p> |

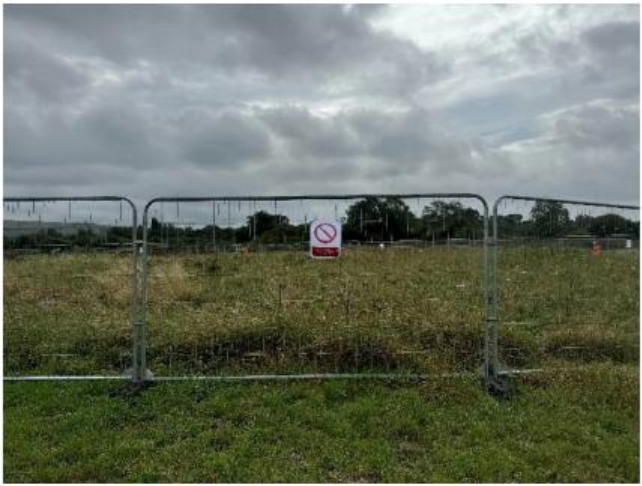
| | <p><b>Image 7:</b> Clear, visible signage of exclusion zones for Scheduled Monument</p> | <p><b>02/09/2024:</b><br/><b>Image 7</b></p> <p><b>Signage advising of exclusion zone on SM Heras demarcation.</b></p> |

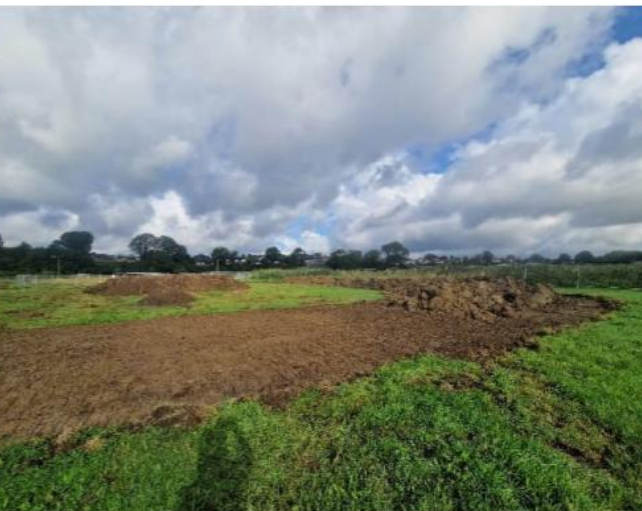
| | <p><b>Image 2:</b> Capping of section 3 walkway (photo taken facing north-west corner of site and historic monument)</p> | <p><b>03/09/2024:</b><br/><b>Image 2</b></p> <p><b>Showing Northern perimeter fencing and Heras demarcation for SM in the background.</b></p> |

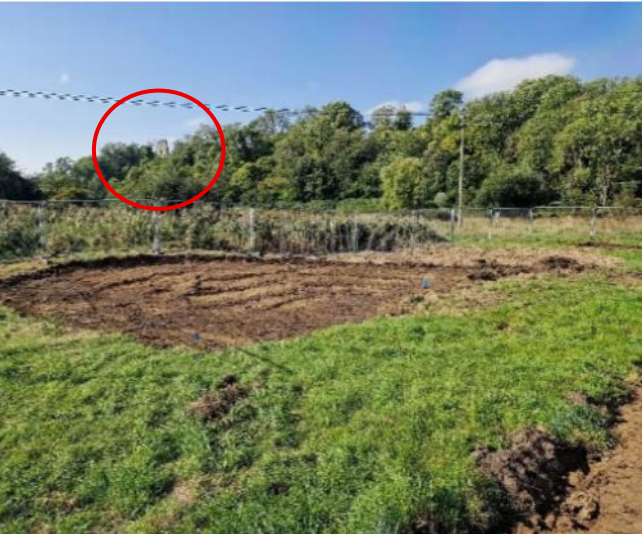
| | <p><b>Image 4:</b> Pond A2 stripped of top soil</p> | <p><b>18/09/2024:</b><br/><b>Image 4</b></p> <p><b>Perimeter fencing in SW corner of the Site. Bramber Castle SM in distant background (circled).</b></p> |

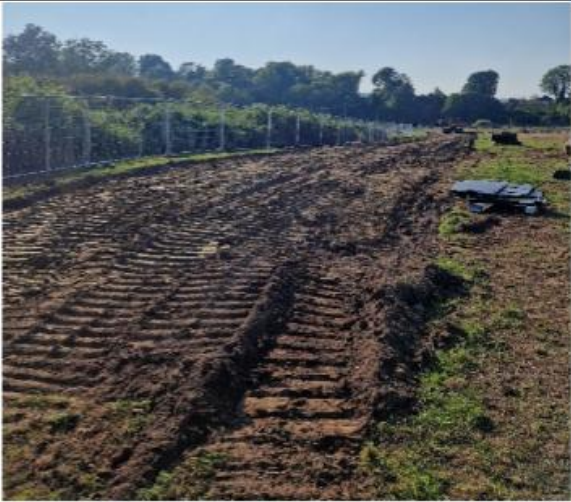
| <p><b>Image 6:</b> Raised walkway section 2 &amp; 4 between compactions.</p> | <p><b>19/09/2024:</b><br/><b>Image 6</b></p> <p><i>Perimeter fencing in on Southern edge of Site. Shows delineation to SM to the South.</i></p> |

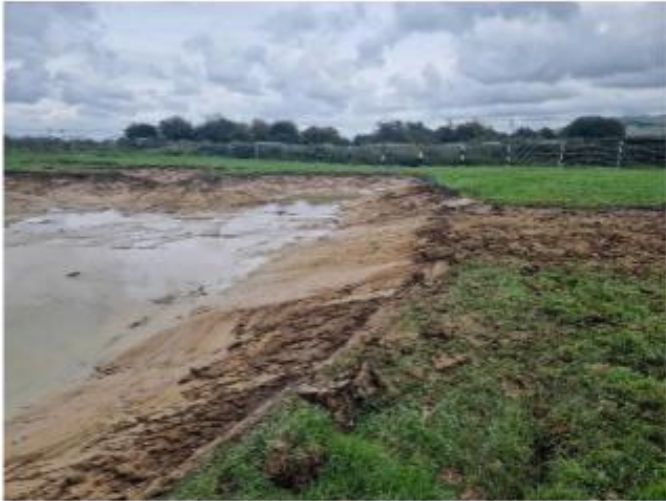
| <p><b>Image 2:</b> Southern area of pond C1 complete</p> | <p><b>25/09/2024:</b><br/><b>Image 2</b></p> <p><i>Perimeter fencing on the Eastern edge of Site up to the drainage ditch.</i></p> |

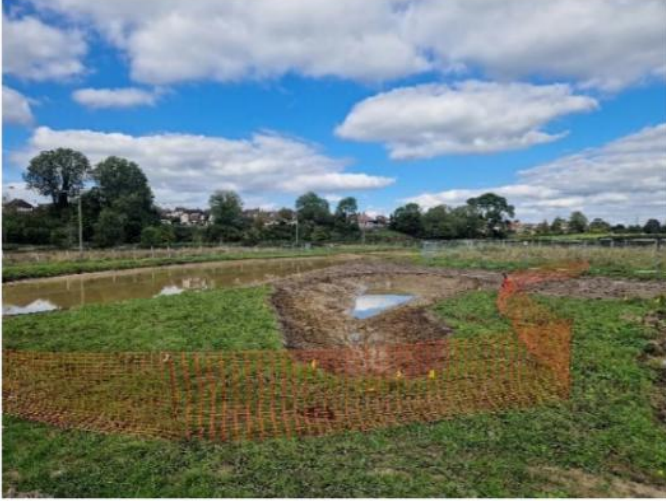
| <p><b>Image 1:</b> Pond B with mesh barrier fencing installed around perimeter. Image taken looking north.</p> | <p><b>04/10/2024:</b><br/><b>Image 1</b></p> <p><i>Heras fencing on right hand side of picture demarcates SM. Maintained in place through out delivery of the scheme.</i></p> |

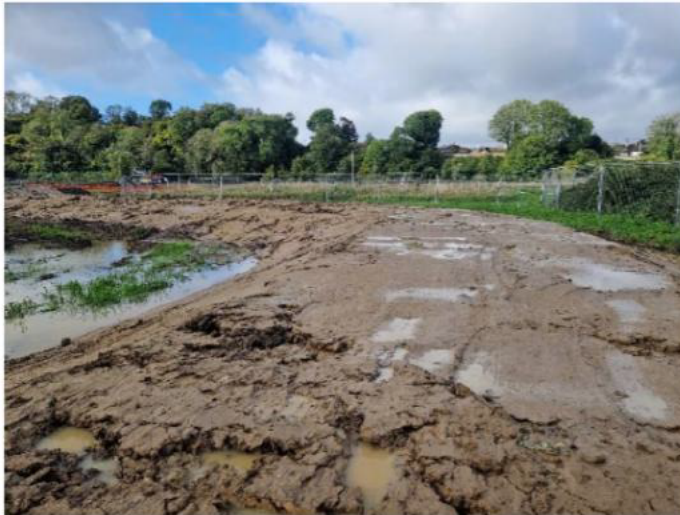
**SM demarcation  
fencing in  
background.**

**Image 5:** Current surface of walkway section 2. Image taken looking west at location of new footbridge between section 2 and 3.

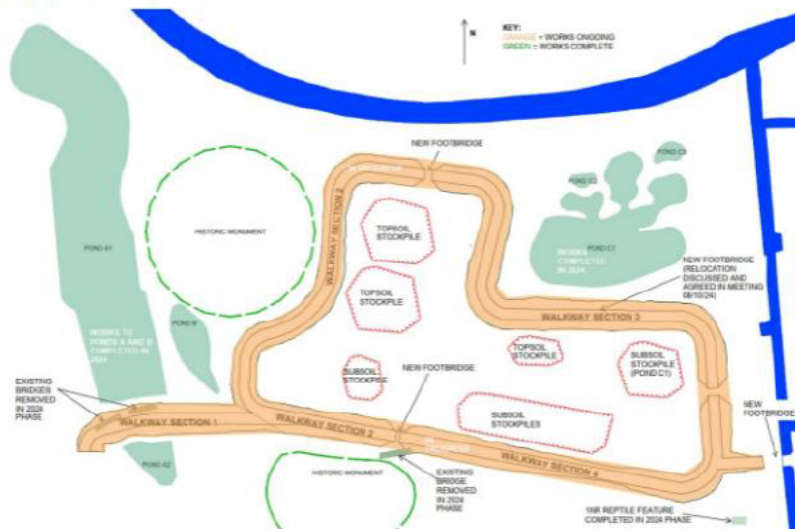
**Sketch showing  
progression of  
site works up to  
23/05/25.**

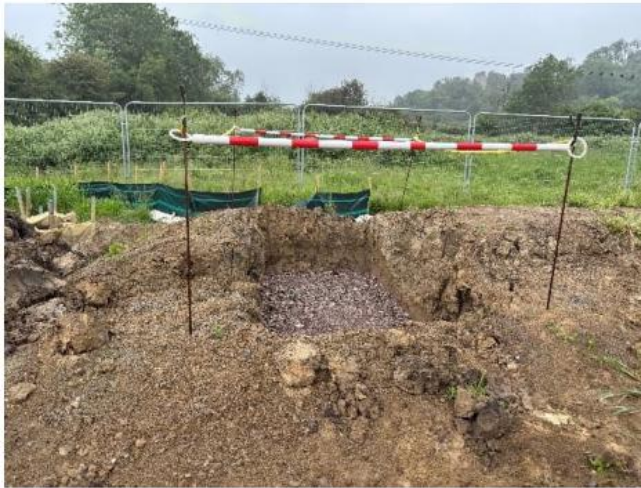
**Image 2:** Example of bridge foundation excavation.

**Perimeter  
fencing at  
Southern edge  
visible whilst  
setting  
foundations for  
Bridge 2.**

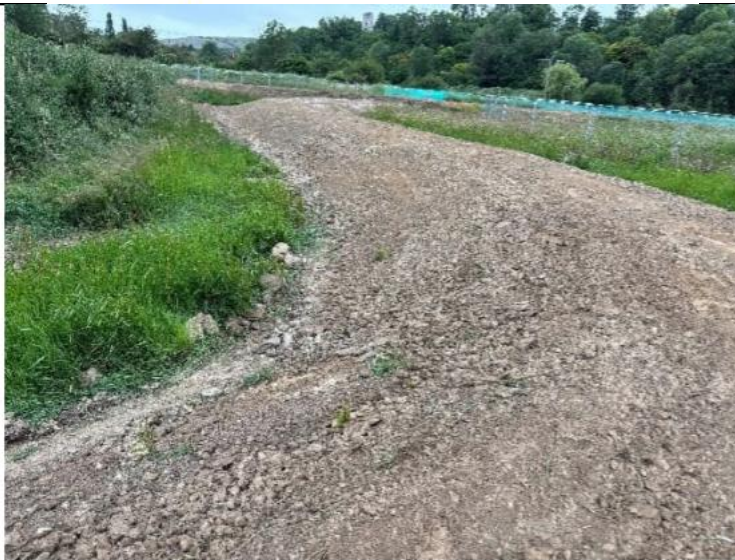
**Image 3:** Walkway from chainage 225m to 170m.

**Heras for SM  
demarcation  
visible on right  
hand side of  
image between  
chainages 170-  
225m.**

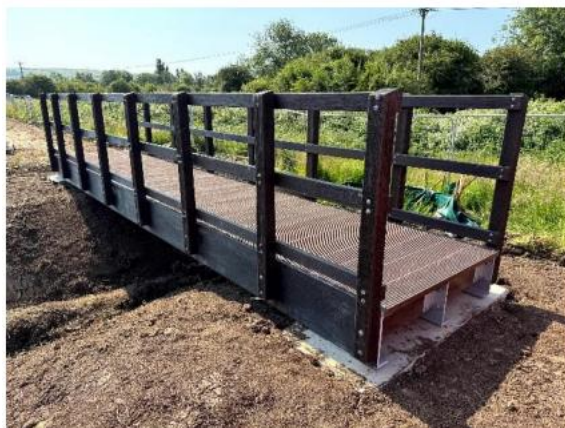
**Image 2:** Image shows complete installation of GPR footbridge 'Bridge 3'. Outstanding works is to only connect bridge to concrete foundations

**Bridge 3 built.  
SM to the South  
is behind the  
southern  
perimeter  
fencing in  
background.**
