## B PHASE I – DESK STUDY

### 6.1 Site Location and Description

## C PHASE II - INTRUSIVE INVESTIGATION

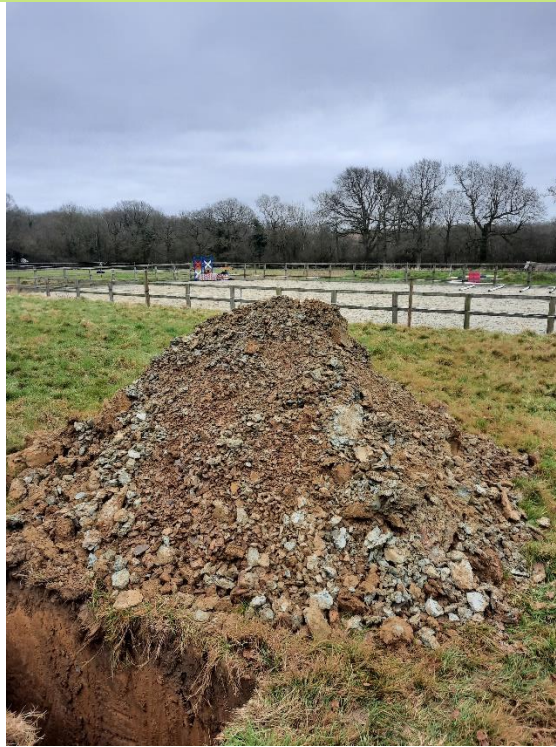
Plate 1 – View from the TP1 location across the area of the hors riding school.

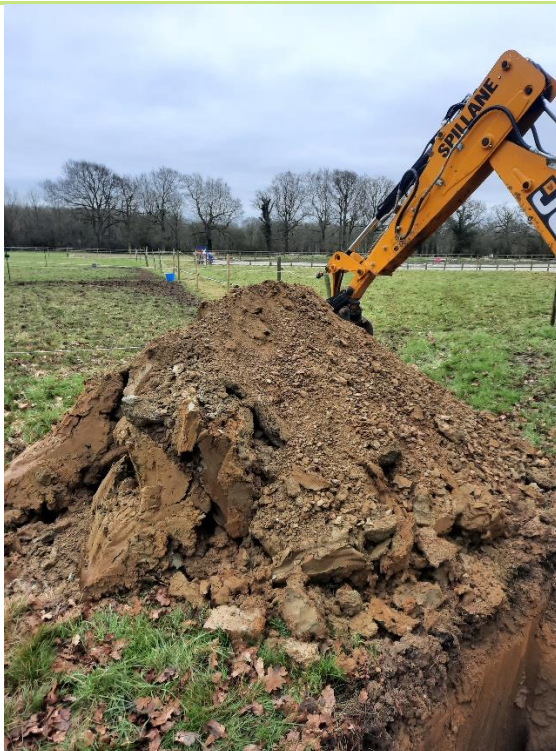
Plate 2 – View from TP2 looking south east.

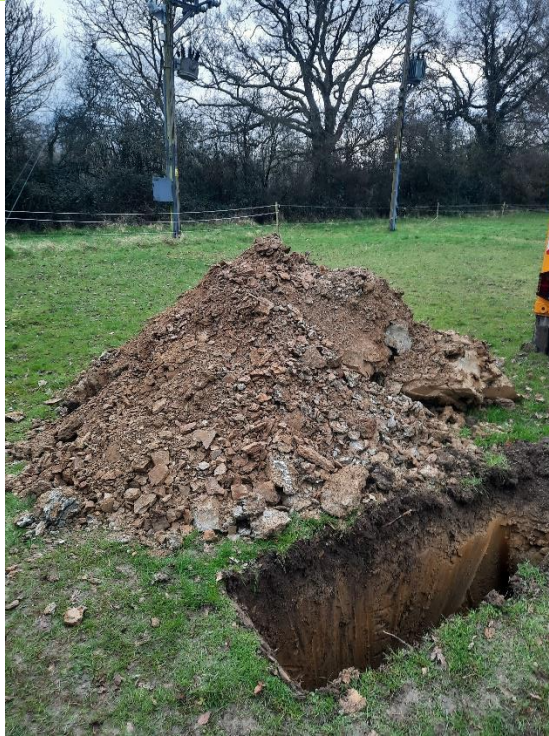
The topsoil encountered in trial pits TP9, TP10, TP11, TP12 and TP14 (all located in the south section of the site) appeared reworked and contained rare fine brick gravel. Furthermore, fine charcoal fragments were noted in the topsoil encountered in TP9.

Plate 3 -Arisings from TP9 with overhead lines visible beyond.

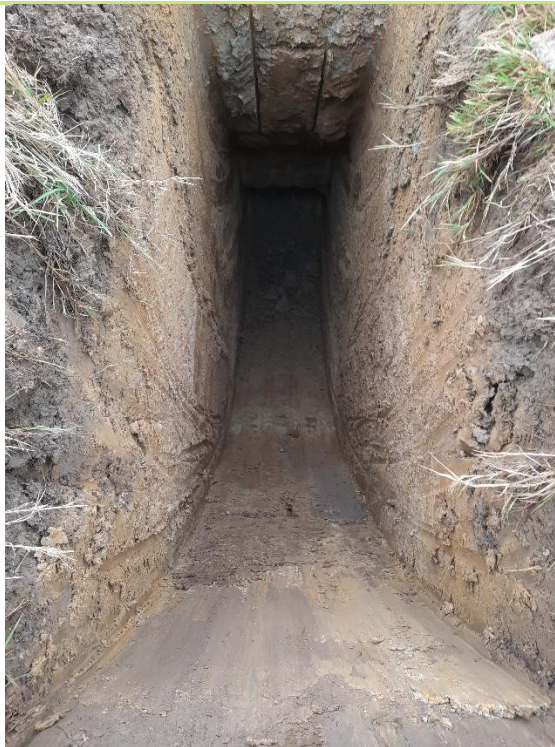
Relic shear surfaces were noted within the clays at between 0.5m and 1.4m bgl in trial pits TP1, TP2, TP5, TP8 and TP13. These surfaces represent layers where the soils have previously sheared and exhibit what is referred to as residual strength. Potentially desiccated soils were encountered in TP2 and TP13 adjacent to the tree line.

Plate 4 – Ground conditions encountered in TP1
