**Our ref:** MDJAC-AM26108-LetRep-01

**RE: Application to remove 1no. ash tree within the rear garden of 9 Bodiam Close, Southwater, RH13 9XW.**

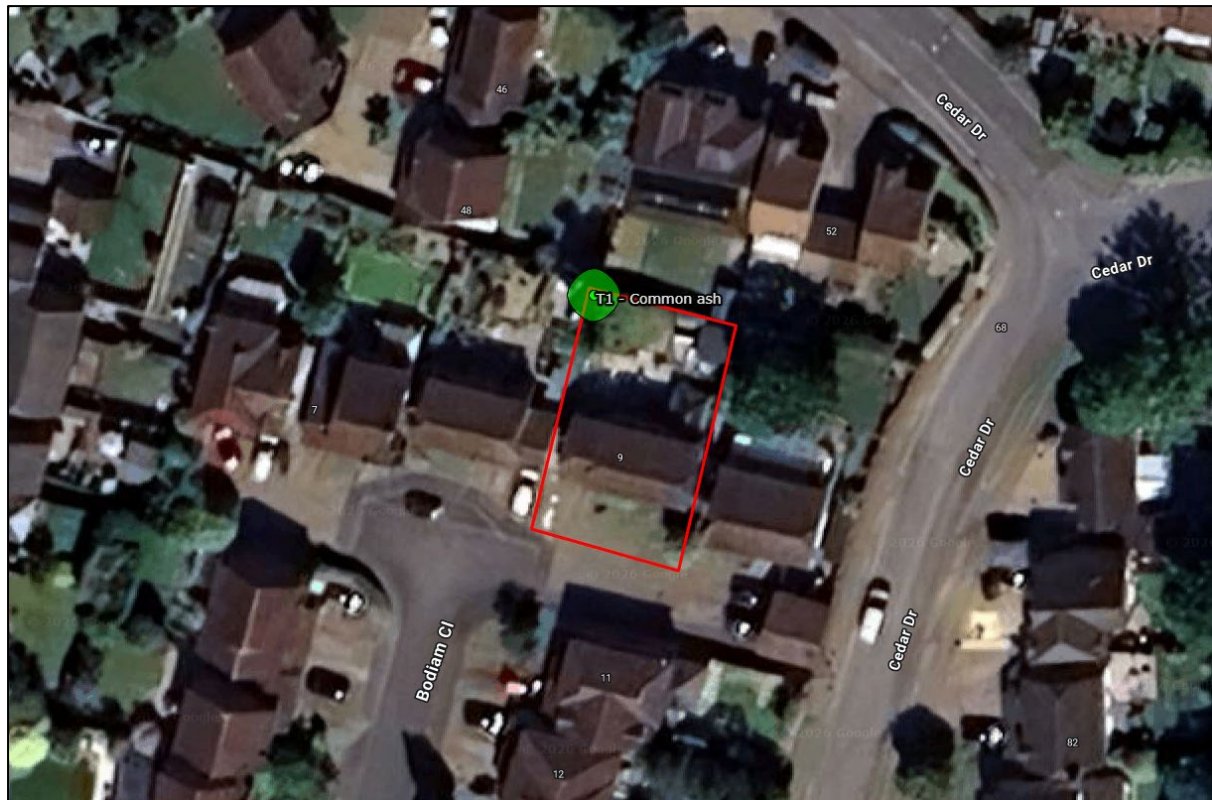
Figure 1: tree location plan.

| Tree No. | Species | Height [m] | Trunk Dia. [mm] | Crown Spread [m] | Comments |
|---|---|---|---|---|---|
| T1 | Common ash | 12 | 675 | 2.5 | Growing in NW corner of garden. Prominent shallow roots extending to the south and south-east, visible to 2.7m from base. Historical wounding on lower trunk; partially occluded. Trunk leans to north but self-optimises at 4.5m where it bifurcates. Past branch failures evident in canopy. Heavily pruned and managed as a high pollard. Potential for aerial decay at pollard points. |

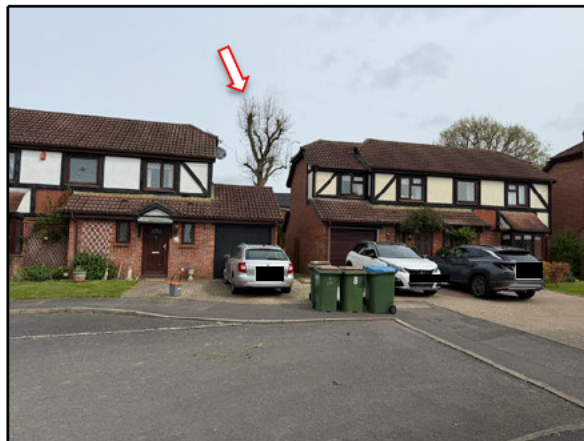
*Photograph 1: below left, looking northwards along Bodiam Close; and*

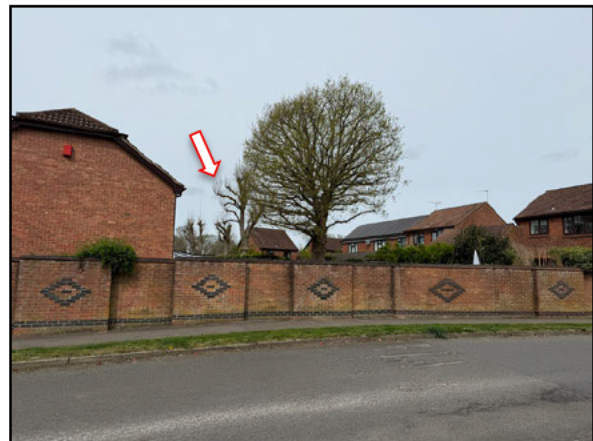
*Photograph 2: below right, looking eastwards towards the subject tree, screened by the adjacent oak.*

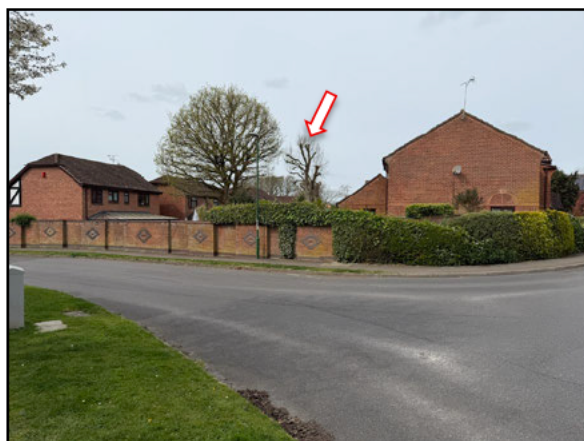
*Photograph 3: looking eastwards towards the subject tree, screened by the adjacent oak; and*

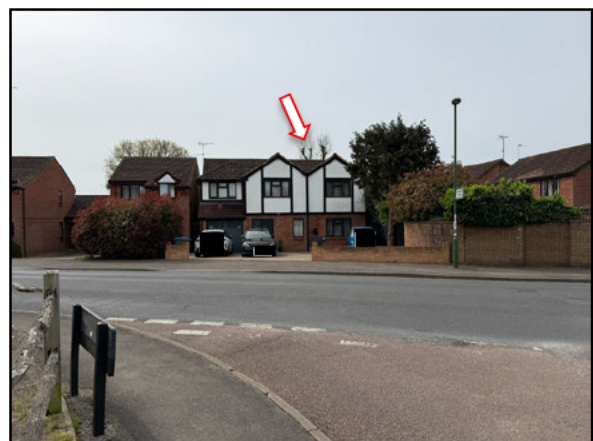
*Photograph 4: looking southwards across Cedar Drive from the junction of Castlewood Road, showing the tree screened by residential properties.*
