# Arboricultural Consultancy for LV=

| Insured | Mr Charan Sandhu | Address | 11 Cape Copse, Rudgwick, Horsham, RH12 3HG | | |
| Report Date | 09/06/2023 | | | | |

**Scope of Report:** To survey the property and determine significant vegetation contributing to subsidence damage, make recommendation for remedial action and assess initial mitigation and recovery prospects. The survey does not make an assessment for decay or hazard evaluation.

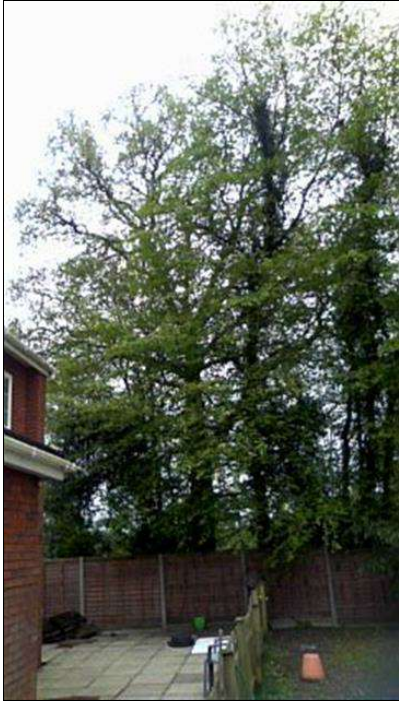
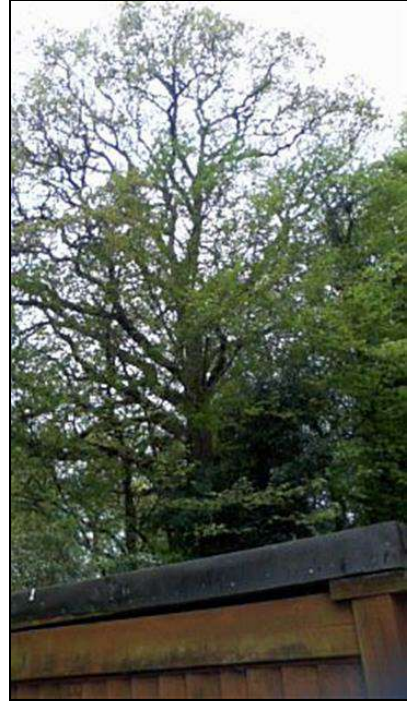
T1 - Oak

With due regards to species profile, size and proximity, the Oak (T1) and the Mixed Species Tree Group (TG1) are considered the dominant features proximate to the focal area(s) of movement and accordingly, where vegetation is confirmed as being causal, we have identified them as the primary cause of the current subsidence damage.

| Tree No. | Species | Age Cat | Approx. Height (m) | Distance to Building (m) * | Ownership | Action | Requirement |
|---|---|---|---|---|---|---|---|
| T1 | Oak | 3 | 17 | 7.25 | B - Local Authority | Remove | Remove close to ground level and treat stump to inhibit regrowth. |

Consequently, we have advocated the complete removal of the Oak (T1) in combination with management (to include partial removal as specified) of the Mixed Species Tree Group (TG1) as it will offer the most certain arboricultural solution likely to restore long-term stability.

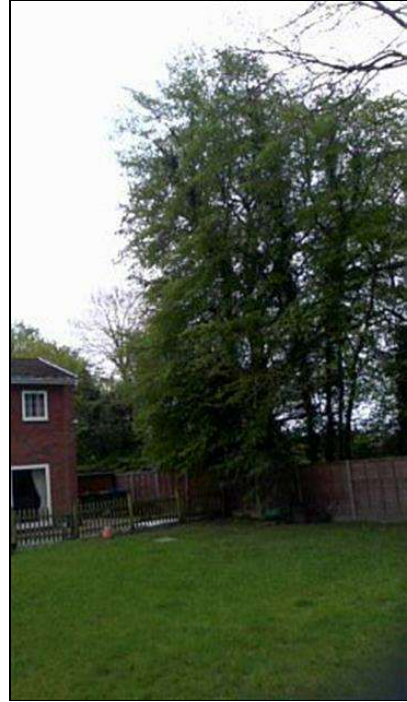
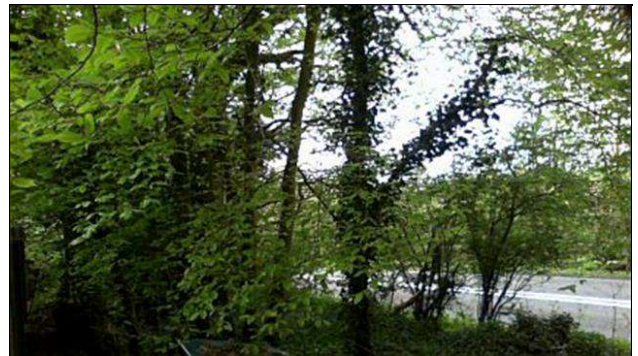
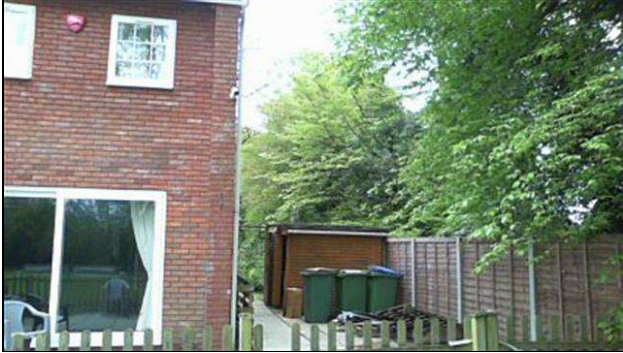
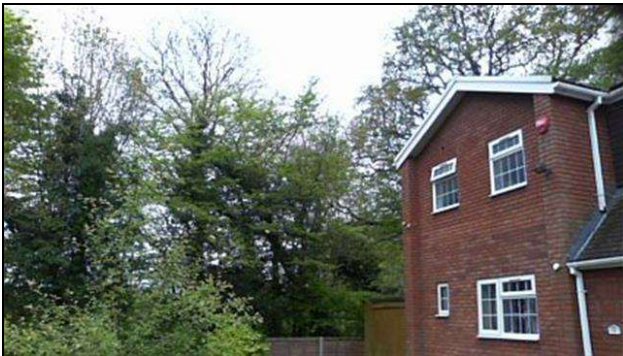
TG1 - Mixed species group

| Tree No. | Species | Age Cat | Approx. Height (m) | Distance to Building (m) * | Ownership | Action | Requirement |
|---|---|---|---|---|---|---|---|
| TG1 | Mixed Species Group: includes hornbeam, ivy, holly, ash, and hawthorn. | 3 | 15 | 5.5 | B - Local Authority | Maintain as detailed | Remove section of group to achieve a minimum clearance of 12m to the insured property; do not treat stumps due to translocation risk. Where such a risk exists, we advise that any emergent regrowth is removed annually. Maintain retained trees within recognised influencing distance of the property (based on species, size and proximity) at, or below current dimensions by way of regular pruning so as to effectively mitigate subsidence risk. Any pruning undertaken should be in accordance with BRE IP7/06 and repeated on a 3-year (max) basis to be deemed as effective. Coppicing, pollarding and targeted / selective removal, followed by replacement planting with lower water demand species may also be deemed as appropriate. |

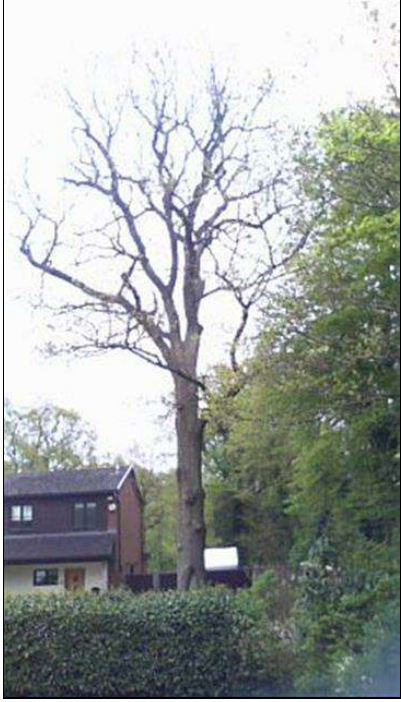
T2 - Oak

| Tree No. | Species | Age Cat | Approx. Height (m) | Distance to Building (m) * | Ownership | Action | Requirement |
|---|---|---|---|---|---|---|---|
| T2 | Oak | 3 | 18 | 15 | A - Third Party | Action to avoid future risk | Maintain at broadly current dimensions by way of regular pruning. |
