## Site Visit

| <b>Policyholder:</b> | <b>Claim Ref:</b><br>IFS-LVI-ROF-23-0107374 | <b>Date of Meeting:</b><br>15/11/2023 |

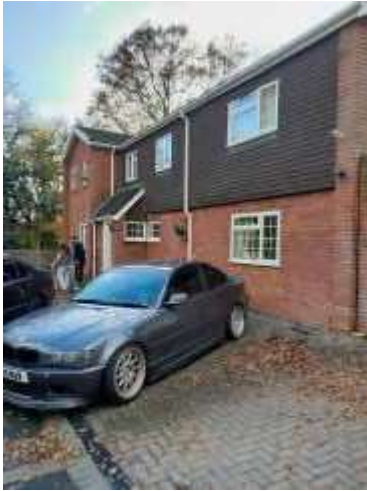
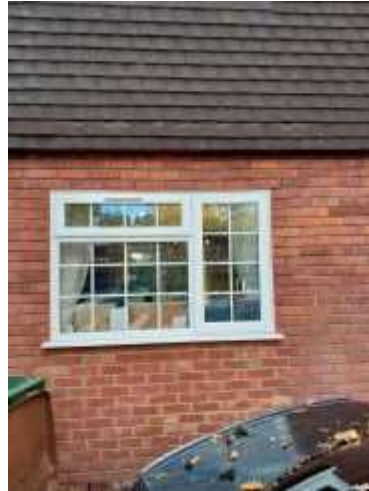
No Lintel above bottom right window

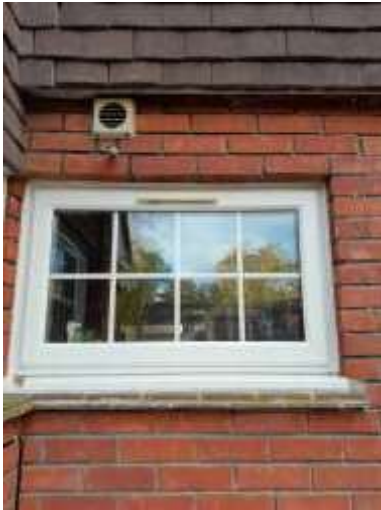
No Lintel above window next to porch

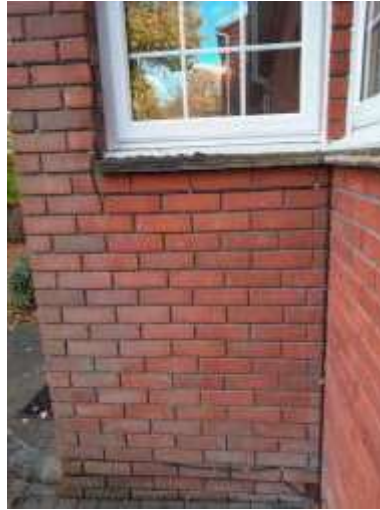
Porch joining main building. The brickwork has slipped off DPC and no separation between the porch and main house on the right side.

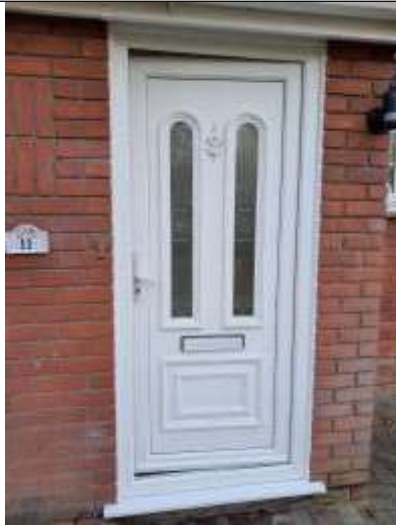
No separation or cracking to the brickwork around the door

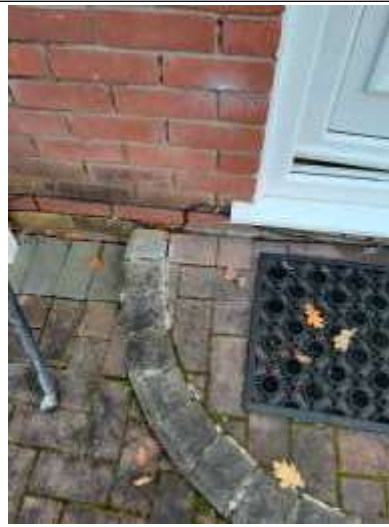
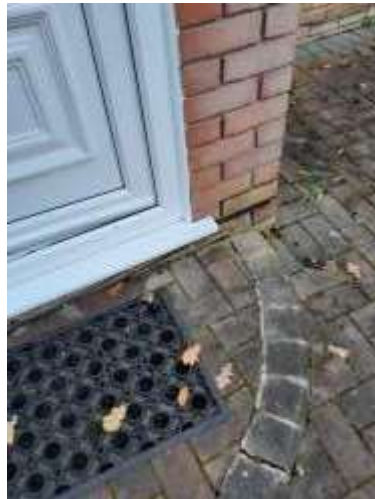
Separation between cill and brickwork

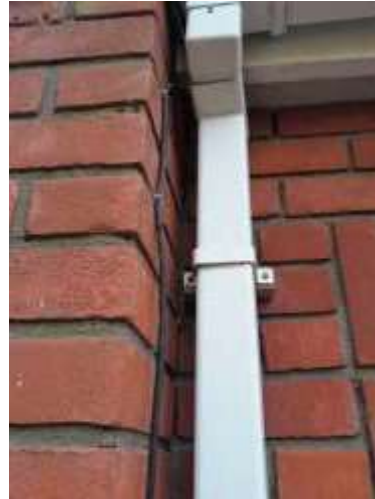
No separation on left side of porch

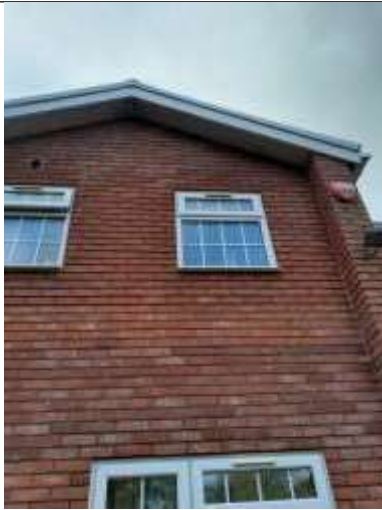
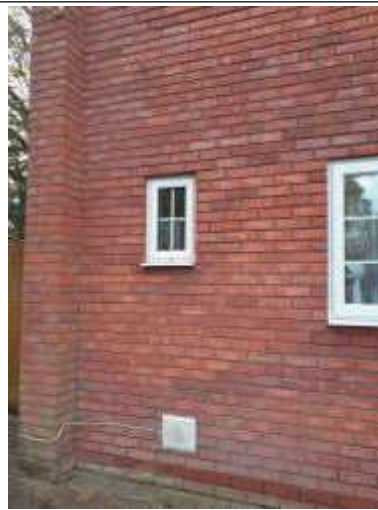
Front elevation of side extension. No cracking or separation visible.

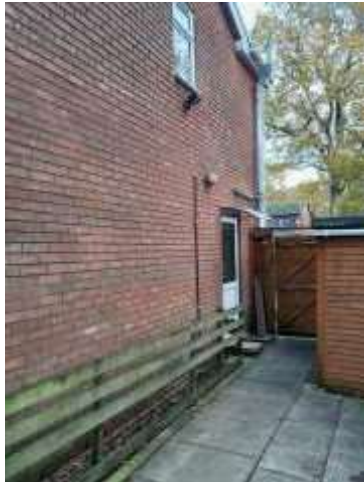
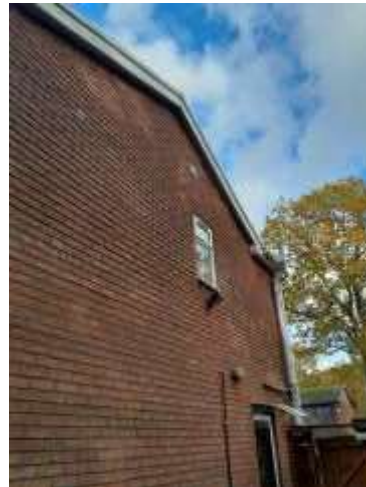
No damage to the brickwork on the side elevation of the extension.

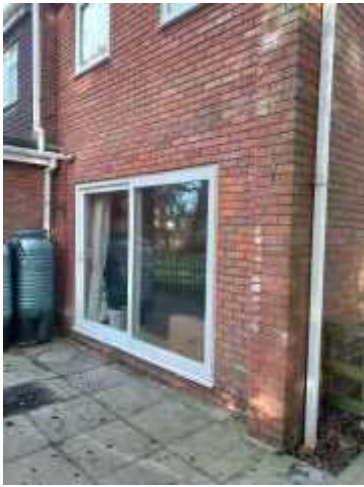
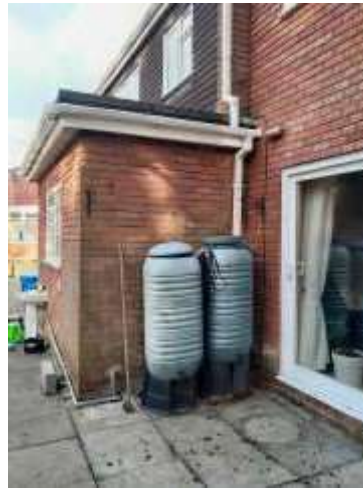
Patio Area – The patio area around the manhole outside of the extension at the rear has sunk significantly directly around the manhole. This is where a drain leak was present which has now been repaired. We will have to take advice from the insurer to see if they would accept this under the claim due to the cause of the subsidence being clay shrinkage and the patio defect caused by EOW.

Extension – some minor stepped cracking and cracked bricks above the top right of the patio door. The patio door has separated slightly from the brickwork above where the lintel is providing sufficient support. There is very minor separation between the extension and the main building. The patio has dropped around the manhole where a drainage leak and repair were undertaken.

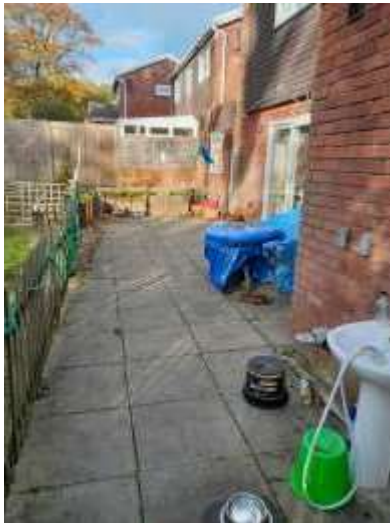
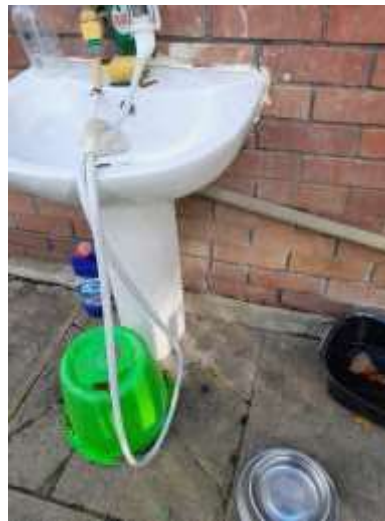
The patio area past the extension has some very minor settlement in areas which will continue to progress over the years due to no pointing between the patio slabs. Water soaking through these gaps will progress the areas which are uneven. This is unrelated to subsidence.

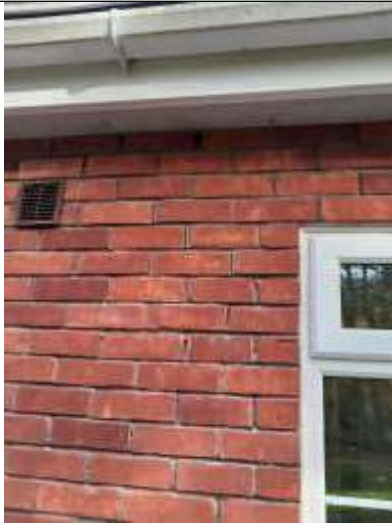
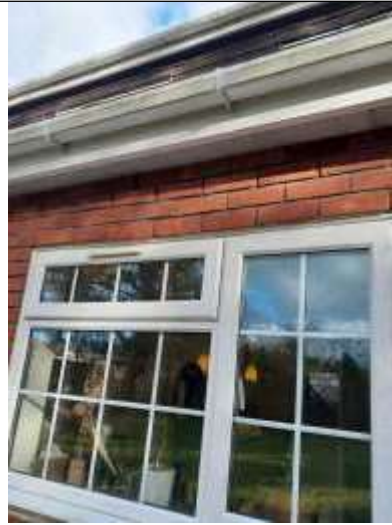
There is some cracking on the rear add-on extension around the window where they have lintel failure/no lintel, which is evident from the bowing of the brickwork dropping in the centre.

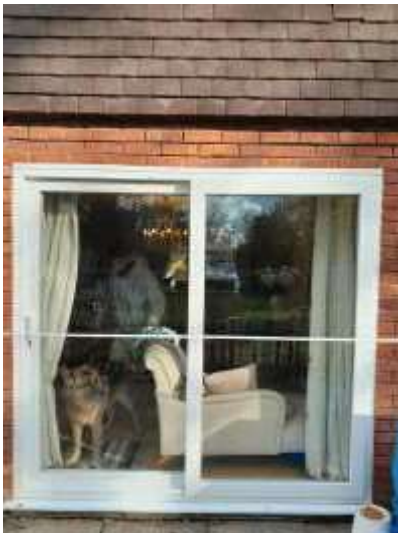
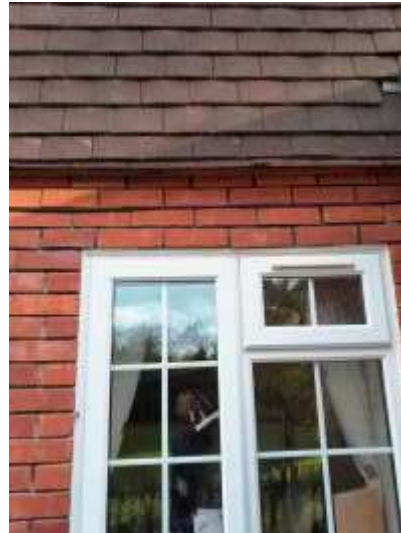
Lintel failure above the rear patio door on the main building and the window to the right of it. This is responsible for the issues faced above in the bedroom and is unrelated to the claim.

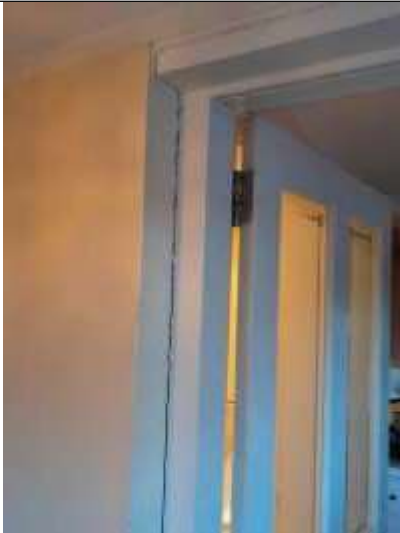
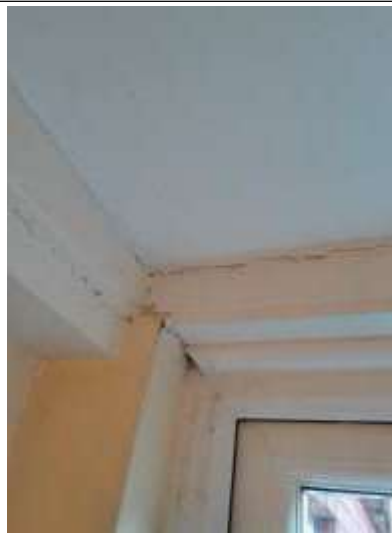
Minor cracking in the porch area. This is inline with the separation from the extension which is evident from the first floor.

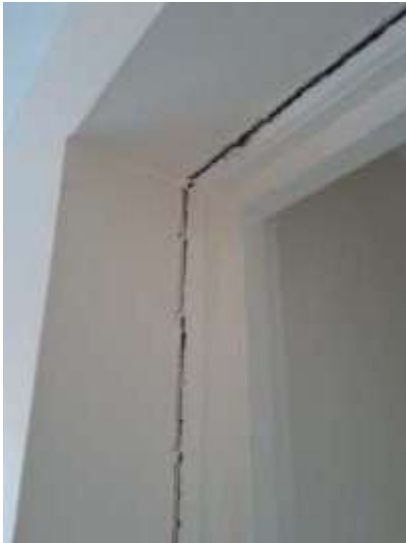
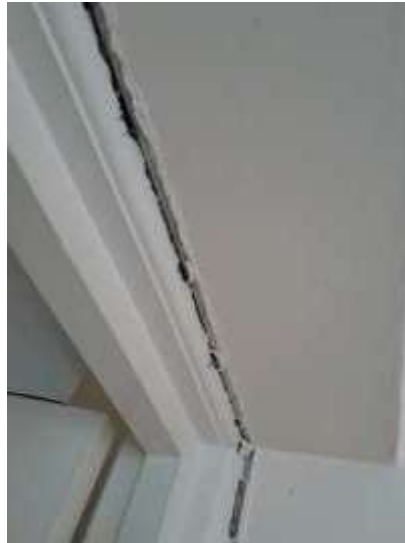
Separation of the door frame on the first floor which enters the extension.

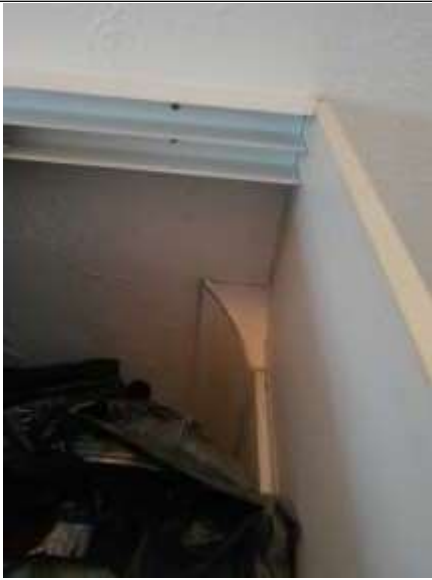
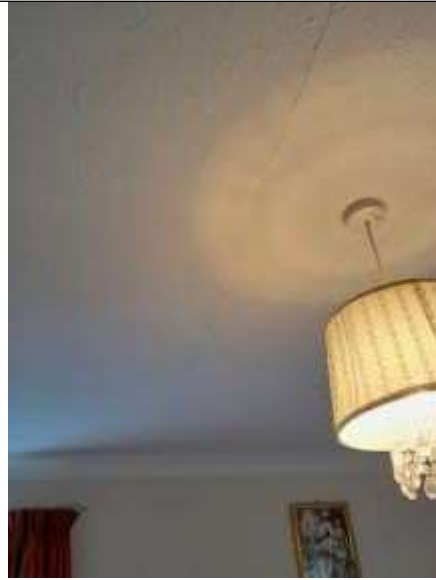
Minor hairline cracking from the wall up and across the ceiling in the bedroom in the extension.

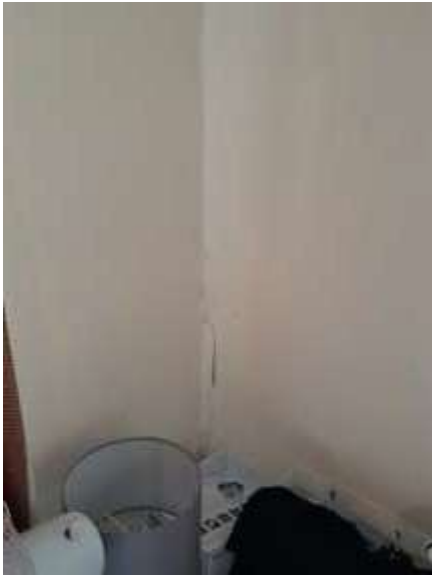
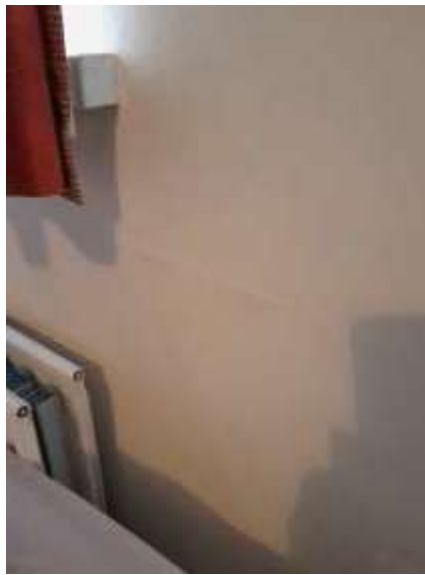
Minor separation in the extension bedroom where the wall joins the main building.

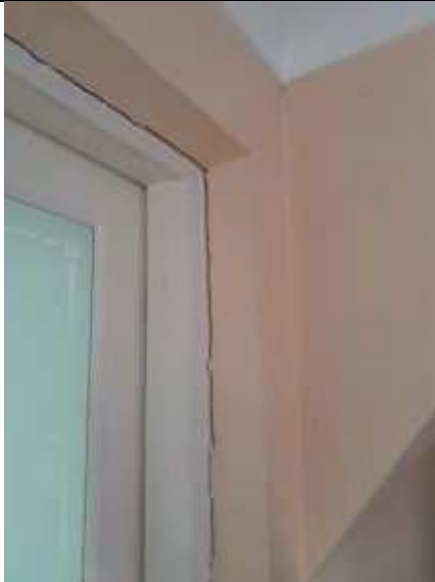
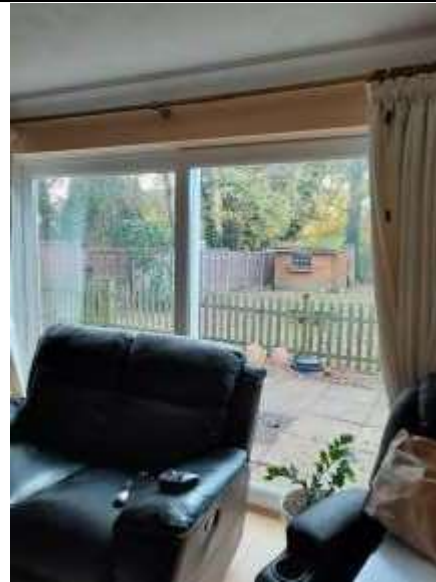
Minor separation between the door frame and the wall in the extension on the ground floor. There is also some minor hairline cracking around the coving ceiling junction.
