# GEOTECHNICAL

## for Subsidence Management Services

### 11 Cape Copse, Rudgwick, Horsham, RH12 3HG

## Drainage Investigation Report

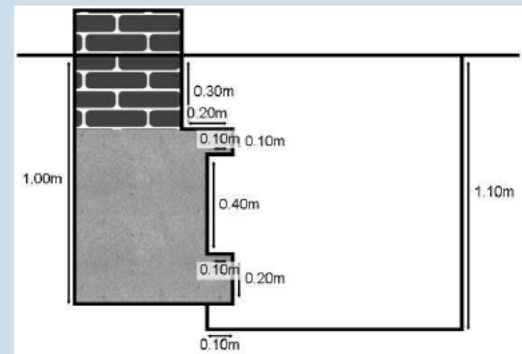
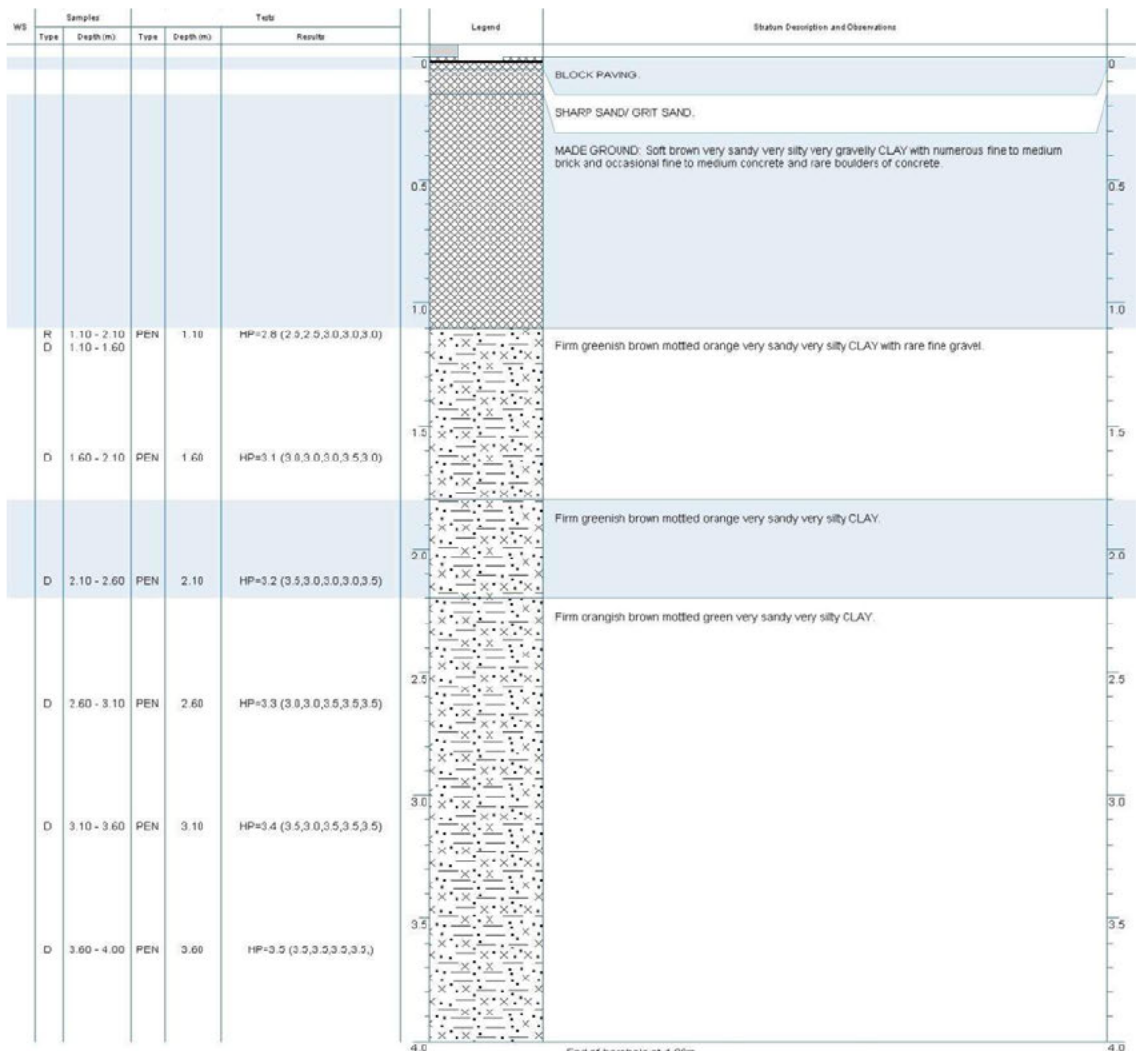
## TP/BH1 Foundation Detail and Borehole Log

House foundation comprised of brick wall to 300mm bgl, bearing on concrete to 400mm bgl with a total projection of 200mm from the elevation. In turn, bearing on concrete to 800mm bgl with a total projection of 100mm from the elevation, In turn, bearing on concrete to 1000mm bgl with a total projection of 200mm from the elevation. Underside of foundation (USF) was exposed to 100mm back from the face of the foundation and probed 200mm back from the face of the foundation.

-- End of borehole at 4.00m --  
Trial pit excavated to 1.10m bgl. Borehole completed by mech window sampler. Roots encountered to 2.1m bgl. Groundwater strikes not encountered. PEN = Hand Penetrometer (kg/sq cm).

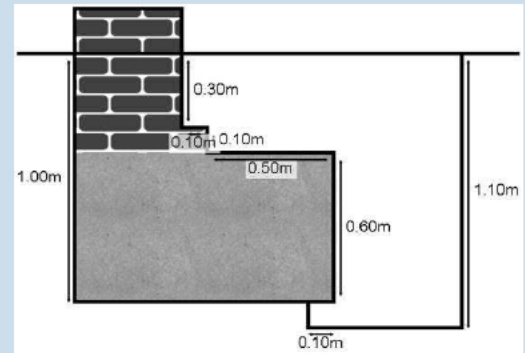
## TP/BH2 Foundation Detail and Borehole Log

House foundation comprised of brick wall to 300mm bgl, bearing on brickwork to 400mm bgl with a total projection of 100mm from the elevation. In turn, bearing on concrete to 1000mm bgl with a total projection of 600mm from the elevation. Underside of foundation (USF) was exposed to 100mm back from the face of the foundation and probed 200mm back from the face of the foundation.

-- End of borehole at 2.30m --  
Trial pit excavated to 1.10m bgl. Borehole completed by mech window sampler. Roots encountered to 2.1m bgl. Groundwater strikes not encountered. PEN = Hand Penetrometer (kg/sq cm). MP = Mackintosh Probe (blows per 75mm).
