# Arboricultural Consultancy for Lloyds Bank

| Insured | | Address | Montrose House, Twittenside, Steyning, BN44 3TW | | |

# GEOTECHNICAL

## Drainage Investigation Report

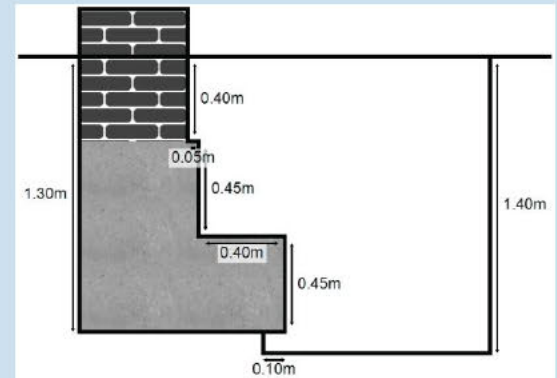
### Foundation Detail

House foundation comprised of brick wall to 400mm bgl, bearing on stepped concrete to 1300mm bgl, with a total projection of 450mm from the elevation. Underside of foundation (USF) was exposed to 100mm back from the face of the foundation and probed 500mm back from the face of the foundation.

House foundation was exposed and the underside of foundation (USF) recorded to be 1.3m bgl (TP/BH 1).

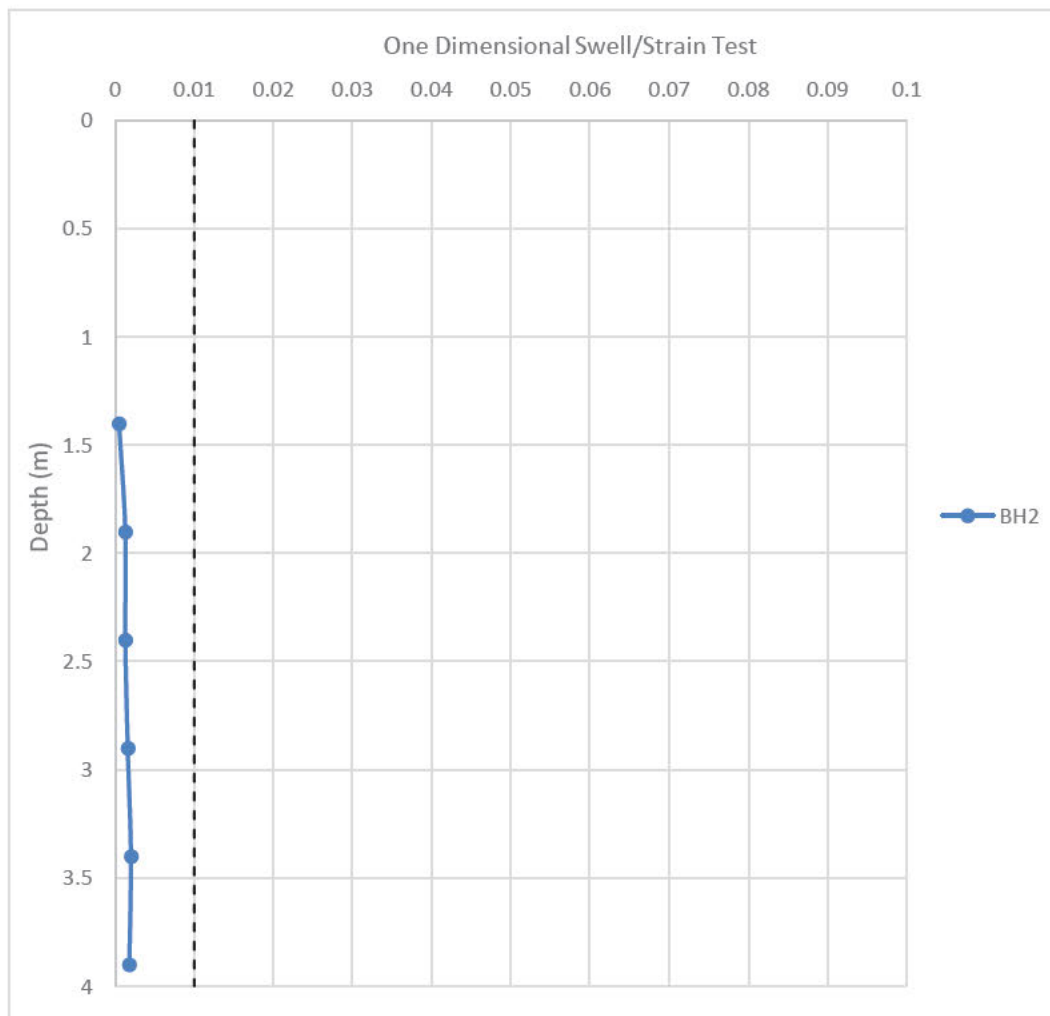
BH 2 estimate of heave

0mm
