# Asbestos Survey Report

## The Old Piggery

Reference: PVES/JM/OP/12.25

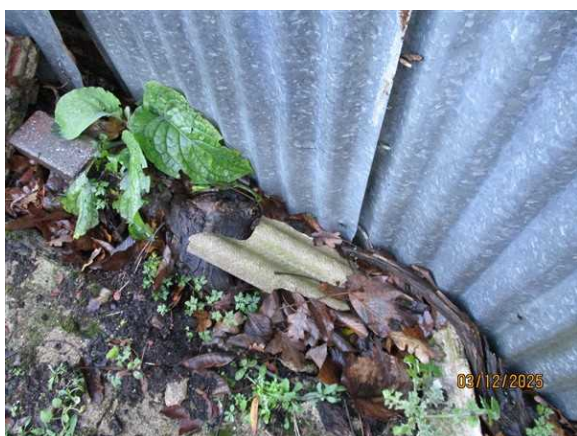
## Debris to Pen 3

*Please note an amount of sheet debris is also found in Pigsty 1 and presumed to be identical to those sampled. Further sheet debris was also noted externally to Pigsty 3 and it is possible further smaller pieces may be present around the building.*

## External Debirs SPST S01

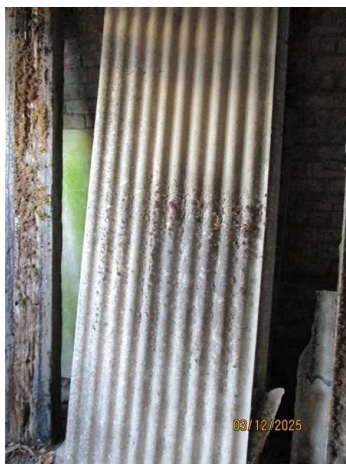
## S01 Sheet debris

- I Samples S01 & S02 - Roof Sheet Debris in Pigsty 1 were confirmed Positive for CHRYSOTILE (white) asbestos. Approximately 20 sheets should be removed before works commence.
- I Sample S03 - Redundant Rain Water Pipe found in Pigsty 1 is also confirmed to contain CHRYSOTILE asbestos and must also be removed by trained and competent contractors.

**S01 Roof Sheetting Debris**

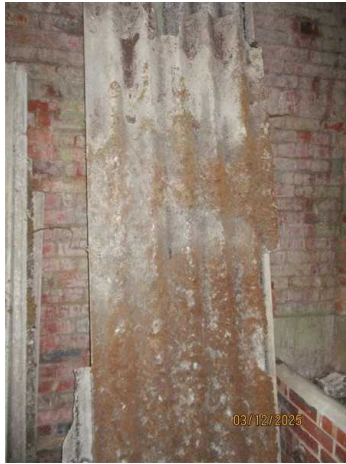
## S02 Sheet Debris 2

### S02 Roof Sheeting Debris 2

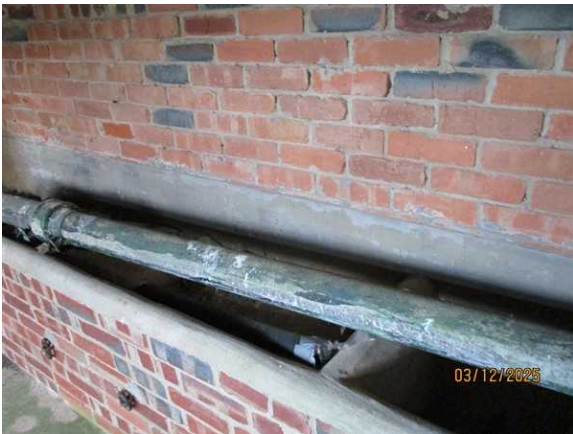
## S03 Pipe

### S03 Redundant RW Pipe

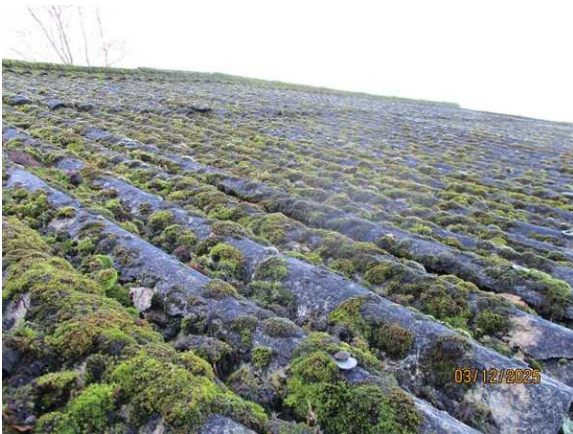
## S04 Roof Sheet 1

- I Samples S04 & S05 Floor - Roof Sheeting to both the barn and pigsty areas of the building are confirmed to contain CHRYSOTILE and again must be removed prior to works commencing.
- I Sample S06 - DPC to external walls was confirmed Negative for asbestos content.

### S04 Roof Sheeting

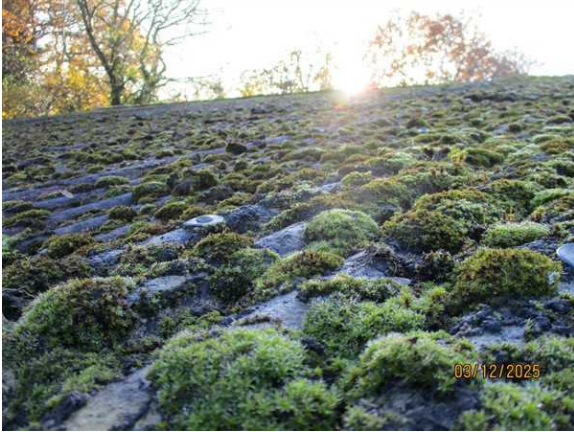
## S05 Roof Sheet 2

### S05 Roof Sheeting

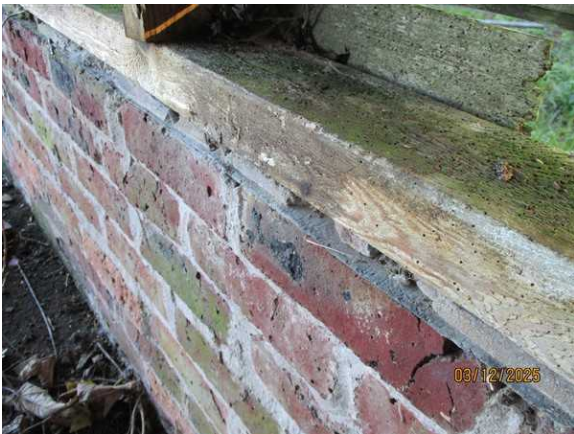
## S06 DPC

### S06 DPC

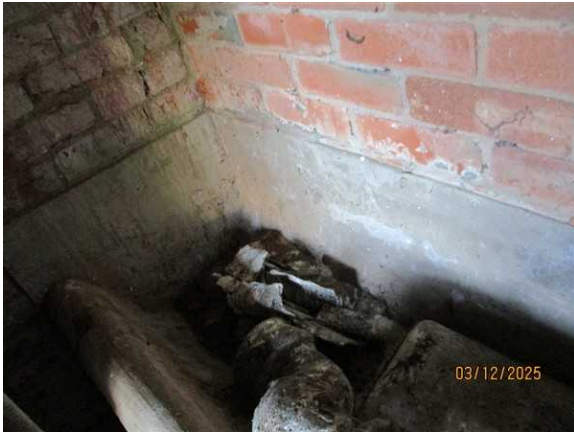
## SPST S01 Debris

### SPST S01 Seet Debris 1

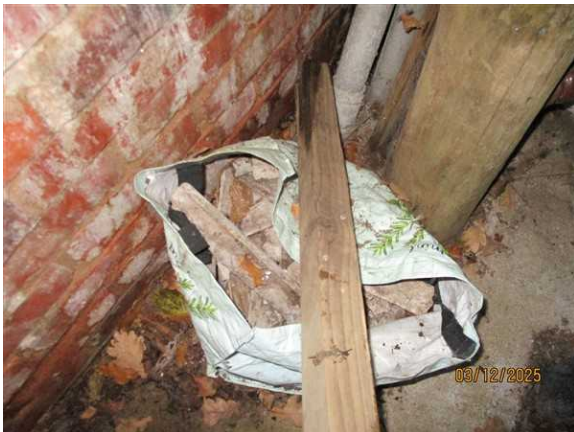
## SPST S01 Debris 2

### SPST S01 Sheet Debris 2

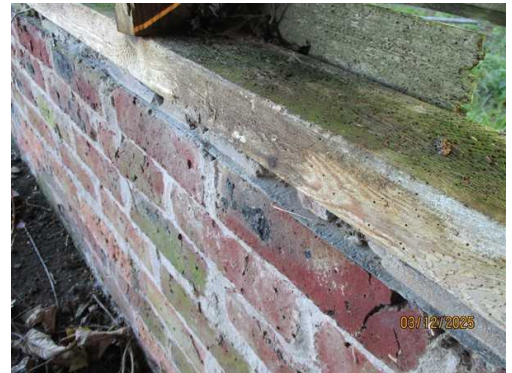
## S06 DPC

Inspection Date 03/12/2025  
Inspected by Paul Craddock  
Next Inspection Date  
Identification Confirmed  
Asbestos Type NADIS

| Samples | | <u>Estimated Amount</u> | <u>Asbestos Type</u> | <u>Test Report</u> |
|---|---|---|---|---|
| 6 | PSC/JM/OP/S06 | 0 | NADIS | ATH-25-12-0364<br>05/12/2025 |

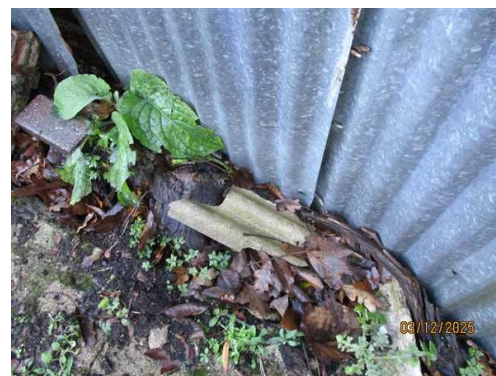
## External Debirs SPST S01

Inspection Date 03/12/2025  
Inspected by Paul Craddock  
Next Inspection Date  
Identification Strongly Presumed  
Asbestos Type Chrysotile (White)

Asbestos Type 1 Chrysotile (White)  
Product Type 1 Asbestos Reinforced Composites (Plastics, resins, mastics, roofing felts, vinyl floor tiles, semi-rigid paints or decorative finishes, asbestos cement etc)  
Extent of Damage / Deterioration 1 Low damage. A few scratches or surface marks, broken edges on boards, tiles etc.  
Surface Treatment 1 Enclosed sprays and lagging, asbestos insulating board (with exposed face painted or encapsulated), asbestos cement sheets etc.

Type of Activity 0 Rare disturbance activity (eg little used store room)  
Location 1 Large rooms or well-ventilated areas  
Accessibility 0 Usually inaccessible or unlikely to be disturbed  
Extent / Amount 1 <=10 m<sup>2</sup> or <=10 m pipe run  
Number of Occupants 0 None  
Frequency of Use 0 Infrequent  
Average time each use 0 Less than one hour  
Maintenance Type 0 Minor disturbance (eg possibility of contact when gaining access)  
Maintenance Frequency 0 ACM unlikely to be disturbed for maintenance

| Actions | <u>Due By</u> | <u>Estimated Cost</u> | <u>Status</u> |
|---|---|---|---|
| Inform | 08/12/2025 | | Active |

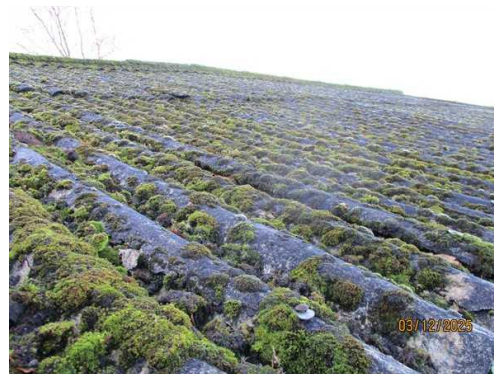
## S04 Roof Sheeting

Inspection Date 03/12/2025  
Inspected by Paul Craddock  
Next Inspection Date  
Identification Confirmed  
Asbestos Type Chrysotile (White)

Asbestos Type 1 Chrysotile (White)  
Product Type 1 Asbestos Reinforced Composites (Plastics, resins, mastics, roofing felts, vinyl floor tiles, semi-rigid paints or decorative finishes, asbestos cement etc)  
Extent of Damage / Deterioration 1 Low damage. A few scratches or surface marks, broken edges on boards, tiles etc.  
Surface Treatment 1 Enclosed sprays and lagging, asbestos insulating board (with exposed face painted or encapsulated), asbestos cement sheets etc.

Type of Activity 0 Rare disturbance activity (eg little used store room)  
Location 0 Outdoors  
Accessibility 0 Usually inaccessible or unlikely to be disturbed  
Extent / Amount 2 >10 m<sup>2</sup> to <=50 m<sup>2</sup> or >10 m to <=50 m pipe run  
Number of Occupants 0 None  
Frequency of Use 0 Infrequent  
Average time each use 0 Less than one hour  
Maintenance Type 0 Minor disturbance (eg possibility of contact when gaining access)  
Maintenance Frequency 0 ACM unlikely to be disturbed for maintenance

| Samples | | <u>Estimated Amount</u> | <u>Asbestos Type</u> | <u>Test Report</u> |
|---|---|---|---|---|
| 4 | PSC/JM/OP/S04 | 70<br>m2 | Chrysotile (White) | ATH-25-12-0364<br>05/12/2025 |

| Actions | | <u>Due By</u> | <u>Estimated Cost</u> | <u>Status</u> |
|---|--|---|---|---|
| Inform | | 08/12/2025 | | Active |

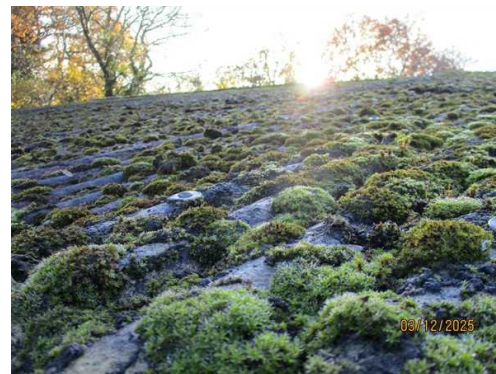
## S05 Roof Sheeting

Inspection Date 03/12/2025  
Inspected by Paul Craddock  
Next Inspection Date  
Identification Confirmed  
Asbestos Type Chrysotile (White)

Asbestos Type 1 Chrysotile (White)  
Product Type 1 Asbestos Reinforced Composites (Plastics, resins, mastics, roofing felts, vinyl floor tiles, semi-rigid paints or decorative finishes, asbestos cement etc)  
Extent of Damage / Deterioration 1 Low damage. A few scratches or surface marks, broken edges on boards, tiles etc.  
Surface Treatment 1 Enclosed sprays and lagging, asbestos insulating board (with exposed face painted or encapsulated), asbestos cement sheets etc.

Type of Activity 0 Rare disturbance activity (eg little used store room)  
Location 0 Outdoors  
Accessibility 0 Usually inaccessible or unlikely to be disturbed  
Extent / Amount 2 >10 m<sup>2</sup> to <=50 m<sup>2</sup> or >10 m to <=50 m pipe run  
Number of Occupants 0 None  
Frequency of Use 0 Infrequent  
Average time each use 0 Less than one hour  
Maintenance Type 0 Minor disturbance (eg possibility of contact when gaining access)  
Maintenance Frequency 0 ACM unlikely to be disturbed for maintenance

| Samples | | <u>Estimated Amount</u> | <u>Asbestos Type</u> | <u>Test Report</u> |
|---|---|---|---|---|
| 5 | PSC/JM/OP/S05 | 70<br>m2 | Chrysotile (White) | ATH-25-12-0364<br>05/12/2025 |

| Actions | | <u>Due By</u> | <u>Estimated Cost</u> | <u>Status</u> |
|---|--|---|---|---|
| Inform | | 08/12/2025 | | Active |

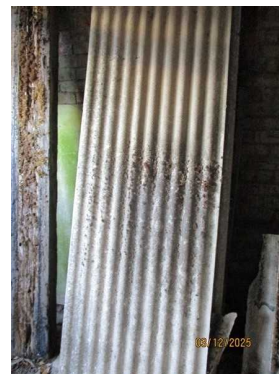
## S01 Roof Sheeting Debris

Inspection Date 03/12/2025  
Inspected by Paul Craddock  
Next Inspection Date  
Identification Confirmed  
Asbestos Type Chrysotile (White)

Asbestos Type 1 Chrysotile (White)  
Product Type 1 Asbestos Reinforced Composites (Plastics, resins, mastics, roofing felts, vinyl floor tiles, semi-rigid paints or decorative finishes, asbestos cement etc)  
Extent of Damage / Deterioration 1 Low damage. A few scratches or surface marks, broken edges on boards, tiles etc.  
Surface Treatment 1 Enclosed sprays and lagging, asbestos insulating board (with exposed face painted or encapsulated), asbestos cement sheets etc.

Type of Activity 0 Rare disturbance activity (eg little used store room)  
Location 0 Outdoors  
Accessibility 0 Usually inaccessible or unlikely to be disturbed  
Extent / Amount 2 >10 m<sup>2</sup> to <=50 m<sup>2</sup> or >10 m to <=50 m pipe run  
Number of Occupants 0 None  
Frequency of Use 0 Infrequent  
Average time each use 0 Less than one hour  
Maintenance Type 0 Minor disturbance (eg possibility of contact when gaining access)  
Maintenance Frequency 0 ACM unlikely to be disturbed for maintenance

| Samples | | <u>Estimated Amount</u> | <u>Asbestos Type</u> | <u>Test Report</u> |
|---|---|---|---|---|
| 1 | PSC/JM/OP/S01 | 15<br>m2 | Chrysotile (White) | ATH-25-12-0364<br>05/12/2025 |

| Actions | | <u>Due By</u> | <u>Estimated Cost</u> | <u>Status</u> |
|---|--|---|---|---|
| Inform | | 08/12/2025 | | Active |

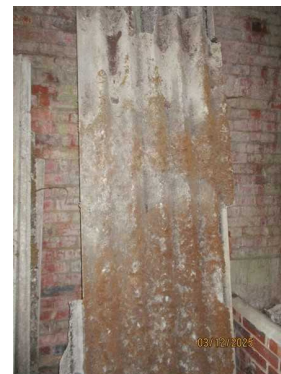
## S02 Roof Sheeting Debris 2

Inspection Date 03/12/2025  
Inspected by Paul Craddock  
Next Inspection Date  
Identification Confirmed  
Asbestos Type Chrysotile (White)

Asbestos Type 1 Chrysotile (White)  
Product Type 1 Asbestos Reinforced Composites (Plastics, resins, mastics, roofing felts, vinyl floor tiles, semi-rigid paints or decorative finishes, asbestos cement etc)  
Extent of Damage / Deterioration 1 Low damage. A few scratches or surface marks, broken edges on boards, tiles etc.  
Surface Treatment 1 Enclosed sprays and lagging, asbestos insulating board (with exposed face painted or encapsulated), asbestos cement sheets etc.

Type of Activity 0 Rare disturbance activity (eg little used store room)  
Location 0 Outdoors  
Accessibility 0 Usually inaccessible or unlikely to be disturbed  
Extent / Amount 2 >10 m<sup>2</sup> to <=50 m<sup>2</sup> or >10 m to <=50 m pipe run  
Number of Occupants 0 None  
Frequency of Use 0 Infrequent  
Average time each use 0 Less than one hour  
Maintenance Type 0 Minor disturbance (eg possibility of contact when gaining access)  
Maintenance Frequency 0 ACM unlikely to be disturbed for maintenance

| Samples | | <u>Estimated Amount</u> | <u>Asbestos Type</u> | <u>Test Report</u> |
|---|---|---|---|---|
| 2 | PSC/JM/OP/S02 | 15<br>m2 | Chrysotile (White) | ATH-25-12-0364<br>05/12/2025 |

| Actions | | <u>Due By</u> | <u>Estimated Cost</u> | <u>Status</u> |
|---|--|---|---|---|
| Inform | | 08/12/2025 | | Active |

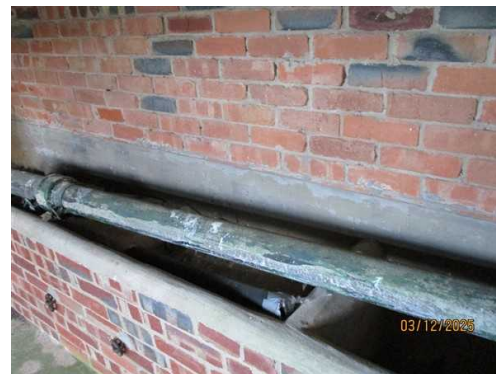
## S03 Redundant RW Pipe

Inspection Date 03/12/2025  
Inspected by Paul Craddock  
Next Inspection Date  
Identification Confirmed  
Asbestos Type Chrysotile (White)

Asbestos Type 1 Chrysotile (White)  
Product Type 1 Asbestos Reinforced Composites (Plastics, resins, mastics, roofing felts, vinyl floor tiles, semi-rigid paints or decorative finishes, asbestos cement etc)  
Extent of Damage / Deterioration 1 Low damage. A few scratches or surface marks, broken edges on boards, tiles etc.  
Surface Treatment 1 Enclosed sprays and lagging, asbestos insulating board (with exposed face painted or encapsulated), asbestos cement sheets etc.

Type of Activity 0 Rare disturbance activity (eg little used store room)  
Location 0 Outdoors  
Accessibility 0 Usually inaccessible or unlikely to be disturbed  
Extent / Amount 2 >10 m<sup>2</sup> to <=50 m<sup>2</sup> or >10 m to <=50 m pipe run  
Number of Occupants 0 None  
Frequency of Use 0 Infrequent  
Average time each use 0 Less than one hour  
Maintenance Type 0 Minor disturbance (eg possibility of contact when gaining access)  
Maintenance Frequency 0 ACM unlikely to be disturbed for maintenance

| Samples | | <u>Estimated Amount</u> | <u>Asbestos Type</u> | <u>Test Report</u> |
|---|---|---|---|---|
| 3 | PSC/JM/OP/S03 | 3<br>m | Chrysotile (White) | ATH-25-12-0364<br>05/12/2025 |

| Actions | | <u>Due By</u> | <u>Estimated Cost</u> | <u>Status</u> |
|---|--|---|---|---|
| Inform | | 08/12/2025 | | Active |

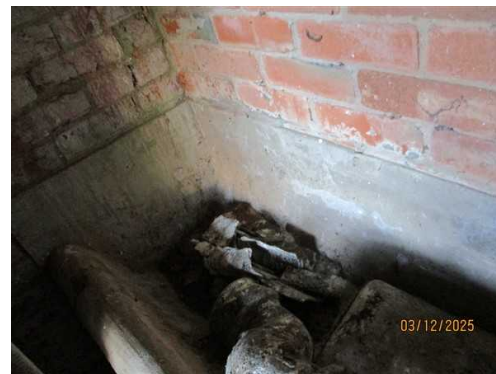
## SPST S01 Seet Debris 1

Inspection Date 03/12/2025  
Inspected by Paul Craddock  
Next Inspection Date  
Identification Strongly Presumed  
Asbestos Type Chrysotile (White)

Asbestos Type 1 Chrysotile (White)  
Product Type 1 Asbestos Reinforced Composites (Plastics, resins, mastics, roofing felts, vinyl floor tiles, semi-rigid paints or decorative finishes, asbestos cement etc)  
Extent of Damage / Deterioration 1 Low damage. A few scratches or surface marks, broken edges on boards, tiles etc.  
Surface Treatment 1 Enclosed sprays and lagging, asbestos insulating board (with exposed face painted or encapsulated), asbestos cement sheets etc.

Type of Activity 0 Rare disturbance activity (eg little used store room)  
Location 1 Large rooms or well-ventilated areas  
Accessibility 0 Usually inaccessible or unlikely to be disturbed  
Extent / Amount 1 <=10 m<sup>2</sup> or <=10 m pipe run  
Number of Occupants 0 None  
Frequency of Use 0 Infrequent  
Average time each use 0 Less than one hour  
Maintenance Type 0 Minor disturbance (eg possibility of contact when gaining access)  
Maintenance Frequency 0 ACM unlikely to be disturbed for maintenance

| Actions | <u>Due By</u> | <u>Estimated Cost</u> | <u>Status</u> |
|---|---|---|---|
| Inform | 08/12/2025 | | Active |

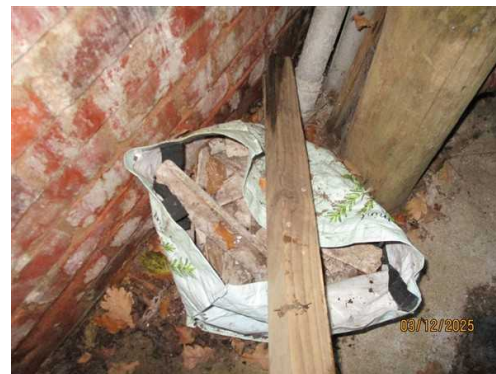
## SPST S01 Sheet Debris 2

Inspection Date 03/12/2025  
Inspected by Paul Craddock  
Next Inspection Date  
Identification Strongly Presumed  
Asbestos Type Chrysotile (White)

Asbestos Type 1 Chrysotile (White)  
Product Type 1 Asbestos Reinforced Composites (Plastics, resins, mastics, roofing felts, vinyl floor tiles, semi-rigid paints or decorative finishes, asbestos cement etc)  
Extent of Damage / Deterioration 1 Low damage. A few scratches or surface marks, broken edges on boards, tiles etc.  
Surface Treatment 1 Enclosed sprays and lagging, asbestos insulating board (with exposed face painted or encapsulated), asbestos cement sheets etc.

Type of Activity 0 Rare disturbance activity (eg little used store room)  
Location 1 Large rooms or well-ventilated areas  
Accessibility 0 Usually inaccessible or unlikely to be disturbed  
Extent / Amount 1 <=10 m<sup>2</sup> or <=10 m pipe run  
Number of Occupants 0 None  
Frequency of Use 0 Infrequent  
Average time each use 0 Less than one hour  
Maintenance Type 0 Minor disturbance (eg possibility of contact when gaining access)  
Maintenance Frequency 0 ACM unlikely to be disturbed for maintenance

| Actions | <u>Due By</u> | <u>Estimated Cost</u> | <u>Status</u> |
|---|---|---|---|
| Inform | 08/12/2025 | | Active |
