## Tree Condition Report

Skeyne Drive, Pulborough, RH20 2BB

Ref: TCR/777/26

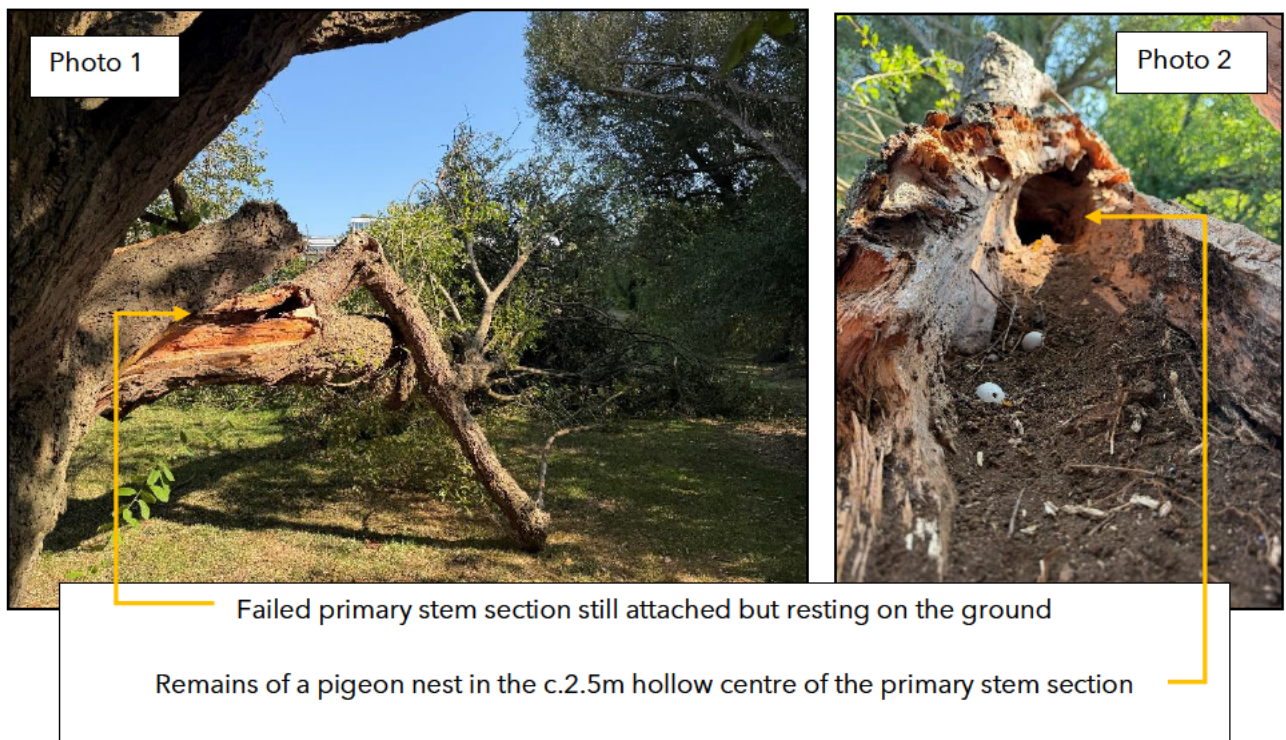
- The extent of the hollow primary stem section suggests decay has been active for many years, with the white mycelium<sup>2</sup> within the wood structure confirming this

- The hollowing nature of the stem section, along with its over extended form, and the excessive dry weather the southeast has experienced has, in my opinion, been the contributing factor in its failure

- The cavity extending into the main stem appears to be following the original branch cone, the more or less cone shaped mass of branch wood embedded in the parent stem wood caused when the branch is smaller than the parent stem

- Although I see no immediate need to remove the tree, I will recommend the tree undergoes a crown volume reduction to lessen the loading on the lower stem area

- This can be achieved by shortening the longest apical and lateral branch lengths by c.2m
- To be undertaken within six months of the reports date

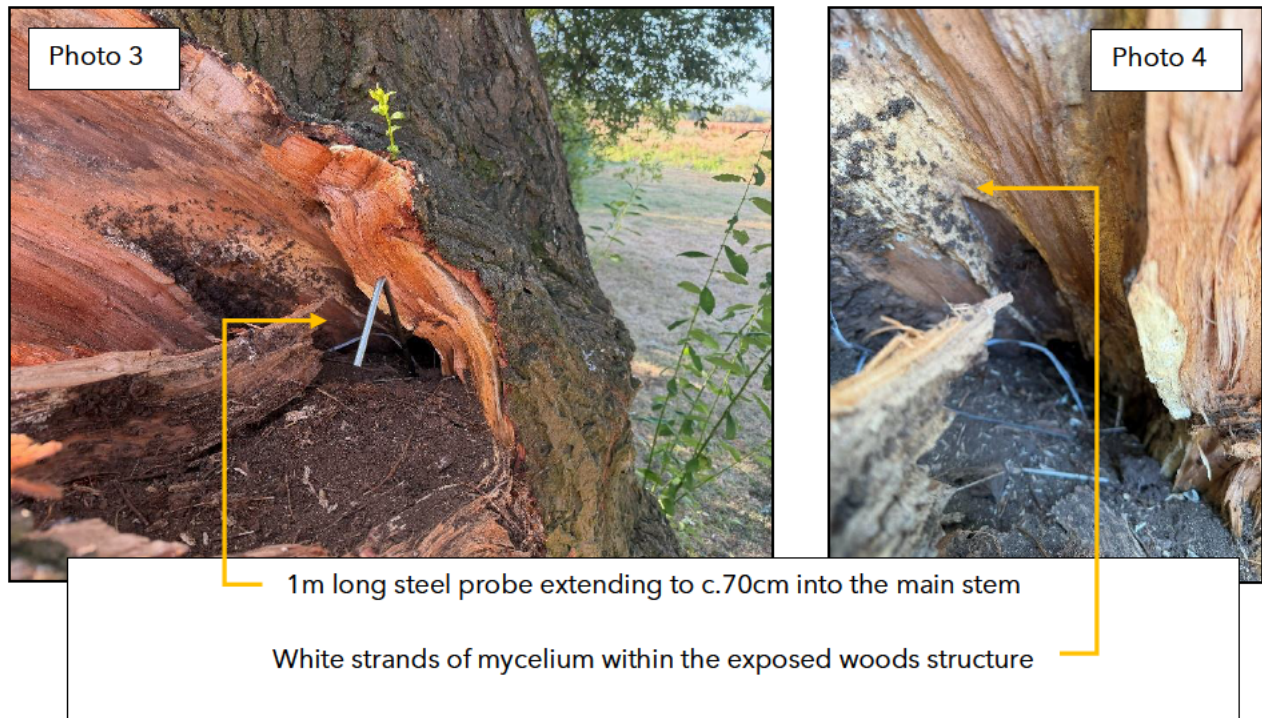
- As evidenced by the audible change in tone beneath the failed section, it appears the decay has migrated outwards and away from the branch cone. However, tests on the remaining stem with the nylon headed sounding mallet suggest that it has not extended further
