## HERITAGE IMPACT ASSESSMENT

**Property Address:** Park Farm House, Wheatsheaf Road, Woodmancote,  
Henfield, West Sussex, BN5 9BA

**Inspection Date:** 23<sup>rd</sup> July 2024

**Prepared by** Richard Pocock MSc MRICS

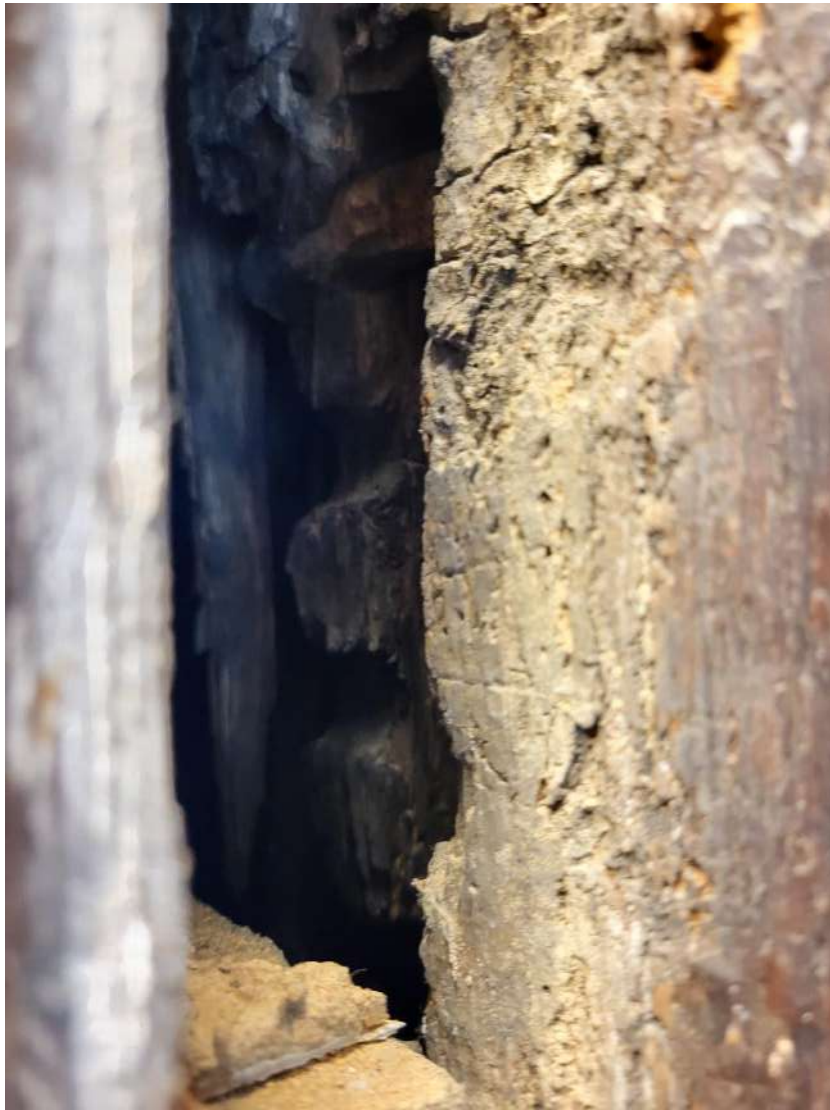
What is fascinating about the post is that it shows distinct evidence of severe fire damage. Views into the surrounding wall lining was limited, but what can be seen is scorching and the loss by burning of parts of a lateral mortise joint.

Given this and other evidence from the re-used timber around the house, it would be reasonable to assume that this earlier building suffered a severe fire. This has a bearing upon Phase 2 of the building's life, as with reasonable continuation of occupation, one can suggest that the fire must have taken place around the end of the first quarter of the 17<sup>th</sup> century, requiring a wholesale rebuilding of the house.

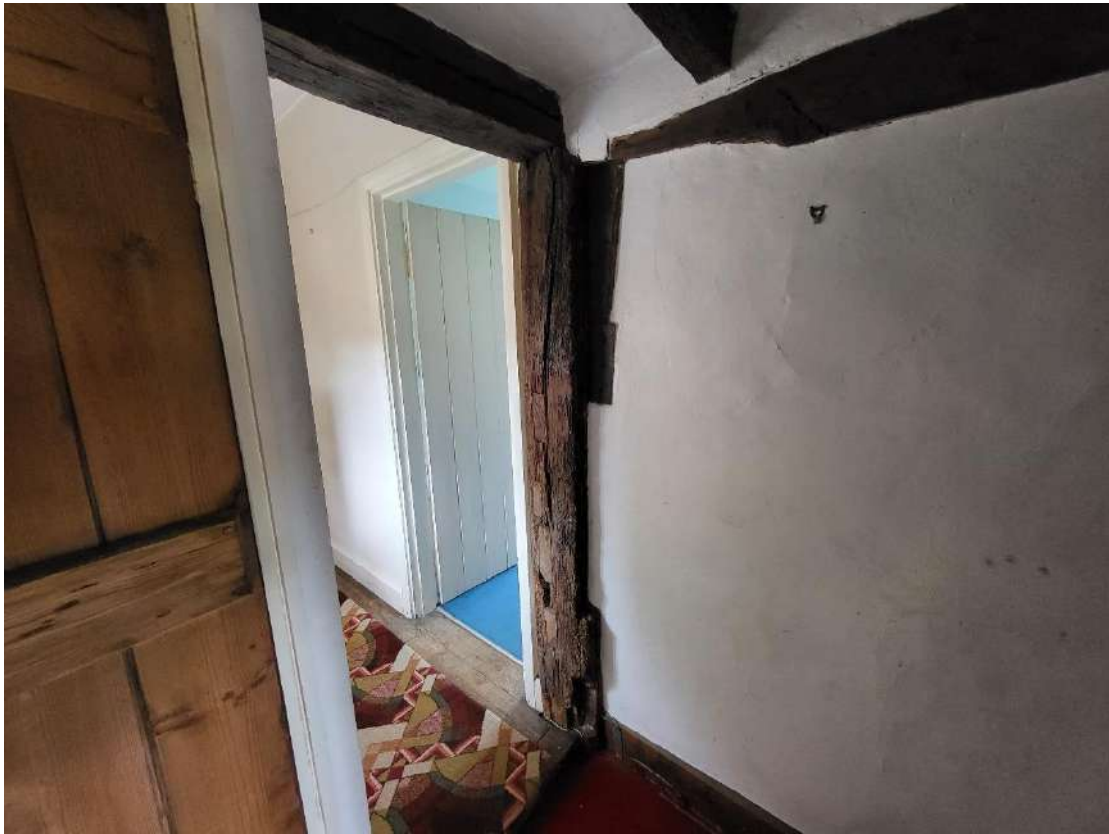
The fact that the property would seem to have been entirely rebuilt after the fire, would certainly explain the lack of other in situ evidence and also the state of some of the re-used elements of timber in the later frame. Some of these are earlier bay posts, scorched and with considerable mortise damage.

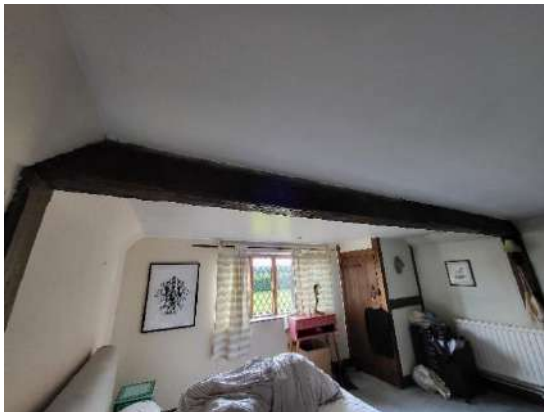
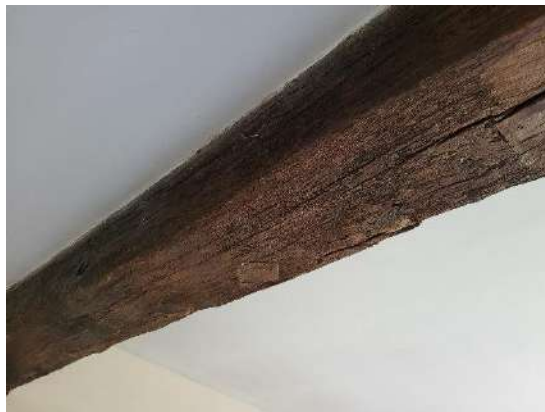
The spanning beam in the master bedroom is also re-used out of situ and can be identified as what was a section of wall plate (complete with former mullion window cut outs).

This section of timber indeed could be misleading, as it is installed in such a way as to possibly suggest that it was the end wall of the original building. However, there are certain signs that this is not the case. The position of the window cut outs is wrong, there is a brace position centrally (something that would only be seen on a face wall in that position, not an end wall). Furthermore, the position of the studs does not equate to an end wall and the post ends are not mortised for suitable connective joints of the era. Therefore, it fits far better with interpretation as a section of face wall wallplate, repurposed in this position. However, this end of the house poses some issues in relation to sequencing, as will be outlined below in the section 'Phase 3'.

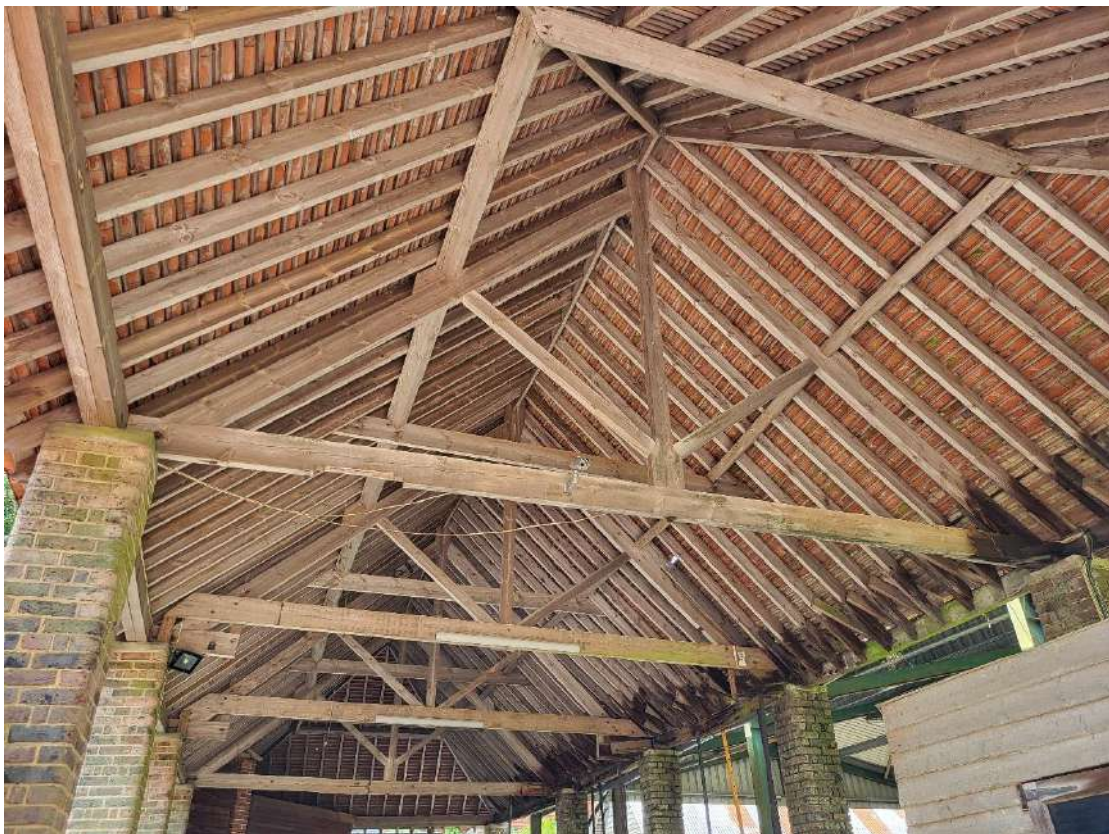
This is a relatively modern structure, with a bolted trussed roof frame. It is probably only 30 years old or more and now in considerably poor structural condition.

It has no heritage value in context.

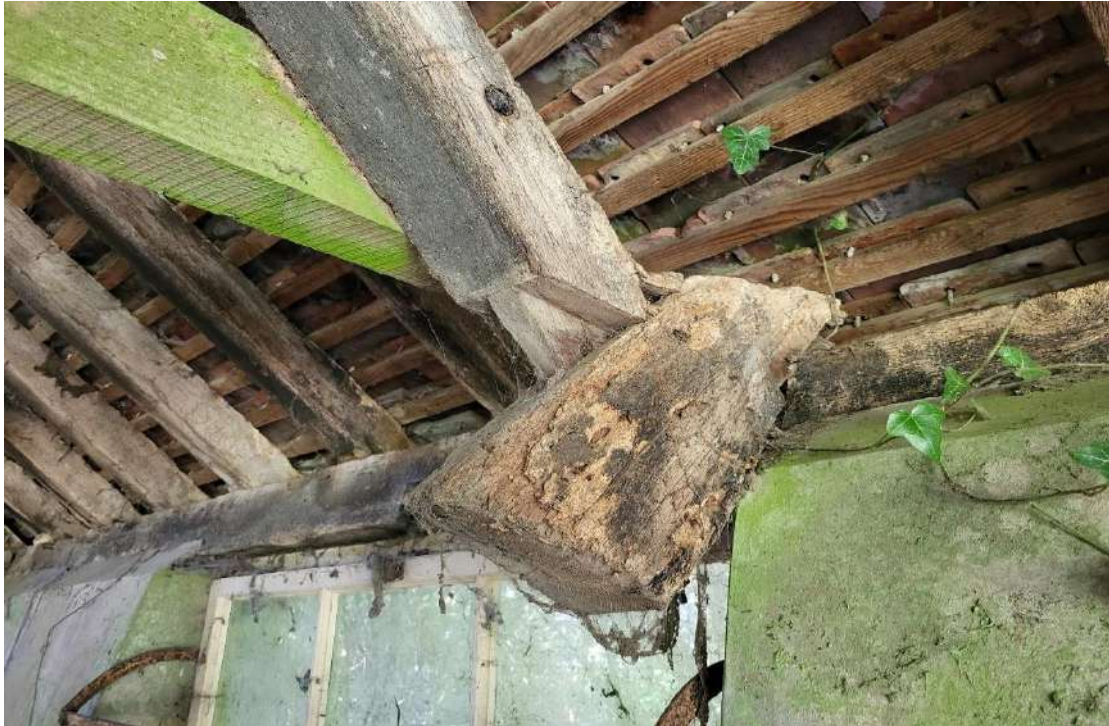
Serious structural problems prevail, despite modern attempts to repair and stabilise the structure. Some of these 'repairs' have resulted in loss of fabric, for instance, the removal of the forward tie where it has failed and been replaced with a softwood upper bolted brace.

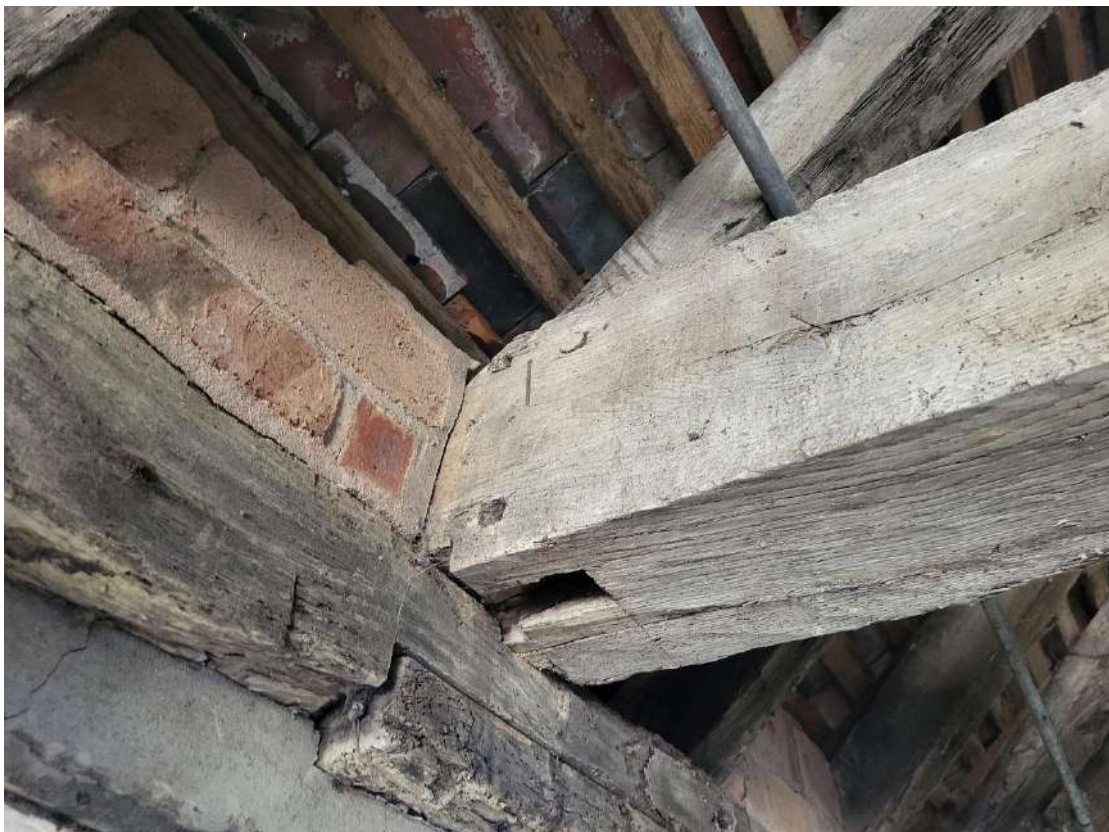
The unit's timber elements are mostly taken from earlier buildings, for instance, one of the repurposed ties is from a formerly fully timber framed unit as evidenced by the open mortise joint for a teasle tenon arrangement.

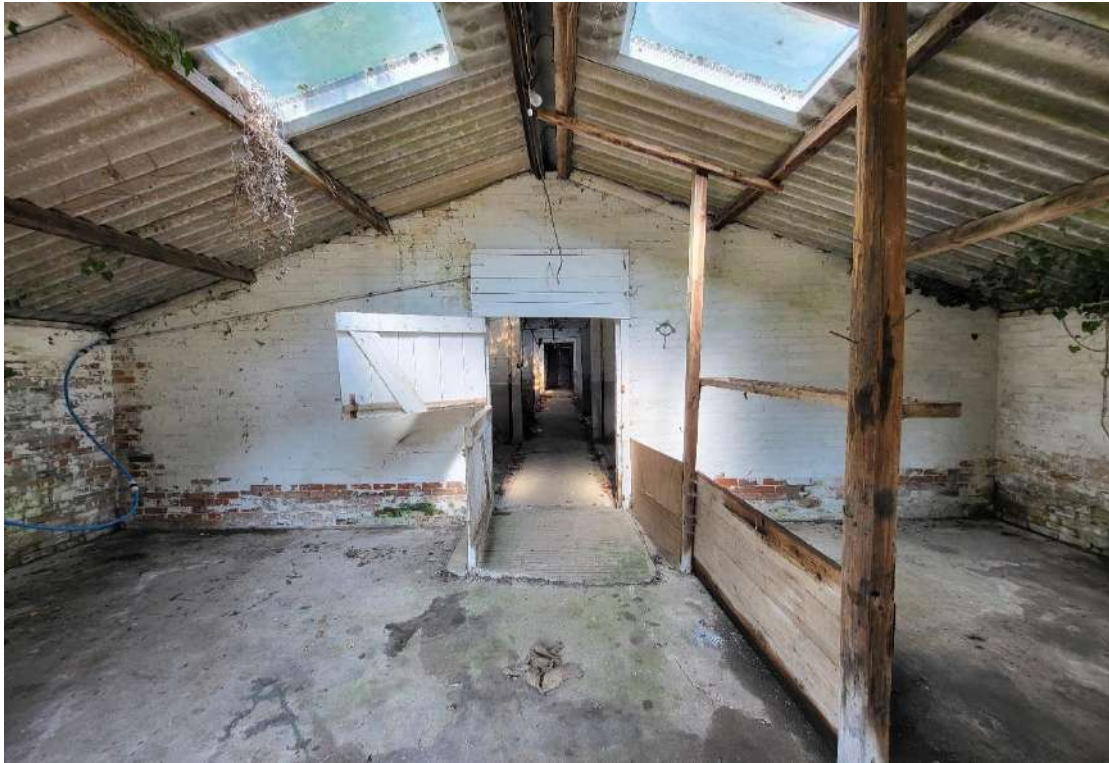
This post WW2 building occupies land to the north east of the former farmyard. It comprises a brick built structure with a corrugated cement sheet roof. There is little of note within, and the building is now in derelict condition.

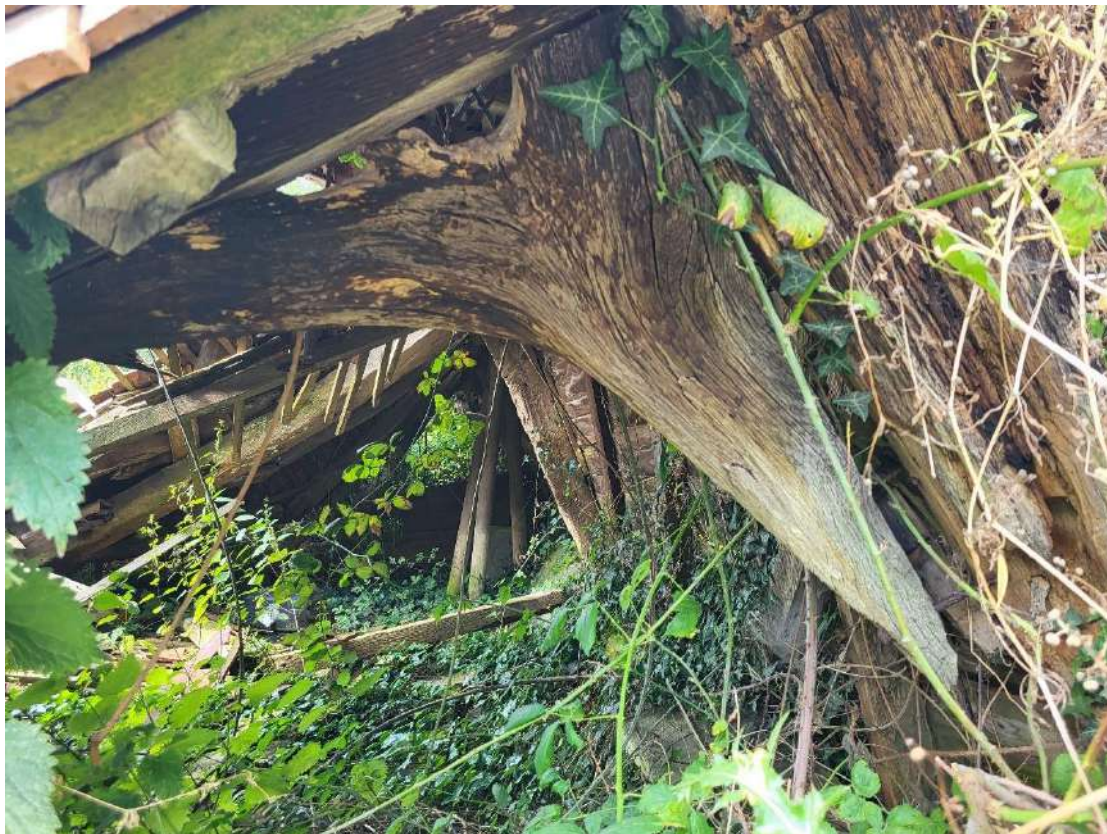
Unfortunately, the structure appears to be well beyond restoration.
