# Tree Condition Survey Report (VTA)

**Site:** Parsonage Business Park, Horsham, RH12 4AL  
**Client:** Workman LLP

| <i>GC Document Reference</i> | J250917 | | |
| | 1 | 20/08/2025 | Final |

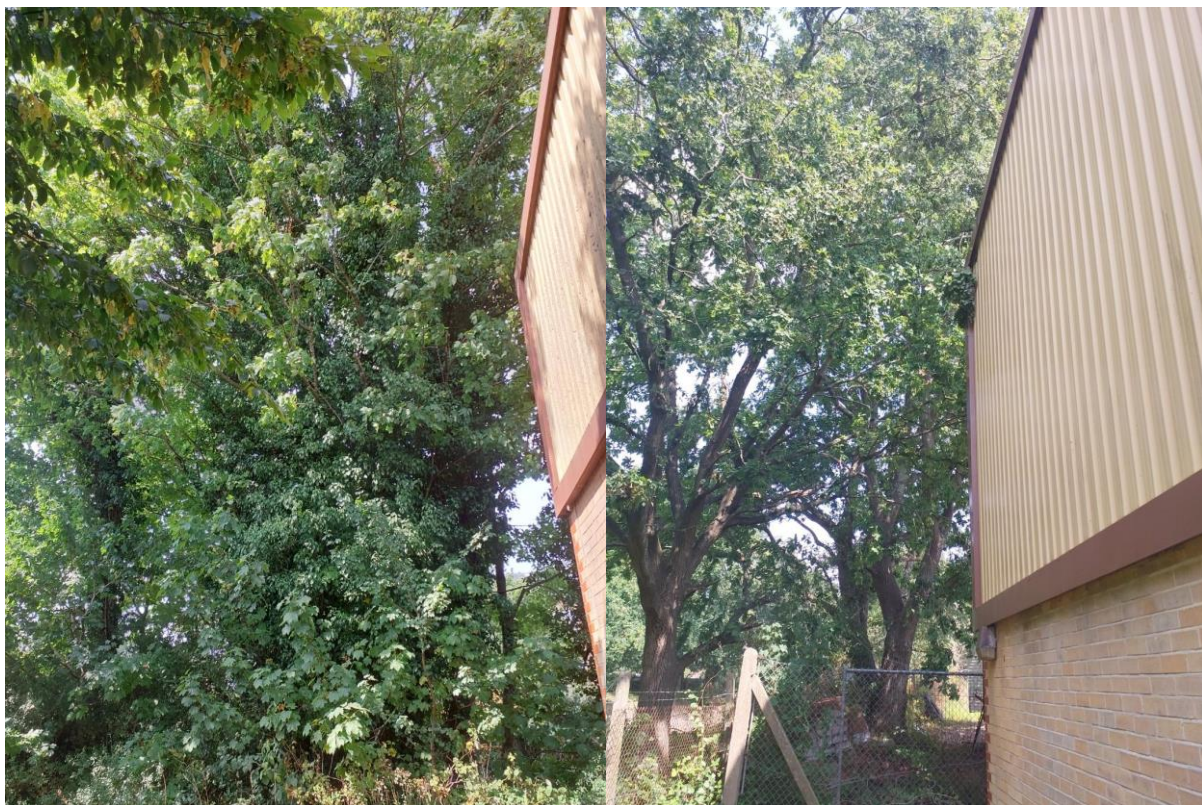
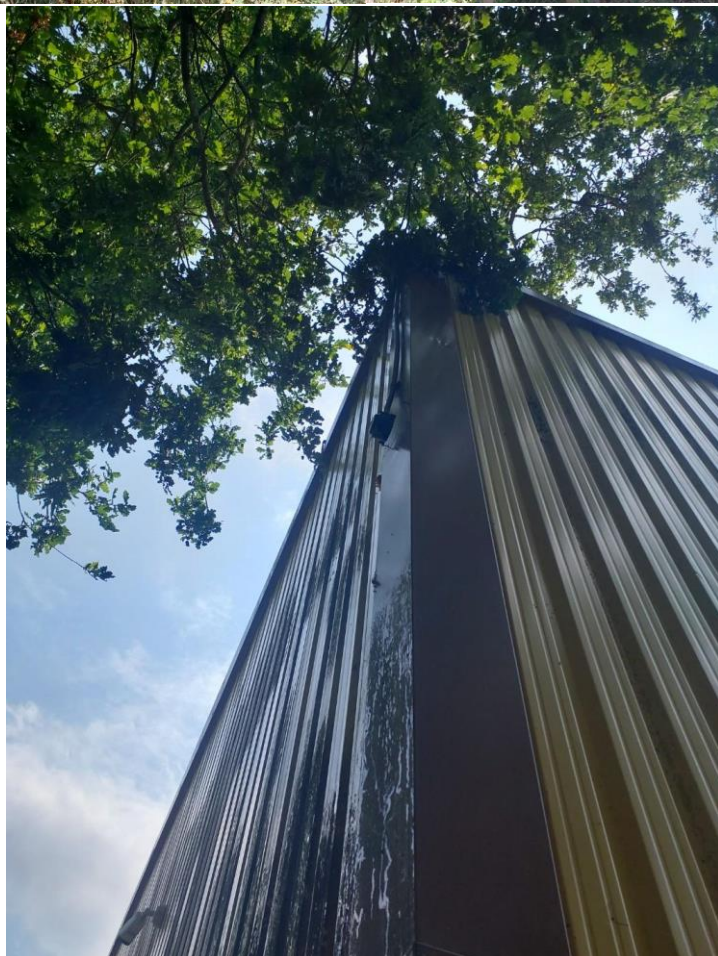
## Group 2

| Tree Group Survey Schedule | | | | | | | | | | | | | | | | | | |
|---|---|---|---|---|---|---|---|---|---|---|---|---|---|---|---|---|---|---|
| 2 | | Sycamore, Silver birch, Common hazel, Common ash, Common holly, Pedunculate oak, Goat willow, Common yew, Mixed species | Acer pseudoplatanus, Betula pendula, Corylus avellana, Fraxinus excelsior, Ilex aquifolium, Quercus robur, Salix caprea, Taxus baccata, Mixed species | | 5-10m | 150-300mm | Early-mature | Mixed | Fair | A trench runs along this group. Trees located in the trench have had inspections from outside of this trench as it is deep and full of brambles. Oaks on the north eastern end have foliage touching building. Sycamores on the south western end are covered in ivy. | None Significant | Ivy Covered Stem, Multi-Stem | Crown Close to Building, Previously Reduced | None Observed | Building, Car park, Fence, Garden, Railway | High | No access to base/stem | Mixed |

| Tree / Group ID | Common Name | Work Task | Work Priority | Description | Tag No |
|---|---|---|---|---|---|
| Group 2 | Sycamore, Silver birch, Common hazel, Common ash, Common holly, Pedunculate oak, Goat willow, Common yew, Mixed species | Sever and Remove Ivy to 1.5m Above Ground Level | Within 12 - 18 Months | Remove ivy from sycamores on the south west end of group ahead of the next inspection. | |
| Group 2 | Sycamore, Silver birch, Common hazel, Common ash, Common holly, Pedunculate oak, Goat willow, Common yew, Mixed species | Prune to Clear structure/wires/buildings by 1m | Within 12 - 18 Months | Oaks touching building on the north east end of group. | |

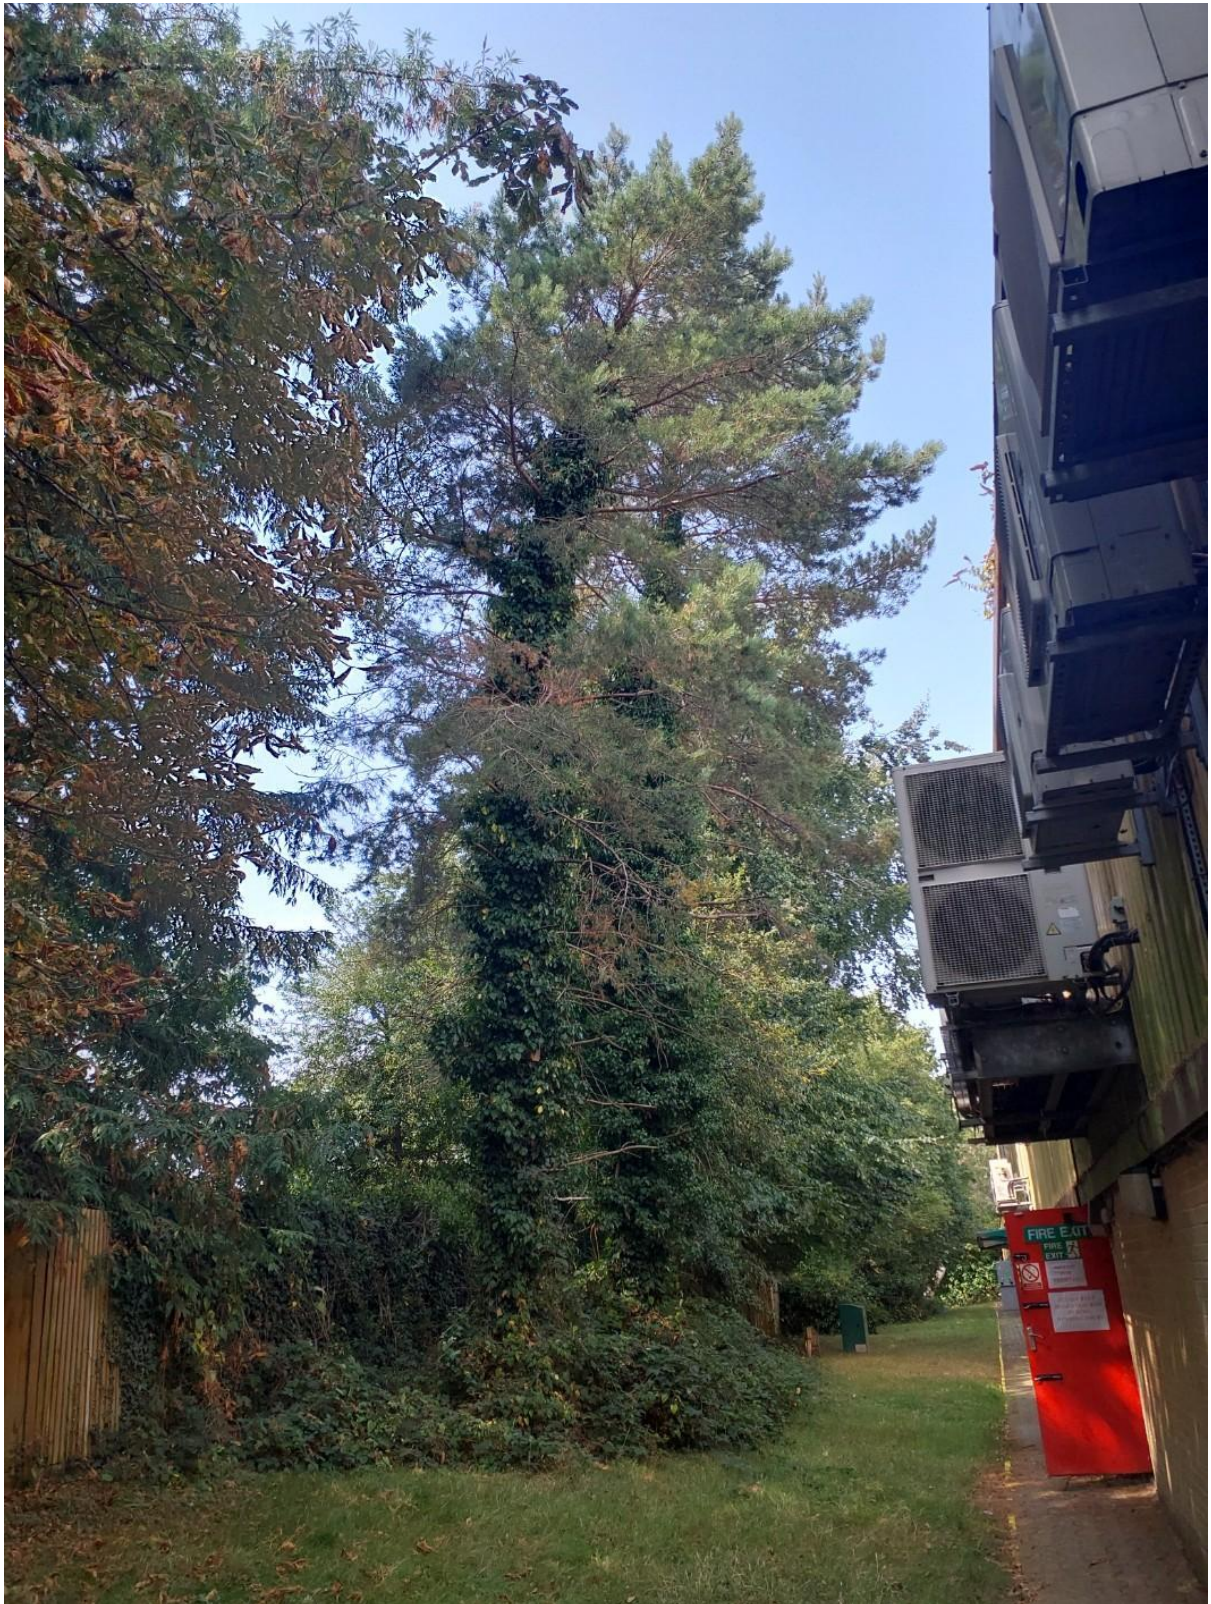
Tree 4

| Tree Survey Schedule | | | | | | | | | | | | | | | | | |
|---|---|---|---|---|---|---|---|---|---|---|---|---|---|---|---|---|---|
| 4 | | Pine species | Pinus sp. | 11-15m | 300 | Mature | Fair | Fair | Surrounding brambles and ivy covered stem limits inspection. | | Ivy - Significant (limits assessment) | Minor Dead Wood Under 50mm Diameter | None Observed | Building, Fence | High | Good | Client |

| Tree / Group ID | Common Name | Work Task | Work Priority | Description | Tag No |
|---|---|---|---|---|---|
| 4 | Pine species | Sever and Remove Ivy to 1.5m Above Ground Level | Within 12 - 18 Months | Ahead of the next inspection. | |
| 4 | Pine species | Clear vegetation to allow access to basal areas of trees for inspection purposes | Within 12 - 18 Months | Remove brambles ahead of the next inspection. | |

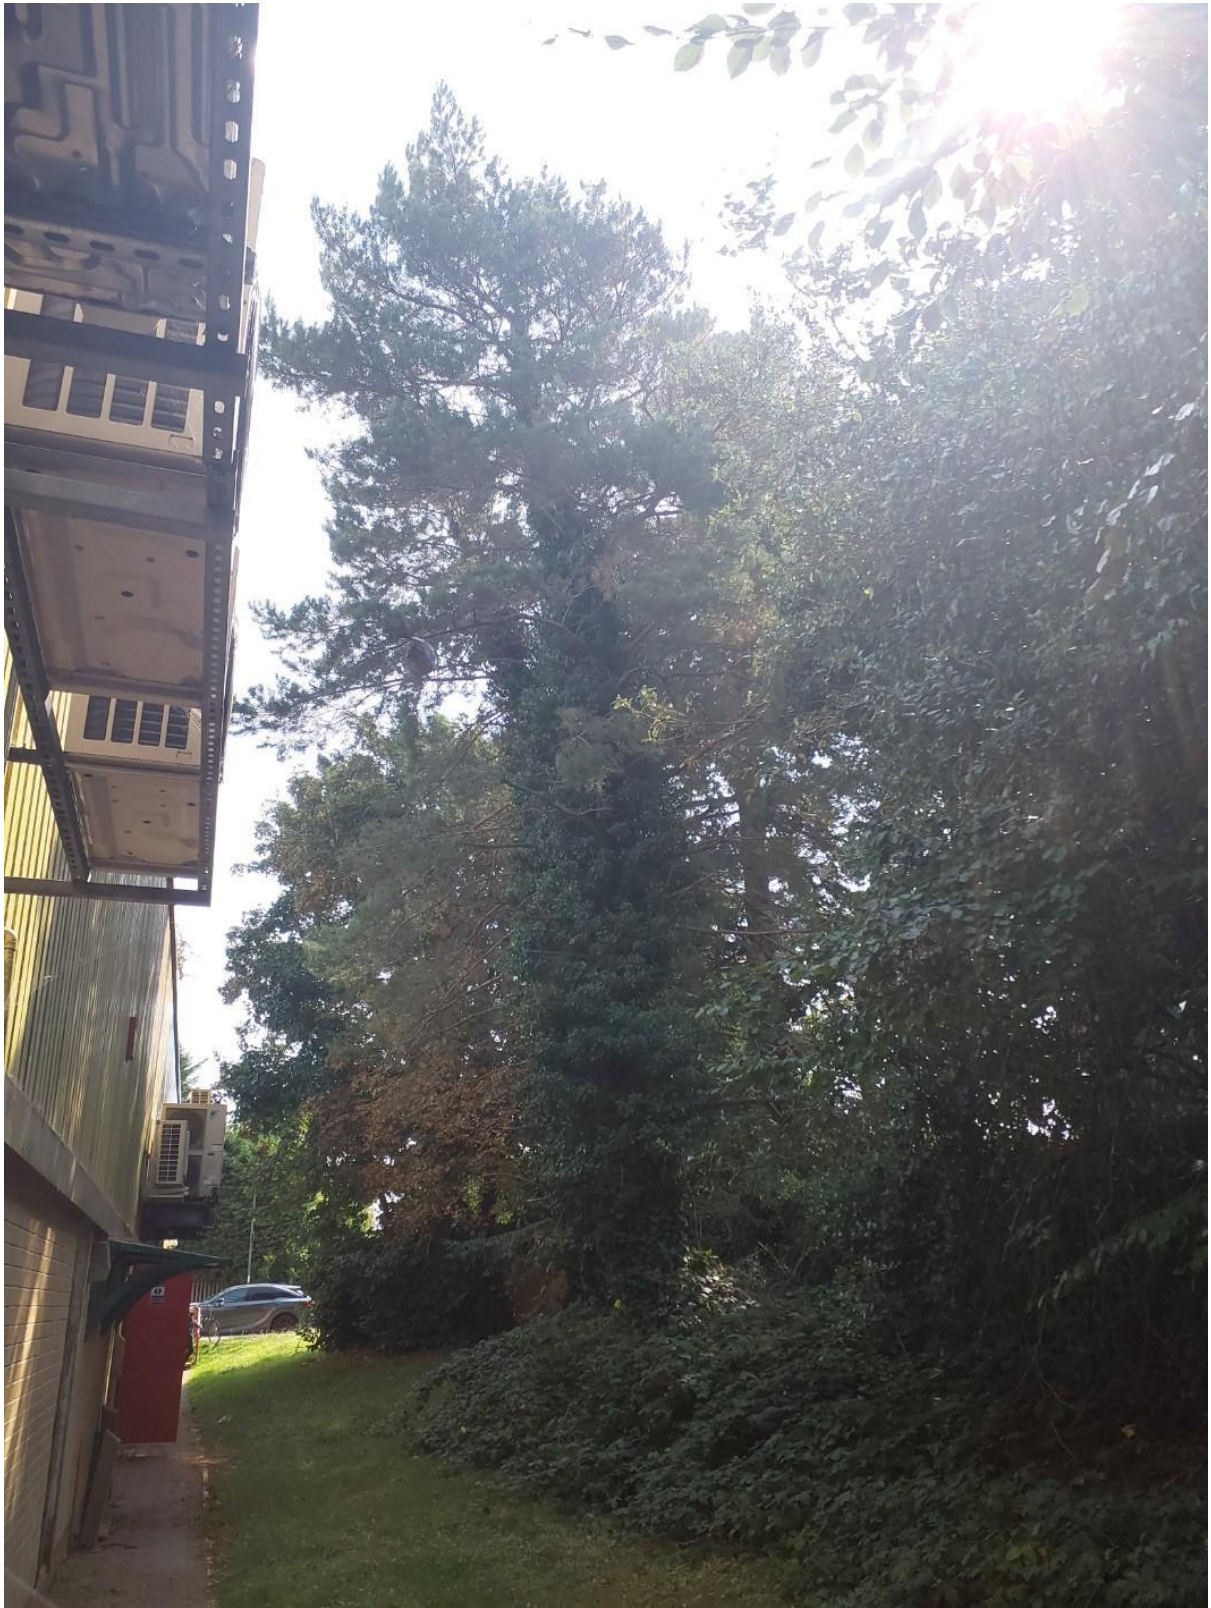
Tree 5

| Tree Survey Schedule | | | | | | | | | | | | | | | | | |
|---|---|---|---|---|---|---|---|---|---|---|---|---|---|---|---|---|---|
| 5 | | Pine species | Pinus sp. | 11-15m | 400 | Mature | Fair | Fair | Surrounding brambles and ivy covered stem limits inspection. | | Ivy - Significant (limits assessment) | Minor Dead Wood Under 50mm Diameter | None Observed | Building, Fence | High | Good | Client |

| Tree / Group ID | Common Name | Work Task | Work Priority | Description | Tag No |
|---|---|---|---|---|---|
| 5 | Pine species | Sever and Remove Ivy to 1.5m Above Ground Level | Within 12 - 18 Months | Ahead of the next inspection. | |
| 5 | Pine species | Clear vegetation to allow access to basal areas of trees for inspection purposes | Within 12 - 18 Months | Remove brambles ahead of the next inspection. | |

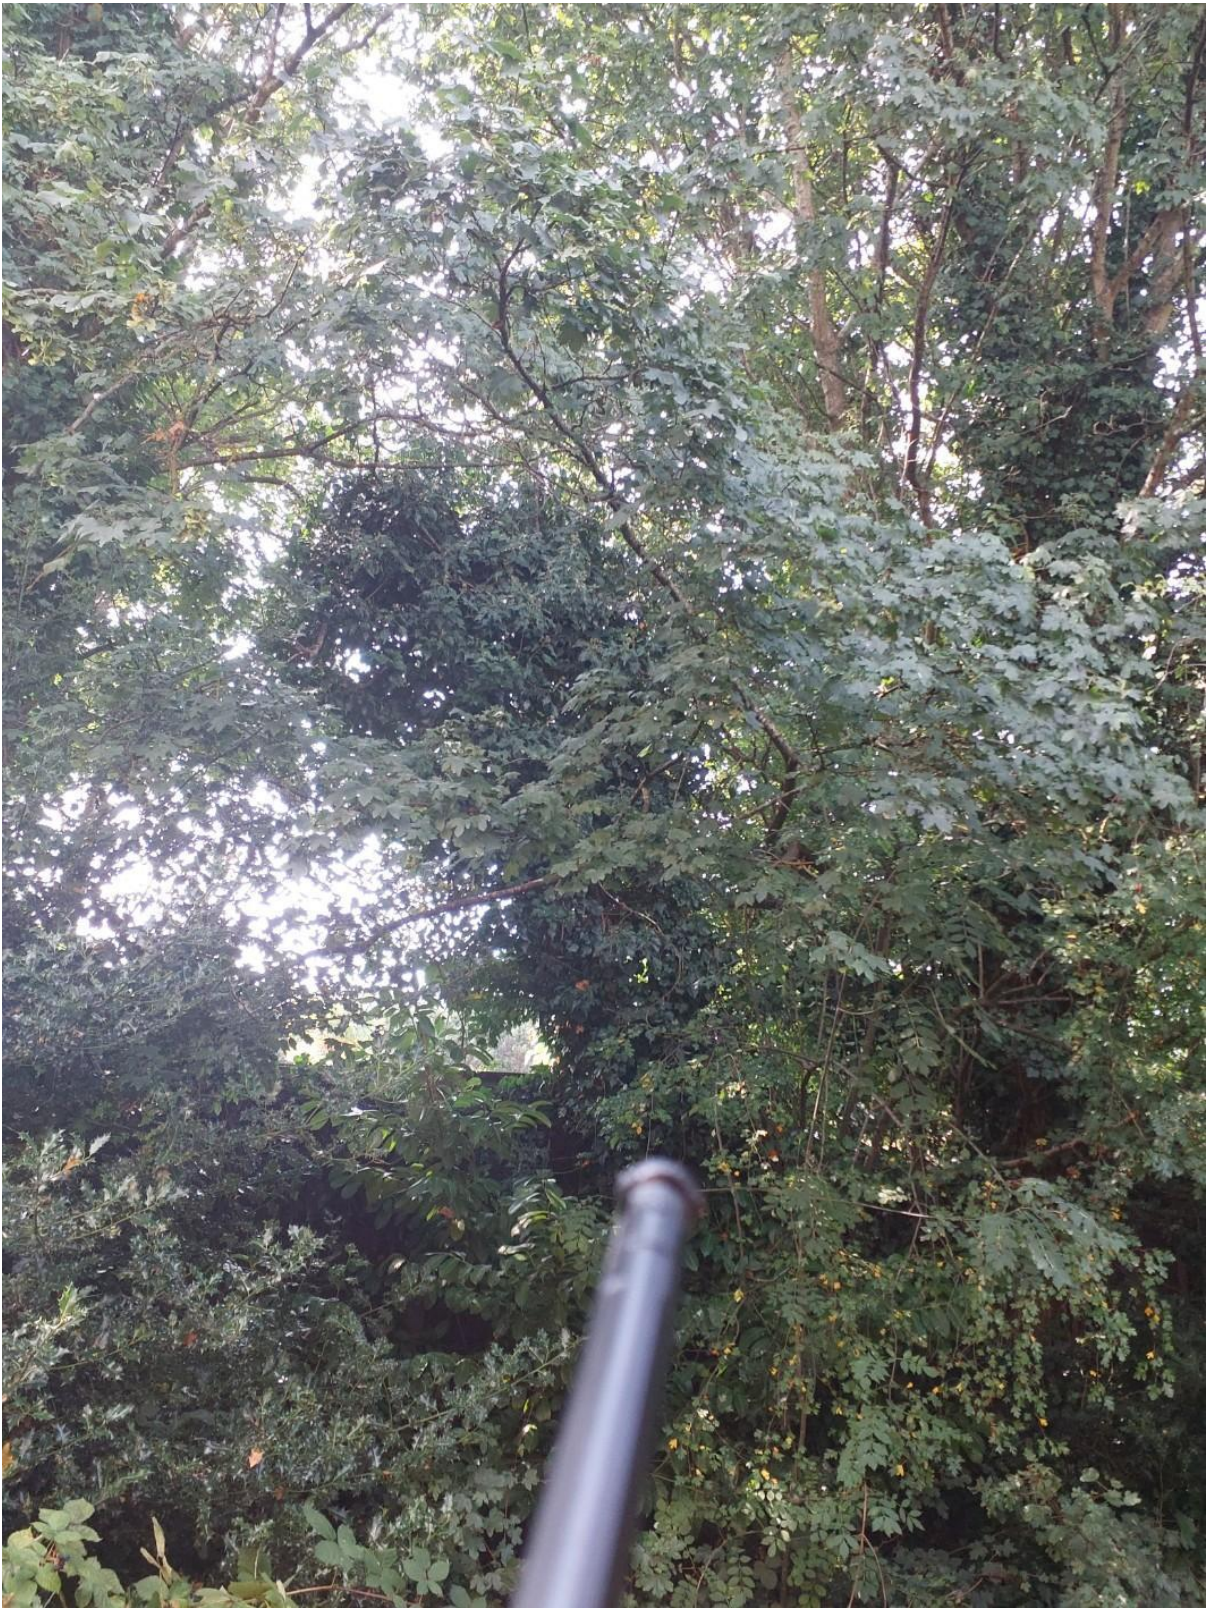
Tree 8

| Tree Survey Schedule | | | | | | | | | | | | | | | | | |
|---|---|---|---|---|---|---|---|---|---|---|---|---|---|---|---|---|---|
| 8 | | Common hawthorn | Crataegus monogyna | 0-5m | 180 | Early-mature | Dead | Fair | Dead standing tree. | | | | | Fence, Garden | High | Good | Client |

| Tree / Group ID | Common Name | Work Task | Work Priority | Description | Tag No |
|---|---|---|---|---|---|
| 8 | Common hawthorn | Dismantle to ground level | Within 3 - 6 Months | Remove tree. | |
