**Arboricultural Report**  
**composed of**  
**Arboricultural Impact Assessment**  
**Arboricultural Method Statement**  
**& Tree Protection Plan**

Haynes, Littleworth Lane  
Partridge Green Horsham  
West Sussex RH13 8JF

Written by  
Barry Holdsworth MBA, RHS. Dip, MCI Hort, M.Arbor.A, MCMI  
Horticultural Consultant

12th August 2025  
UPDATED 17th April 2026

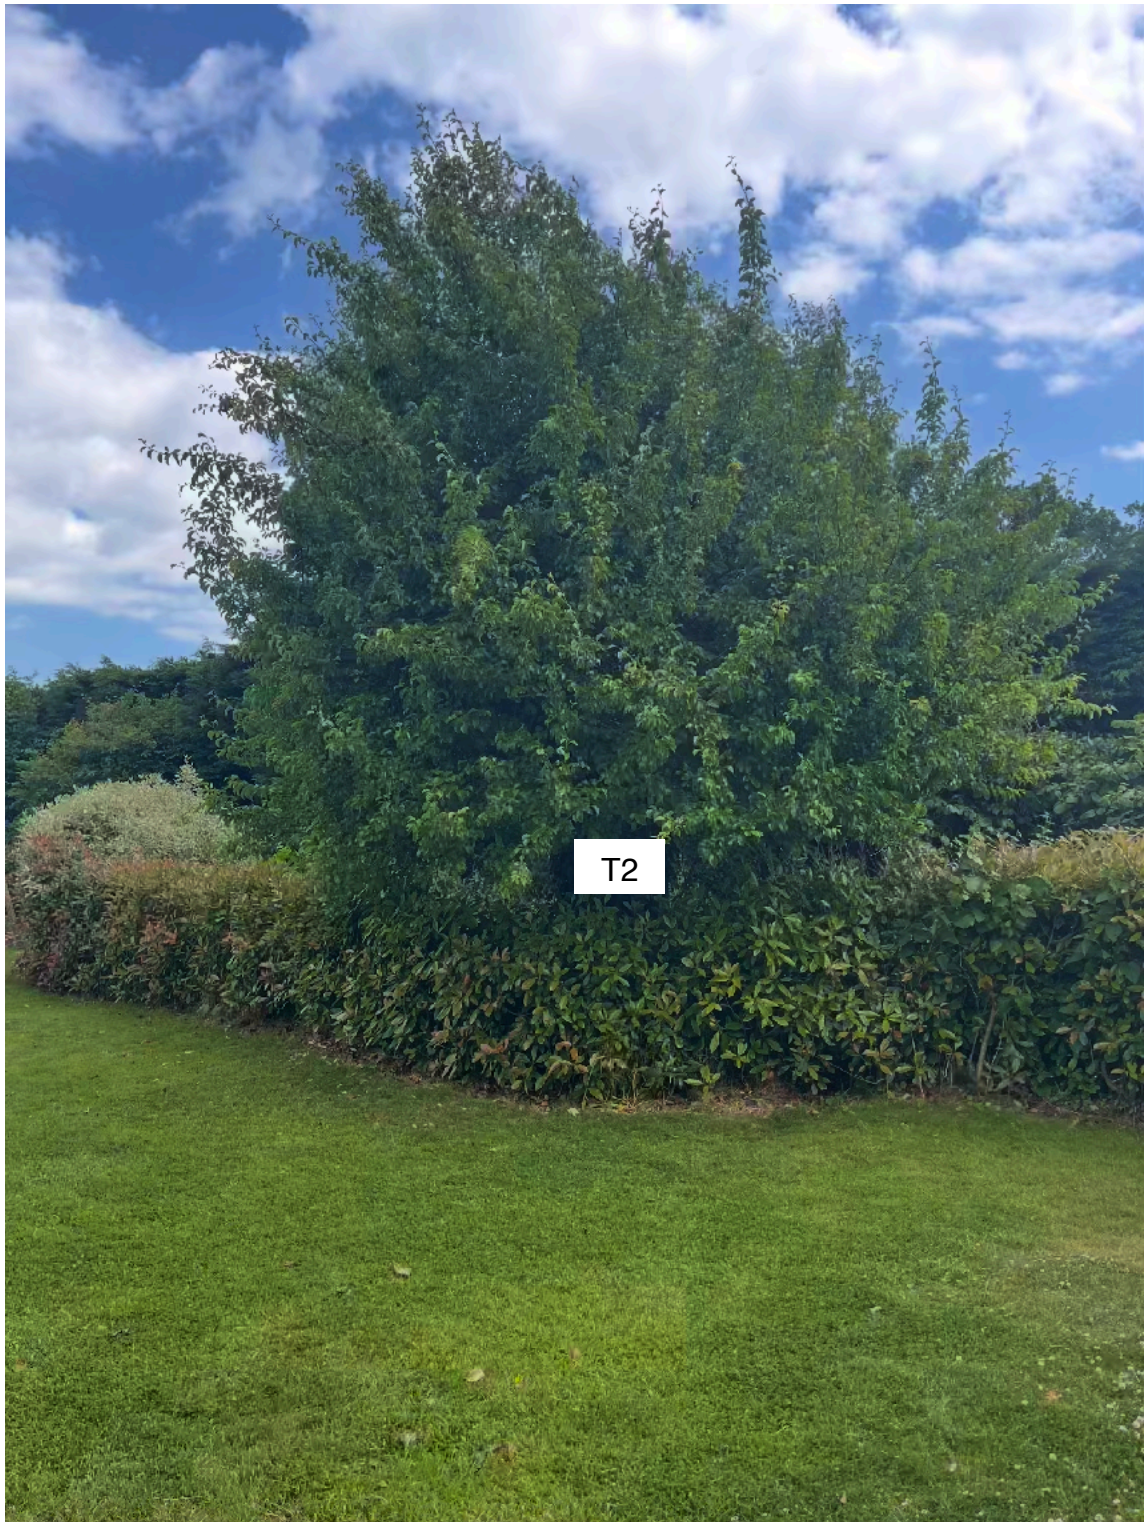
The small group of trees G1 (Category C) being a mixture of Elm and Wild Plum is to be removed for the drive along with the Pear tree T2 (Category C), the Photinia hedge H3 (Category C) and shrubs within the footprint of the drive.

Site of access drive requiring the removal of the Photinia hedge and T2

| No | Species | Height | Ø at 1.5m | Spread | Crown | Age | Condition and<br>Recommendations | Removal | ERC | BS<br>Grade | RPA |
|---|---|---|---|---|---|---|---|---|---|---|---|
| T2 | Pear | 10 | 695 | 6.0Ø | 2mN | OM | Physiological Condition: Fair<br>Structural Condition: Fair<br>Public Amenity Value: Low<br>Inspection Limitations: Yes - vegetation cover<br>Hollow trunk with decay. Lost leader but good regrowth<br>Ivy into canopy<br><b>Recommend:</b> Remove for development | Y<br>Fell | >10<br>B | C2 | 8.34 |

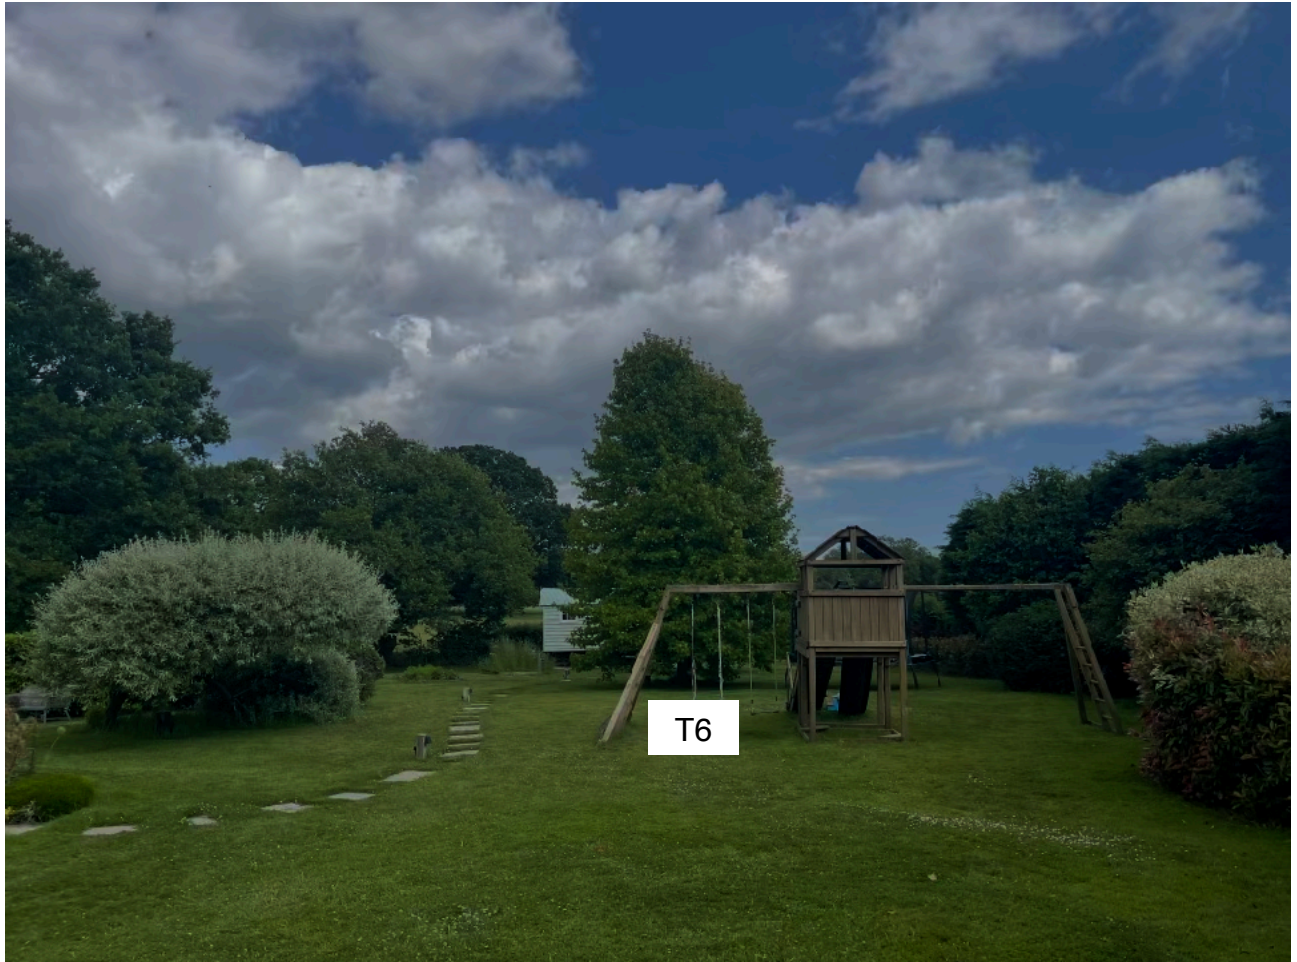
The house footprint will require the loss of the Sweet Gum T6 (Category B).

Access drive on right of picture with parking and turning where playground is sited. T6 to be removed to site new house

| T6 | Sweet Gum | 17 | 220+250 | 6.0Ø | 1mN | M | Physiological Condition: Good<br>Structural Condition: Good<br>Public Amenity Value: Moderate<br>Inspection Limitations: None<br><b>Recommend:</b> Remove for development | Y<br>Fell | >40<br>B | B2 | 3.99 |

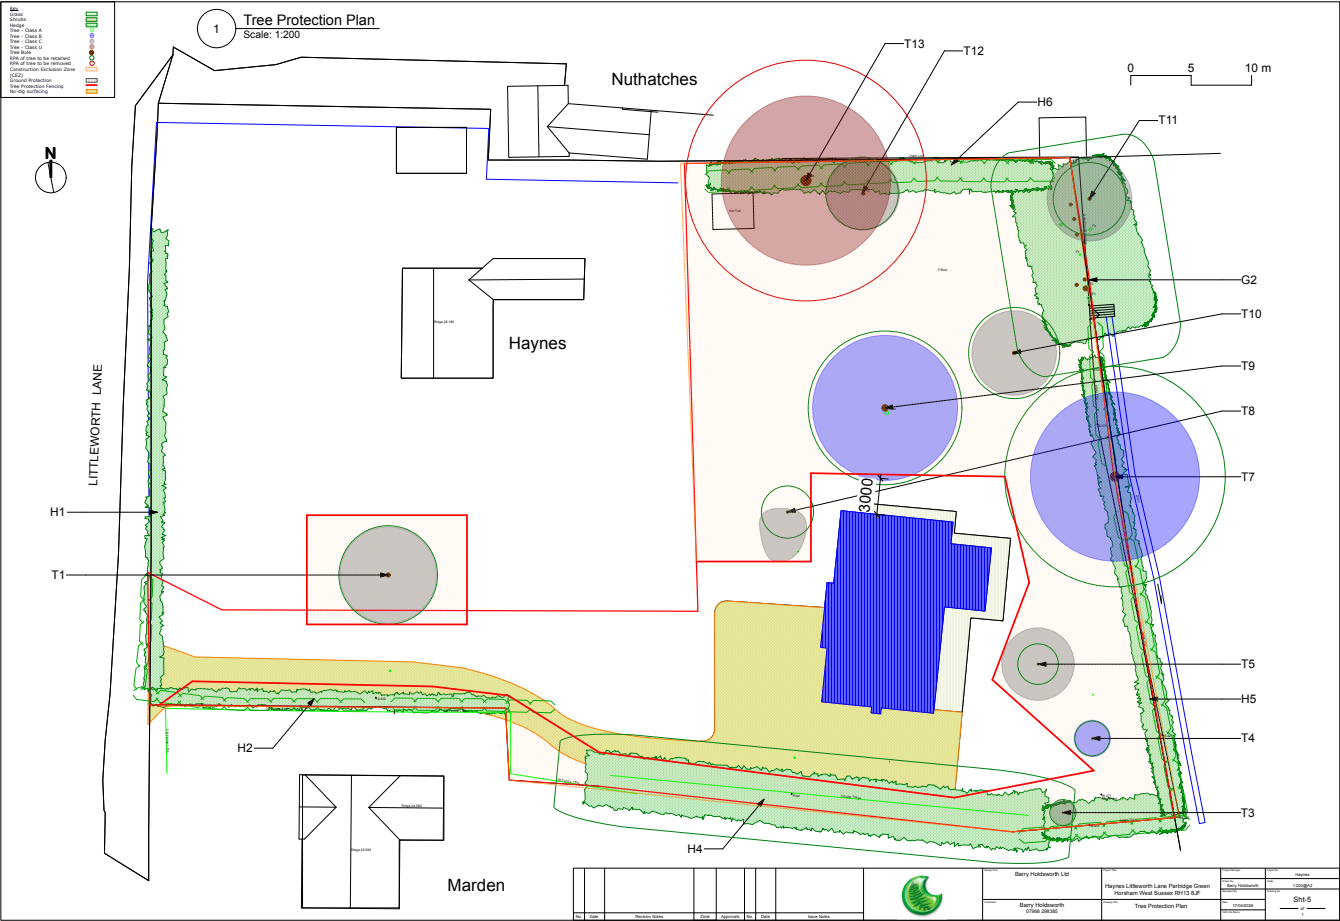
Appendix 2. Tree Protection Plan

The house position has been relocated 3m south of the canopy of T9, as shown on the Tree Protection Plan. 'If built as proposed, T9 will never reach its full potential as a landscape and visual amenity feature. Consideration should therefore be given to increasing the separation distance between T9 and the new dwelling. This could reasonably be achieved by shifting the building 3 m to the south.' in line with recommendations from the Tree Officer Andy Bush dated 11/11/25 Reference:DC/25/1531.

All the remaining trees found on the site are situated outside the building zone. However, in order to protect the root zones and canopies of the remaining trees a Construction Exclusion Zone is to be arranged with tree protection fencing erected across the site, as shown on the Tree Protection plan, see Appendix 2.

3.7.2. The Tree Protection Fence will create a Construction Exclusion Zone (CEZ) and this is shown as orange hatching on the Tree Protection Plan (Appendix 2. Tree Protection Plan).

4.1.1. All the remaining trees on site will be protected by the use of stout barrier fencing that is erected in the position indicated on the Tree Protection Plan. This fencing will be in accordance with the requirements of BS 5837:2012 including any necessary ground protection and will be erected prior to any development commencing on the site, therefore ensuring the maximum protection. This fencing, which must have all weather notices attached stating 'Construction Exclusion Zone – No Access', or similar, with a sign such as shown in Appendix 7. Tree Protection Warning Sign. This area will be regarded as sacrosanct and, once erected, will not be removed or altered without the prior consent of the Local Planning Authority.

4.4.1. The protective fencing that forms the CEZ will be erected along the lines indicated on the Tree Protection Plan by Barry Holdsworth, together with the ground protection measures as detailed above prior to commencement of any development works on the site.
