## Heritage and Design and Access Statement - repairs following flood

Jessamine Cottage, Gay Street  
Pulborough, West Sussex RH20 2HL

Date: 30<sup>th</sup> May 2026

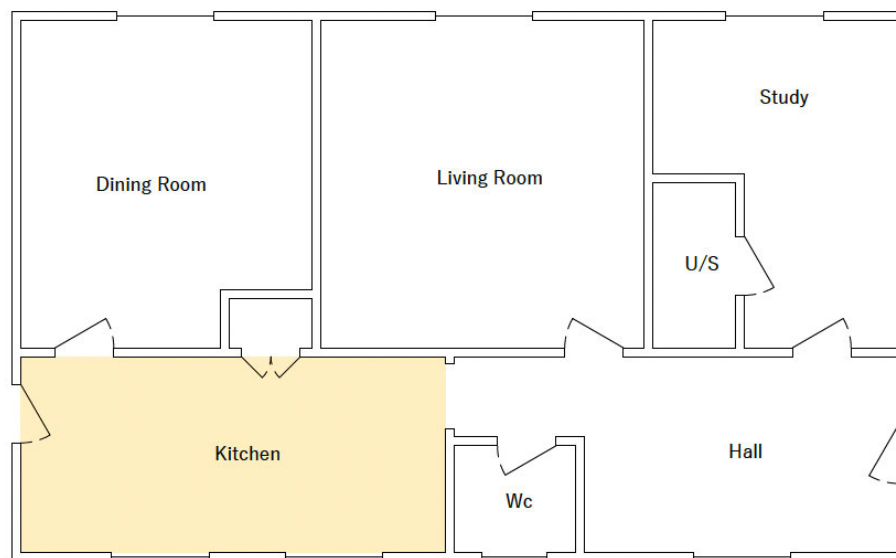
Fig (ii) – kitchen floor floor to be replaced in limecrete

It is proposed to replace the existing modern slate tiled floor, (photo iv) and assumed concrete floor to the kitchen, with a limecrete floor, (fig ii). It is assumed that the existing foundations will be extremely shallow. It is therefore extremely important to ensure that the new floor does not undermine the existing shallow footings. It is proposed to either chamfer at a 45 degrees angle from the wall as indicated in Fig(iii), or if the foundations are found to be too shallow for this, then the floor will be stepped in by 200mm and then chamfered at 45 degrees from here. The make up will consist of a breathable geotextile membrane on levelled and compacted ground, a 80-100mm layer of recycled foamed glass insulation, followed by another layer of geotextile membrane and with a 100mm NHL5 limecrete slab, with a 30mm cork board to the external perimeter walls, with a 50mm NHL 2:1 mix lime screed topping, finished with a new slate floor to match the original with joints pointed in a lime mortar. Note: the slate floor will not be laid until the limecrete floor has fully cured, and any sealer applied will be a natural stone breathable sealer so as not to trap the moisture in.

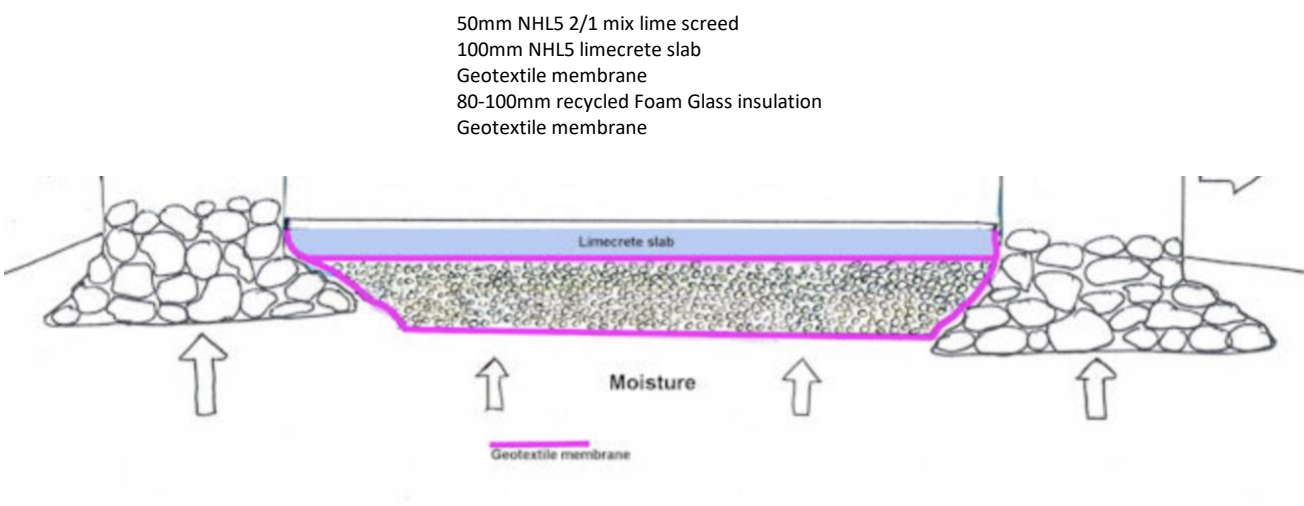
Fig (iii) – proposed new limecrete floor makeup for kitchen

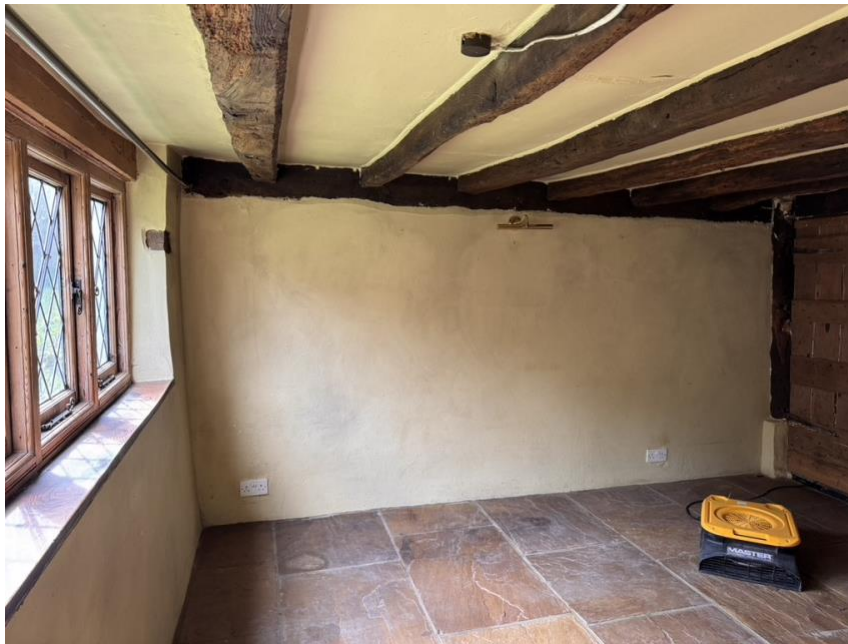
The existing walls throughout the property are a mixture of lime and modern plasters, (photo v), including what would appear to be an historic attempt at damp proofing. Unfortunately, there is a very hard cement type render encasing the ground beam within the dining room on the end wall. As a result, water has become trapped behind the render resulting in decay of the ground beam. Due to the large amounts of modern renders and plasters to the wall and the use of modern unbreathable paints, removal of the existing

Photo (v) – typical plastered wall

It is proposed to carefully remove the existing plaster up to a height of 1.2m to all walls, (fig ii) and allow the walls to dry out. Following repairs to the timber frame and the infill panels using matching materials, the walls will be replastered using a three coat lime putty plaster, (10mm scratch coat and then 15mm ready mixed haired lime mortar from Mike Wye with Pozzolan and 3mm heritage lime plaster setting coat). Following completion and allowing the plaster to dry for around 6 weeks a breathable clay paint will be applied.

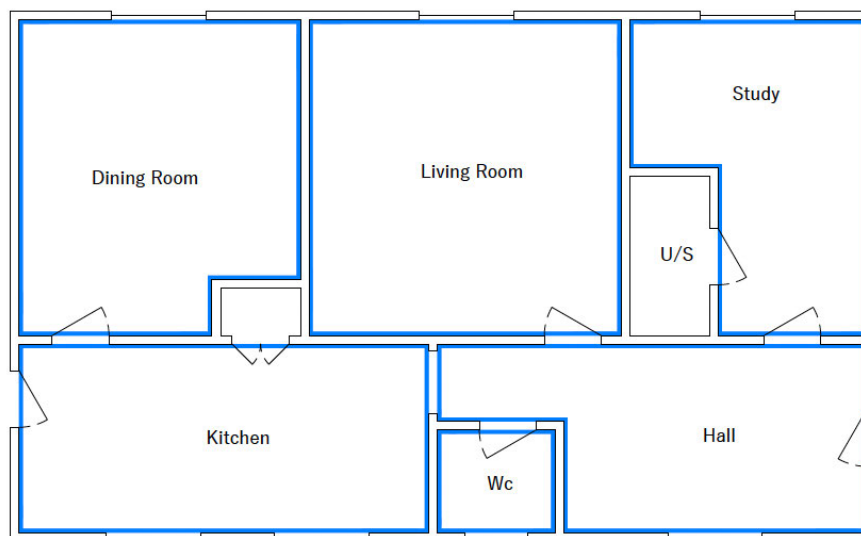
Fig (iv) – floor plan showing proposed removal of wall plaster to a height of 1.2m

plaster up to a height of 1.2m is required following the flood to all external and internal walls and partitions to the extent shown in blue in fig (iv). It is also necessary to replace the ground beam as discussed later.

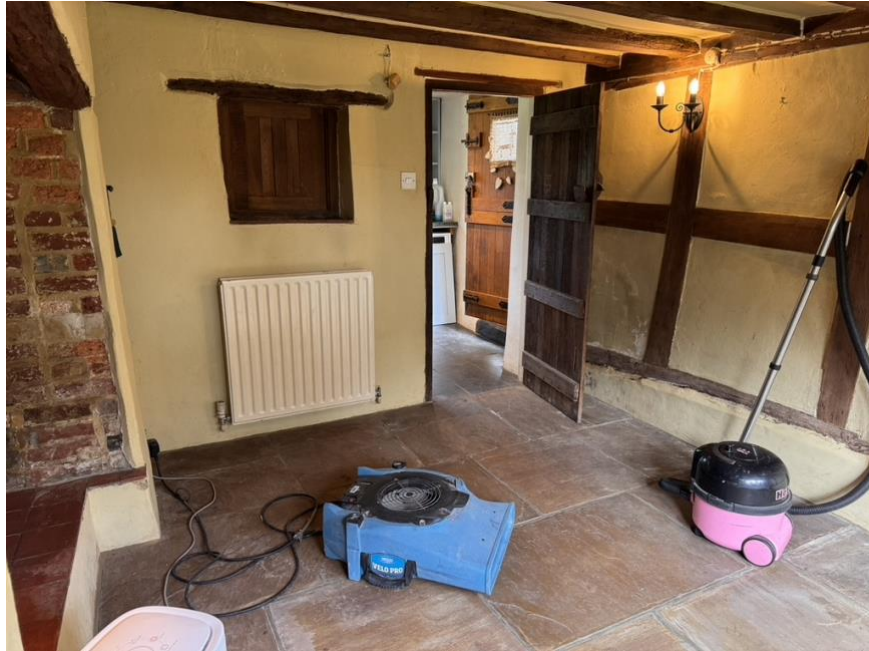
The remaining floors throughout the property are a mixture of brick and stone all pointed using a cement mortar, (photos vi and vii). It is acknowledged that the stone and brick floors should be pointed in a lime mortar as cement is too strong and does not allow for any moisture to escape. However, removal of the cement joints is likely to cause damage to the stone and brick floors and is therefore best left undisturbed. It is therefore proposed to steam clean the floors throughout the remainder of the property using a DOFF system. A sample area will be carried out first to ensure the bricks and stone flags are not damaged.

Photo (vi) – typical stone floor (dining room)

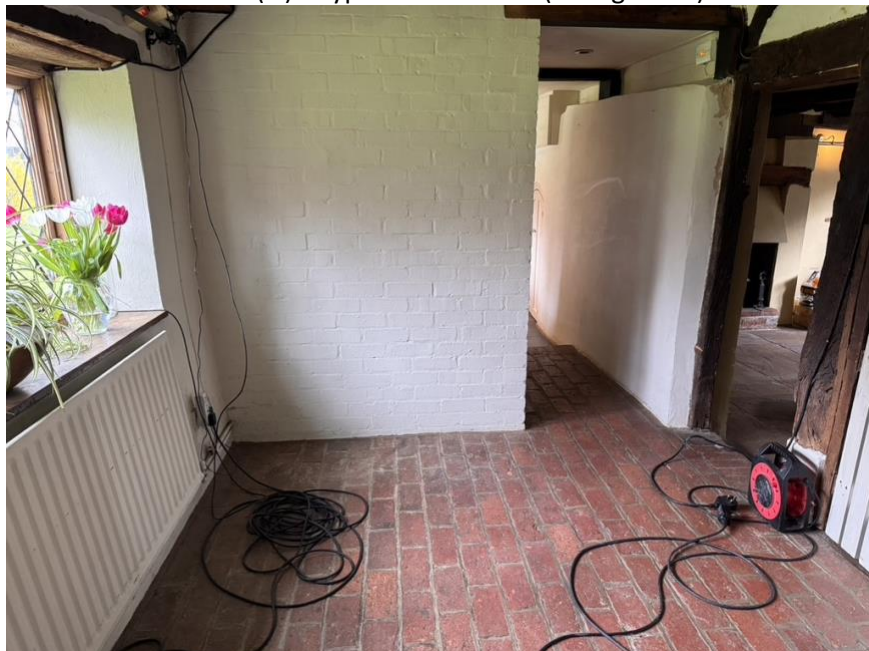
Photo (vii) – brick flooring (hall)

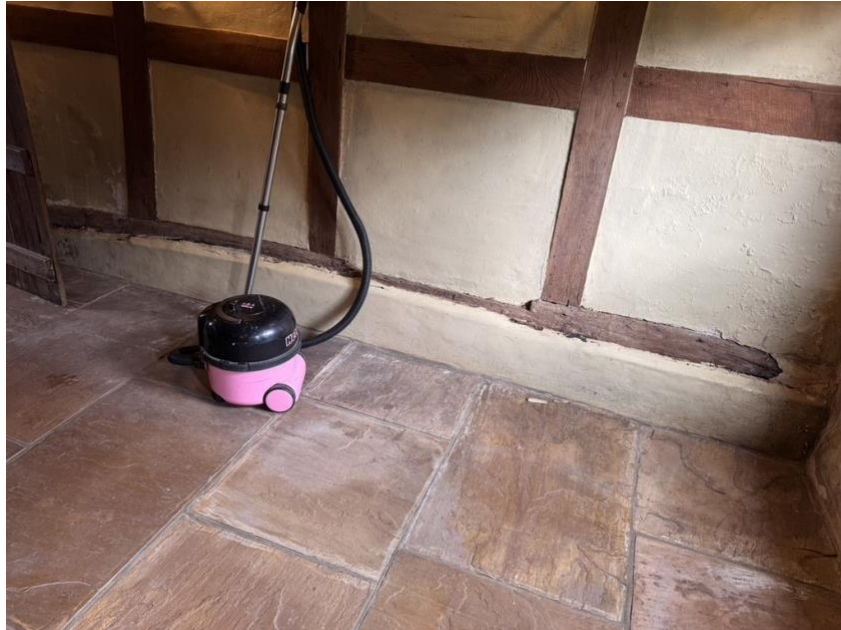
The timber ground beam within the dining room was found to be encased in a hard cement type mortar which would appear to be an historic attempt at damp proofing, (photos viii and ix). A small section of the hard render was removed revealing the severely decayed ground beam, (photo ix). It is therefore proposed to remove the hard cement render and replace the ground beam together with the bottom of the corner post which is also decayed, and suffering from a previous cement mortar inappropriate repair (photo xi). The ground beam was also noted to be encased in cement mortar externally, (photo x). External ground levels will also be lowered to help prevent future decay.

Photo (viii) – timber ground beam to dining room encased in mortar

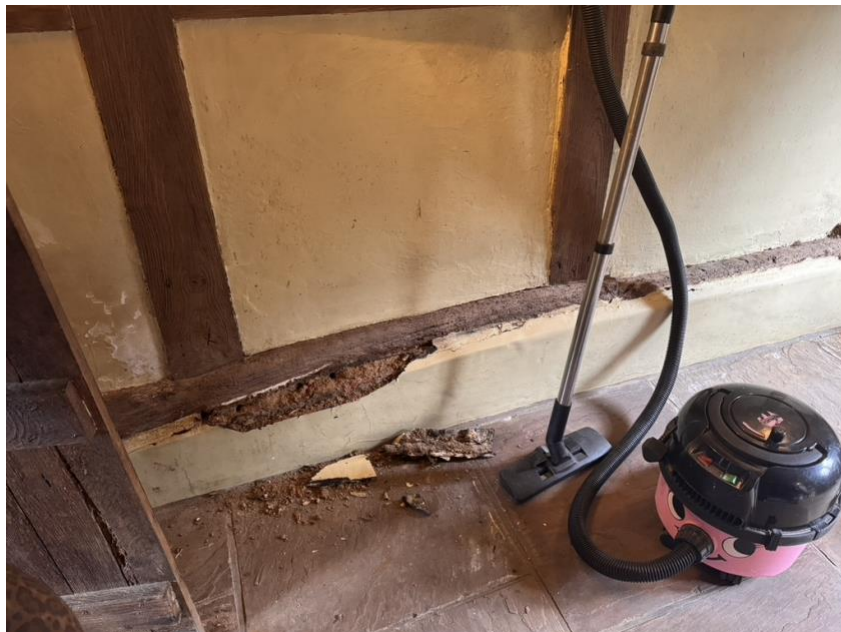
Photo (ix) – small section of mortar removed revealing decayed ground beam

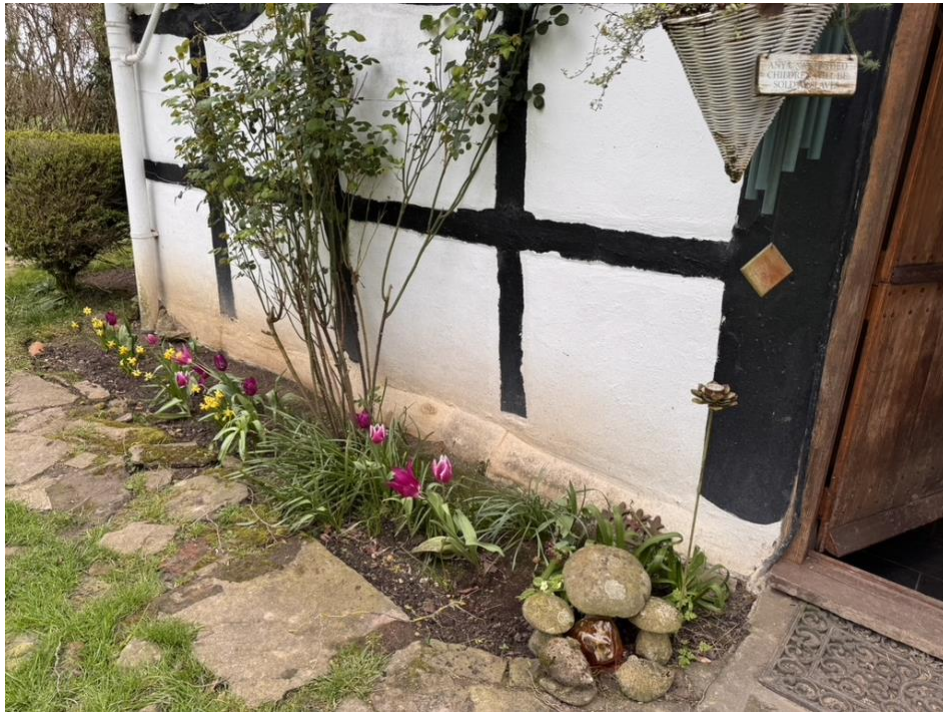
Photo (xi) – ground beam encased in cement render to be replaced

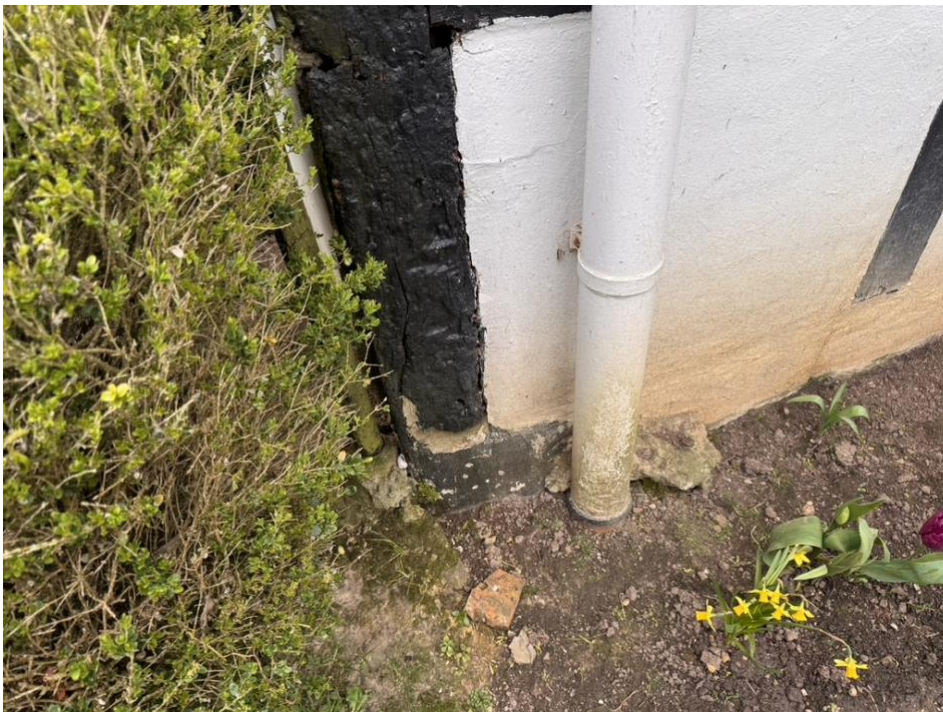
Photo (xii) – decayed bottom section of corner post with cement mortar repair

It is proposed to carefully cut off the damaged section of the corner post and form a new traditional splayed, undersquinted and cogged scarf joint as shown in fig (v). The new timber sole plate will be morticed and tenoned into the existing posts as shown in figs (vi) and (vii). All new timbers will be air dried oak and sized to match the existing timbers.

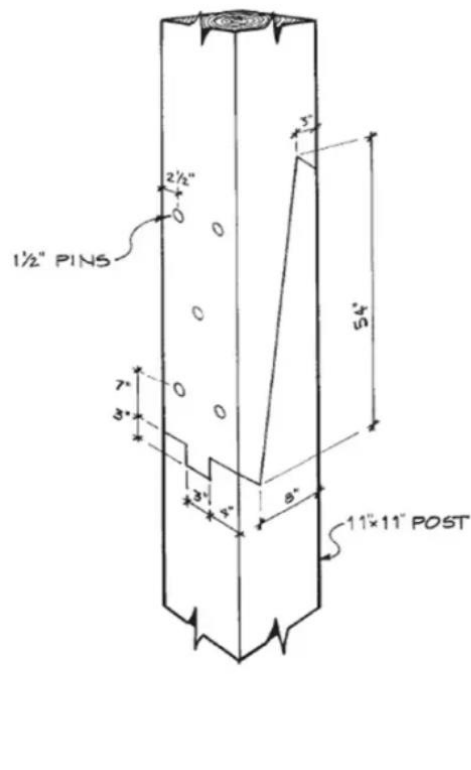
Fig (v) – splayed undersquinted and cogged scarf joint

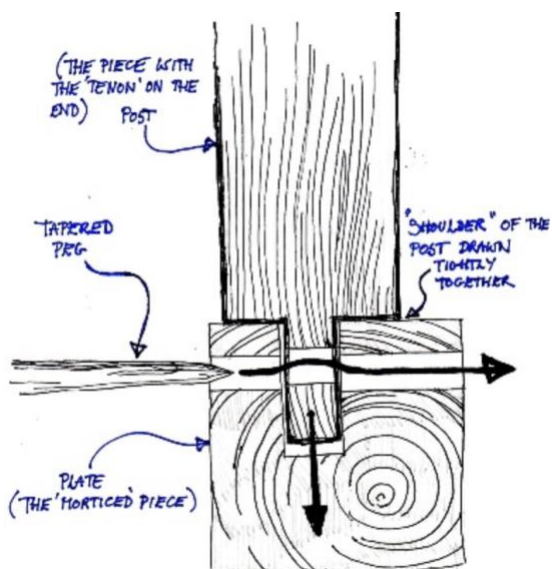
Fig (vi) – proposed base timber joint with timber pegs

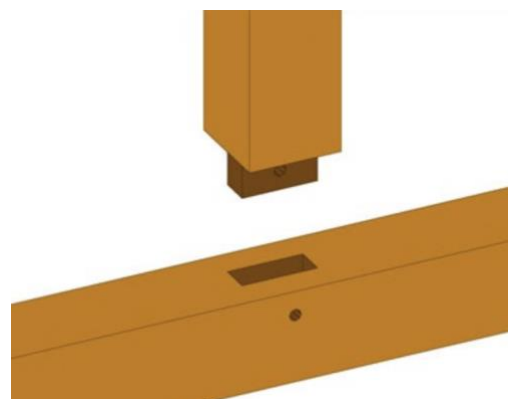
Fig (vii) – mortice and tenon joint
