# Asbestos Refurbishment Survey

First Floor Freshwater Parade Bishopric Horsham West Sussex RH12 1QD

Surveyed On: 7 Sep 2026

Project: R & D Asbestos Survey

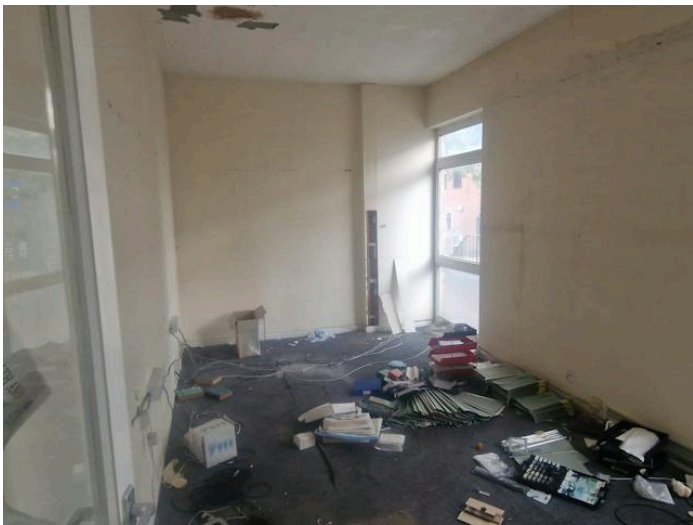
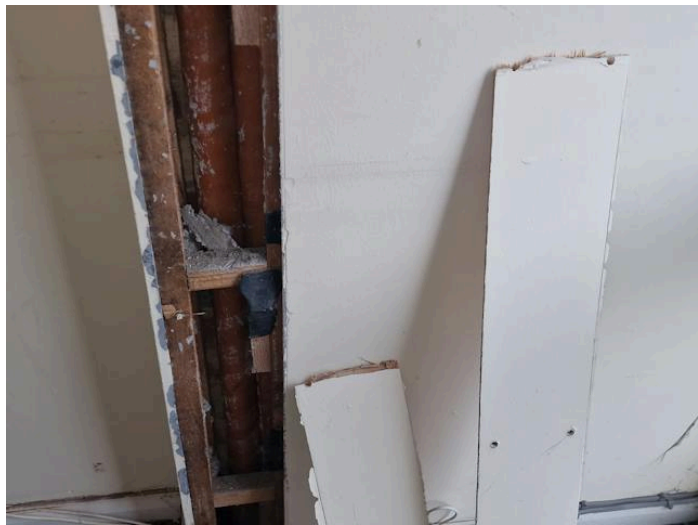
| Location Notes | Solid, timber and plasterboard walls. Concrete ceiling. Carpet on concrete base. Timber riser cladding and foam insulated pipework within riser. | | |

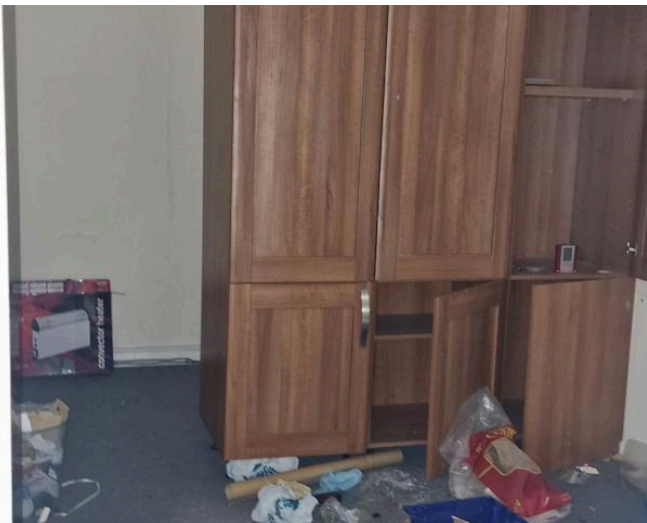
| Location | 002 - | Item | |

| Building / Level / Location | Item | Material | Access / Notes | Material Score | Recommendation | Page |
|---|---|---|---|---|---|---|
| Main Building / 1 / 002 - | Solid, timber and plasterboard walls. Concrete ceiling. Carpet on concrete base. | | | | | 11 |

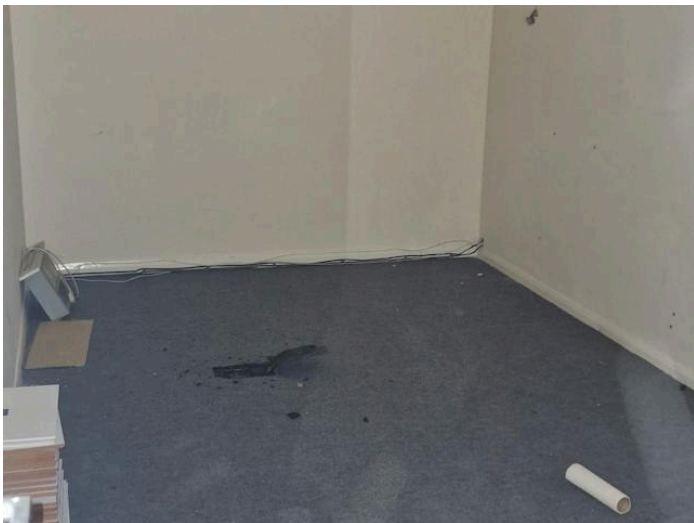
| Location | 003 - | Item | |

| Location Notes | Solid, timber and plasterboard walls. Concrete ceiling. Carpet on concrete base. | | |

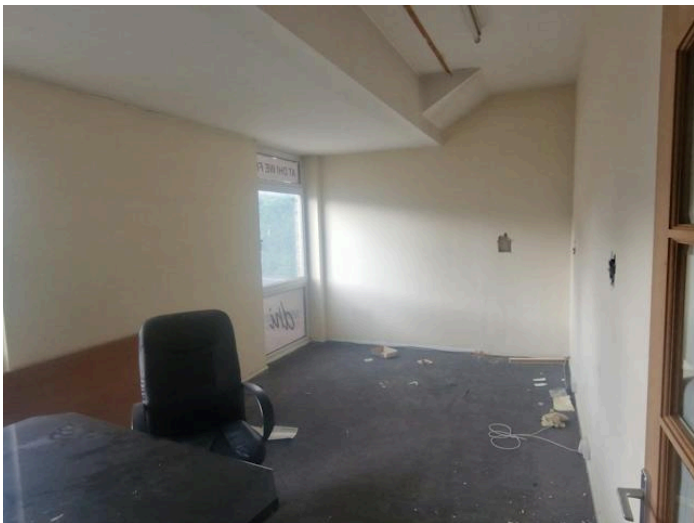
| Location | 004 - | Item | |

| Location Notes | Solid, timber and plasterboard walls. Concrete ceiling. Carpet on concrete base. | | |

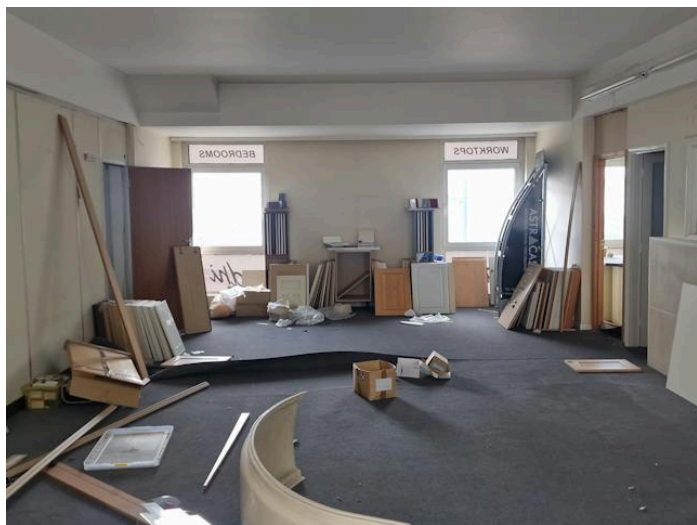
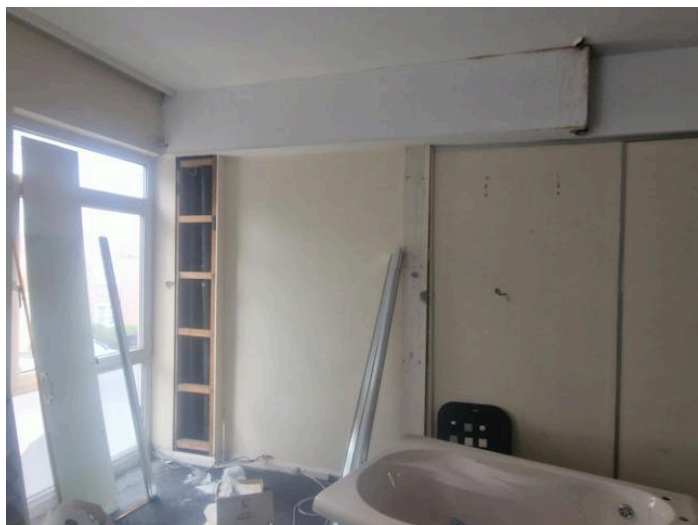
| Location Notes | Solid, timber and plasterboard walls. Concrete ceiling. Carpet on concrete base. Timber and plasterboard box and riser cladding. Plastic pipework within riser. | | |

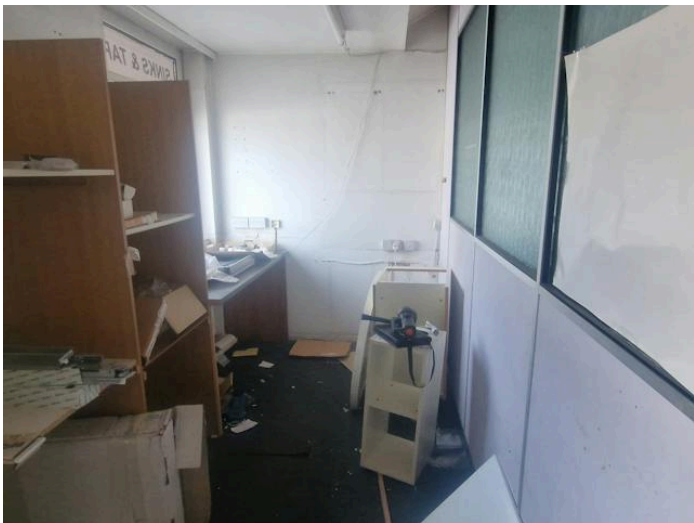
| Location | 006 - | Item | |

| Location Notes | Solid, timber and plasterboard walls. Concrete ceiling. Carpet on concrete base | | |

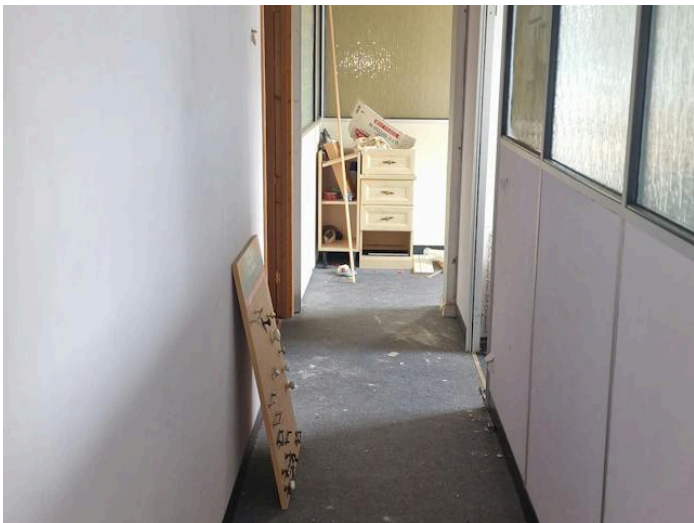
| Location | 007 - | Item | |

| Location Notes | Solid, timber and plasterboard walls. Concrete ceiling. Carpet on concrete base | | |

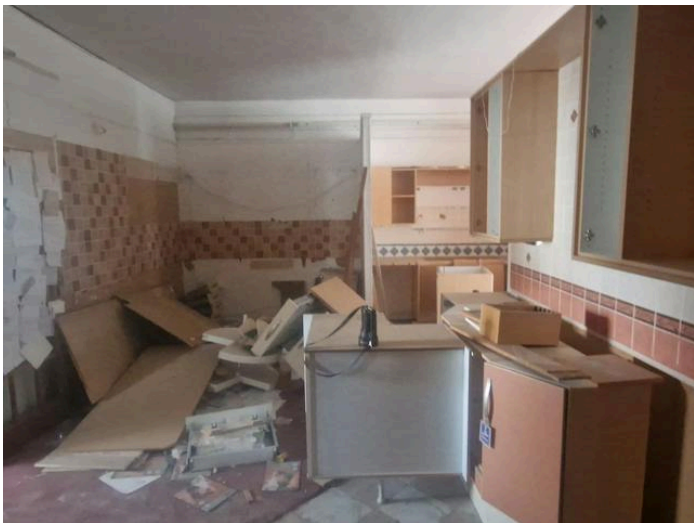
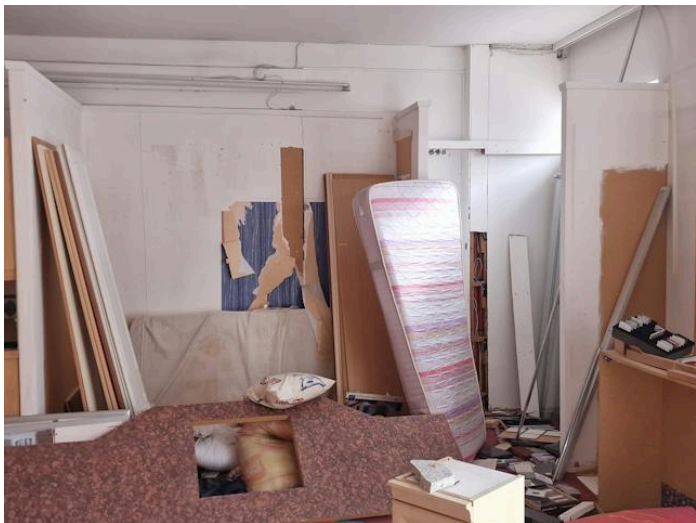
| Location Notes | Solid, timber and plasterboard walls. Concrete ceiling. Carpet and tiles on concrete base. Timber and mdf riser and box cladding and foam insulated pipework within riser. | | |

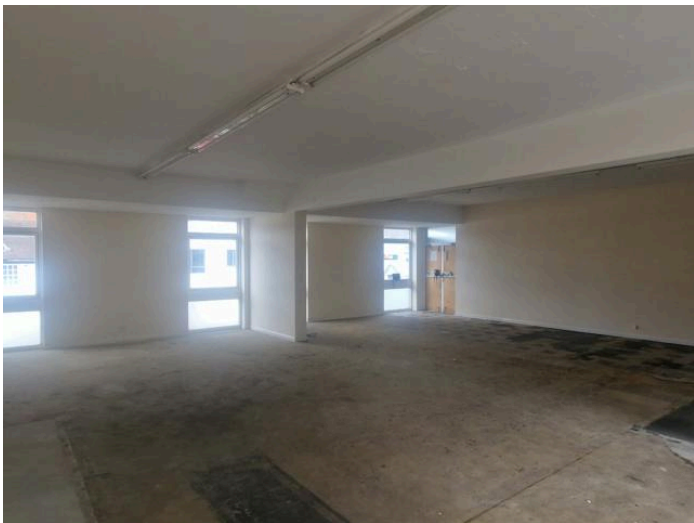
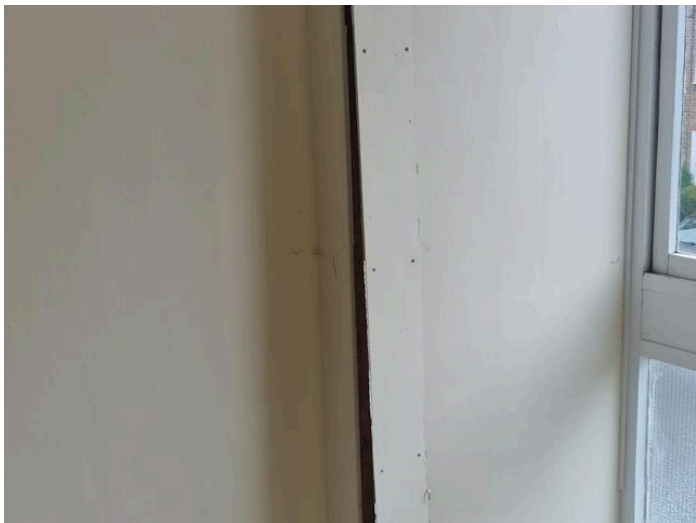
| Location | 009 - | Item | |

| Location Notes | Solid and plasterboard walls. Concrete ceiling. Concrete floor. Timber riser cladding. Foam insulated pipework within riser. | | |

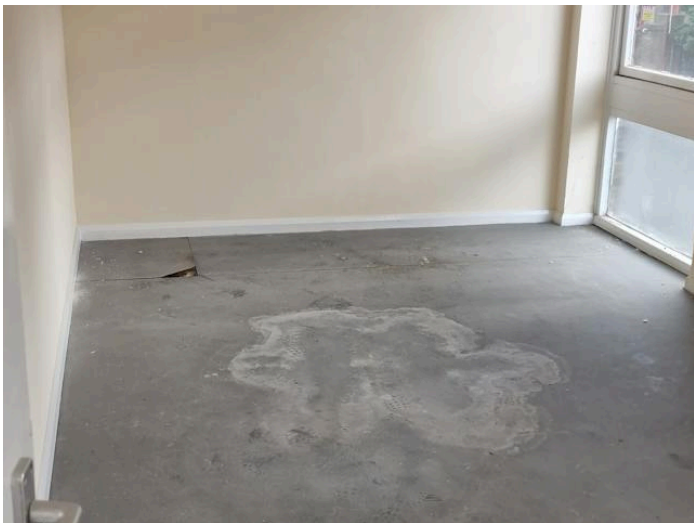
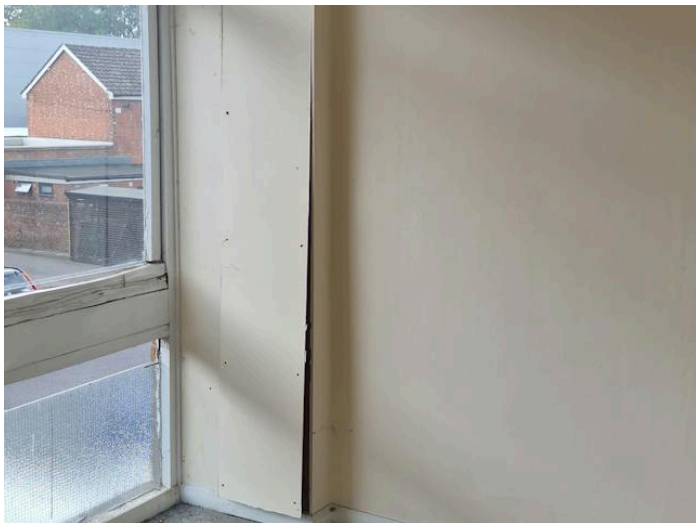
| Location Notes | Solid and plasterboard walls. Concrete ceiling. Non-asbestos vinyl flooring on concrete base. Recent electric consumer unit. Timber riser cladding. Plastic pipework within riser. | | |

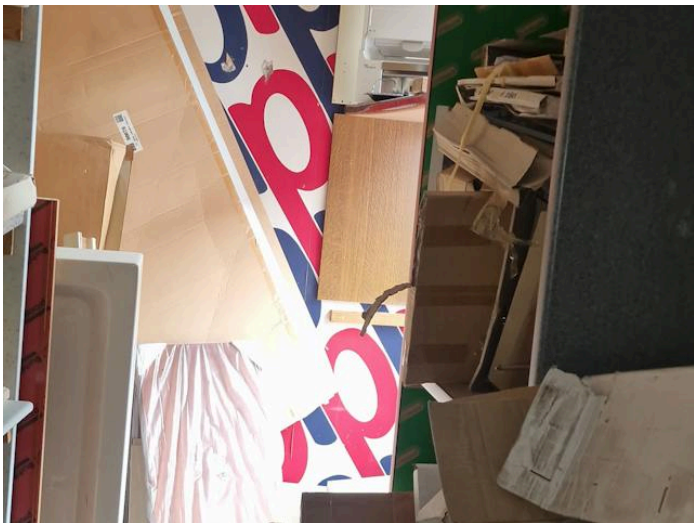
| Location | Electric Store | Item | |

| Location Notes | Solid, timber and plasterboard walls. Concrete ceiling. Carpet on concrete floor. | | |
