# Verification of Remediation

at: Northern Area, Land  
at Sumners Pond, Chapel  
Lane, Barns Green,  
Horsham, RH13 0PR

for: Sigma Homes Ltd

Report Reference: 3750604/VRN/01  
Report Date: 16 February 2026

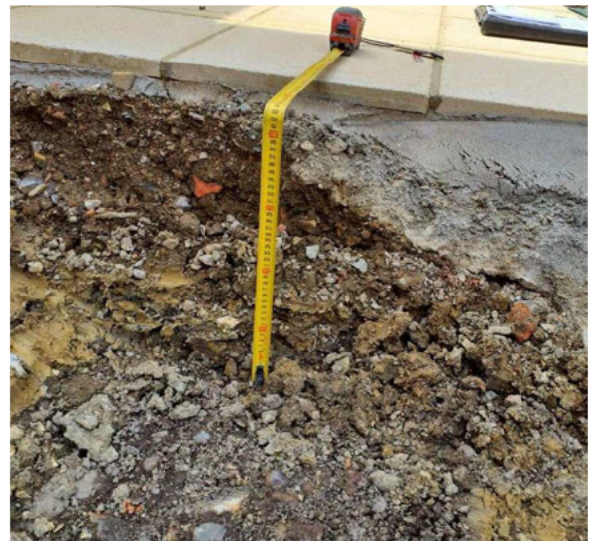
Tape measure showing comparison of finished level to formation level at time of visit, approximately 430mm.

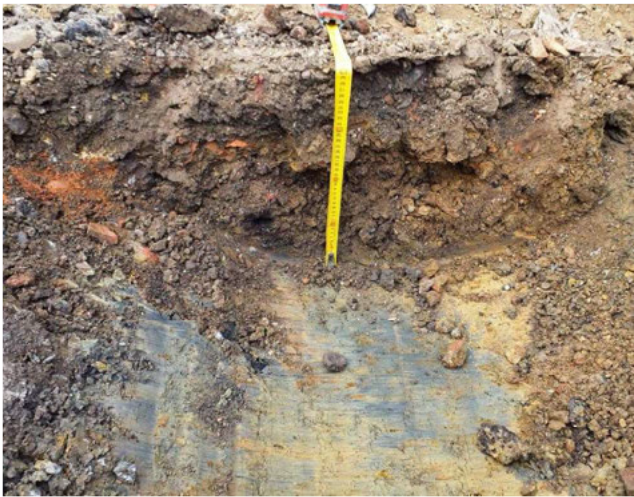
In Plot 2 the formation level had initially been reduced by 400 mm from finished level. However, within the inspection pit anthropogenic materials including brick and concrete were encountered in the shallow soils, and some dark staining. Sigma Homes were requested to reduce the formation level by another 200 mm to remove the made ground up to 600 mm below finished level. This was completed following LEAP's visit, and photographs were provided by Sigma Homes Ltd (see **Appendix C** for the photographs). The photographs indicated made ground still present at formation level, however the formation level had been reduced to ~ 800 mm below the finished level. As such it was considered that in accordance with the RMS the formation level had been reduced sufficiently.

2nd inspection pit excavated into formation level in Plot 2 indicating presence of made ground.

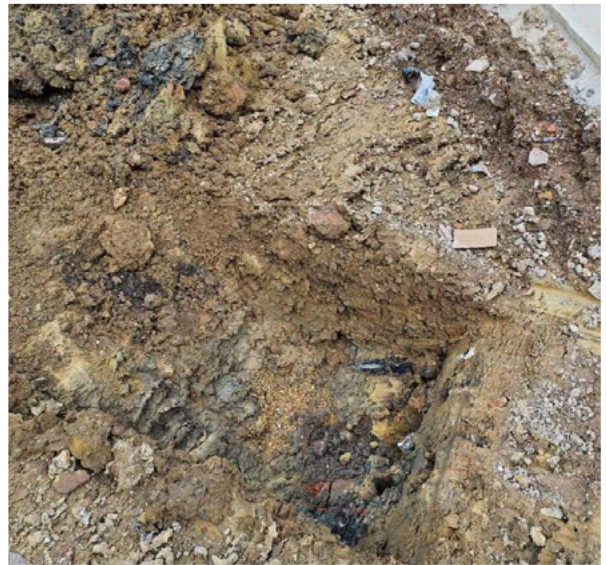
Inspection pit in Plot 2 indicating presence of made ground soils

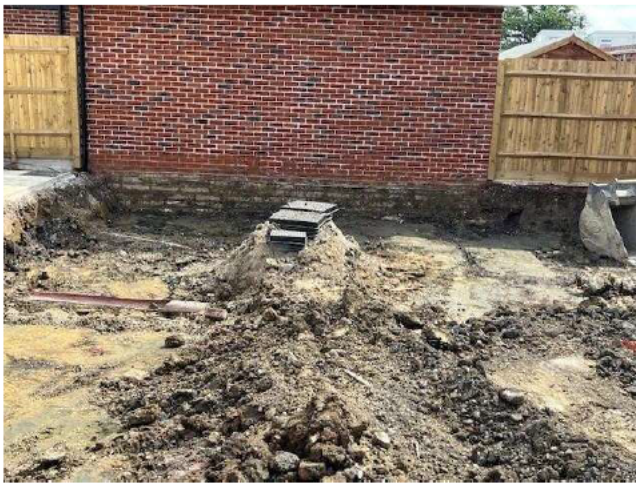
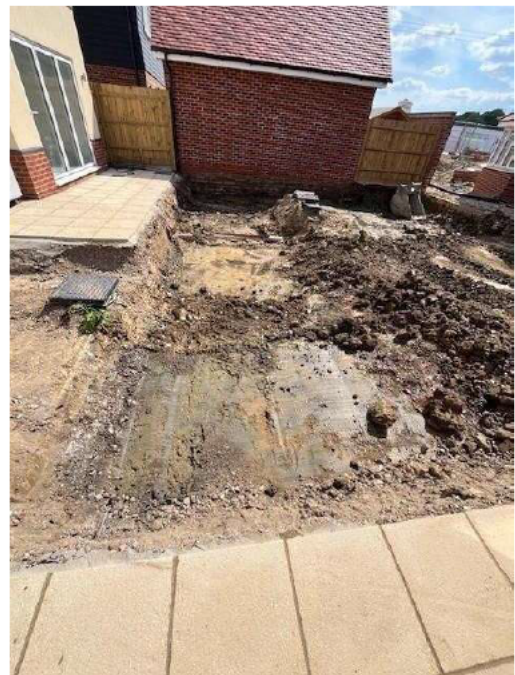
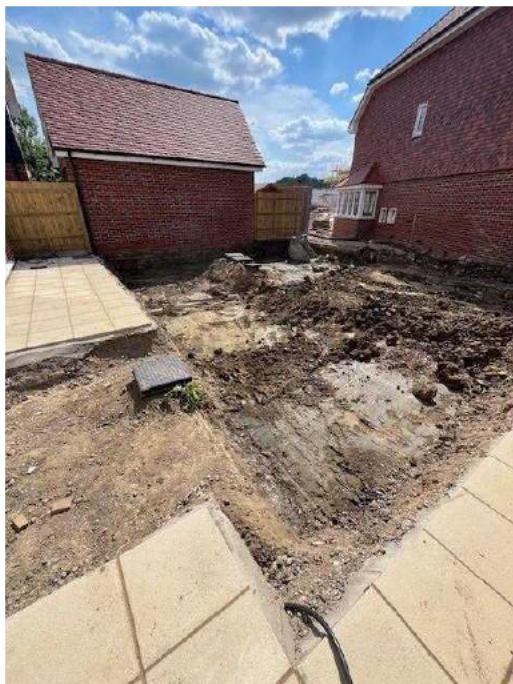
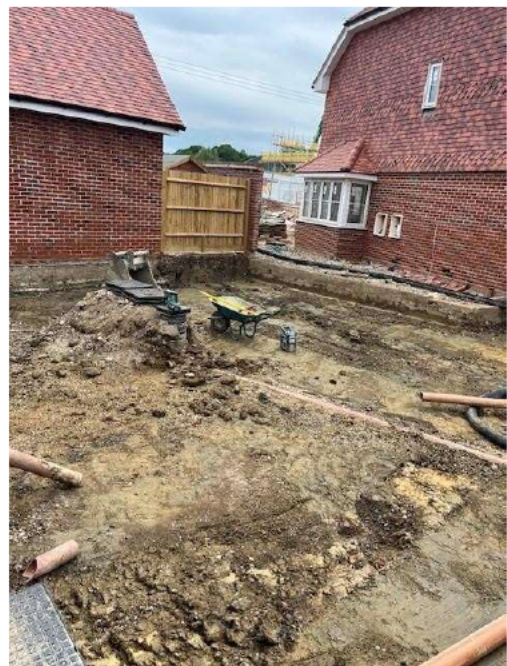
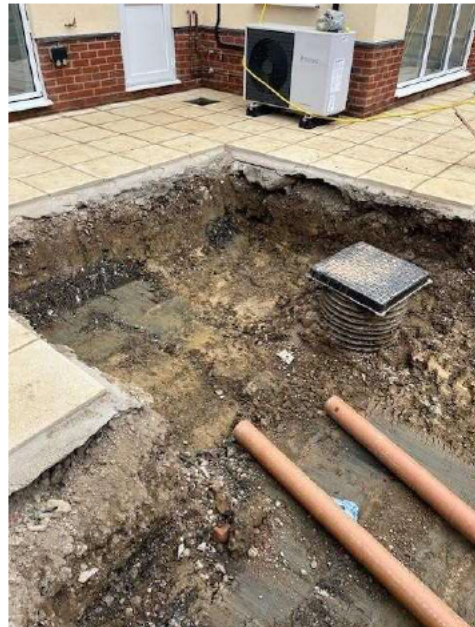
View of Plot 2 following removal of made ground in top 600mm  
(photograph provided by client)

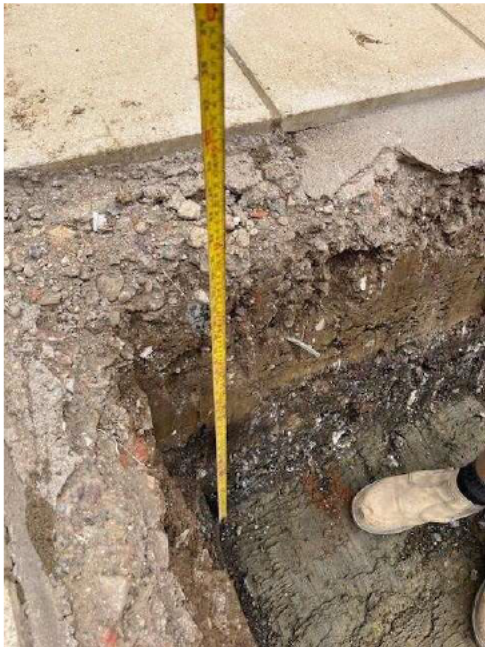
Tape measure comparing formation level from finished level, indicating formation level ~ 800 mm below finished level (photo provided by client)

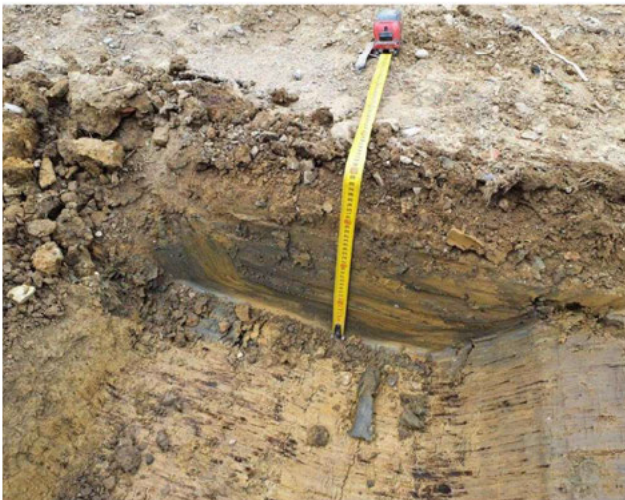
Inspection pit excavated ~400mm through formation level in Plot 3.

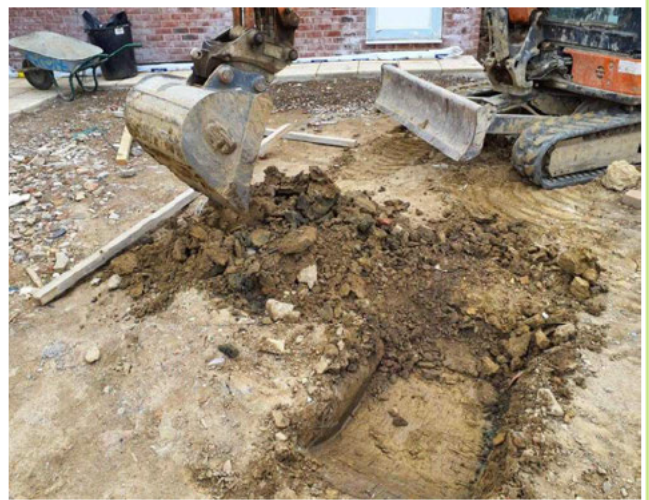
Inspection pit excavated through formation level in Plot 3.

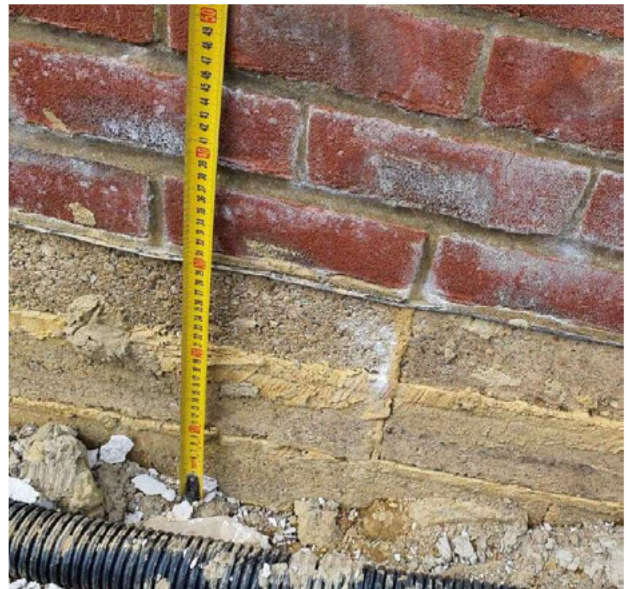
Tape measure showing comparison of finished level (top of 2 blocks and 2 bricks) to formation level, approximately 450mm
